Inspection Photos  
Operator: Hilcorp Energy  
Facility: 067-08319  
Date: 4/12/2021

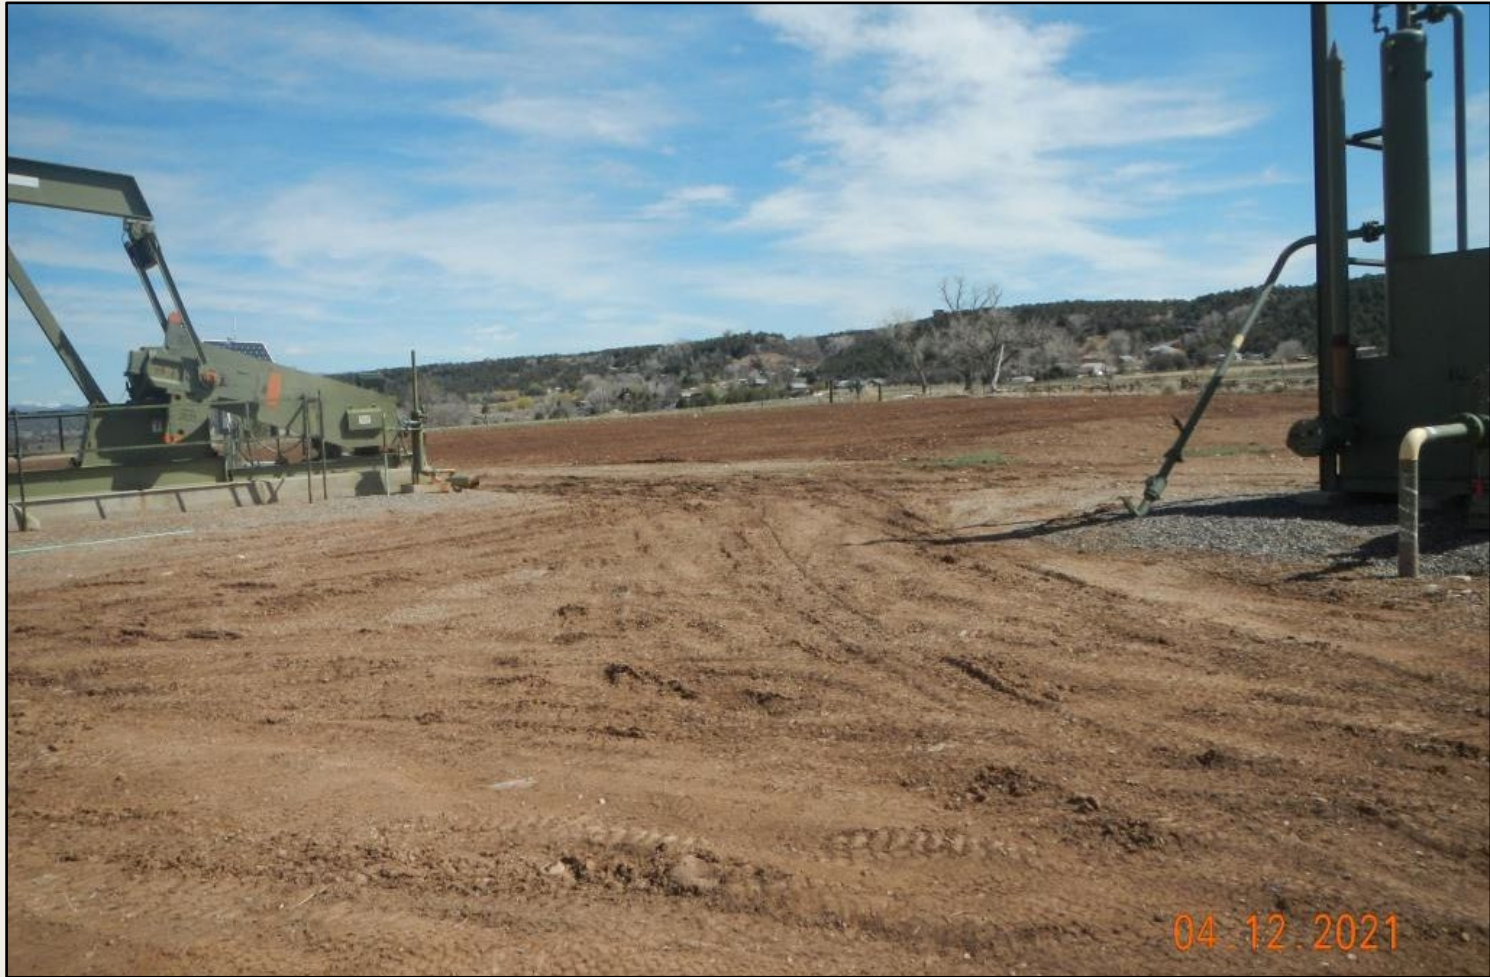
Photo 1. View of the project area from the well pad entrance facing center. Equipment observed during previous inspection, is no longer present.

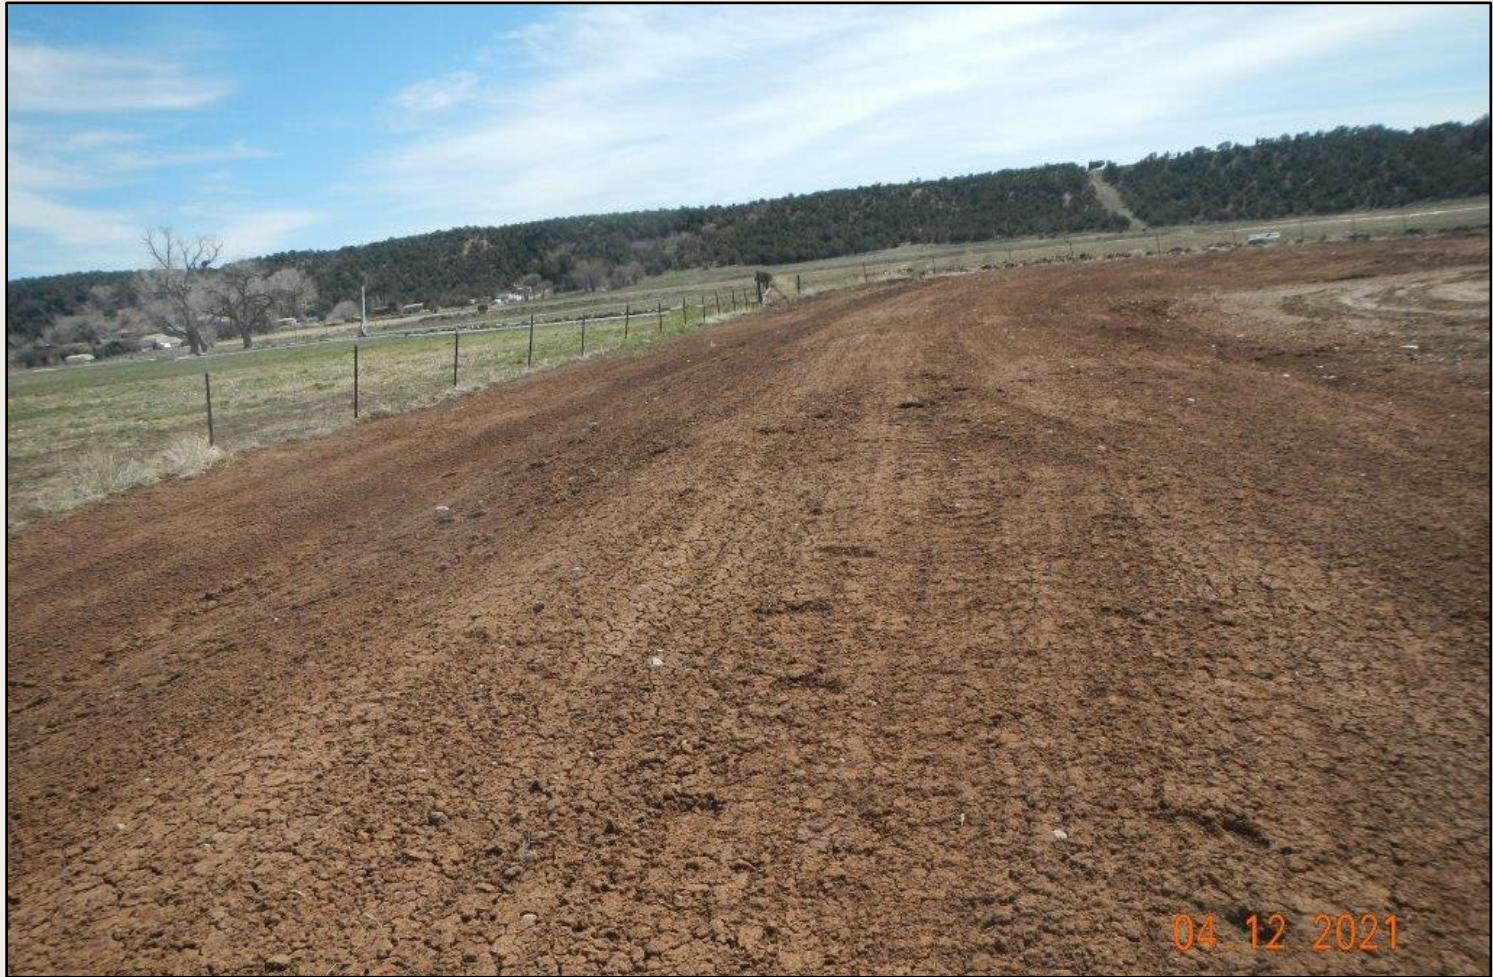
Photo 2. View of the northern project area from the northwestern corner facing eastward. Revegetation is conducted within the interim reclamation areas. Germination observed. However, bare soils are not protected and erosion controls not installed.
