Inspection Photos
Location Name: Albert Martinez #1
API: 05-007-06253

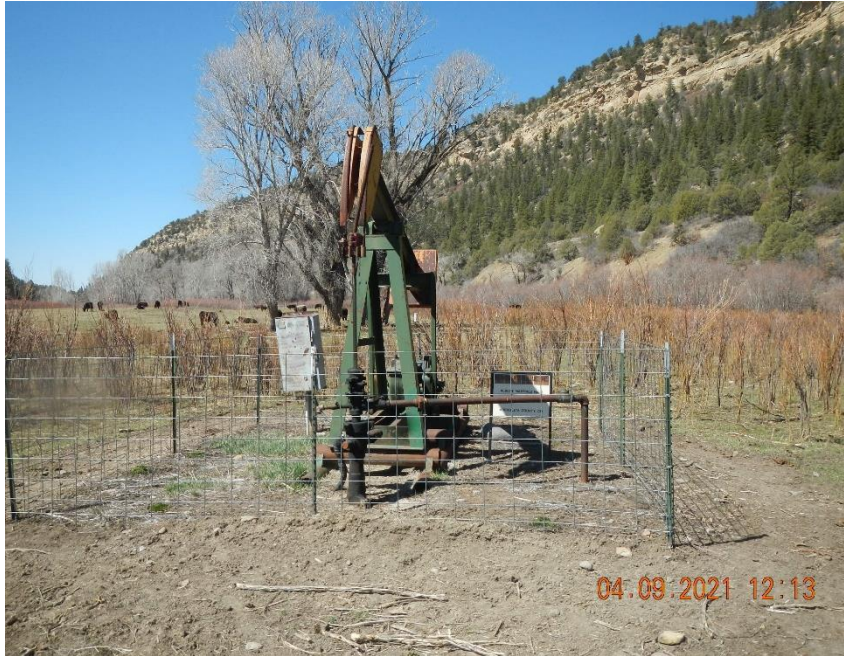
Albert Martinez #1 well head and pump jack.

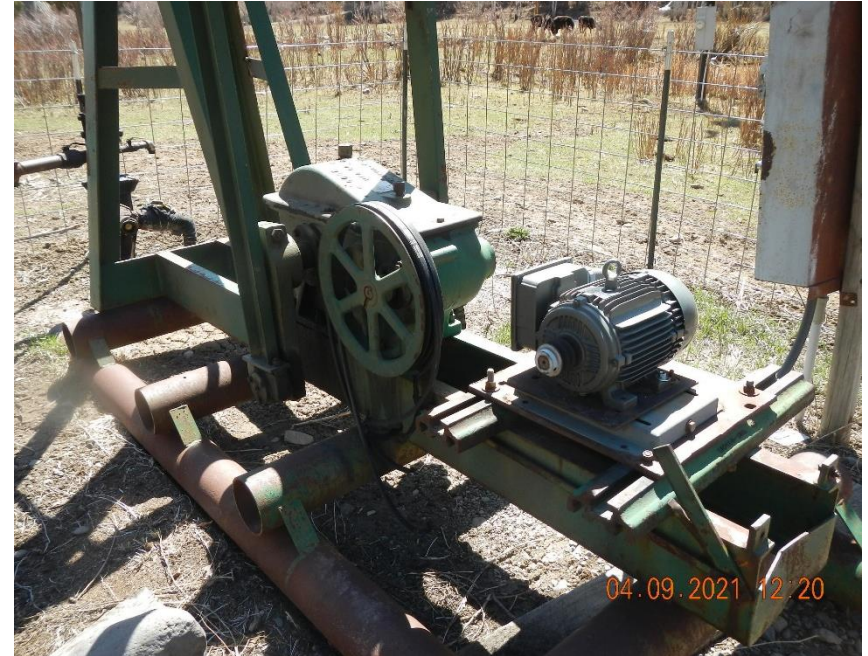
Drive belts on pump jack have broken. EPS staff shut down power to electric motor.

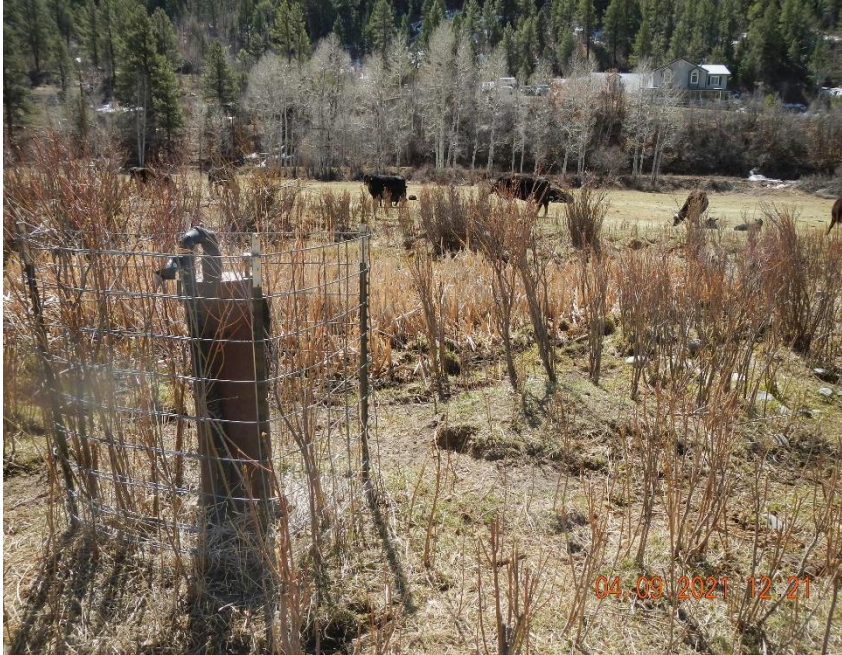
Drop out tank for domestic tap.

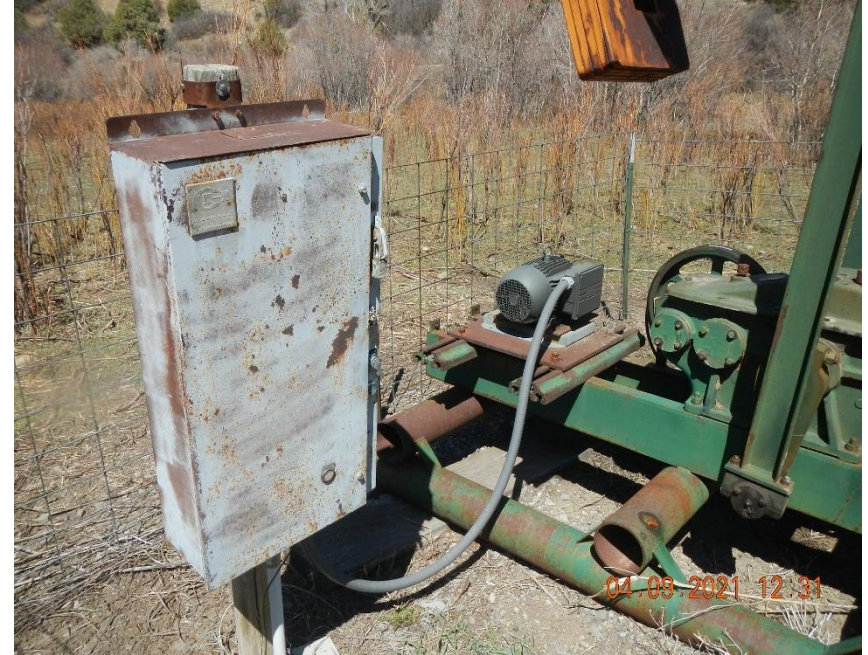
Electrical supply to pump jack turned off during this inspection.

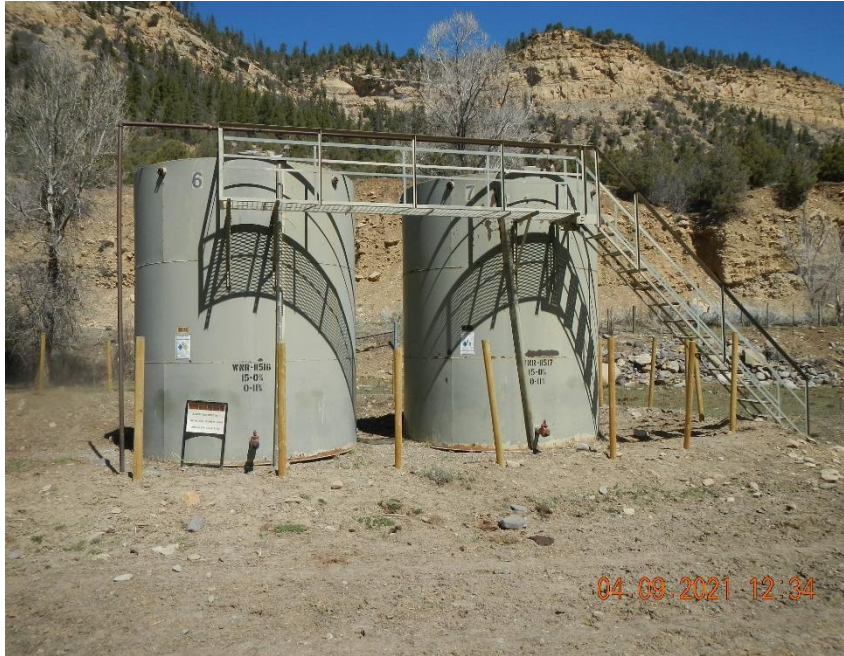
Albert Martinez #1 tank battery. Anchors were observed during this inspection. Tanks are not attached to anchors.

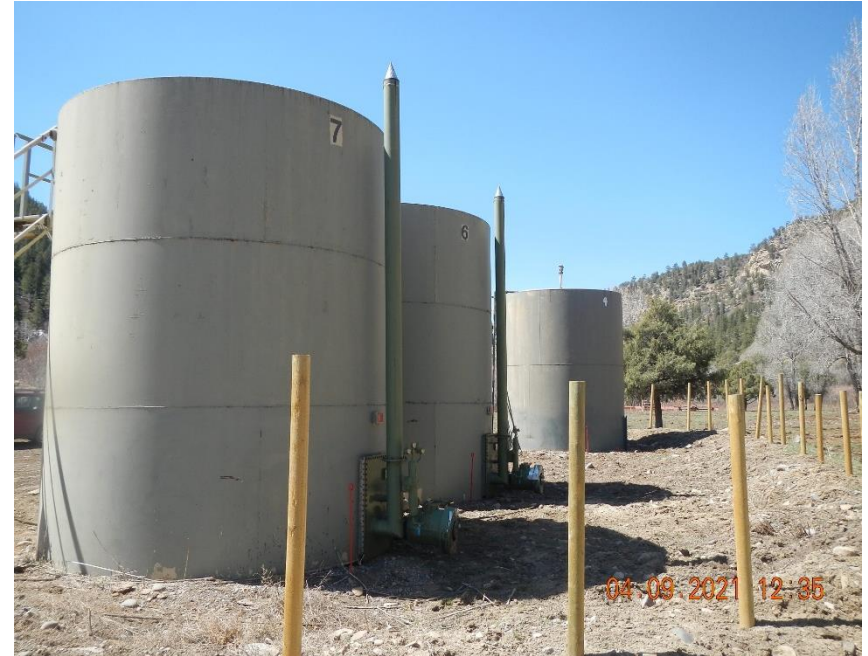
Albert Martinez #1 and Nielson #4 ASTs.
