Inspection Photos
Location Name: Chavez #1
API: 05-007-06120

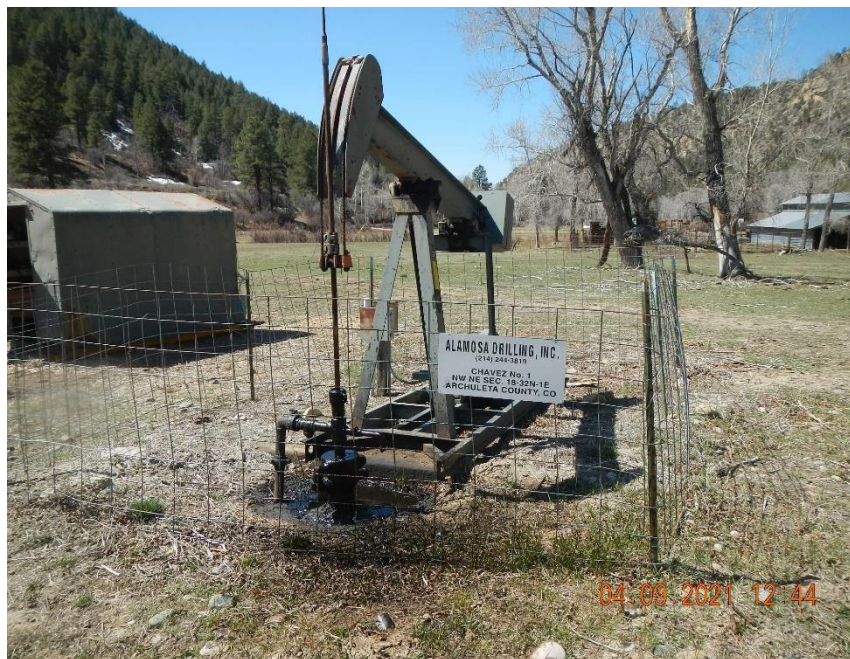
Chavez #1 well head and pump jack with oil impacted soil and vegetation.

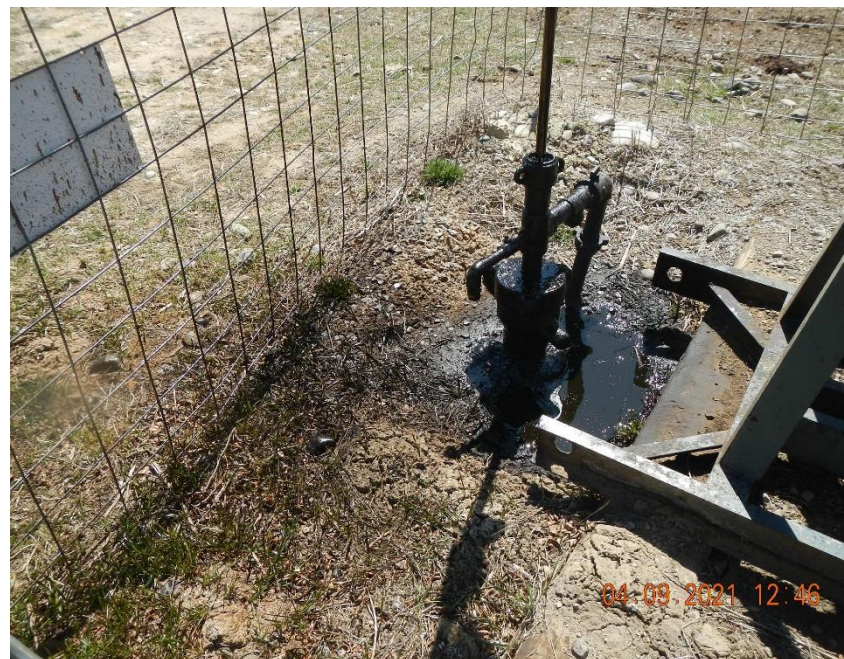
Chavez #1 well head is wet and stained. Surrounding area is wet and stained with oil.

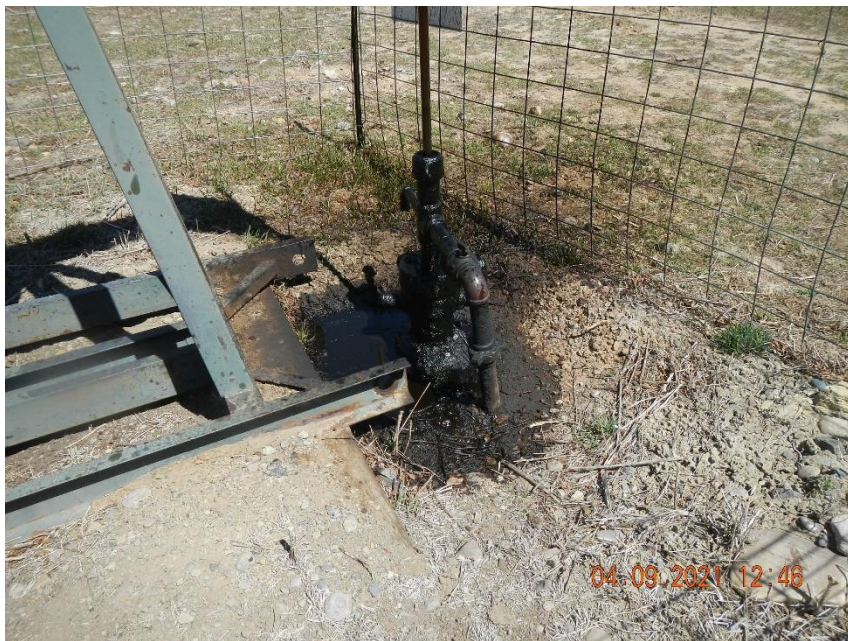
Oil puddle around well head and stained/wet vegetation and soil.

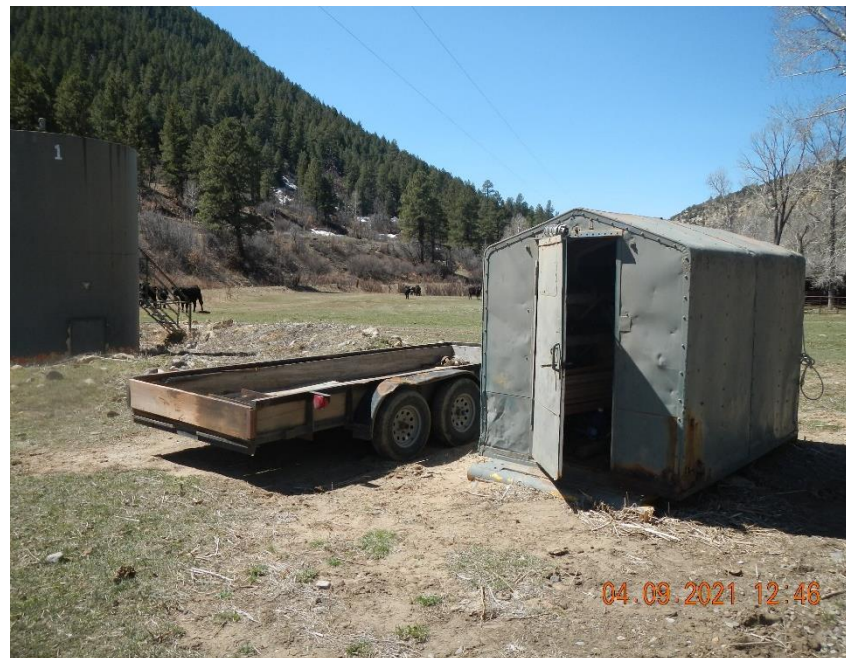
Trailer stored on location.

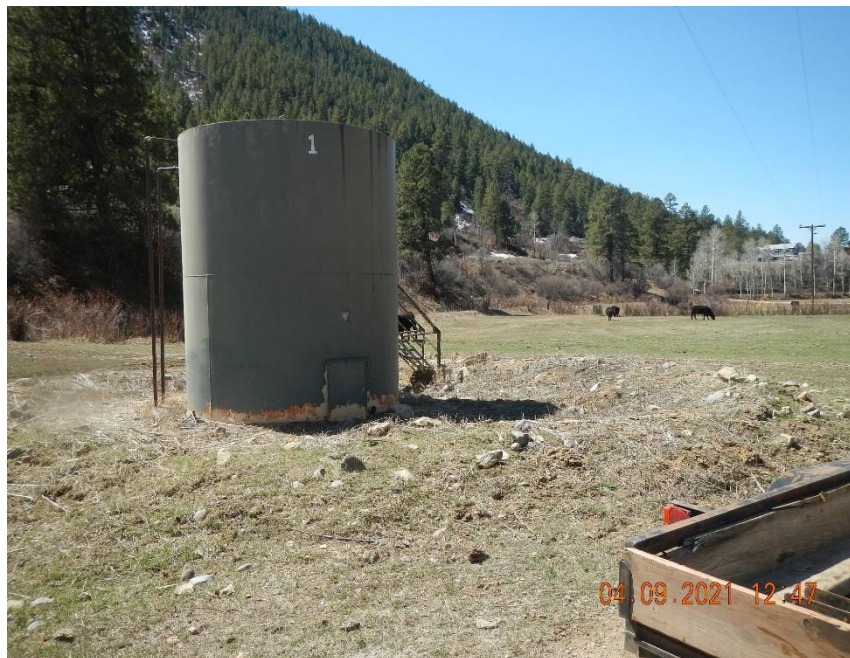
300 bbl. crude oil AST for Chavez #1 and #2.

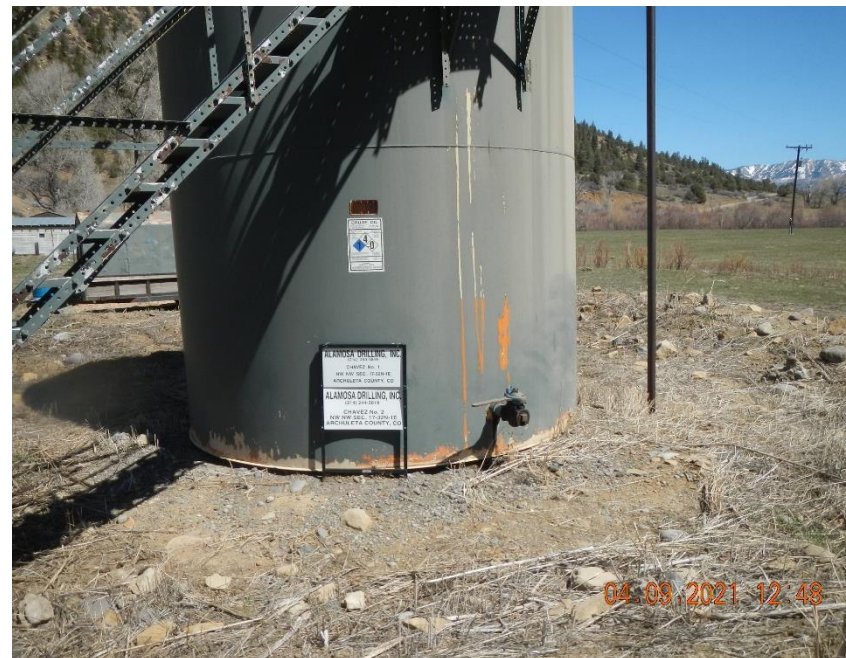
Tank battery sign is not compliant with Rule 605.e(2).
