Inspection Photos
Location Name: Chavez #2
API: 05-067-06136

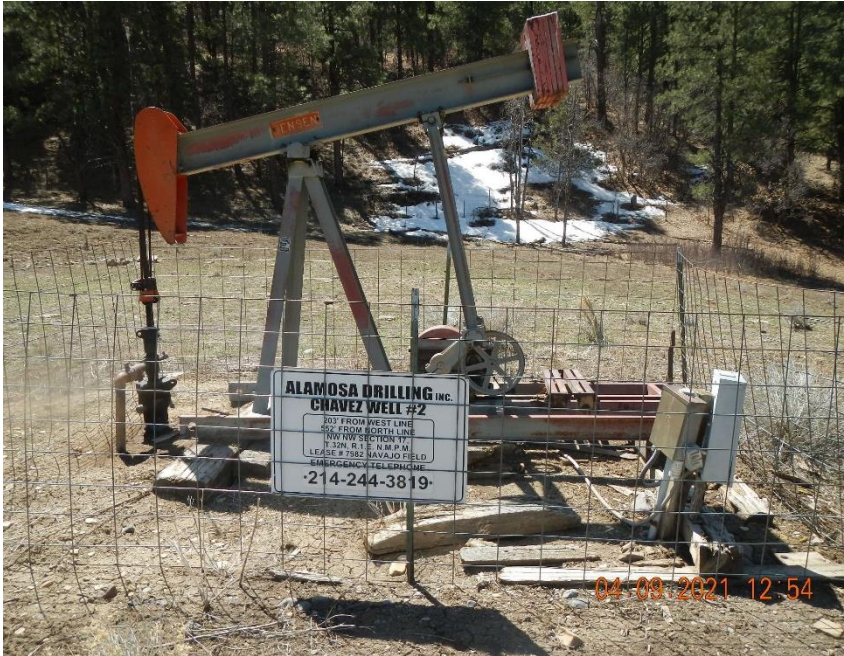
Chavez #2 pump jack and well head.

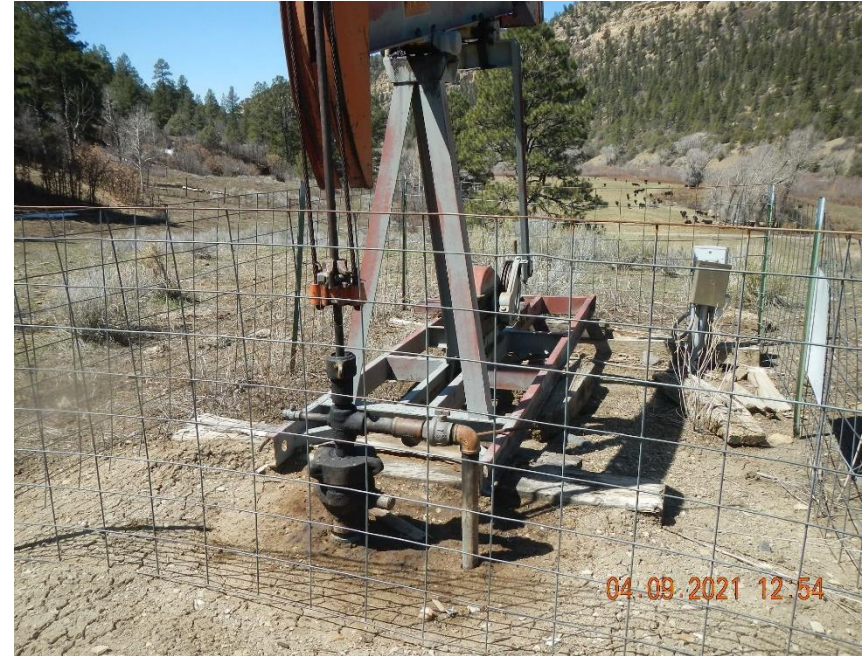
Electric motor is not present.

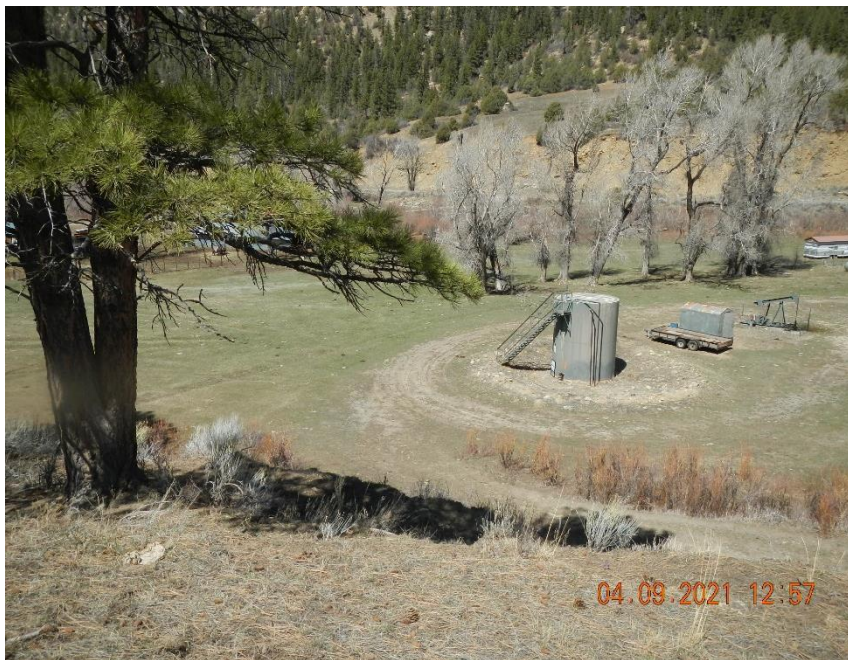
View of AST used by Chavez #1 and #2 wells.

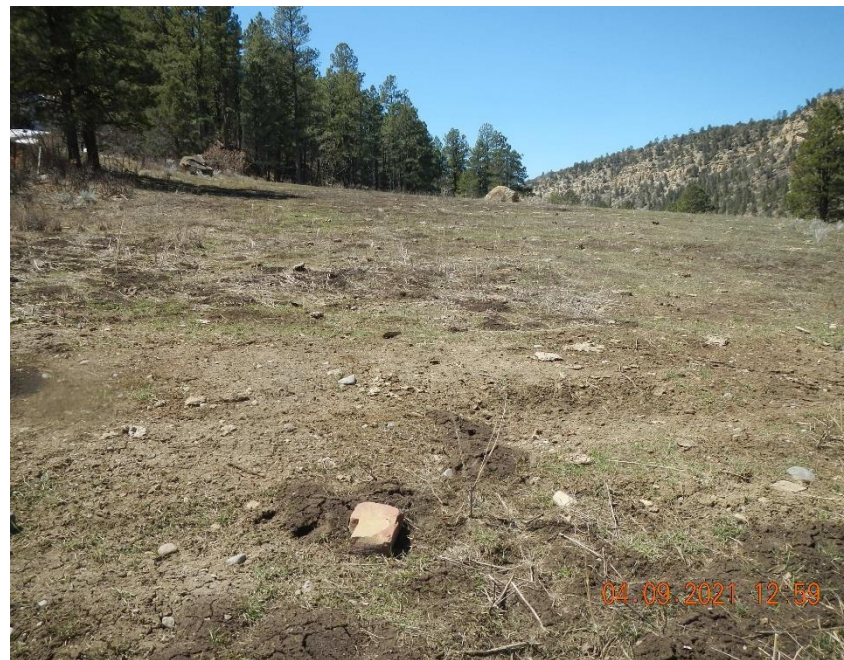
Soil from the Albert Martinez #1 REM #13940 has been removed.
