Inspection Photos
Operator: Linde Operating
Facility: 083-06256
Date: 4/12/2021

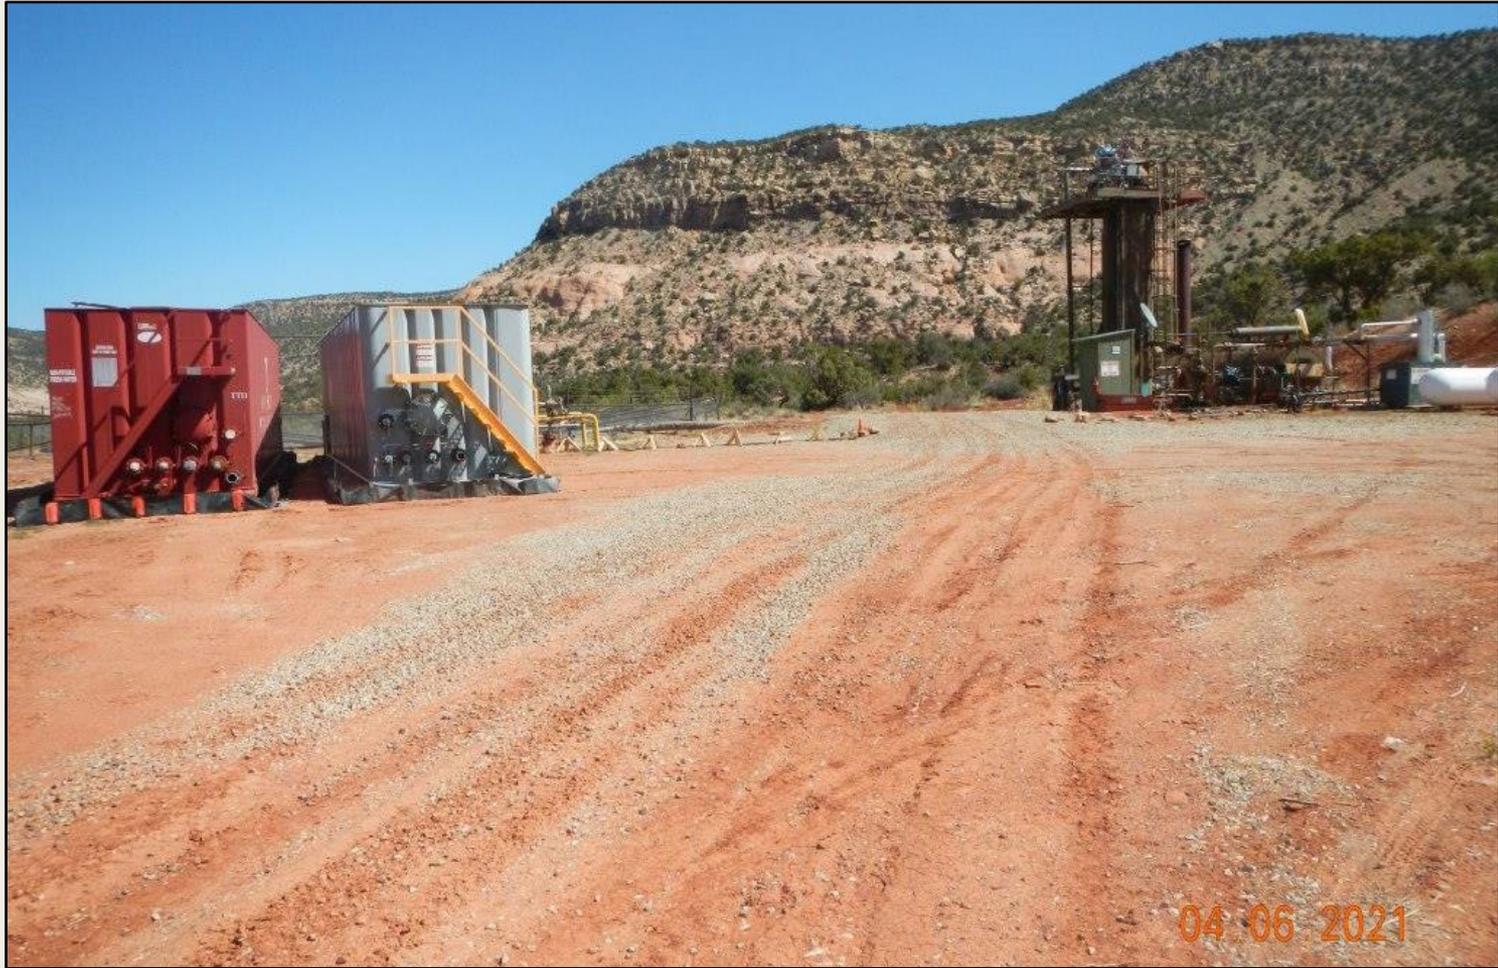
Photo 1. View of the project area from the well pad entrance facing center.

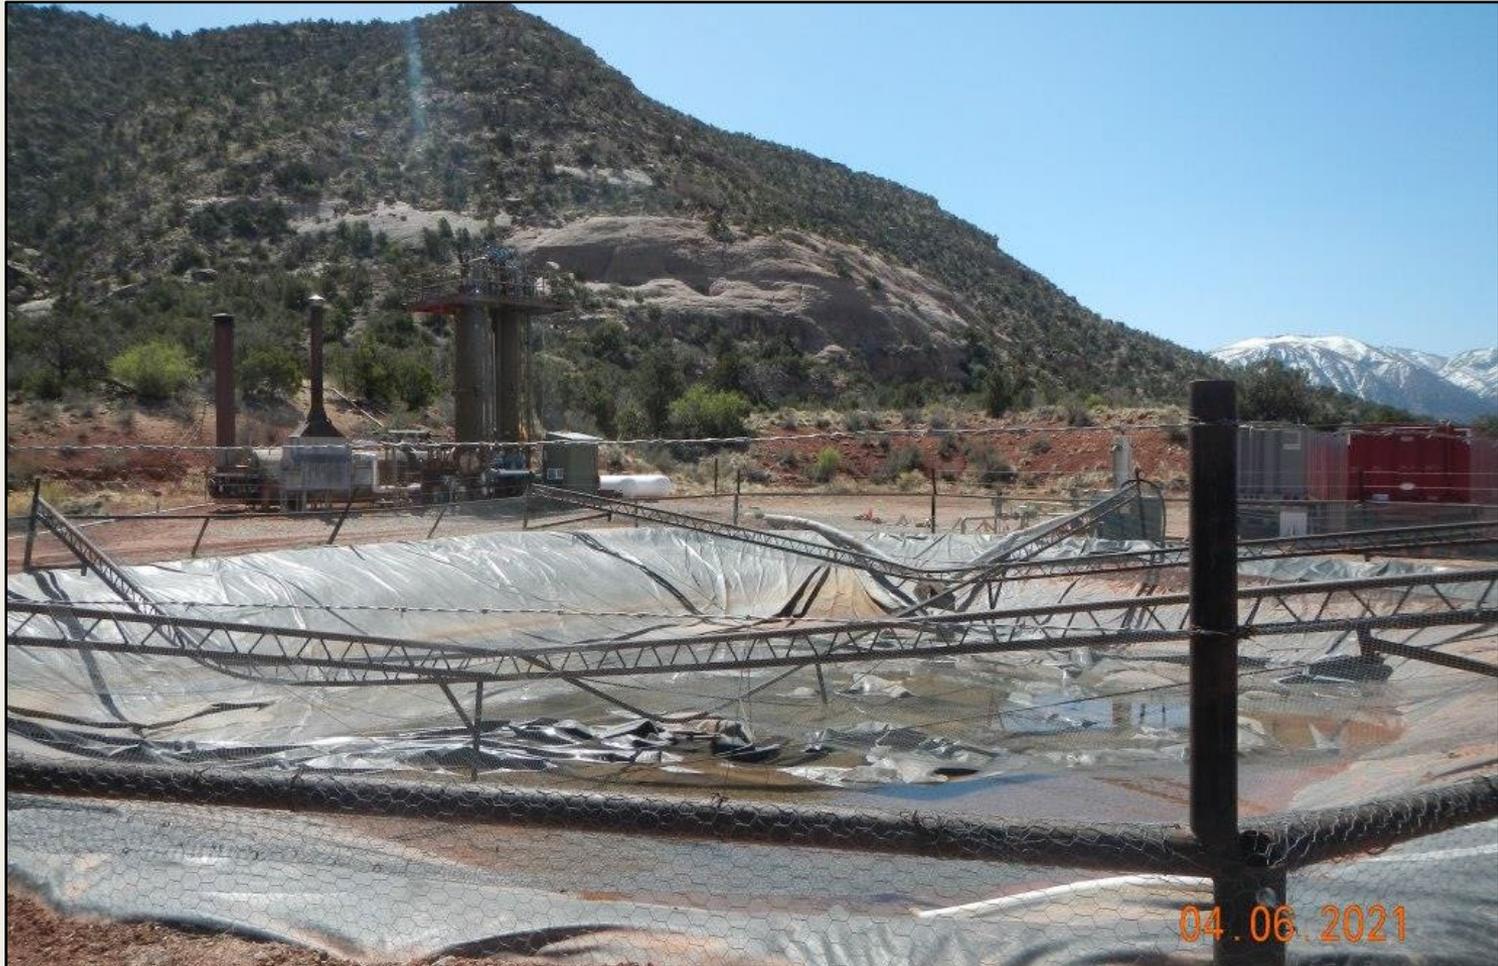
Photo 2. View of the project area from the northwestern corner facing center. Netting scaffold appears to have collapsed. Netting in disrepair.

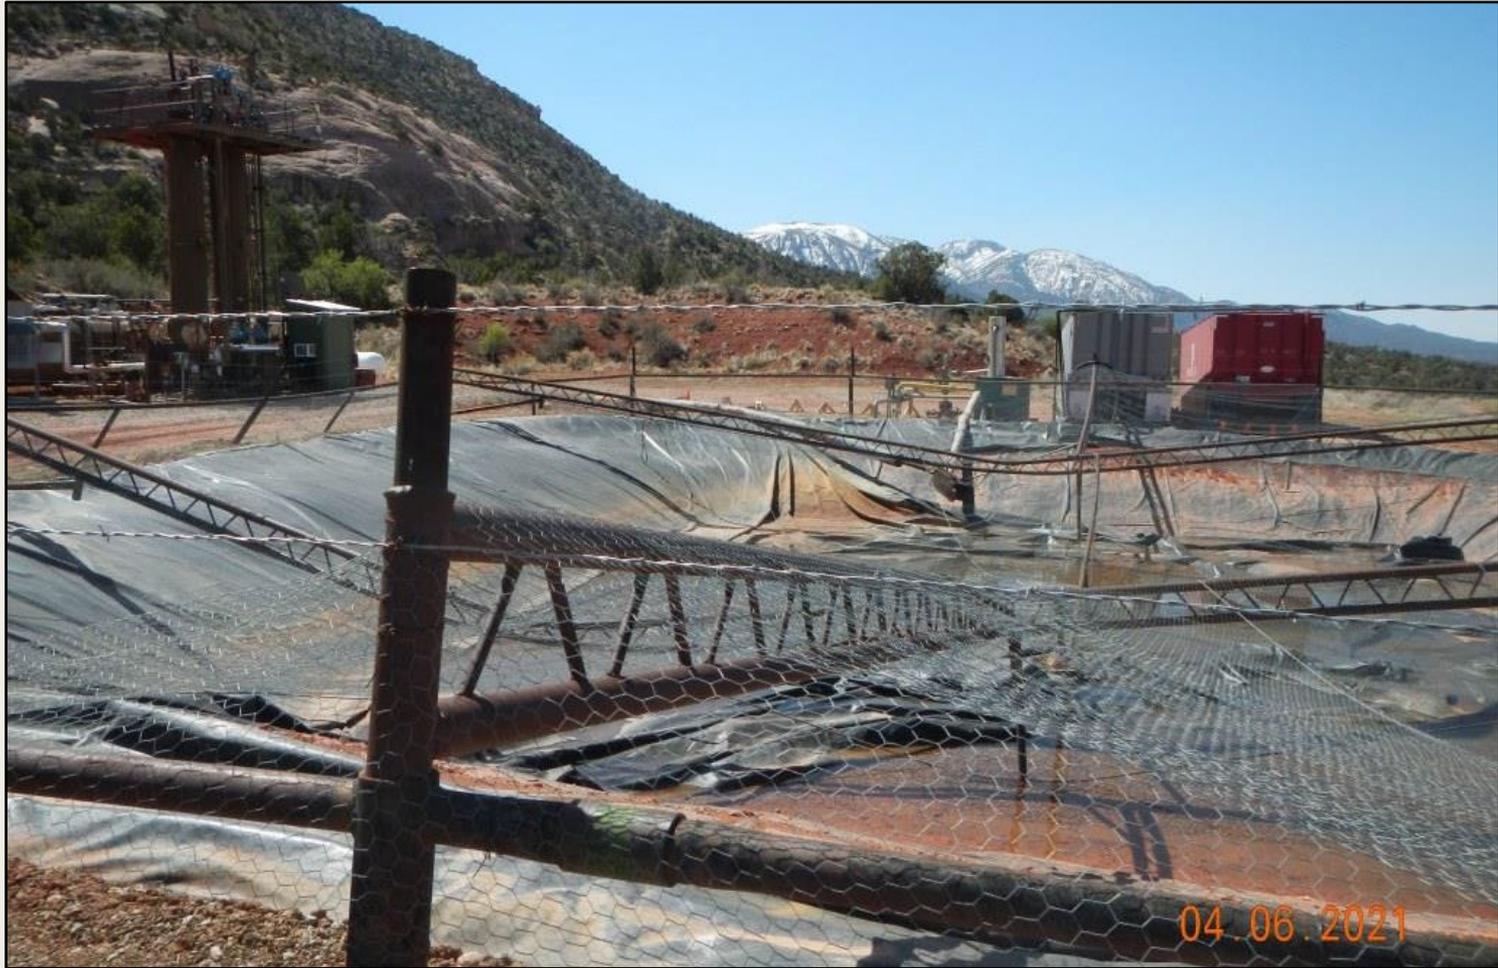
Photo 3. Another view of pit area. Liner may be compromised. Netting in disrepair.

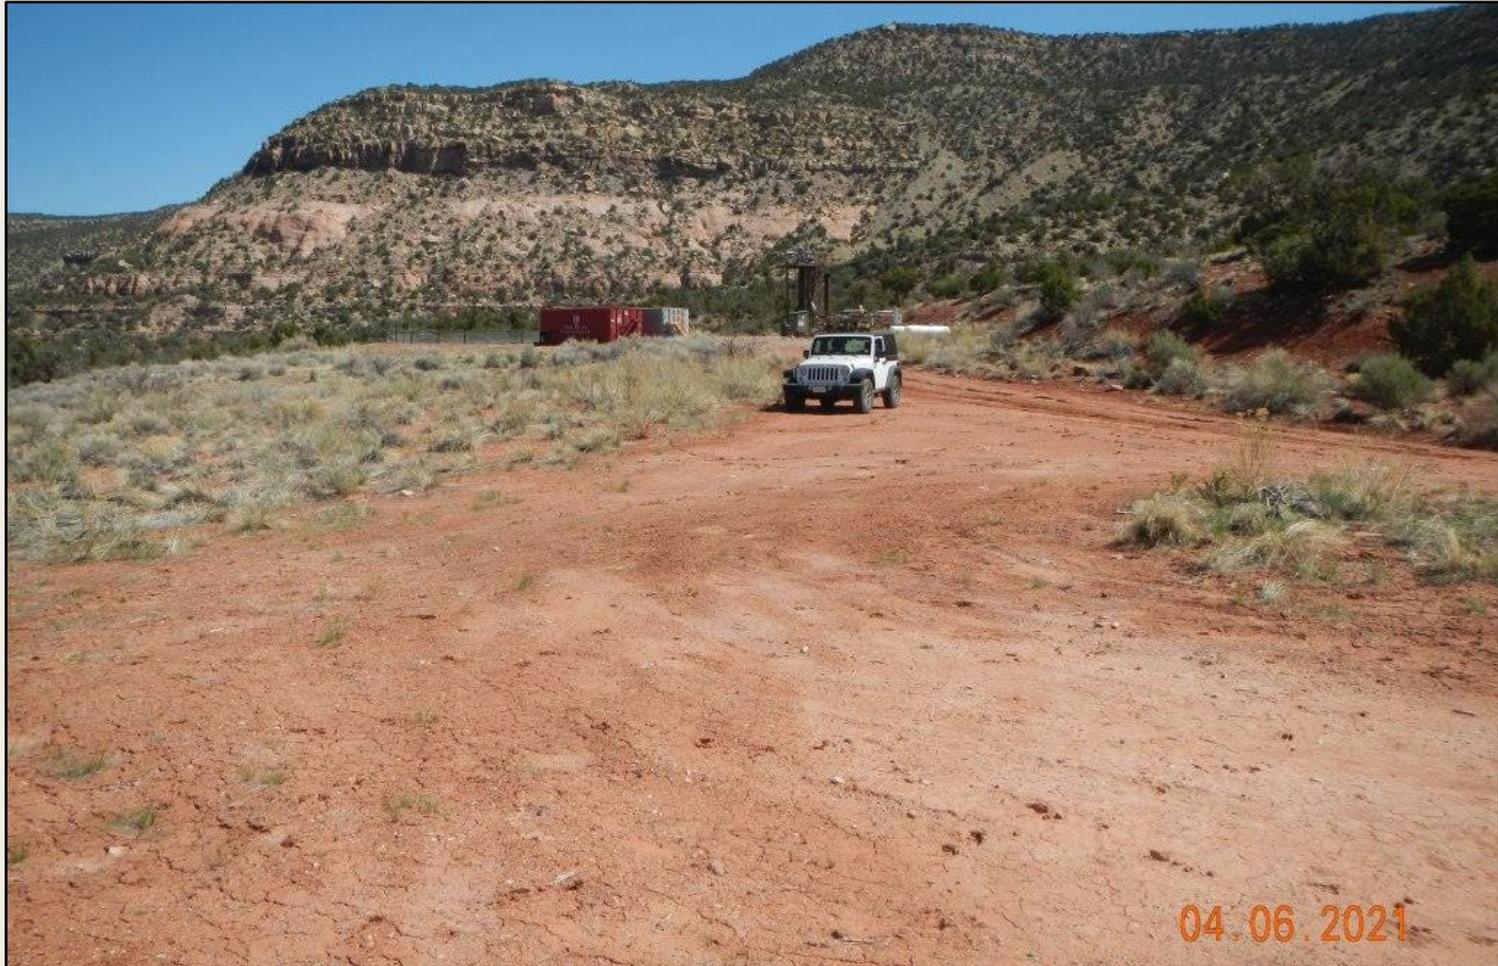
Photo 4. View of the western project area facing northward. Area around dry hole marker is in use for parking and vehicle traffic. This area will require reclamation after plugging.

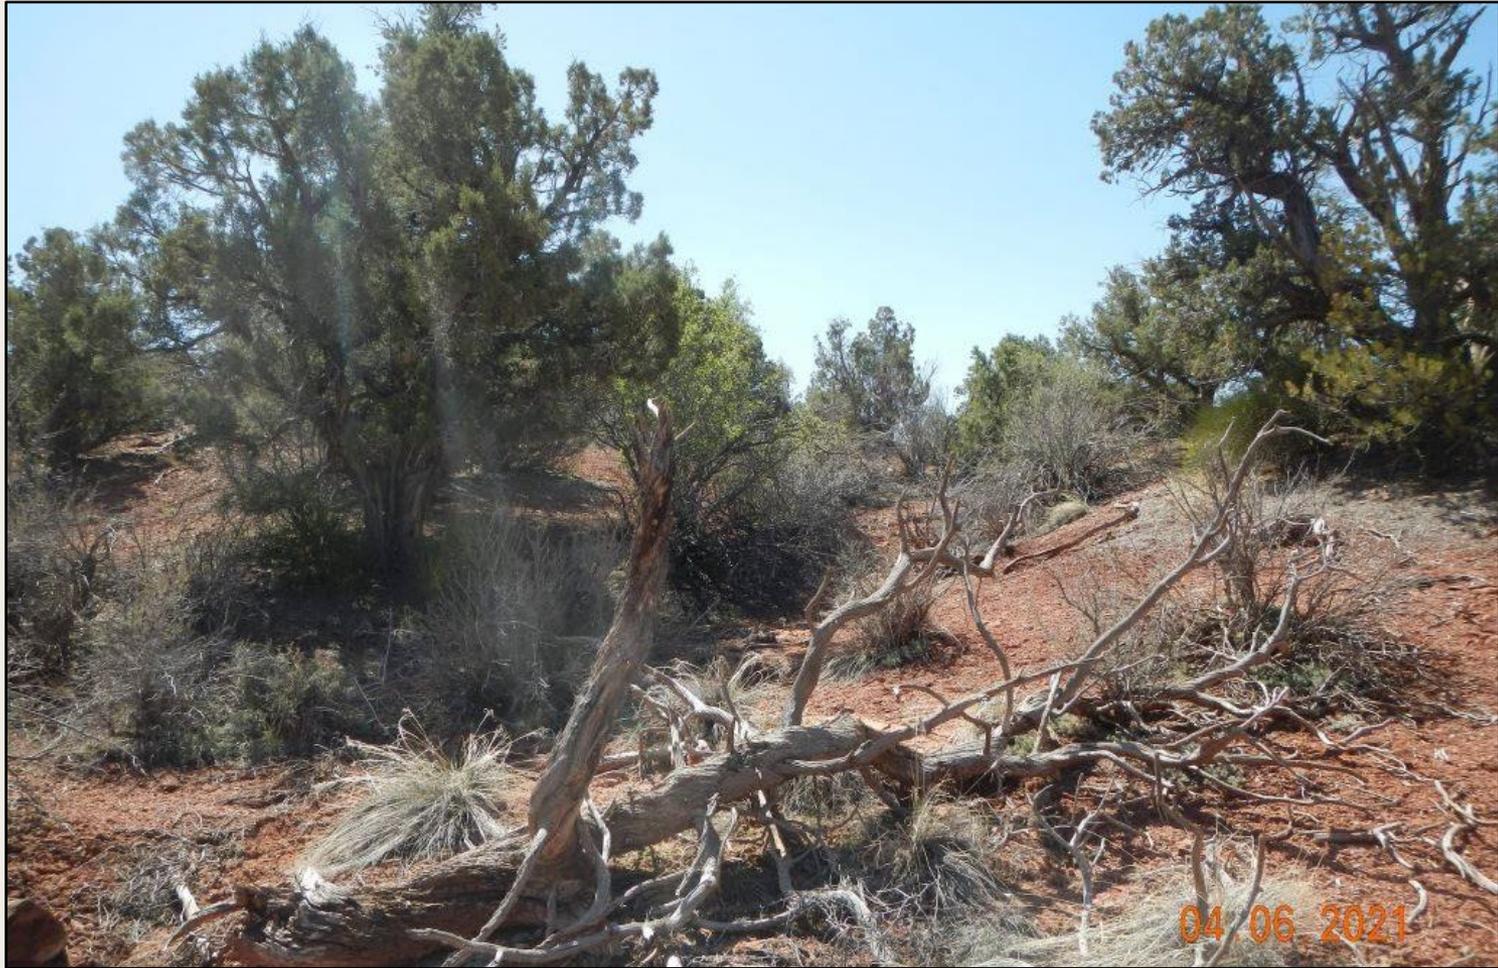
Photo 5. View of the reference area comprised of pinyon and juniper woodland with understory of serviceberry, cliffrose, and Indian ricegrass.
