Inspection Photos
Operator: Linde Inc.
Facility: 083-06522
Date: 4/6/2021

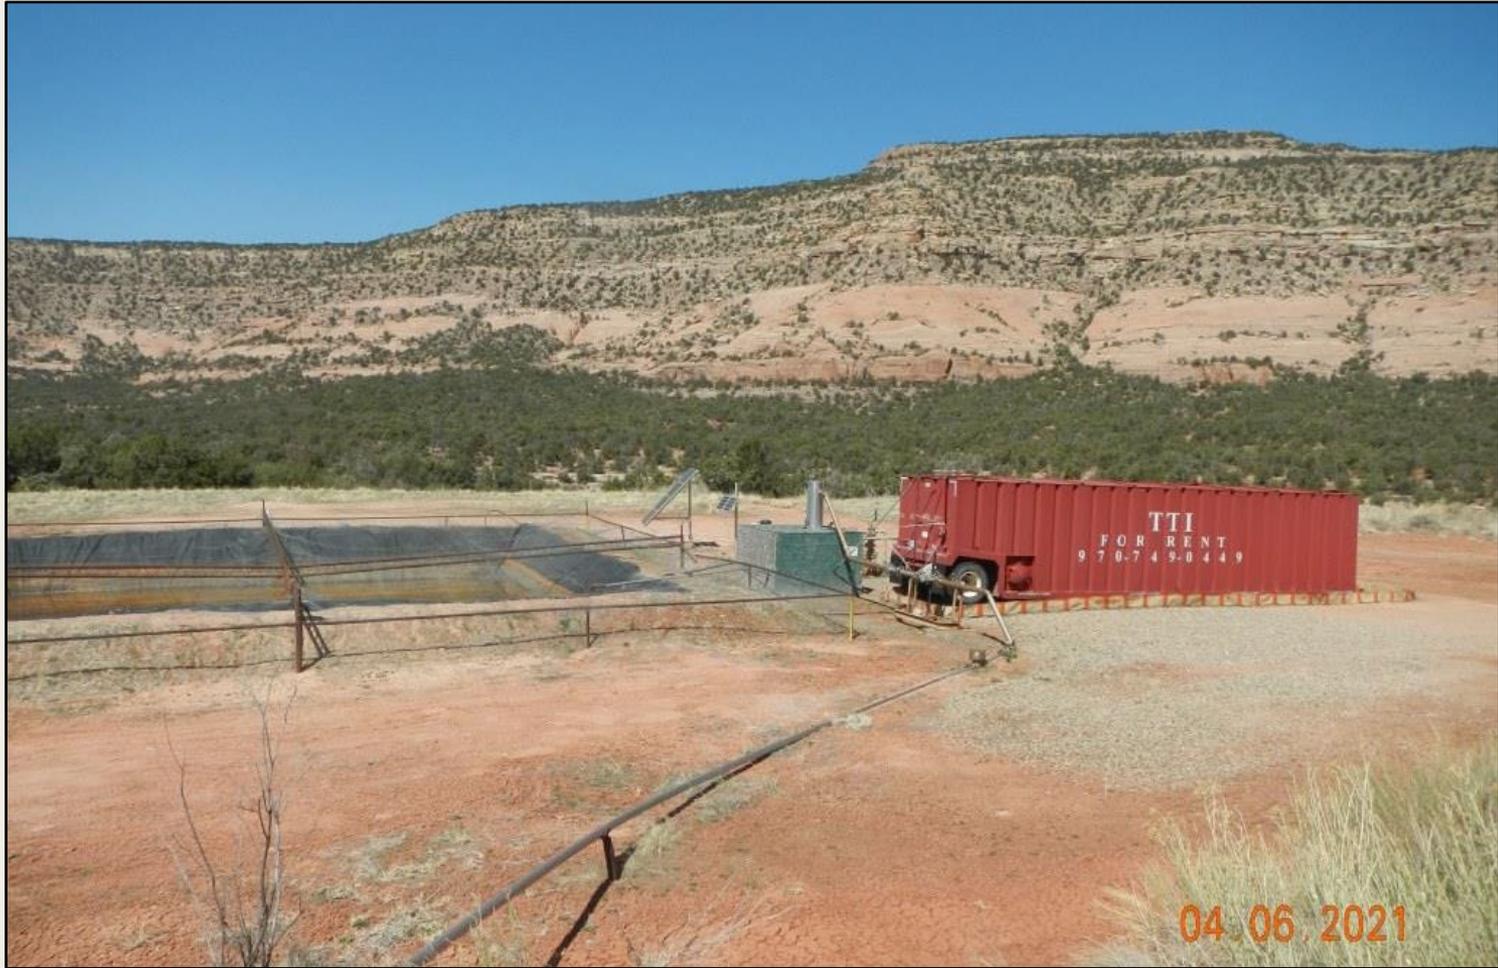
Photo 1. View of the project area from the well pad entrance facing center.

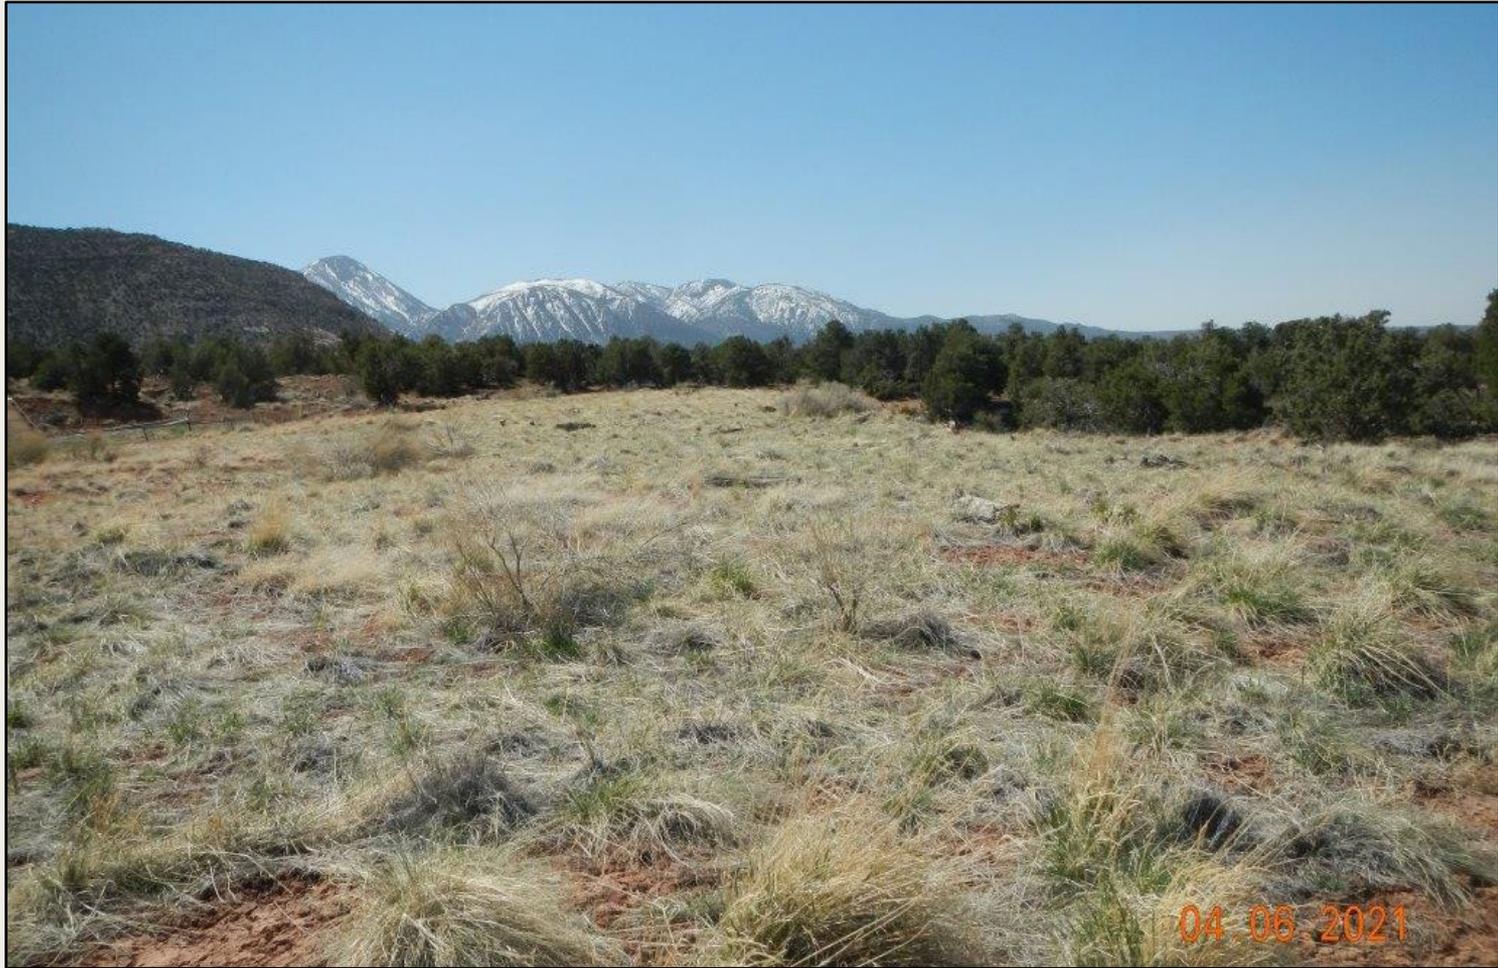
Photo 2. View of the western project area from the northwestern corner facing southward. Revegetation is progressing with a variety of grasses such as Indian ricegrass, crested wheatgrass, and James galleta.

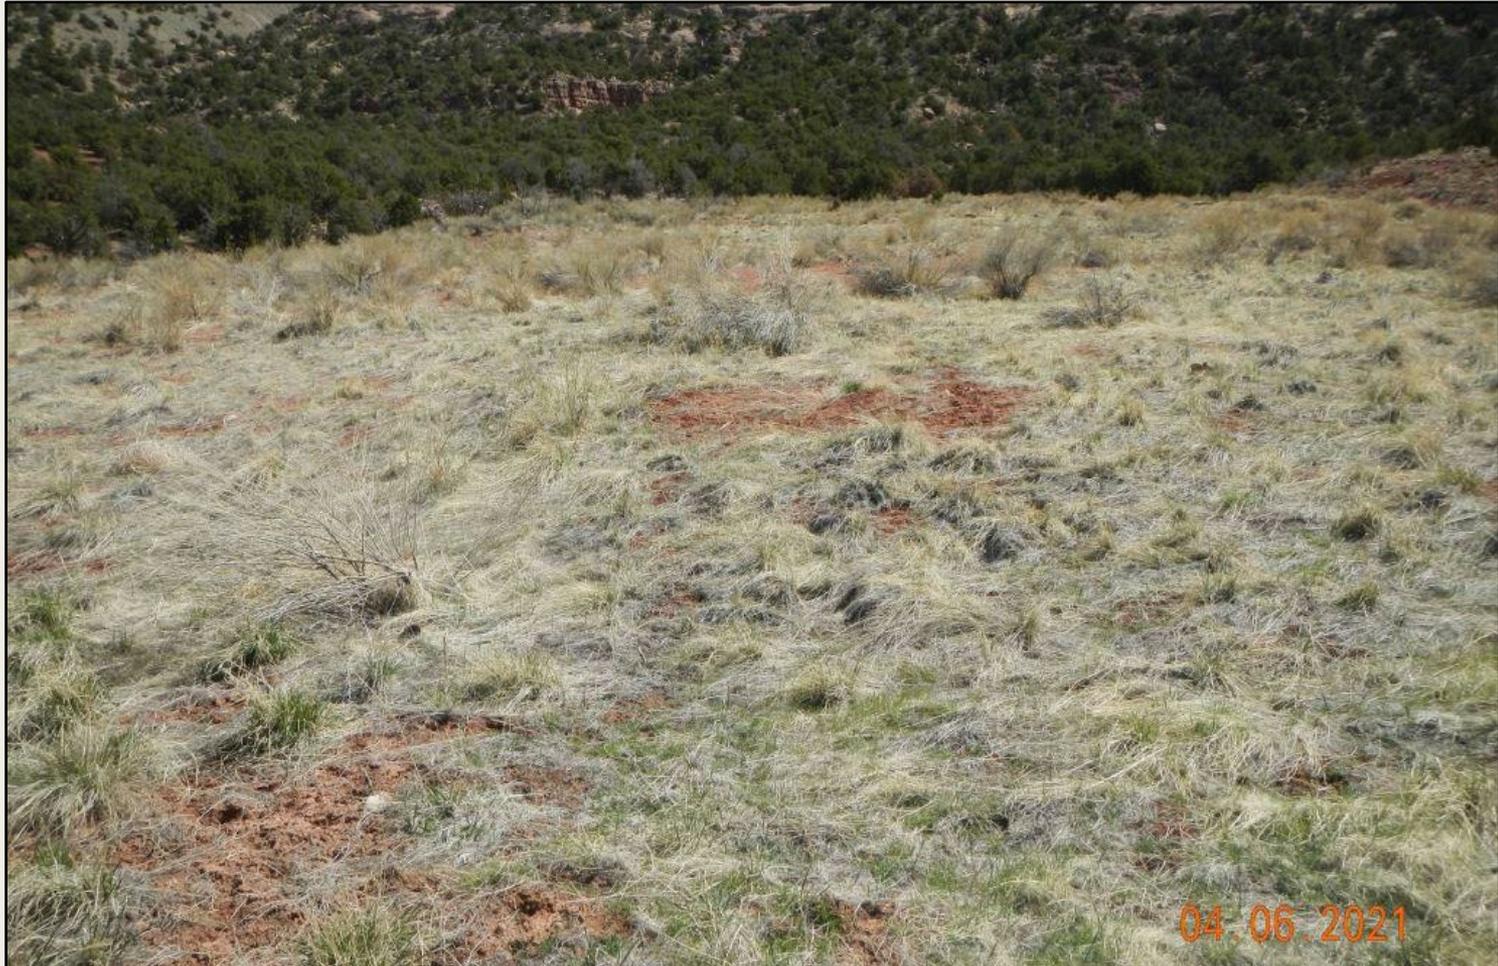
Photo 3. View of the northern project area from the northwestern corner facing eastward.

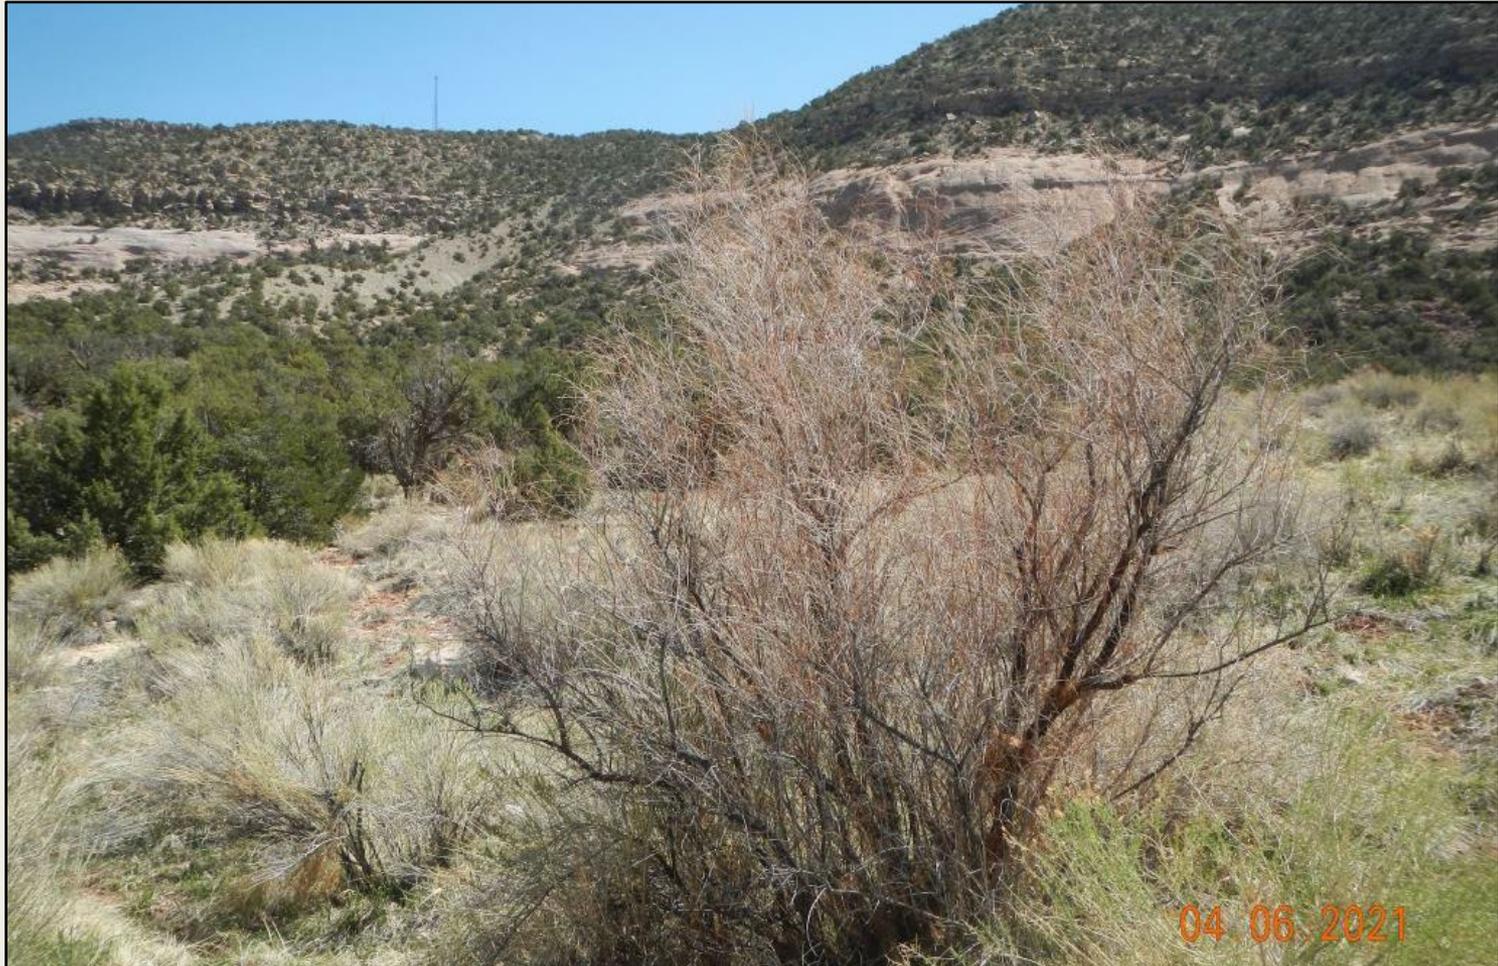
Photo 4. View of tamarisk growing in the northern project area, needs to be removed.

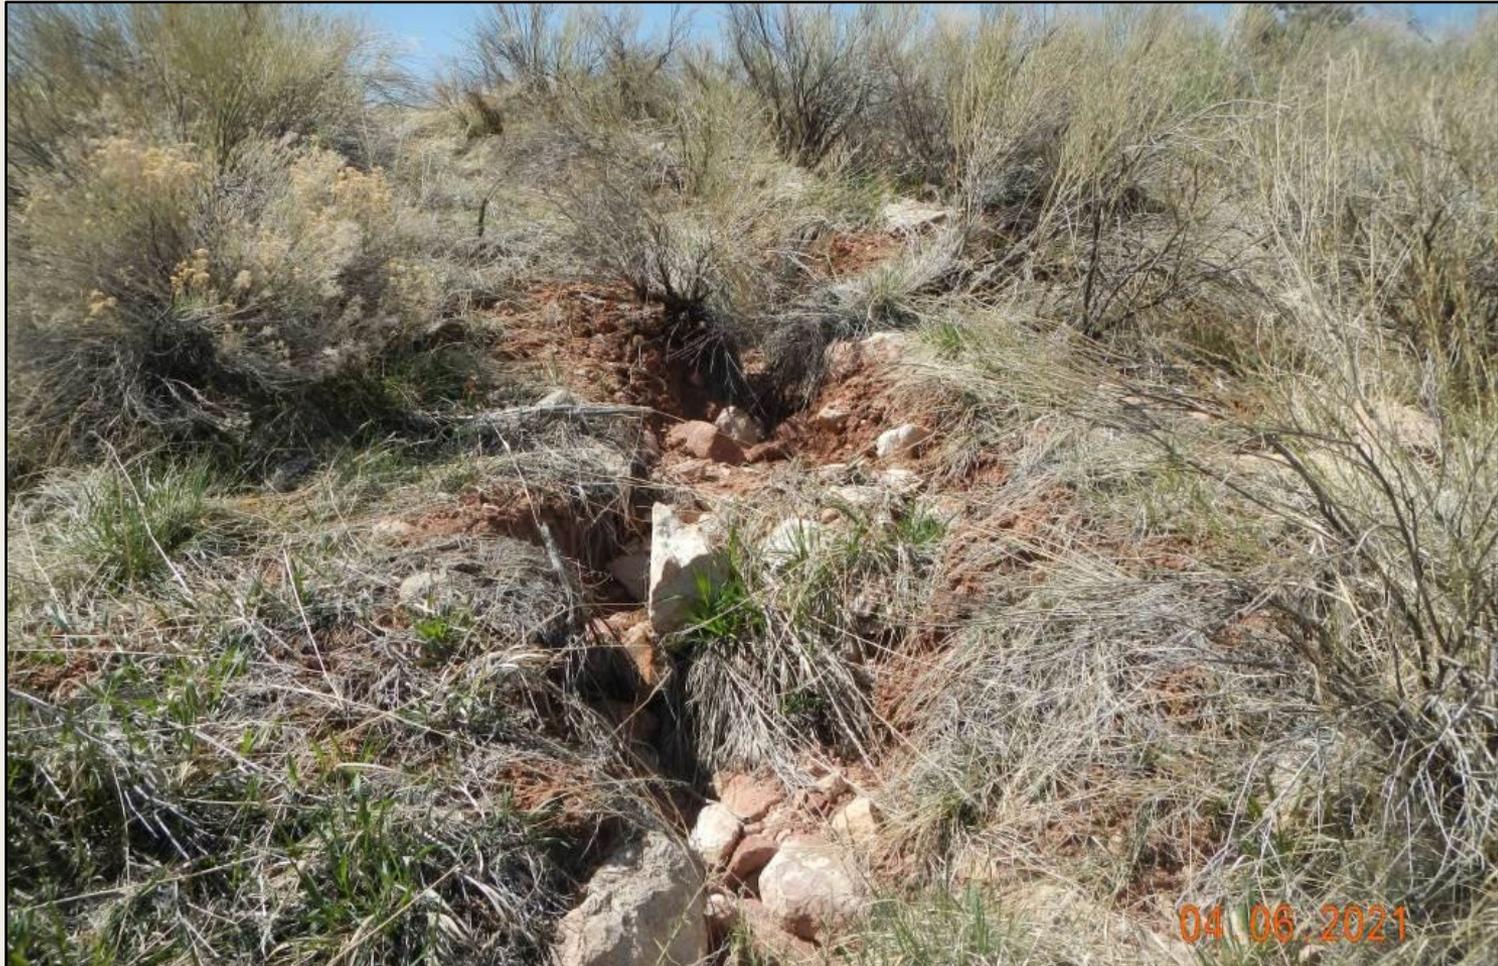
Photo 5. View of erosional channel in the northern project area needs stabilization.

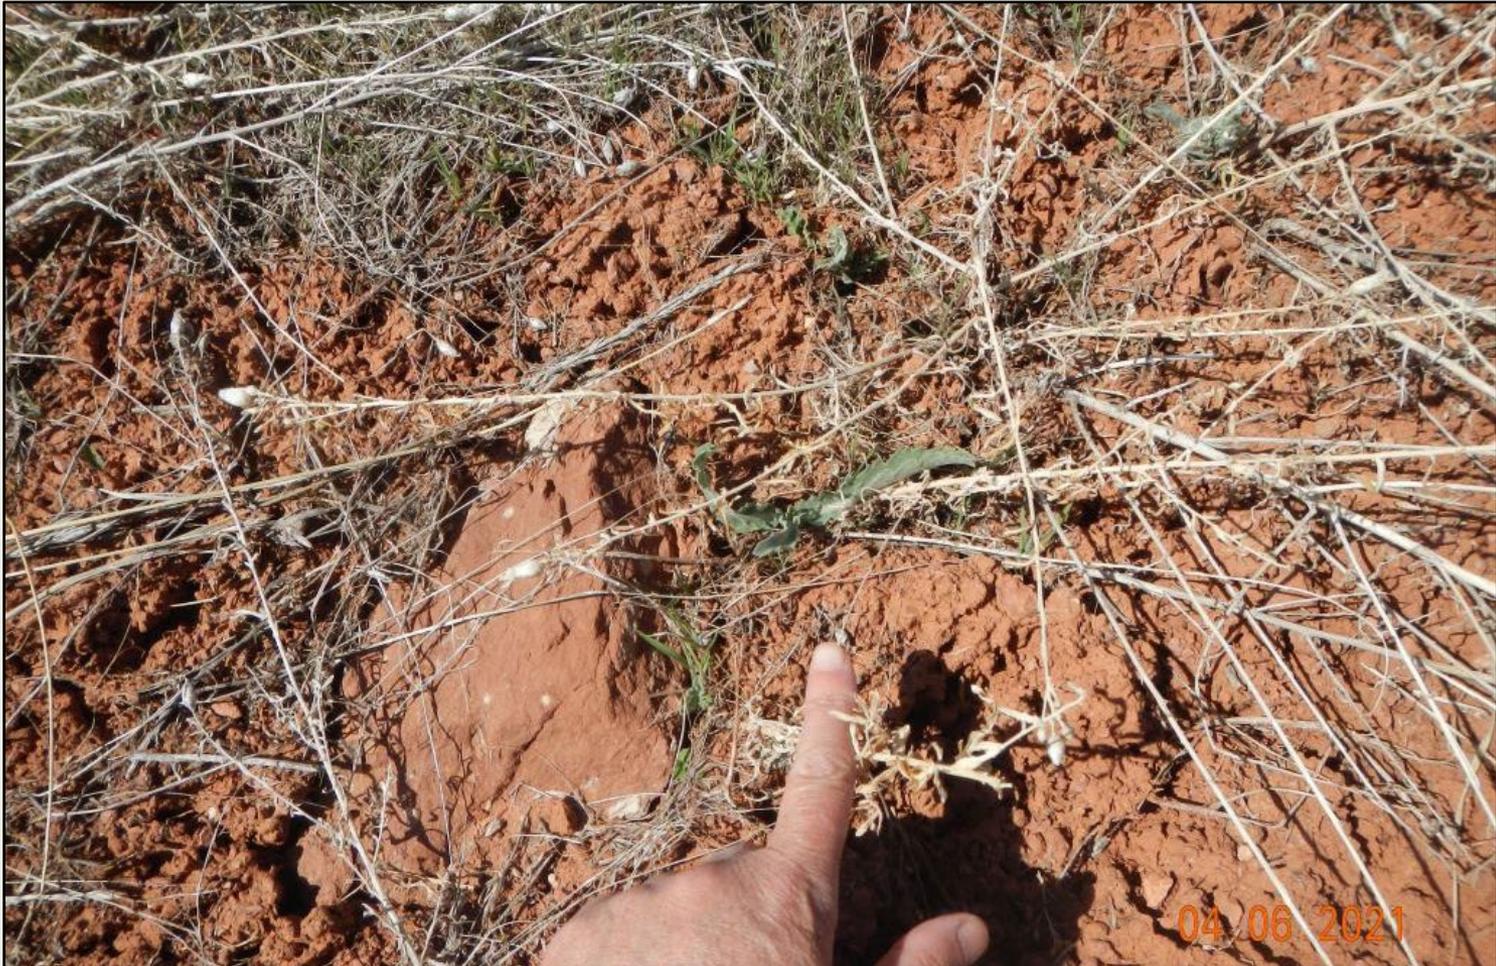
Photo 6. View of Russian knapweed within the northeastern interim reclamation area. Approximately 200 individuals observed.
