Inspection Photos  
Operator: Linde  
Facility: 083-06536  
Date: 4/6/2021

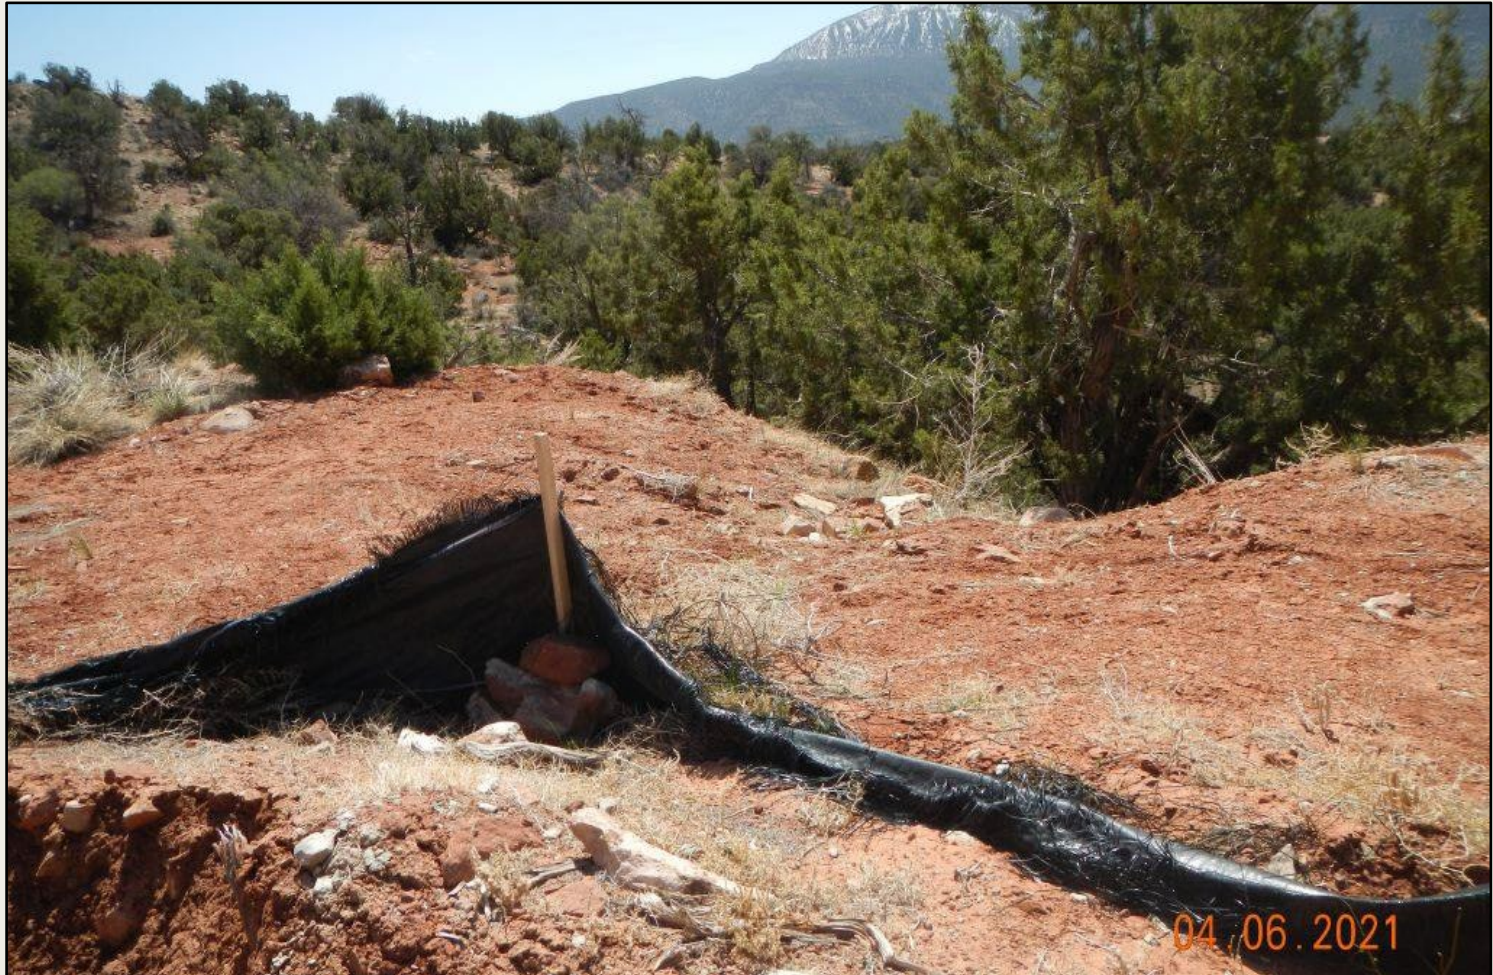
Photo 3. View of silt fence in the southeastern project area, in disrepair.

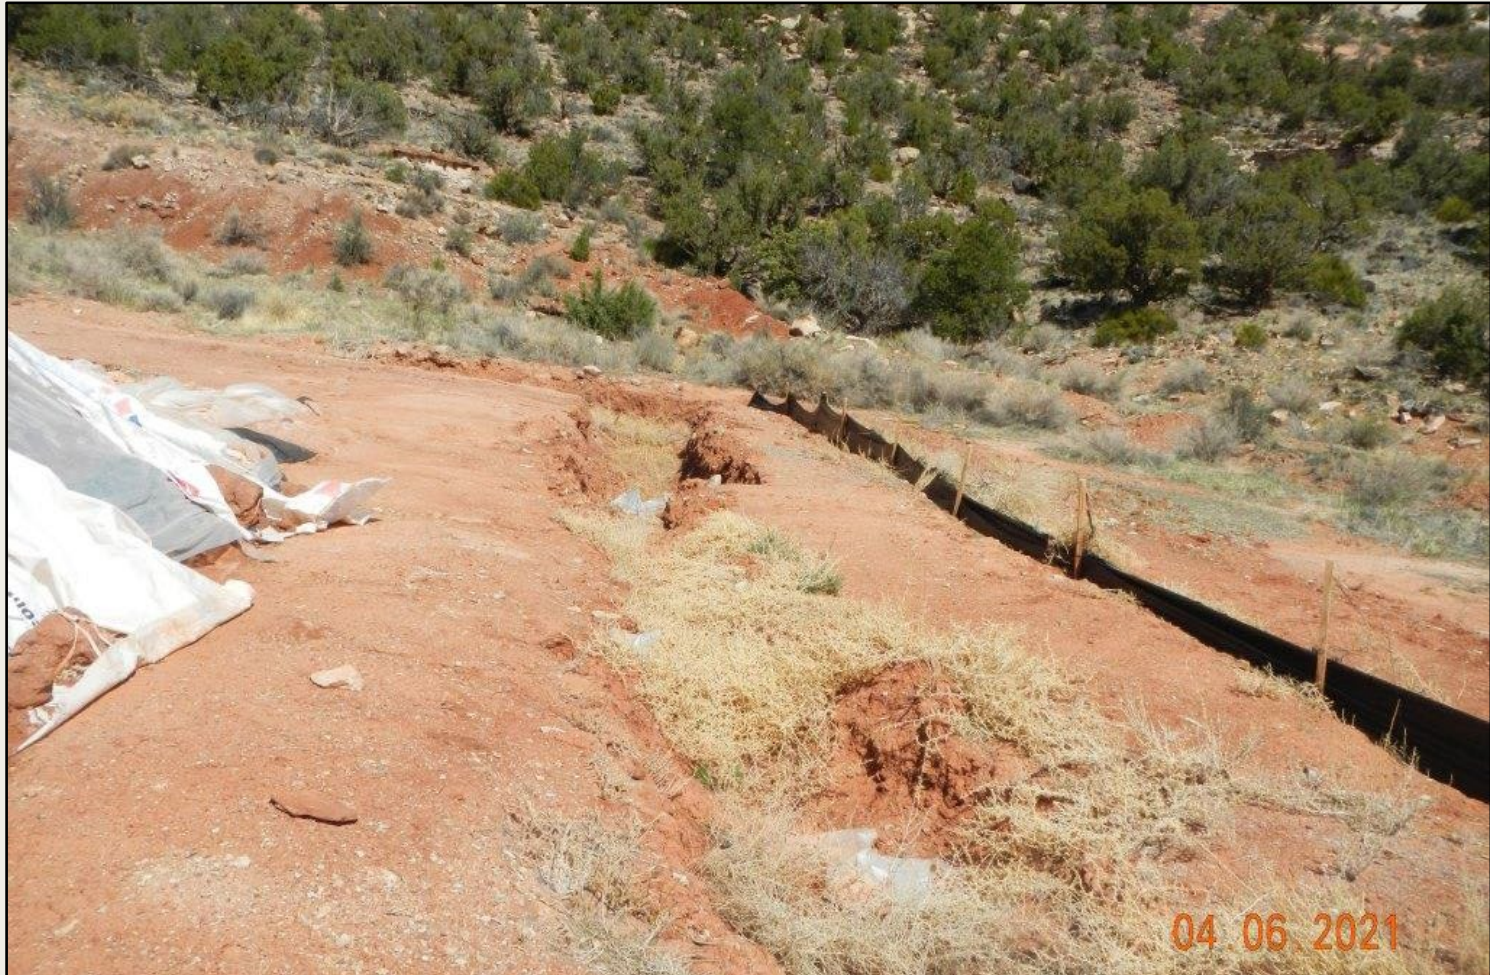
Photo 4. Another view of trench and silt fence in the eastern project area. Russian thistle and plastic debris observed in trench.

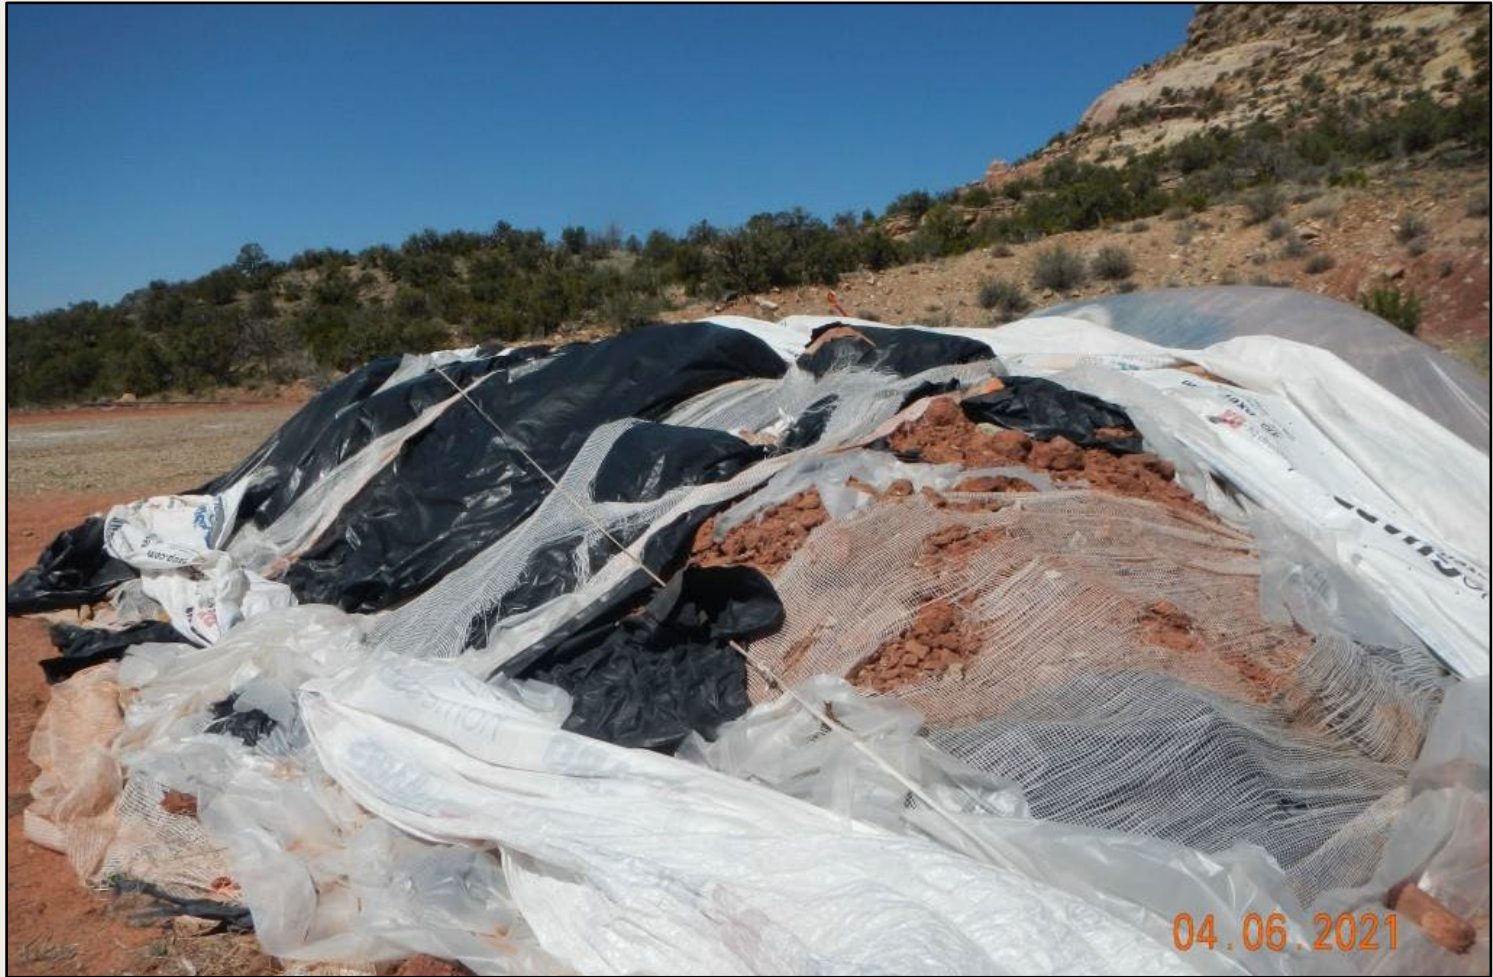
Photo 5. View of decomposing plastic covering soil pile in the eastern project area.

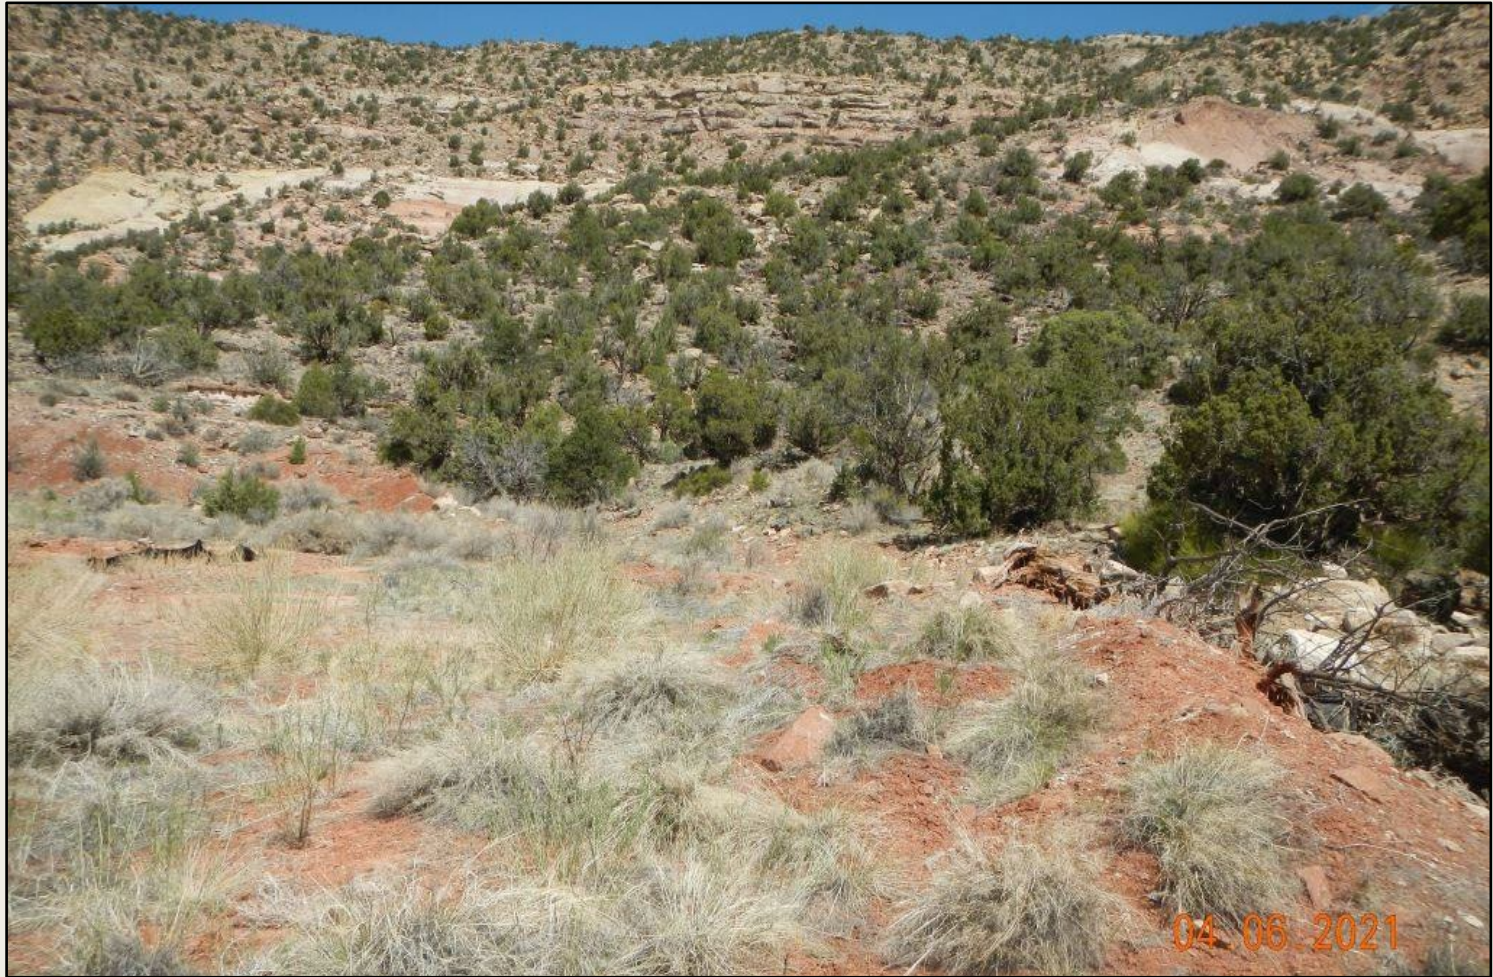
Photo 6. View of revegetation with Indian ricegrass and rubber rabbitbrush within the eastern project area, facing northward.

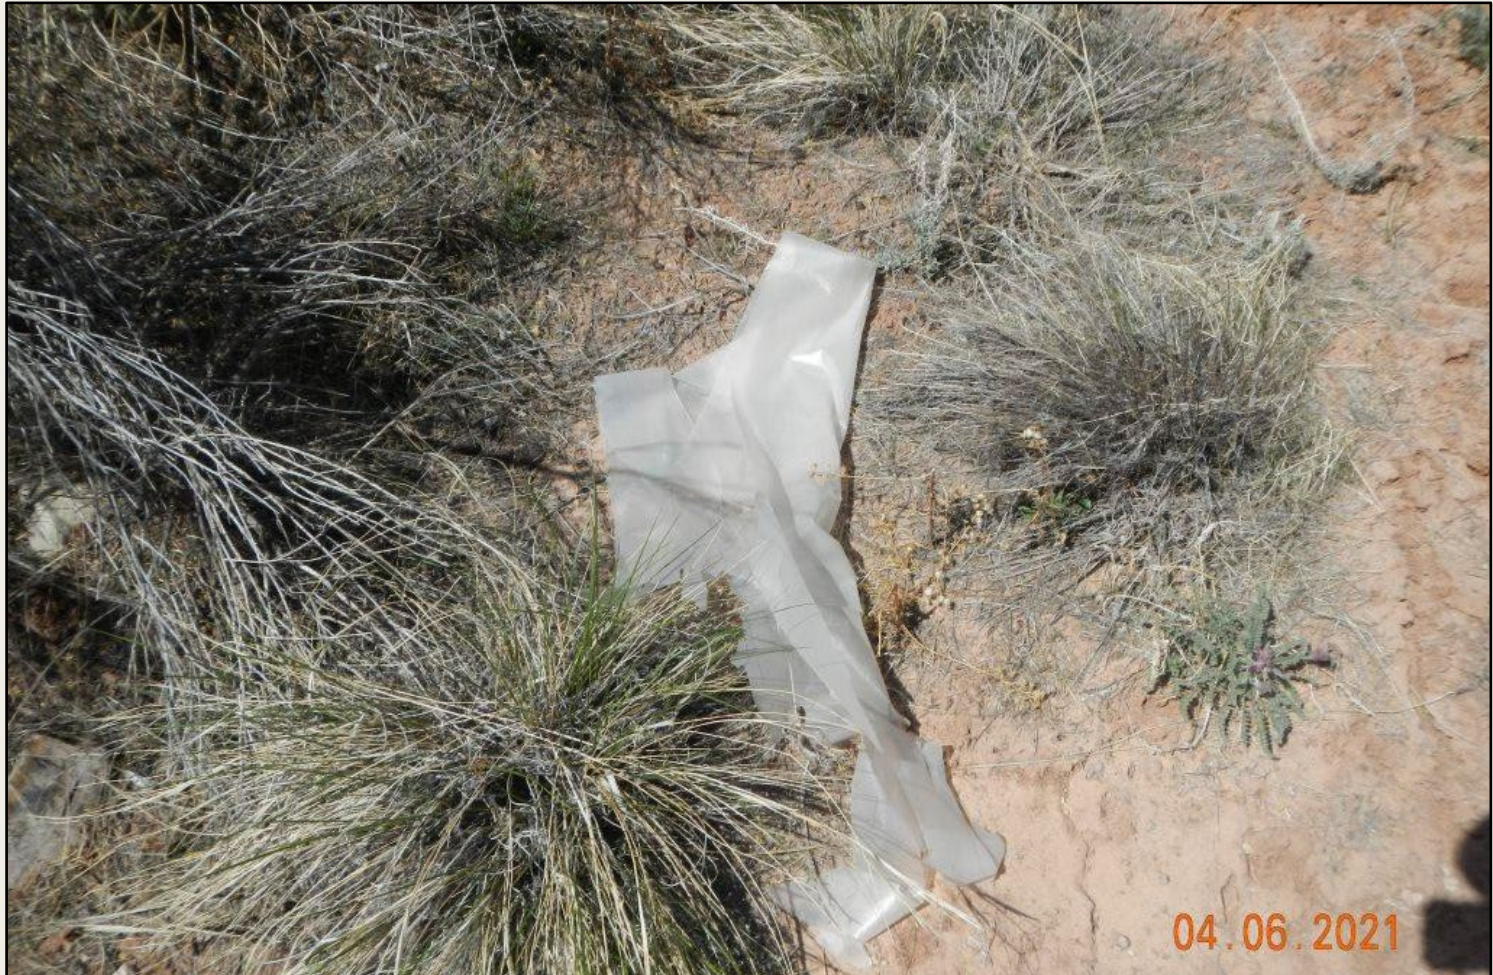
Photo 7. View of plastic debris blown off of the well pad.

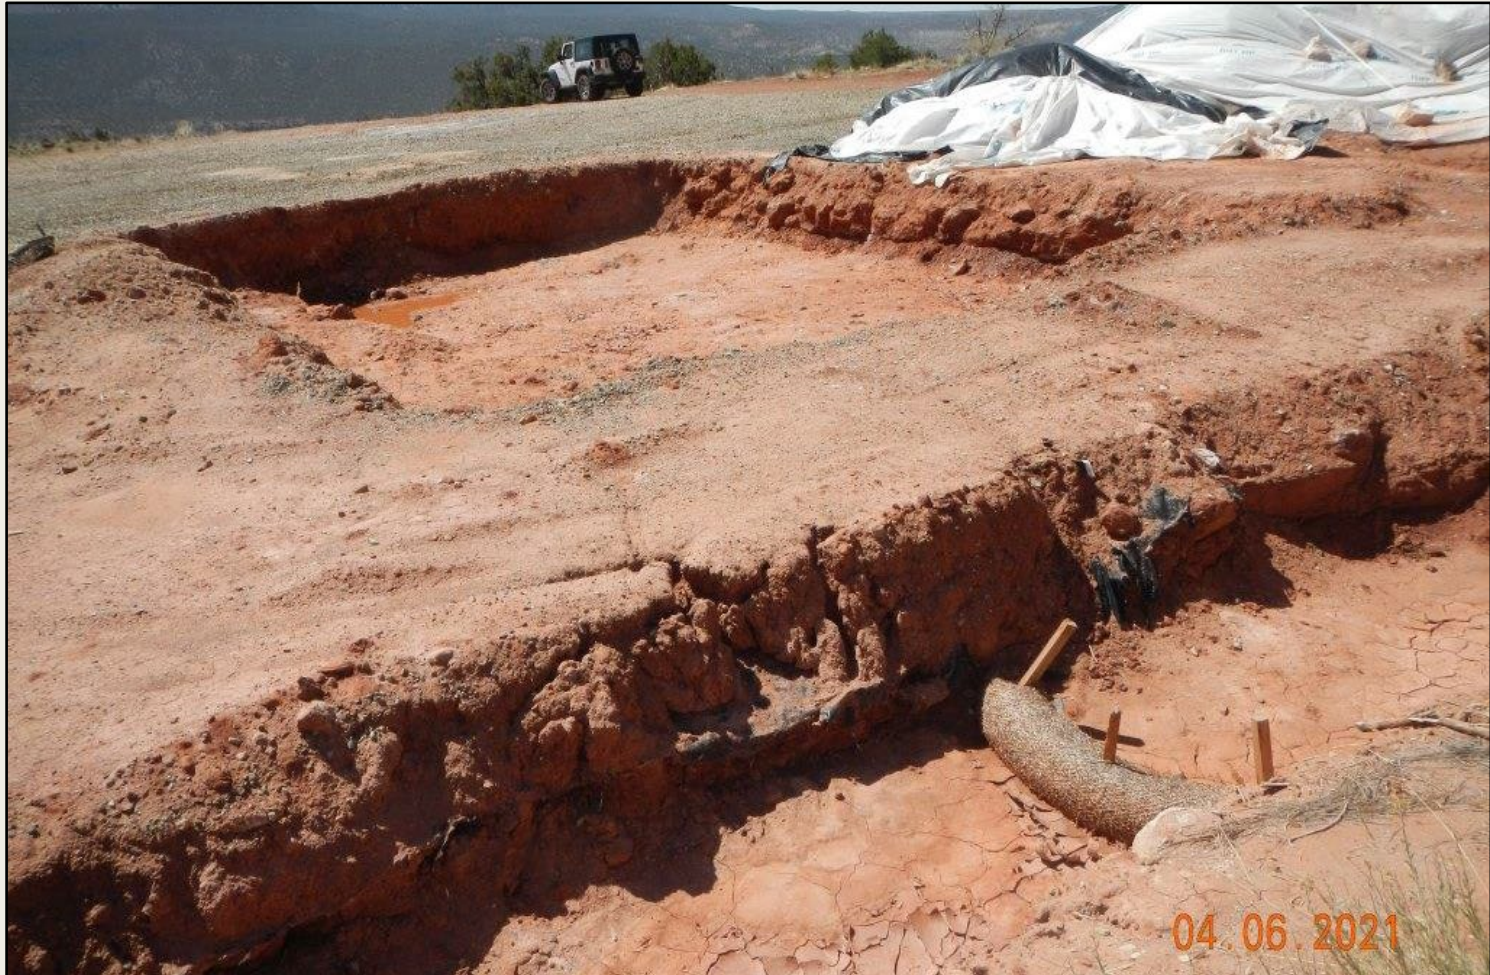
Photo 8. View of excavated area in the northern project area and trench in foreground

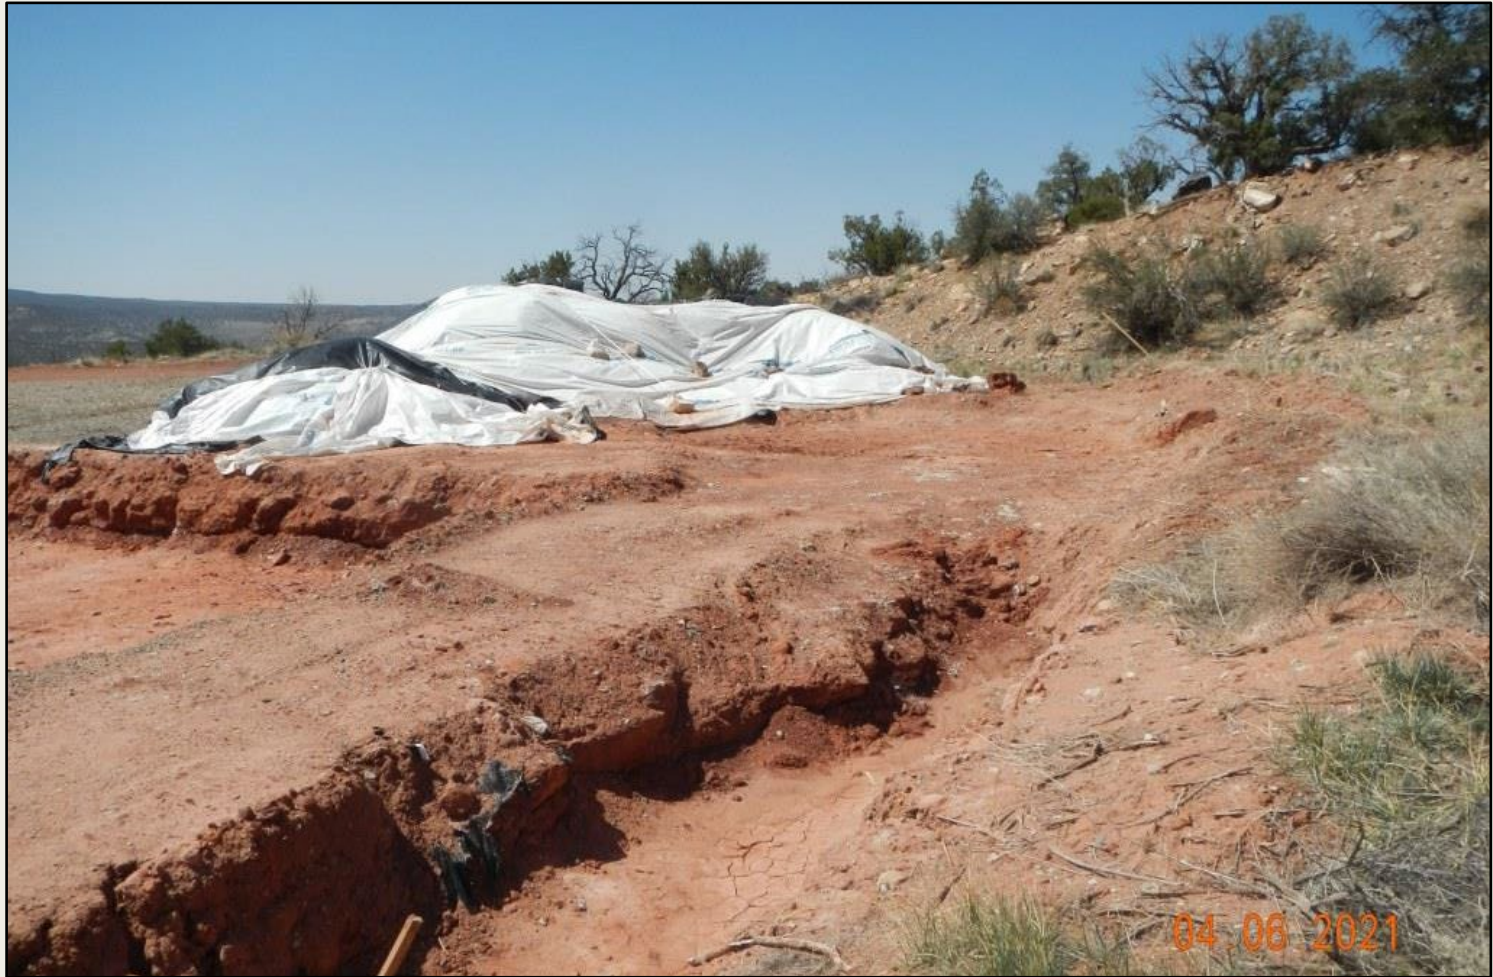
Photo 9. View of covered soil pile in the western project area.

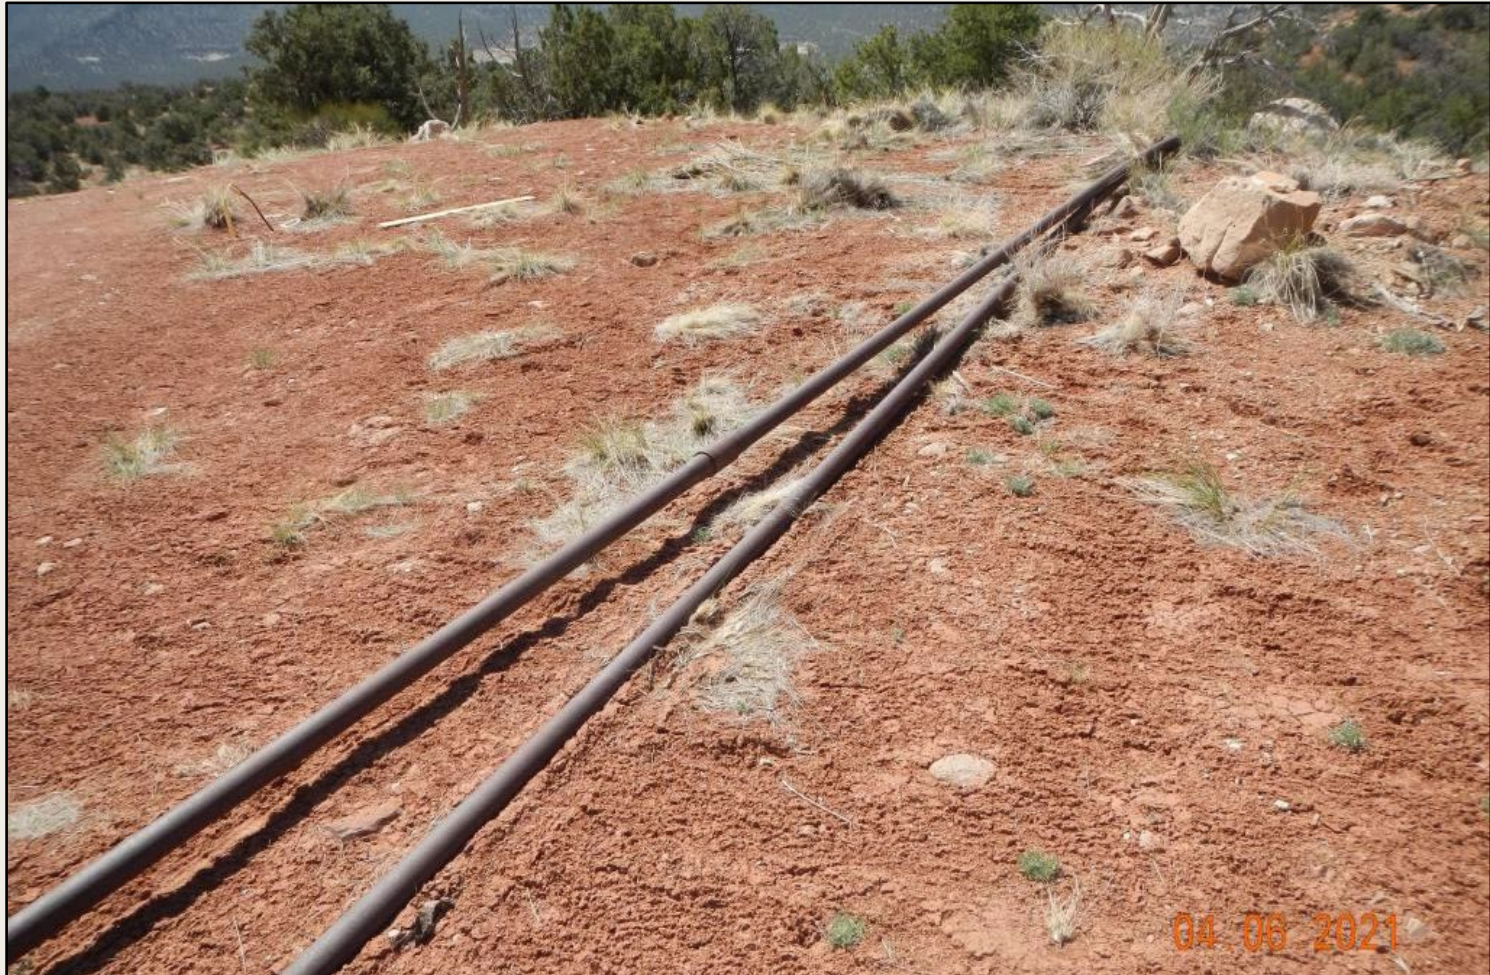
Photo 10. View of surface flowlines need to be properly abandoned.

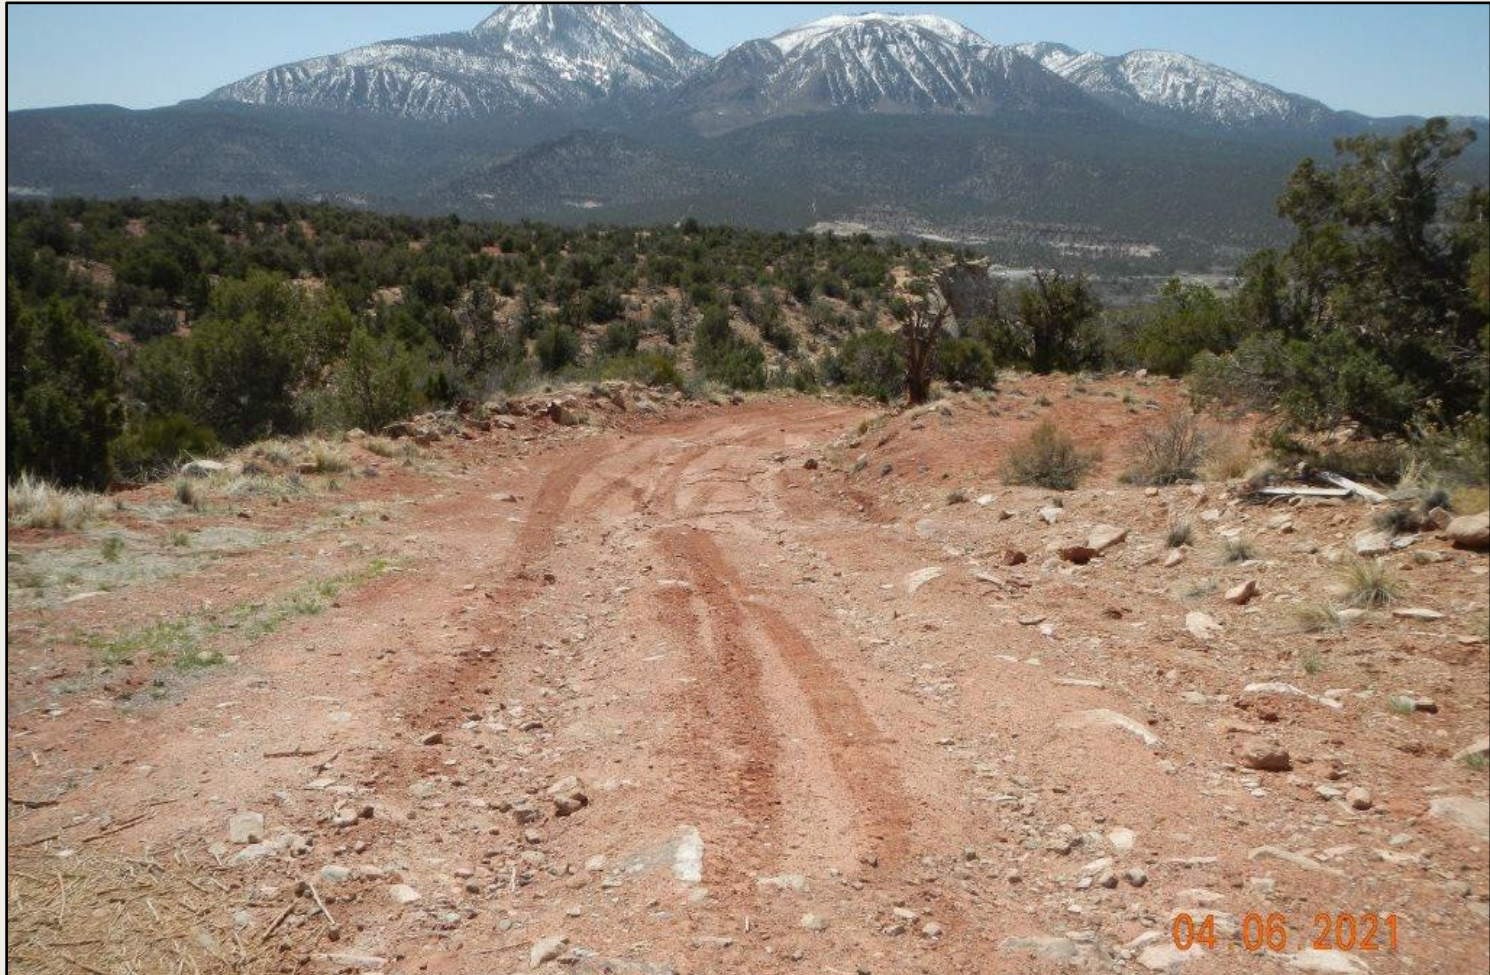
Photo 11. View of access road that needs to be reclaimed.

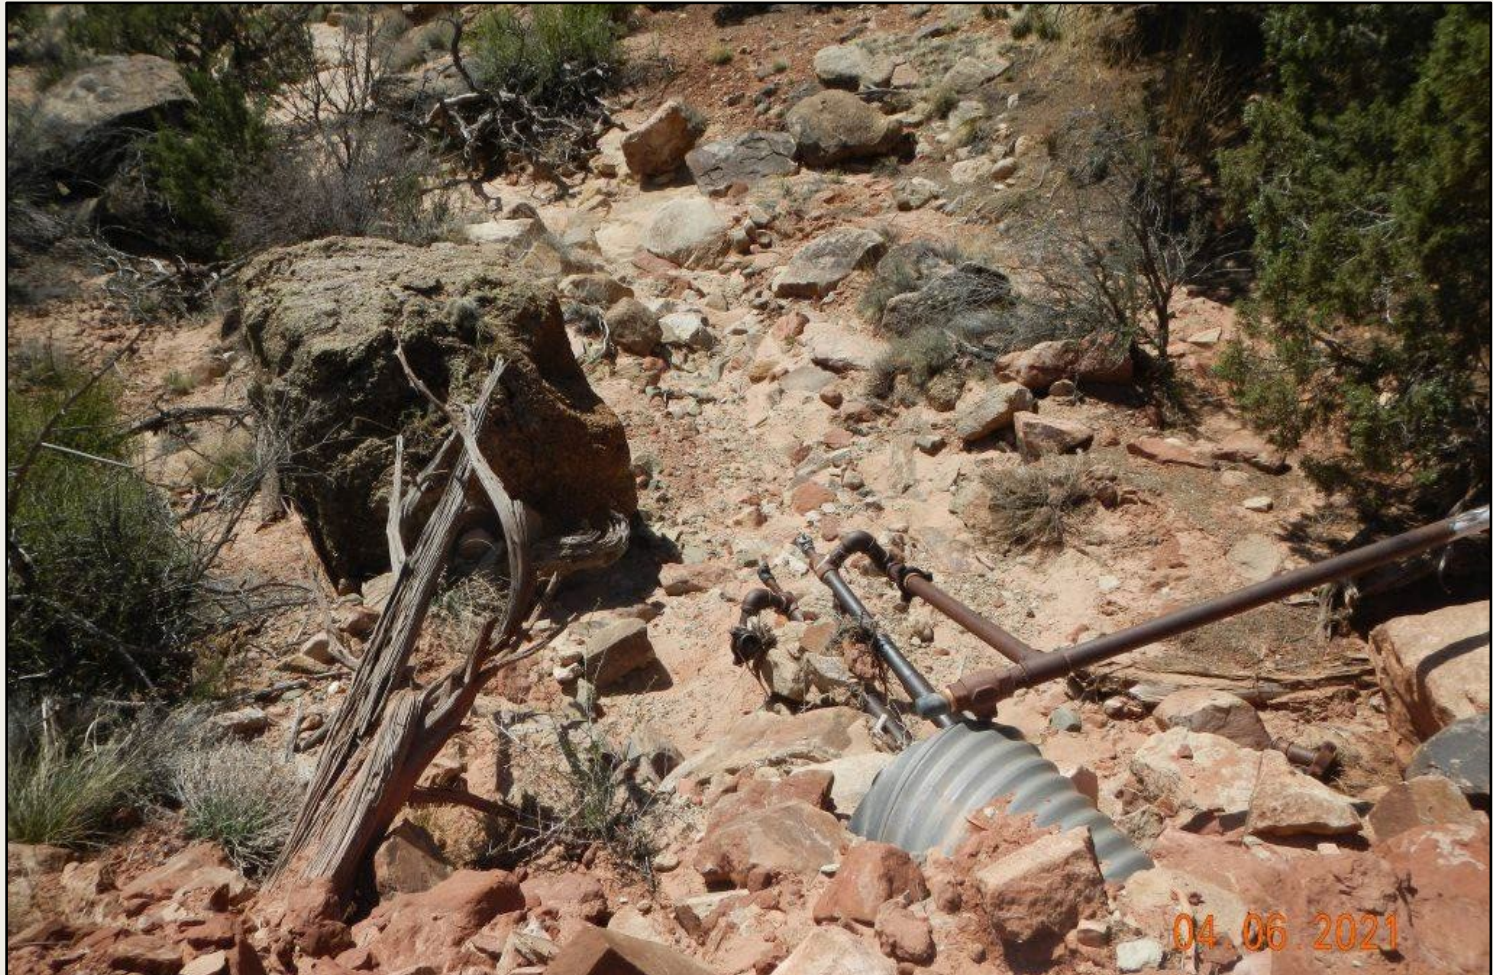
Photo 12. View of flowline at drainage intersection. Valve is open into drainage.

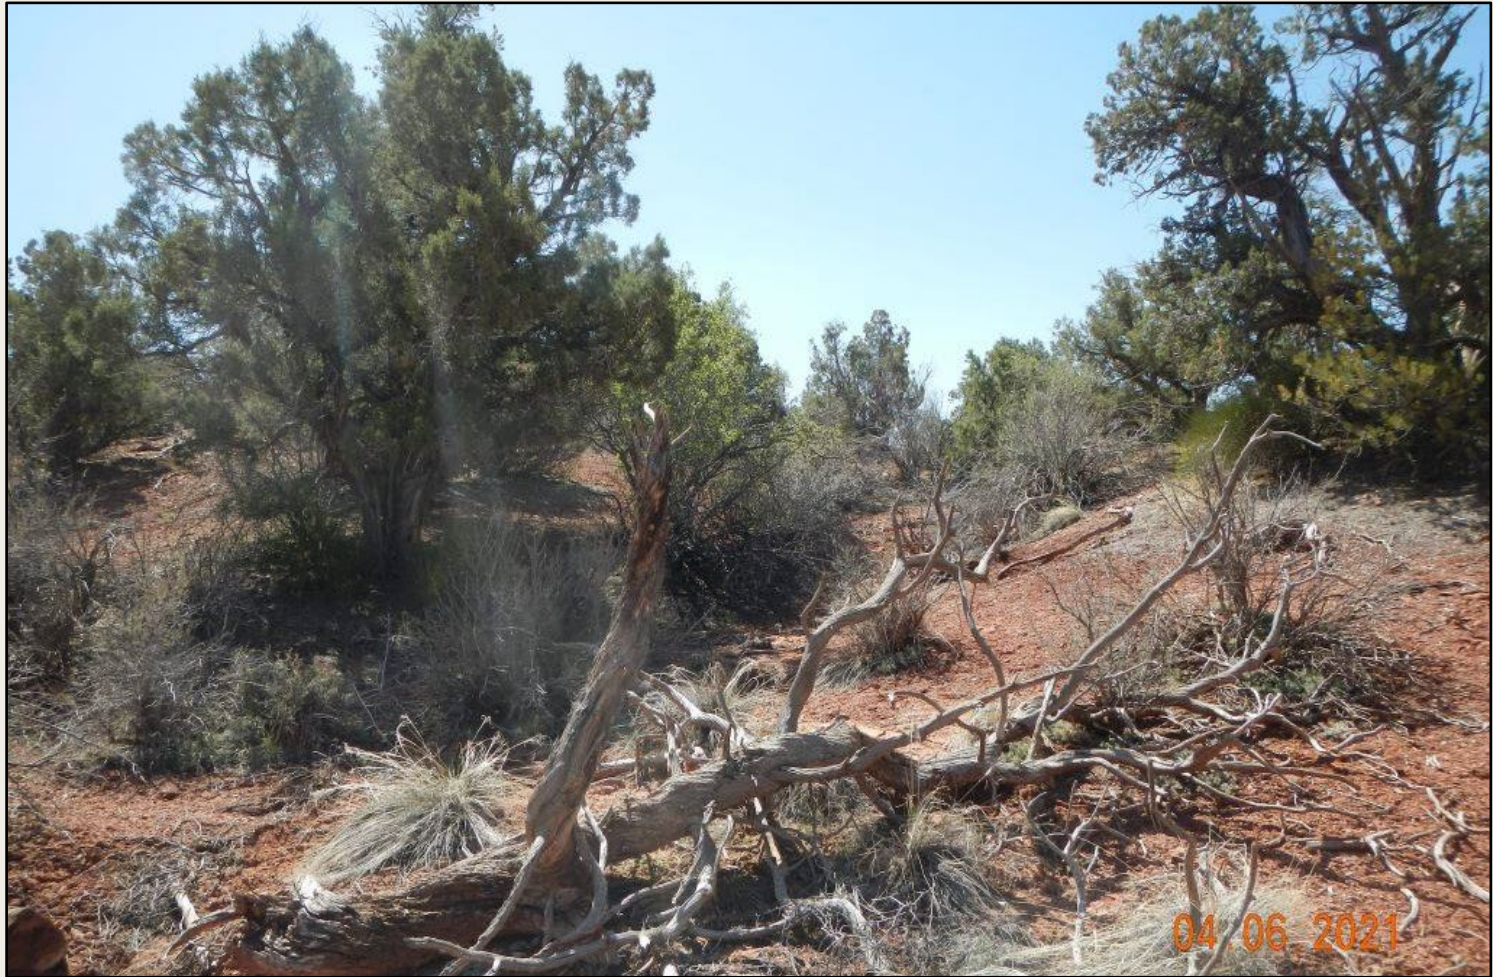
Photo 13. View of the reference area comprised of pinyon and juniper woodland with understory of serviceberry, cliffrose, and Indian ricegrass.
