Inspection Photos
Location Name: Duncan Van Schaick Unit 1 2
Location ID: 313051

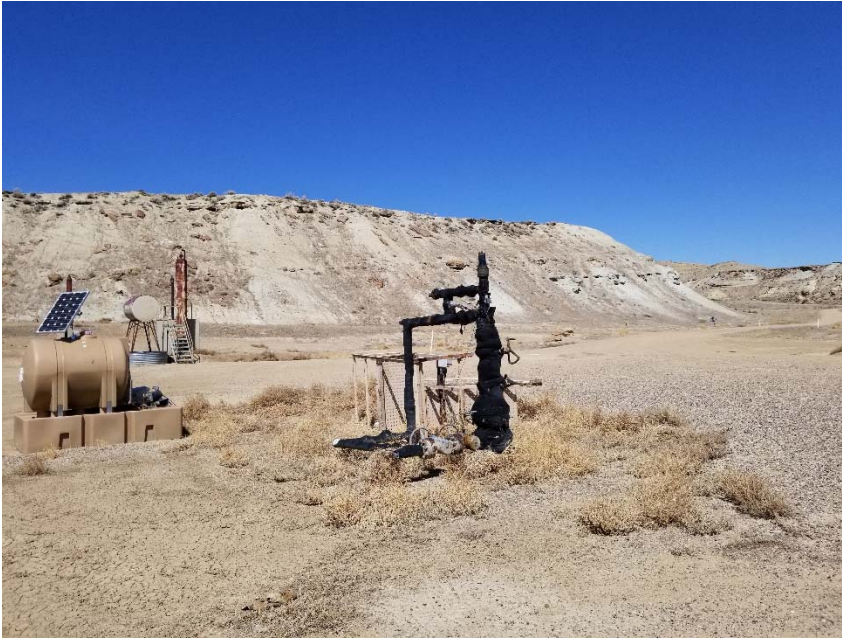
Photo 1. Overview of location taken facing northwest. Dried annual weeds on location.

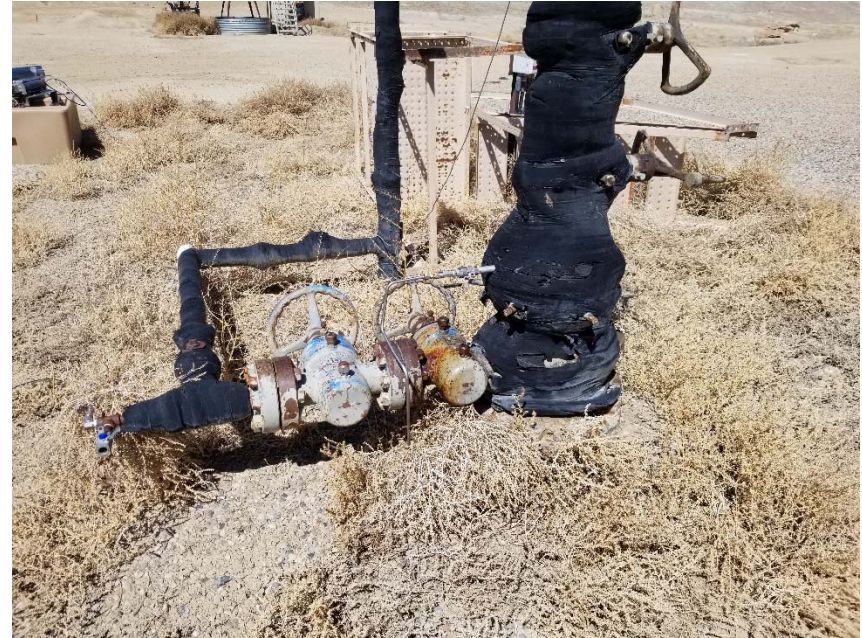
Photo 2. No bradenhead access apparent. Dried annual weeds on location.

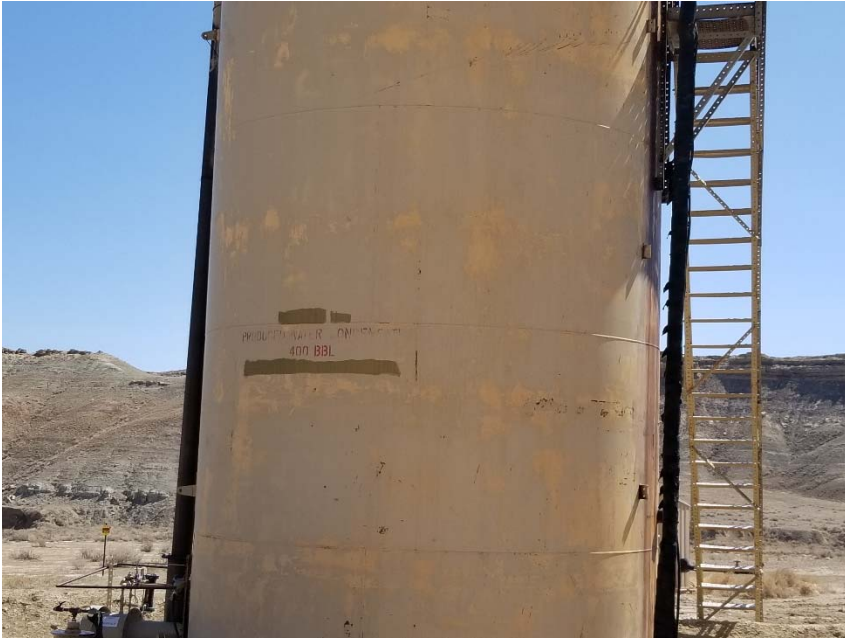
Photo 3. Tank label incomplete and faded.

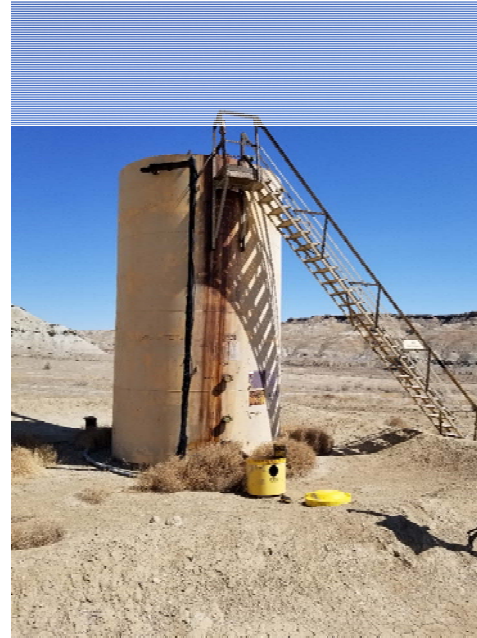
Photo 4. Tank overflow. Dried annual weeds.
