Inspection Photos
Operator: Hilcorp
Facility: 067-09460
Date: 4/15/2021

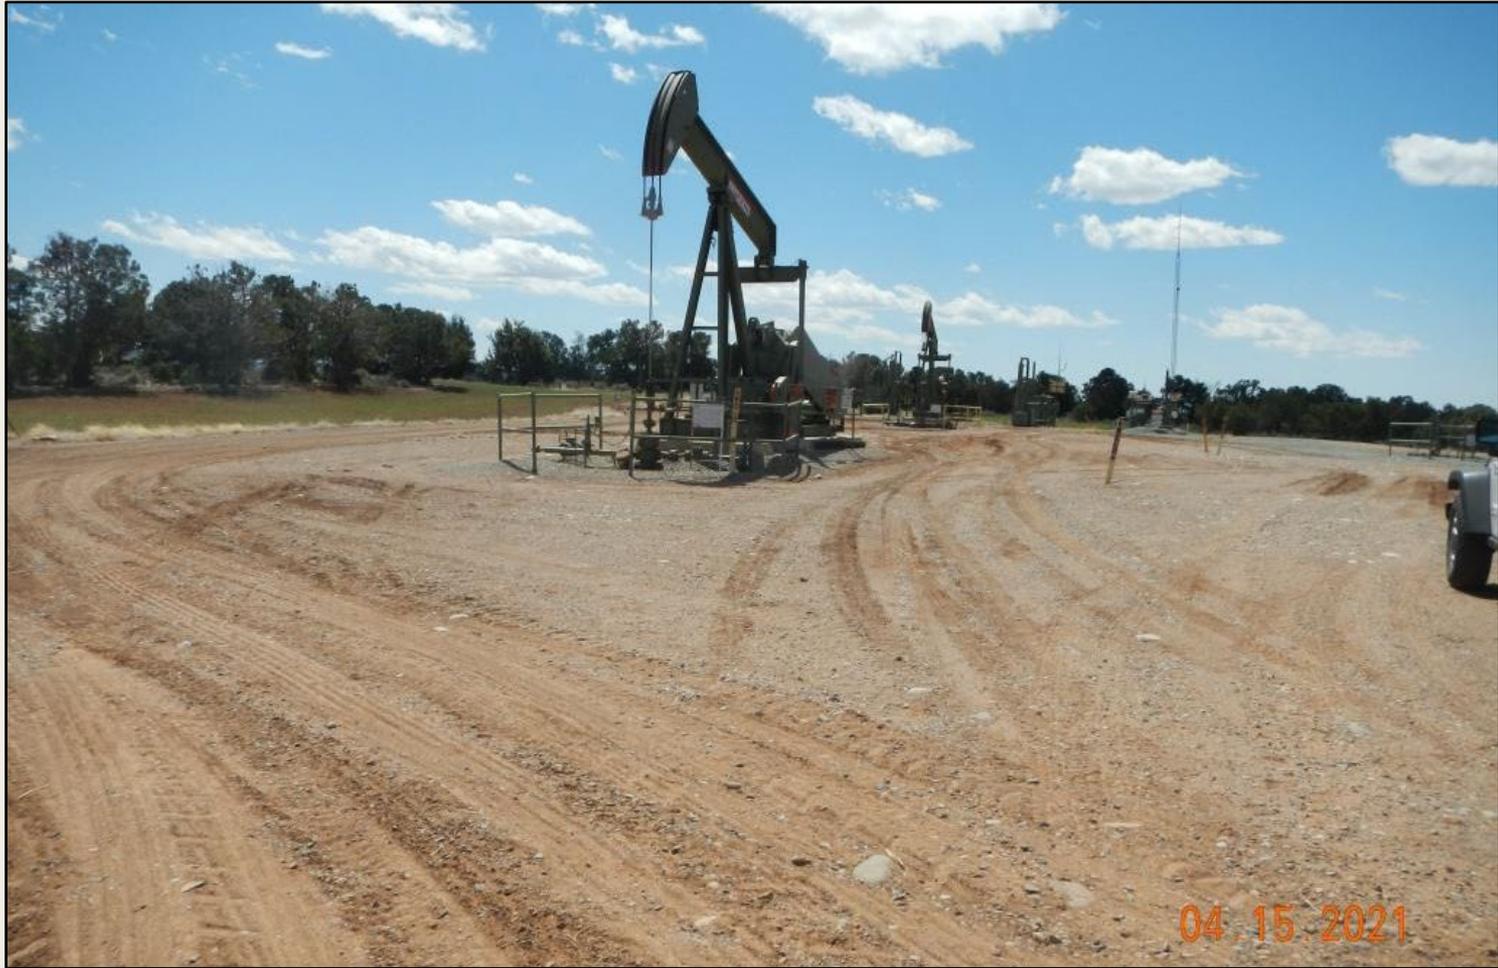
Photo 1. View of the project area from the well pad entrance facing center.

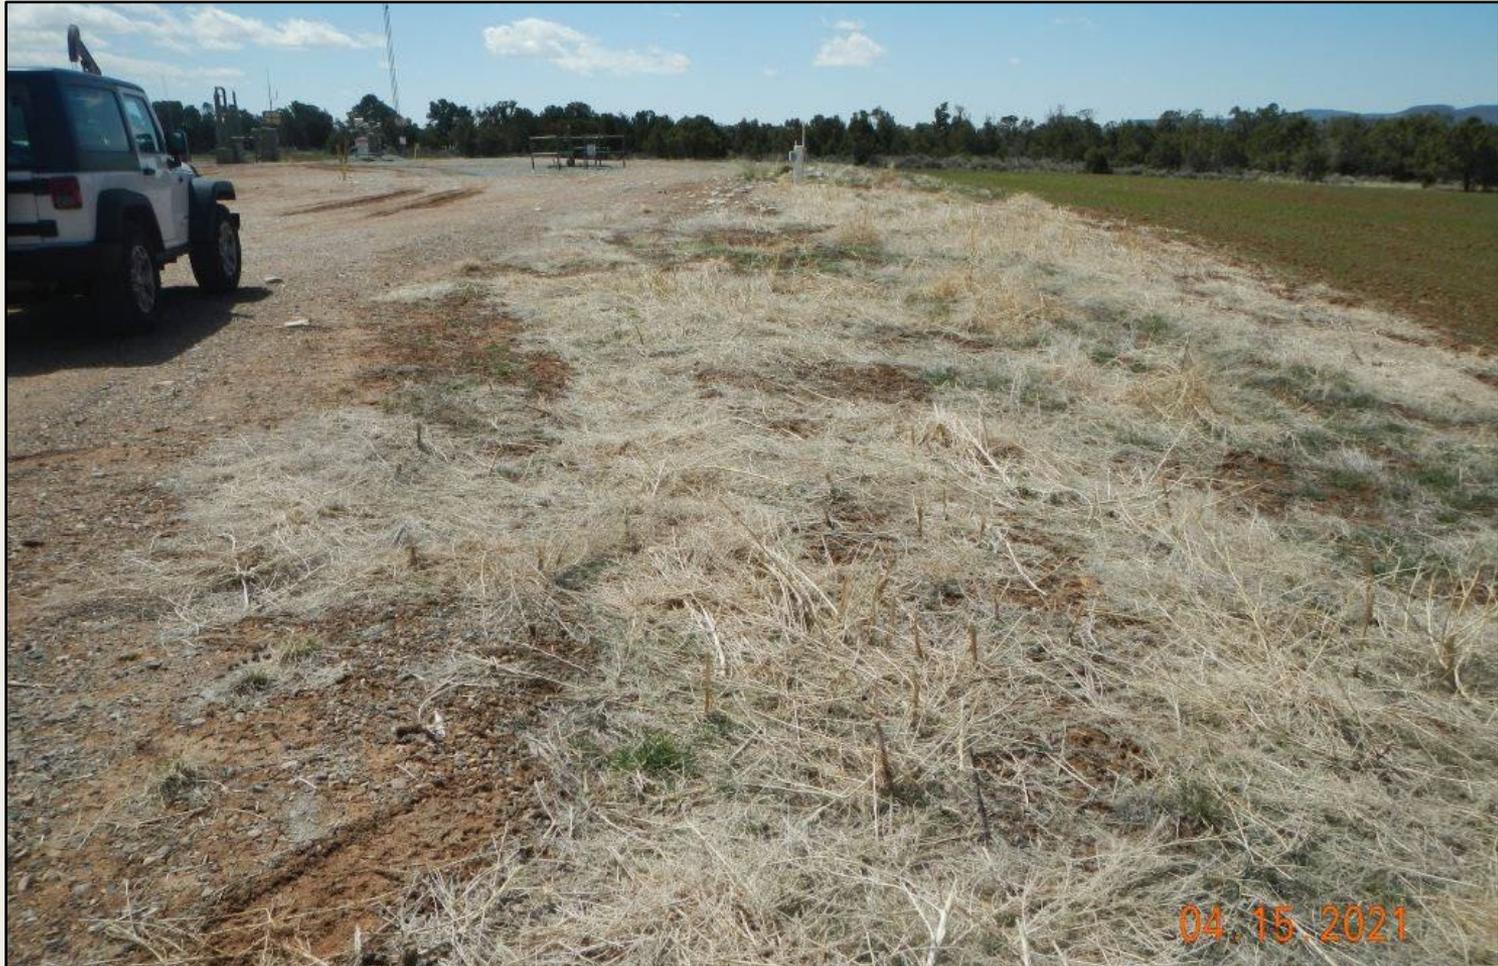
Photo 2. View of the western project area from the northwestern corner facing southward. Dense weed debris observed on the well pad edges.

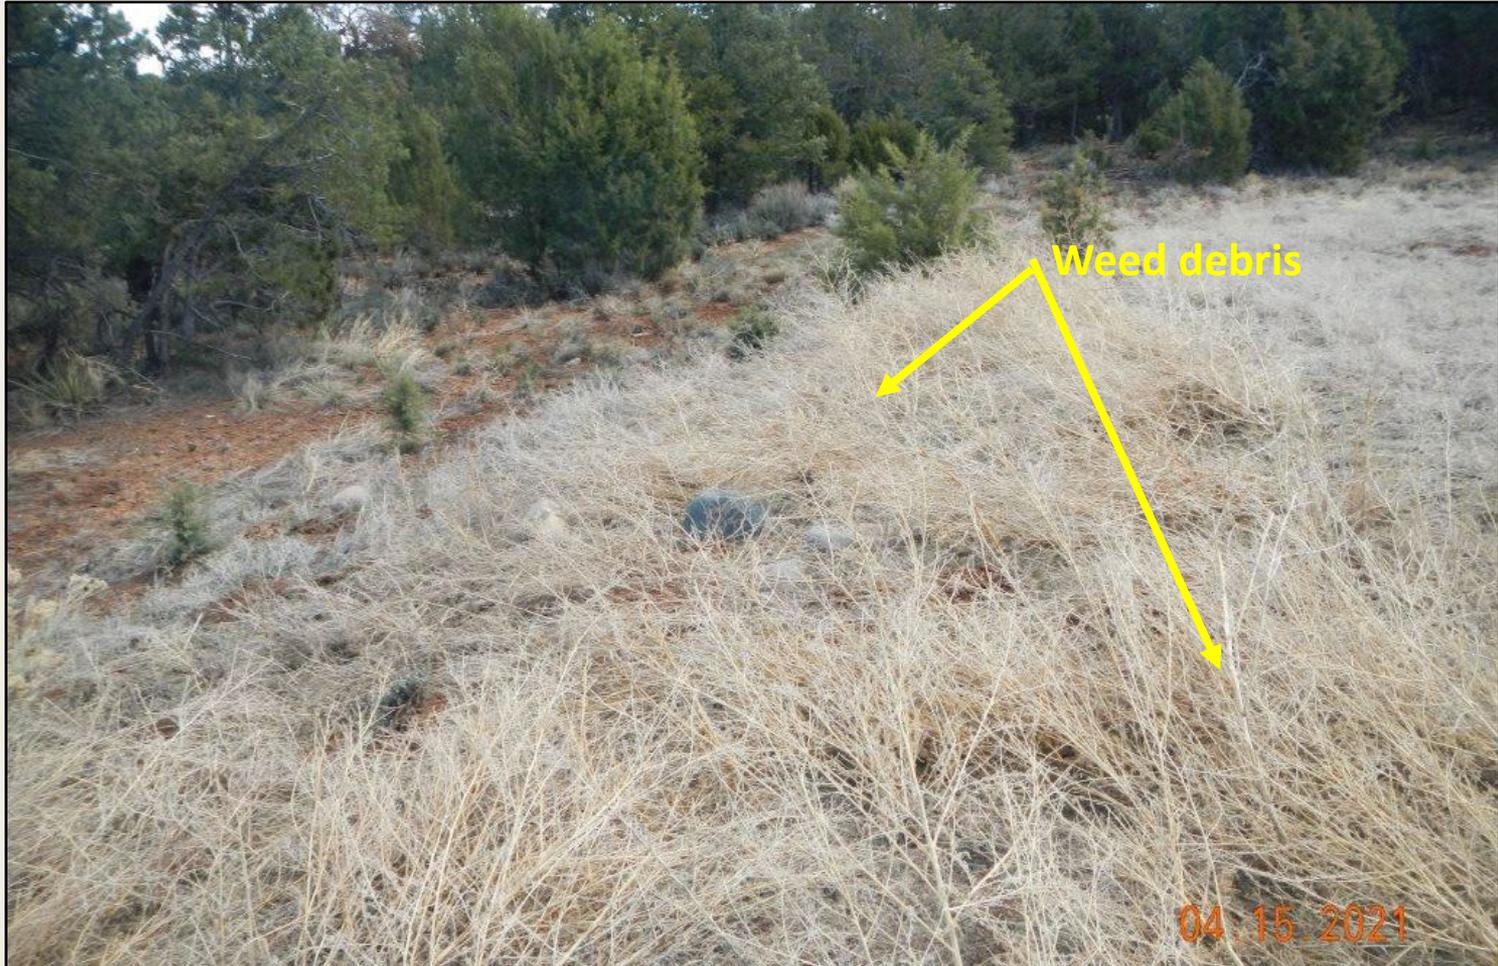
Photo 3. View of dense weed debris within the northeastern portion of the project area.

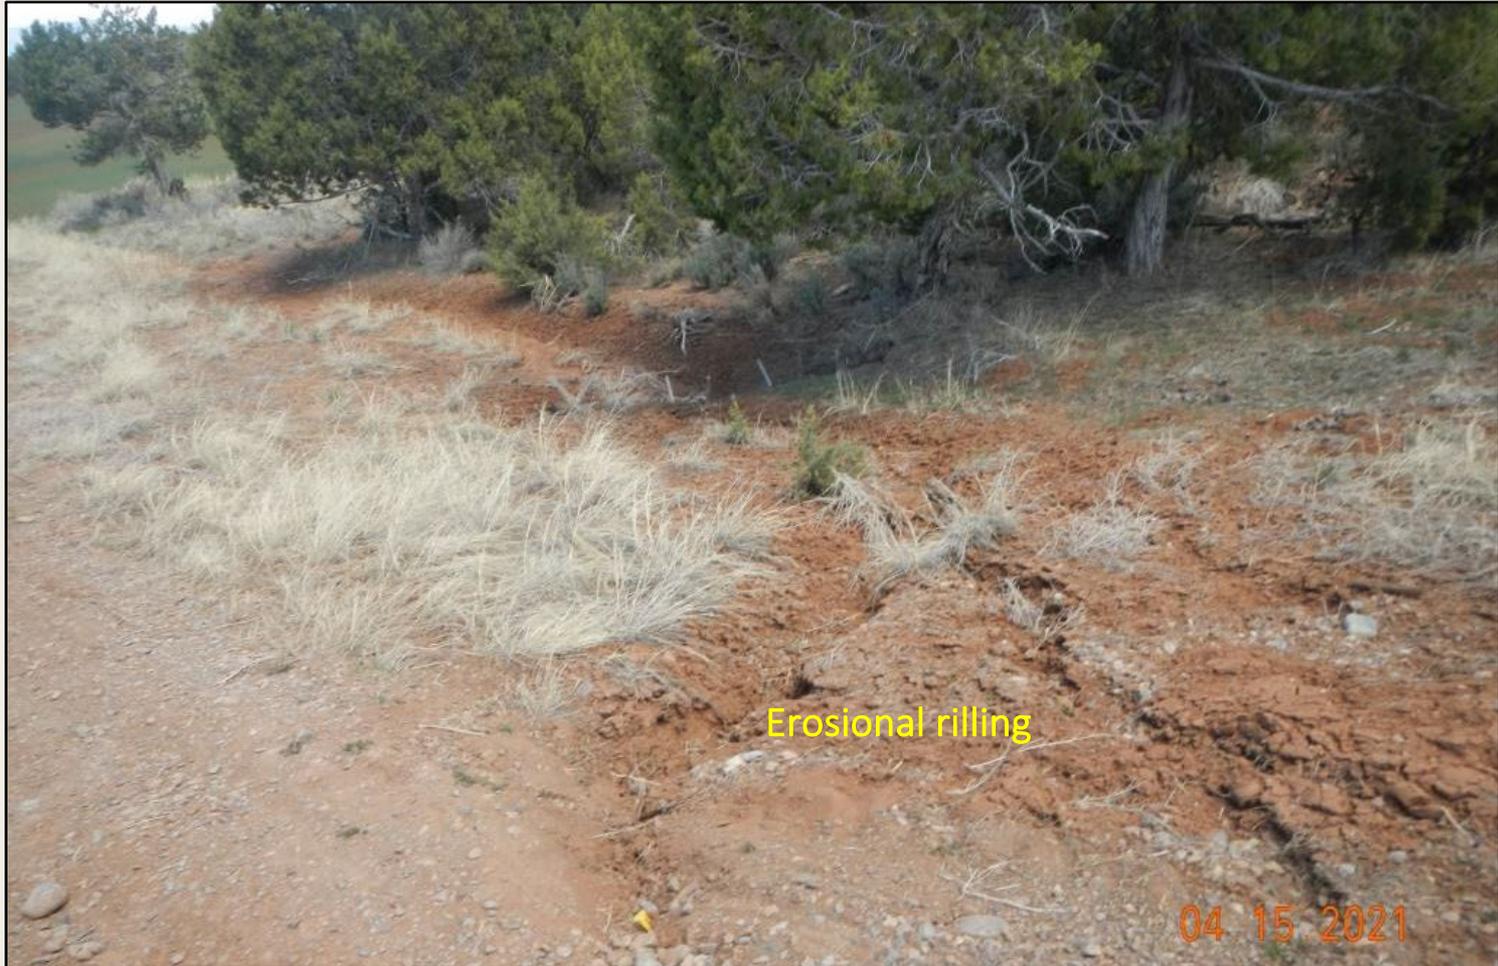
Photo 4. View of erosional rilling at the well pad entrance, facing downslope.

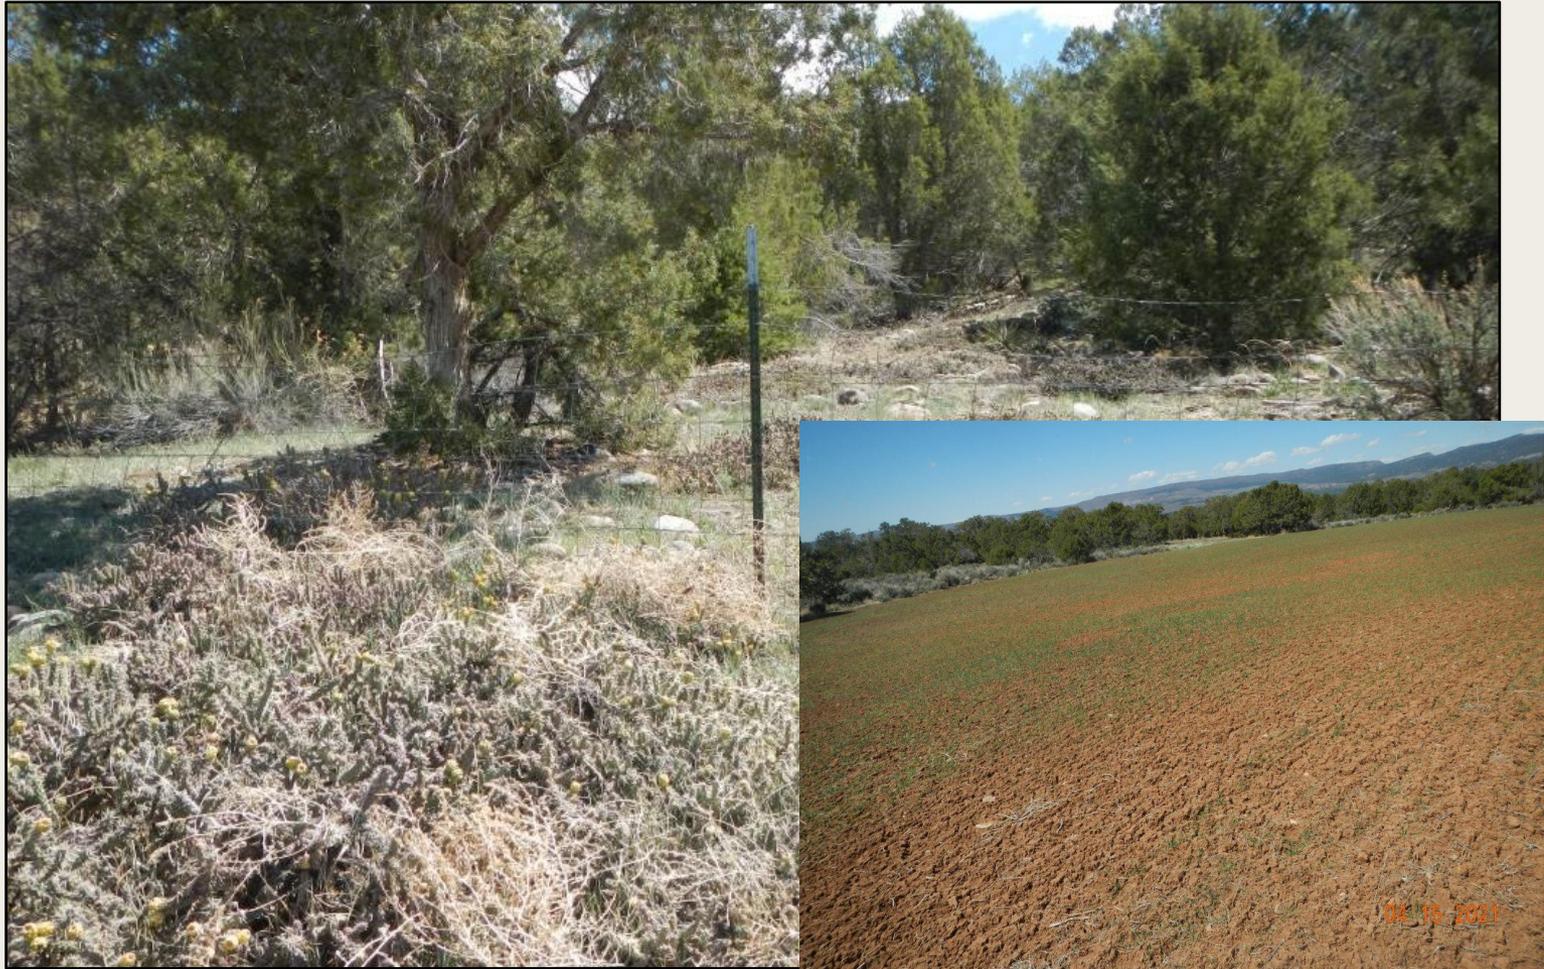
Photo 5. View of the reference area comprised of pinyon and juniper woodland with understory of cholla, sagebrush, western wheatgrass, and Indian ricegrass. Inset shows portion of reference area comprised of cultivated wheat field in early vegetative condition.
