**Inspection Photos**  
**Operator: Hilcorp**  
**Facility: 067-09461**  
**Date: 4/15/2021**

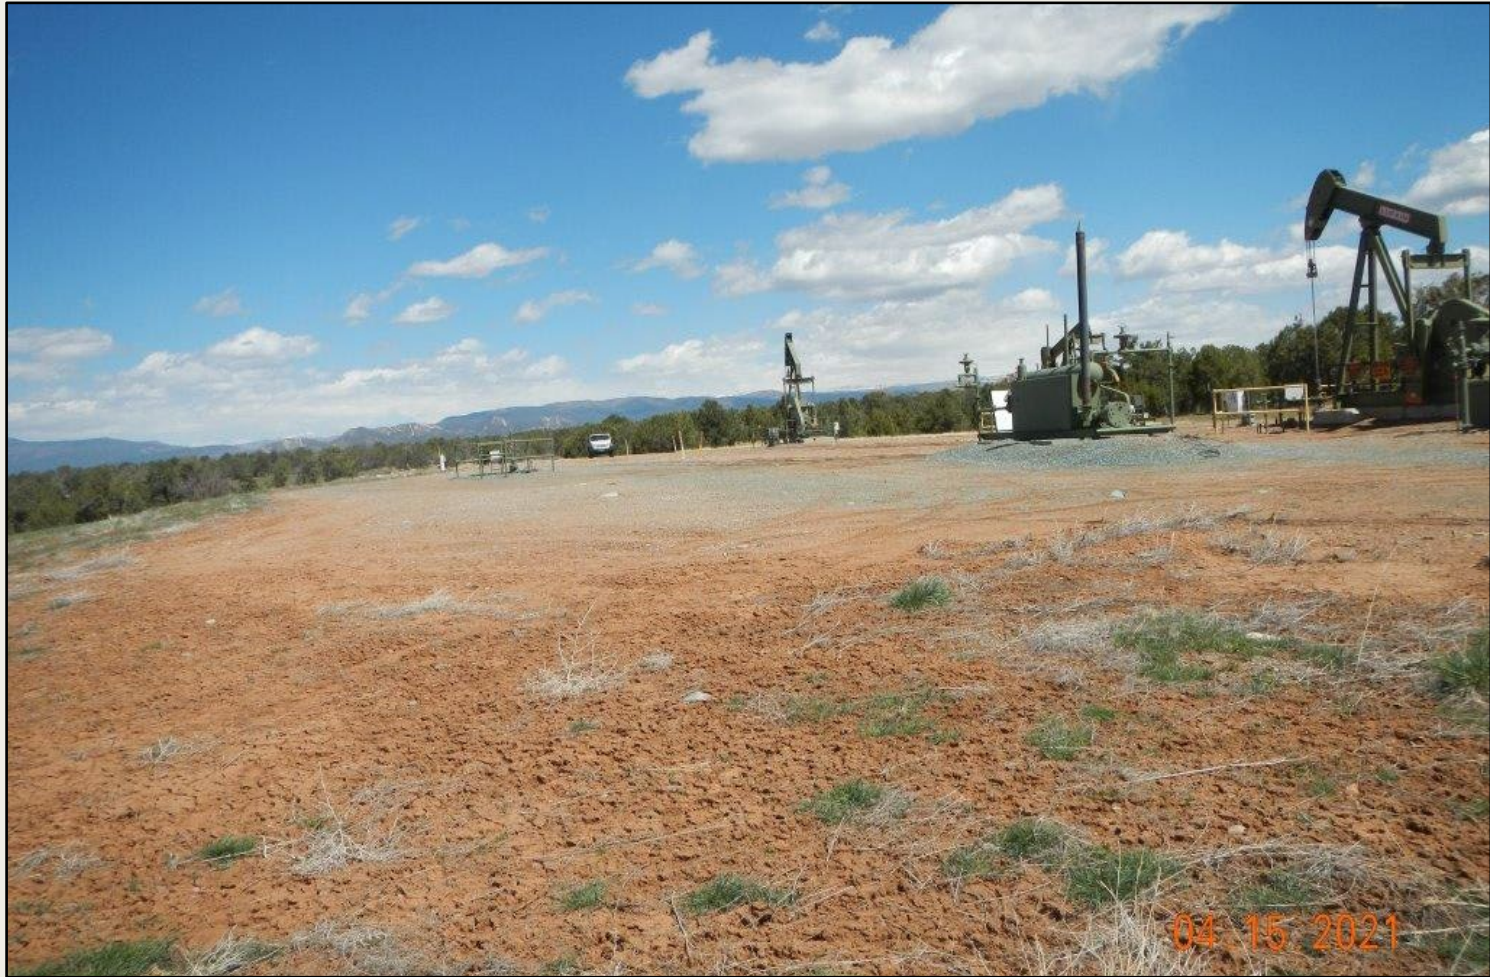
Photo 1. View of the project area from the southwestern corner facing center.

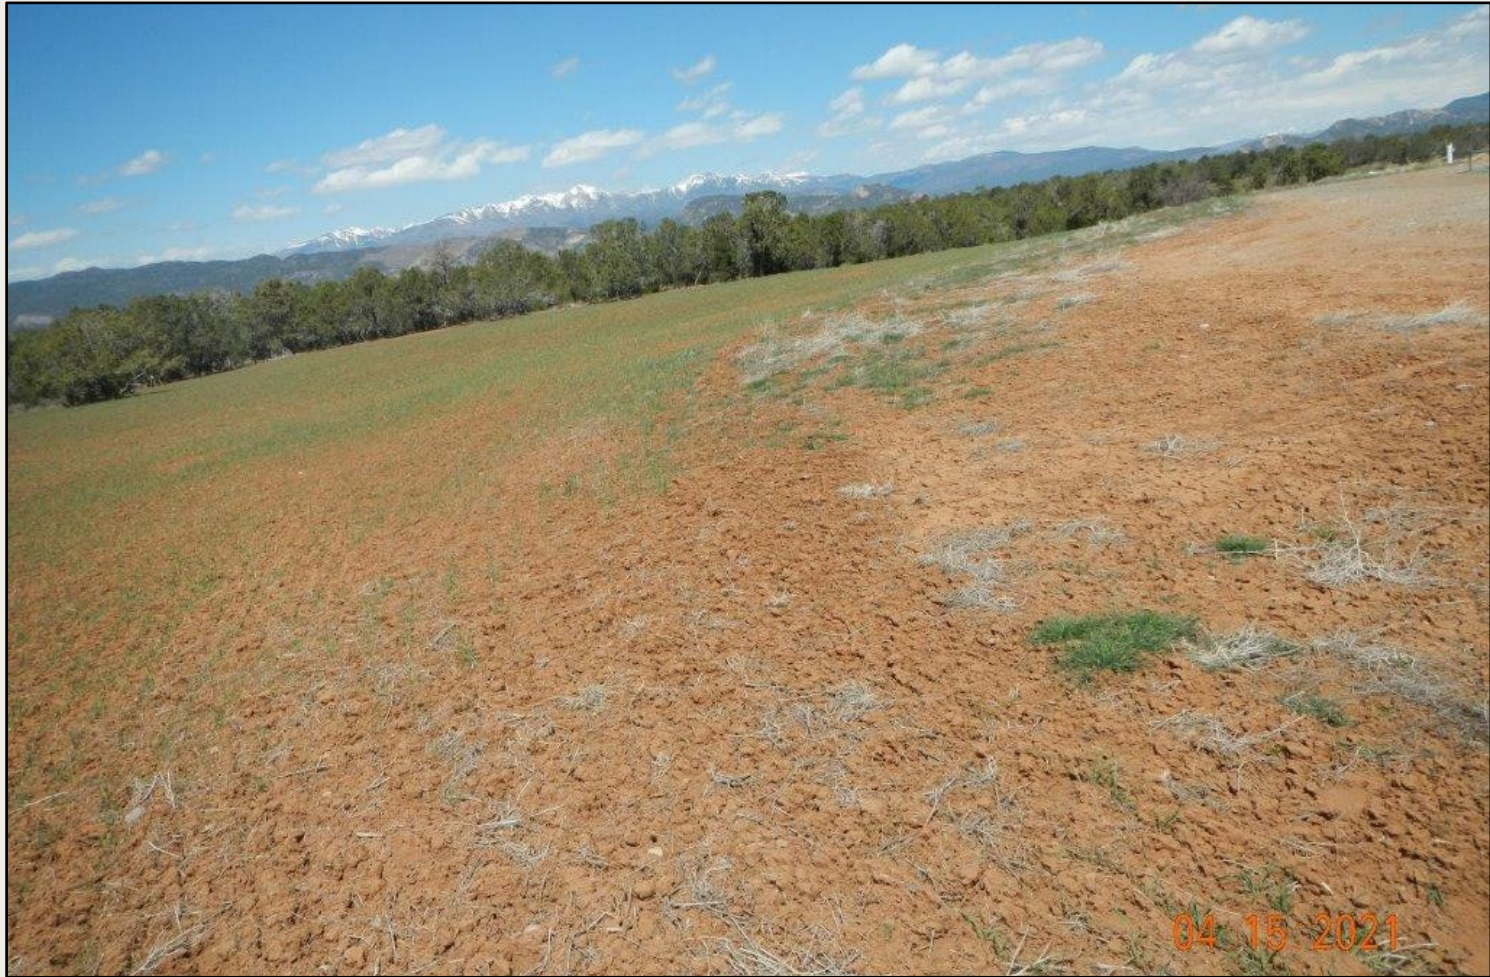
Photo 2. View of the western project area from the southwestern corner facing northward. Vegetation within the outer project area is in cultivation. Vegetation on the edges of the project area is comprised of grasses such as crested wheatgrass.

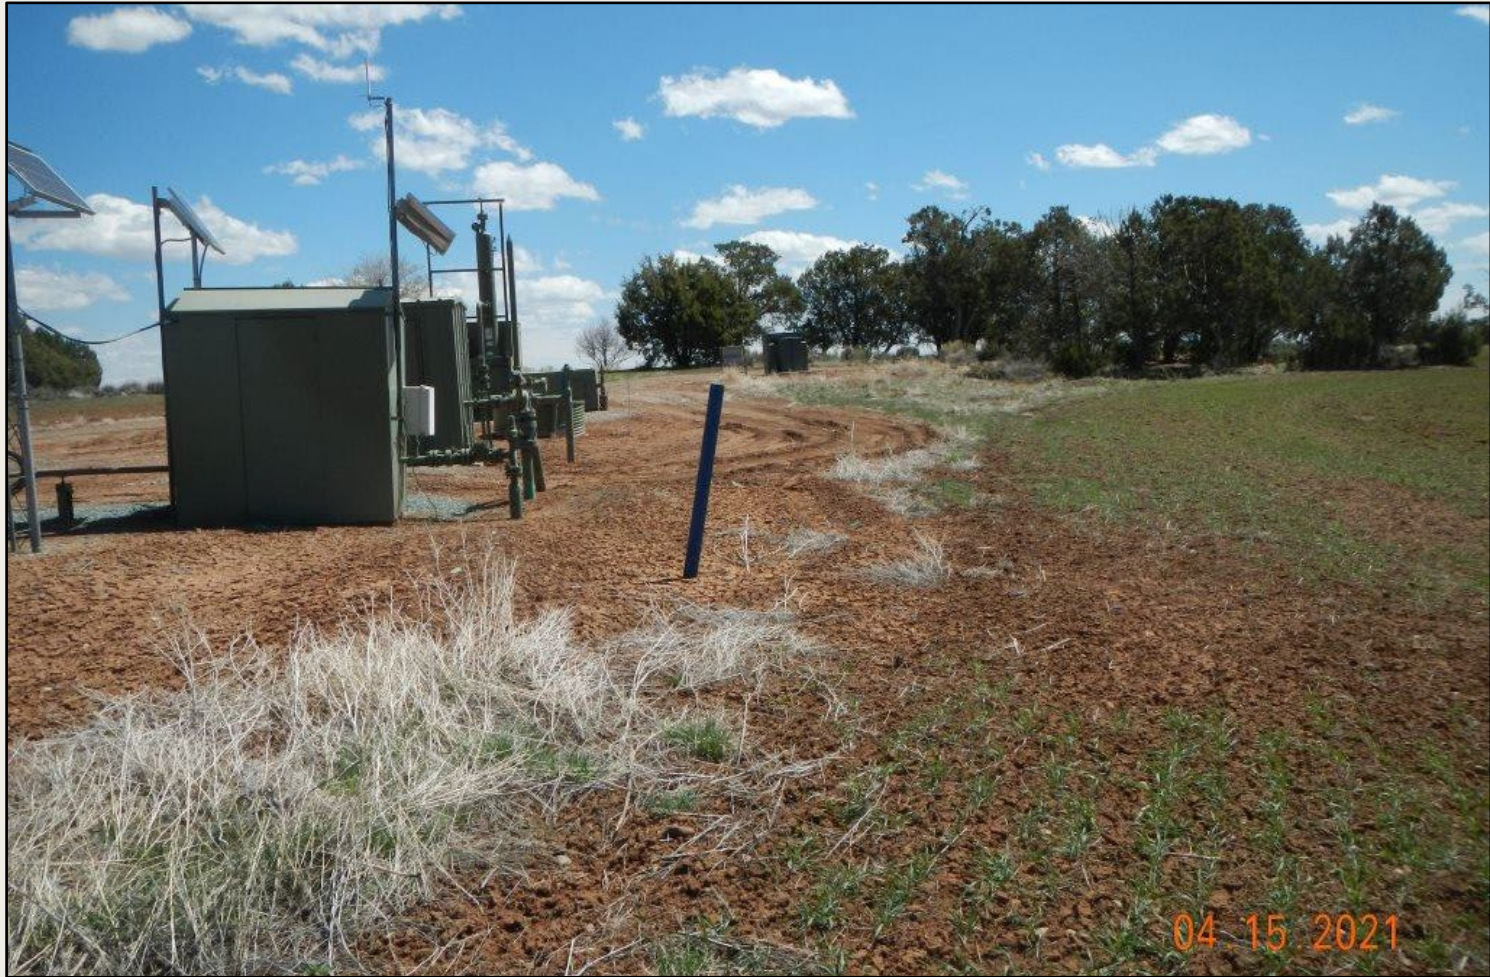
Photo 3. View of the southern project area from the southwestern corner facing eastward.

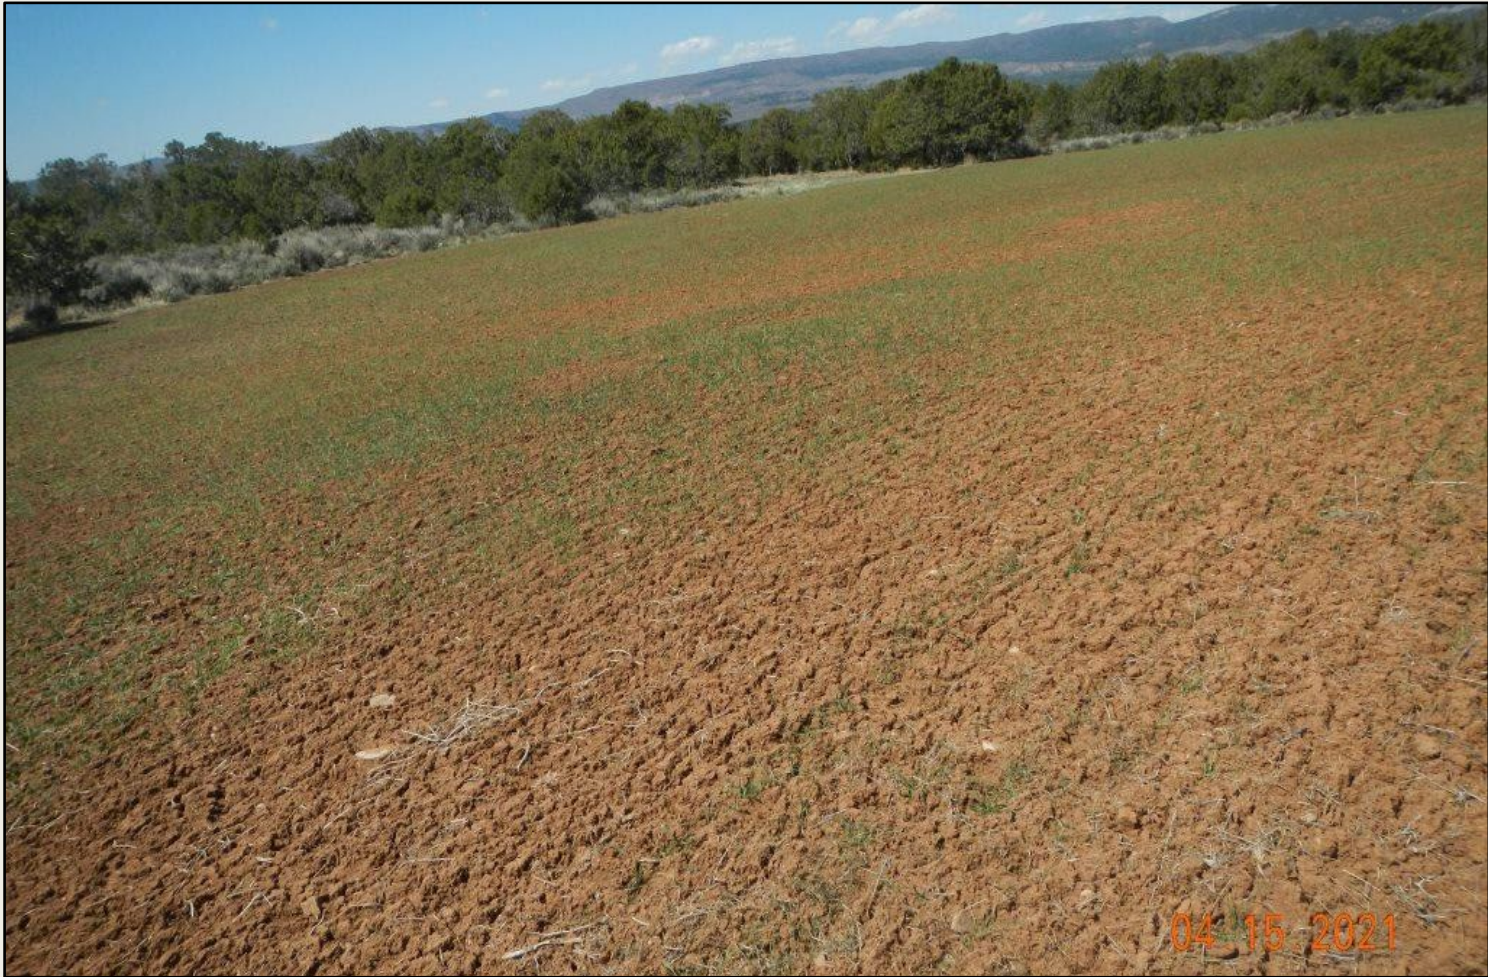
Photo 4. View of the reference area comprised of grass crop field in early vegetative condition.
