Inspection Photos
Location Name: Duncan Van Schaick 4
Location ID: 333337

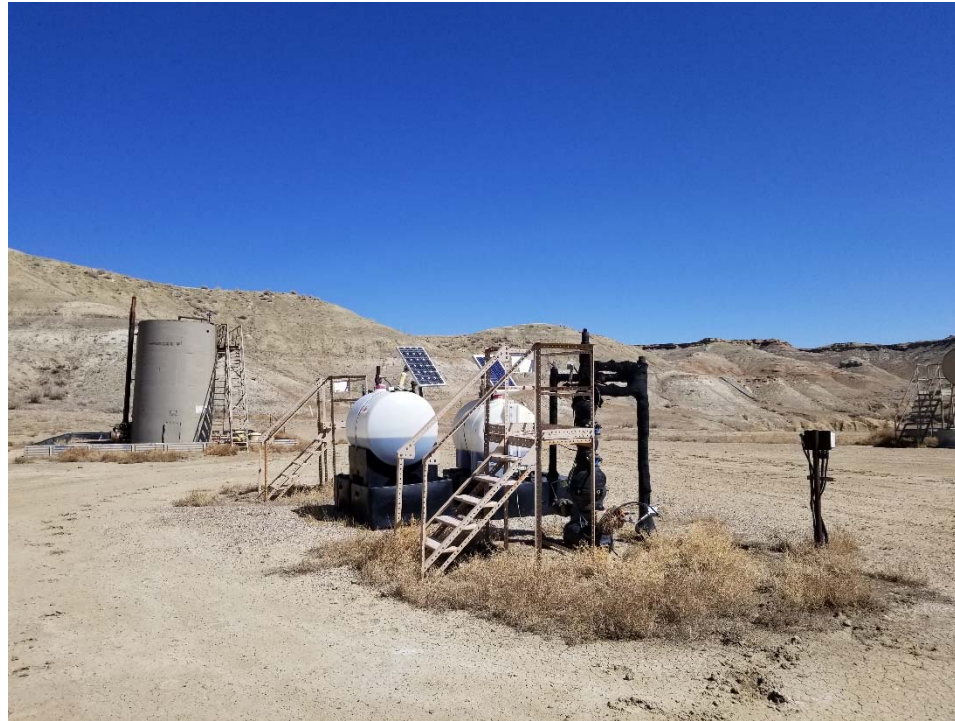
Photo 1. Overview of location taken facing northwest. Dried annual weeds on location.

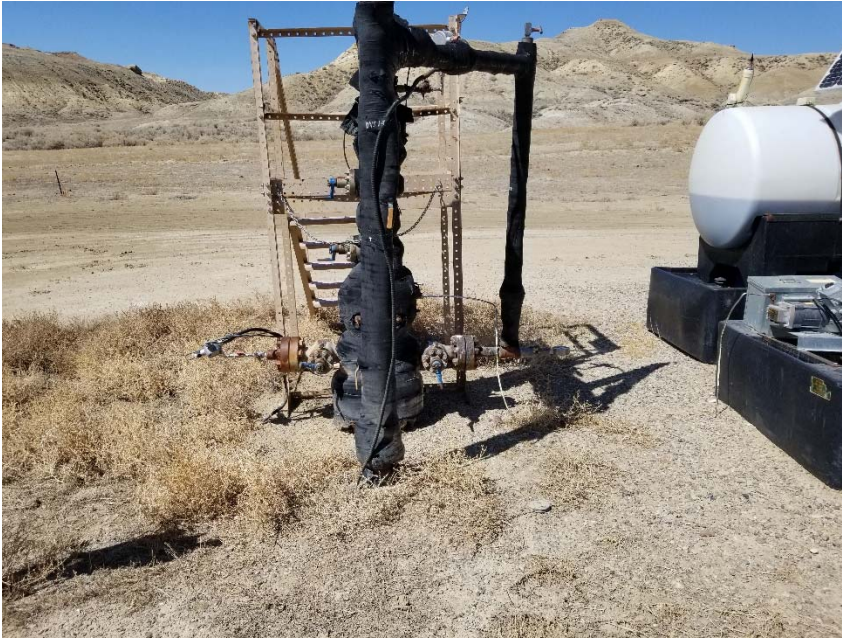
Photo 2. No bradenhead access apparent. Dried annual weeds on location.

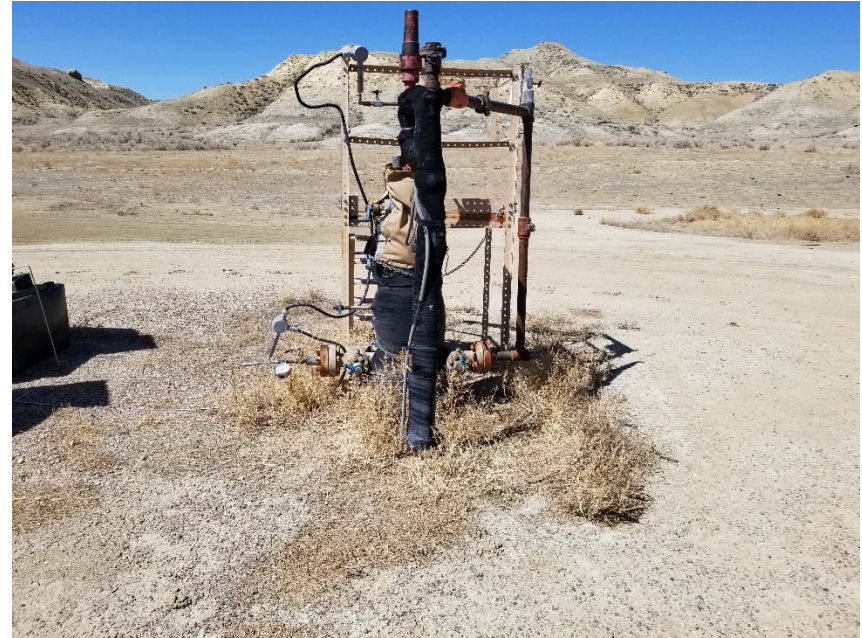
Photo 3. No bradenhead access apparent. Dried annual weeds on location.

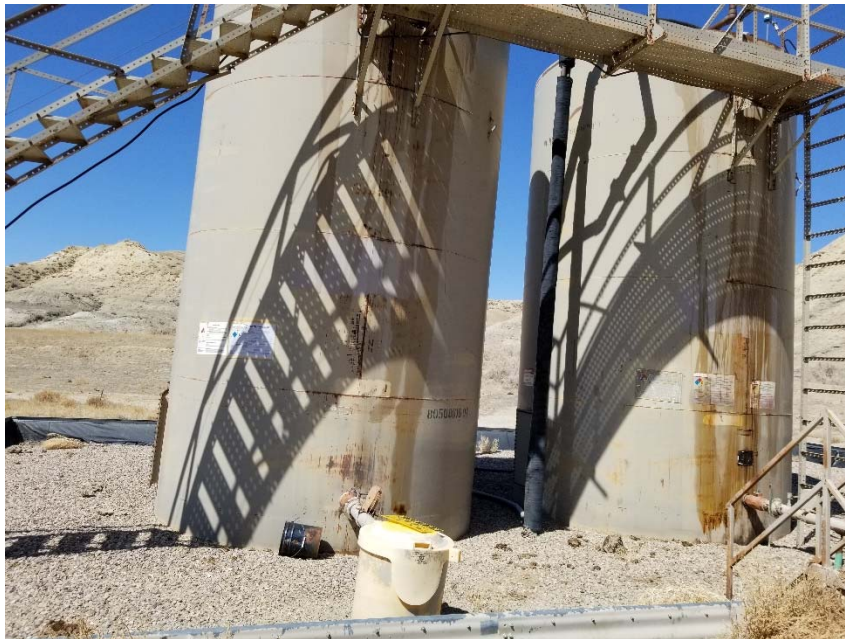
Photo 4. Tank labels faded/incomplete.

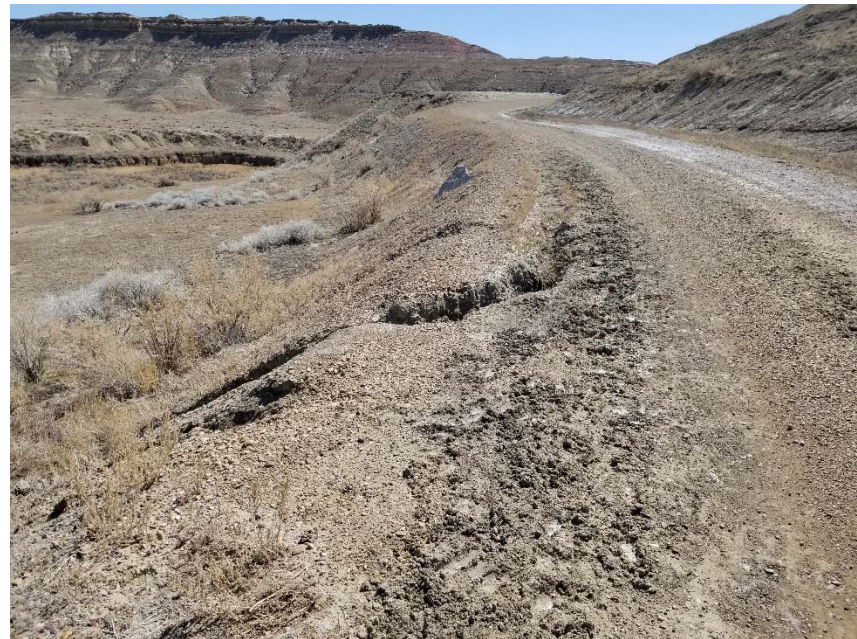
Photo 5. Erosion on access road.

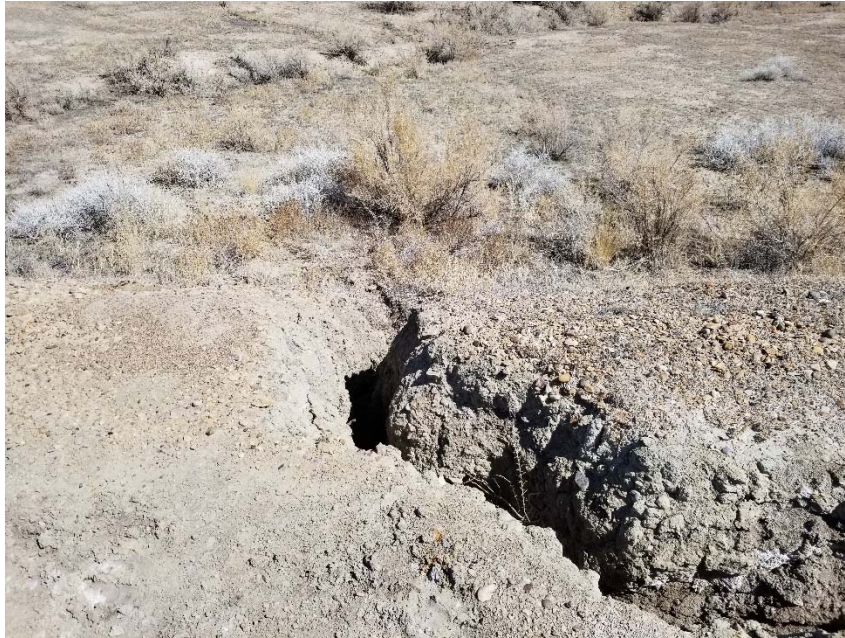
Photo 6. Erosion rill transporting sediment off access road.

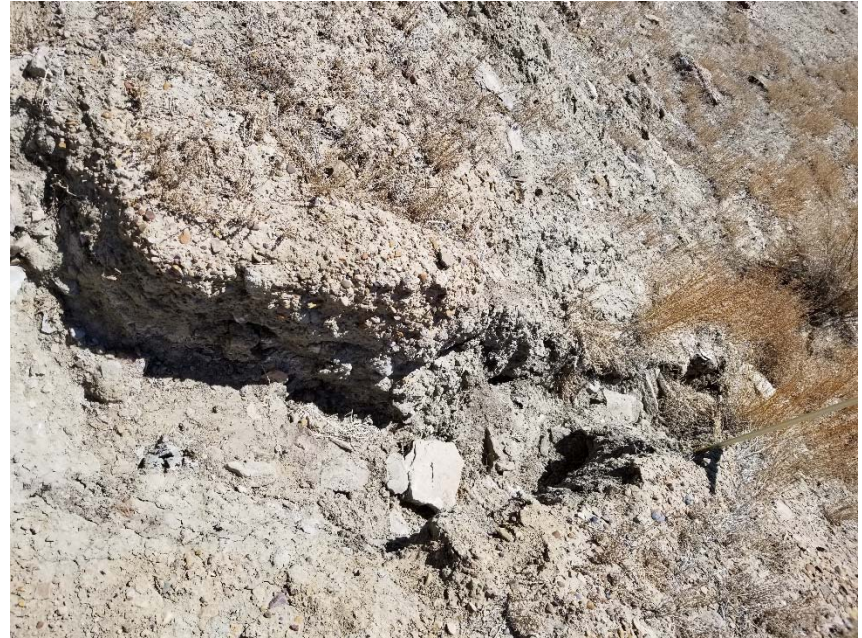
Photo 7. Sediment leaving access road.
