Inspection Photos
Location Name: Van Schaick C 10
Location ID: 313150

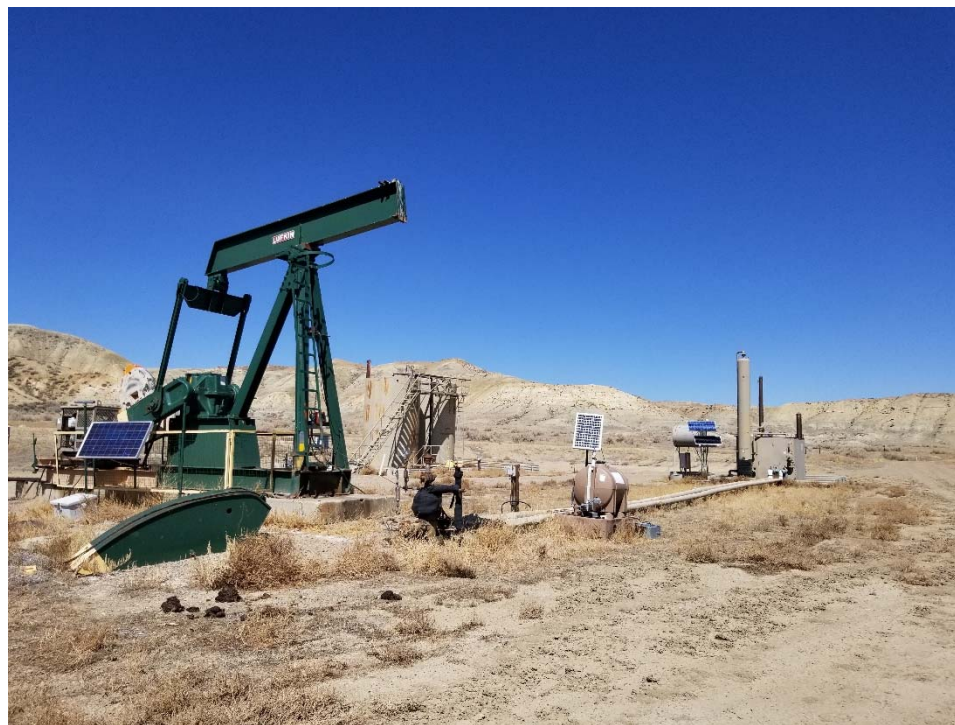
Photo 1. Overview of location taken facing northwest. Dried annual weeds on location.

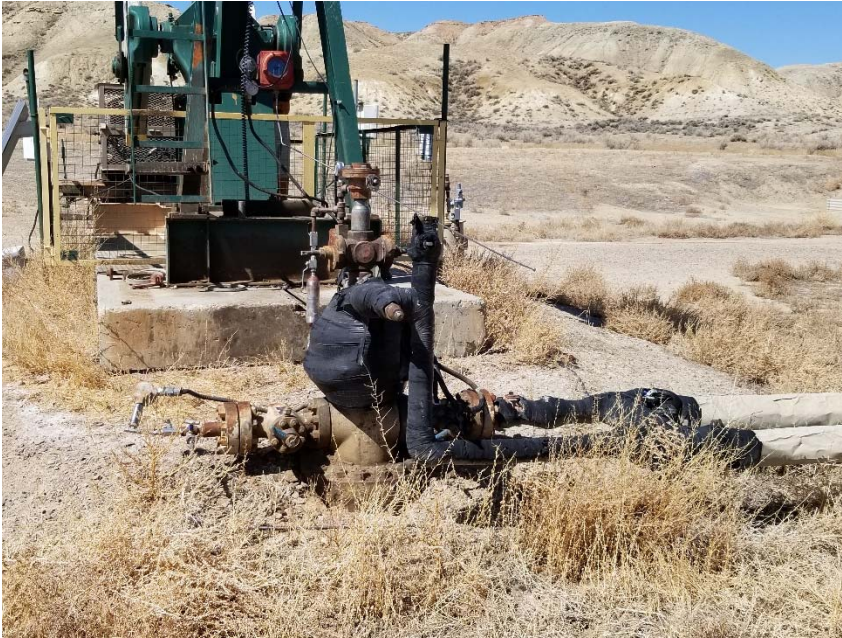
Photo 2. No bradenhead access apparent. Dried annual weeds on location.

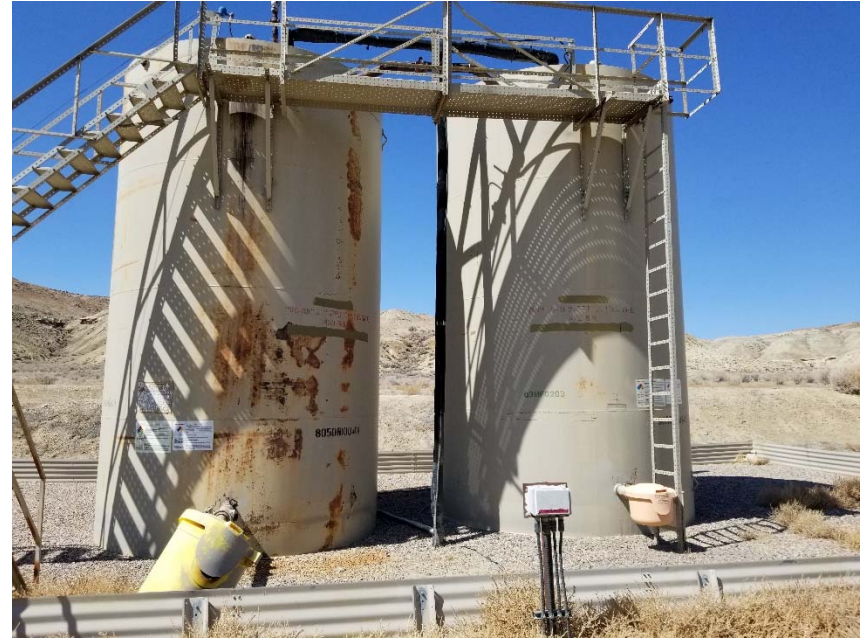
Photo 3. Tank labels faded/incomplete. Dried annual weeds on location.

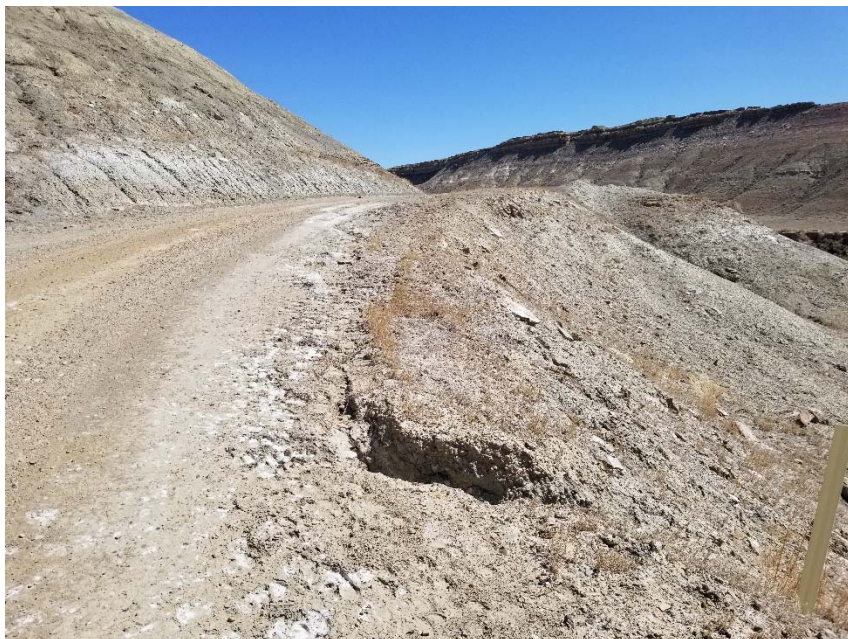
Photo 4. Erosion rill on access road.

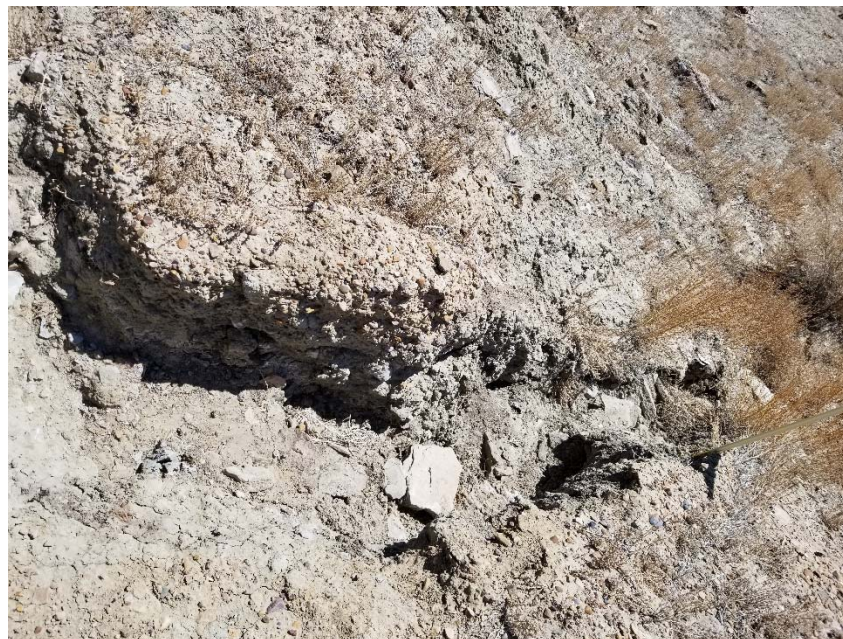
Photo 5. Sediment transport off access road.

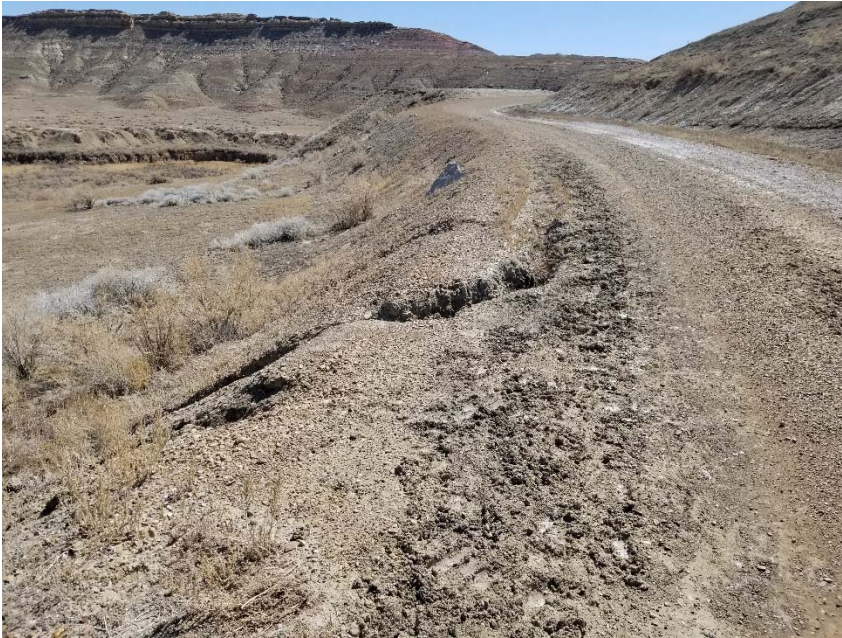
Photo 6. Erosion rill on access road.

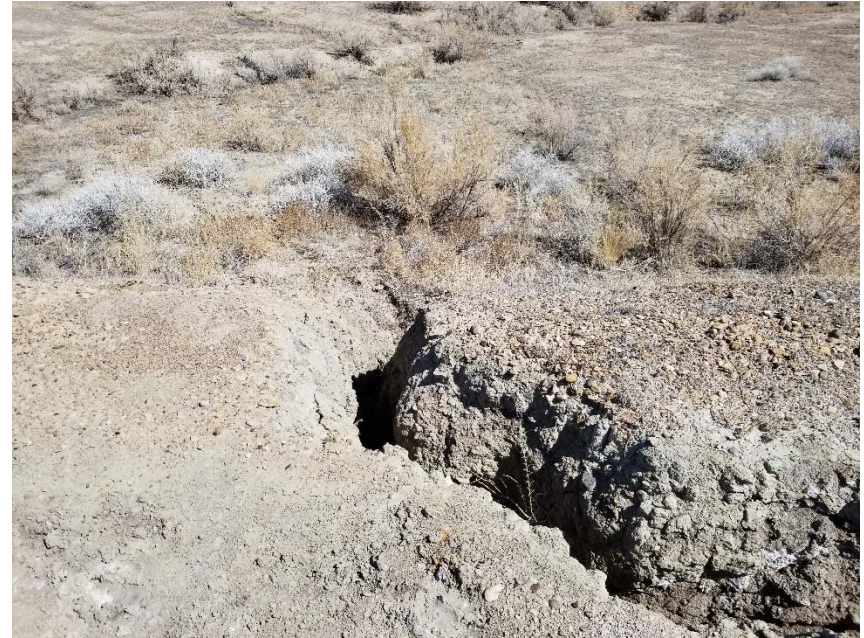
Photo 7. Sediment transport off access road.
