## Inspection Photos

Location Name: CAERUS PICEANCE LLC WALLING-68S96W /1NWSE

Location ID: 334062

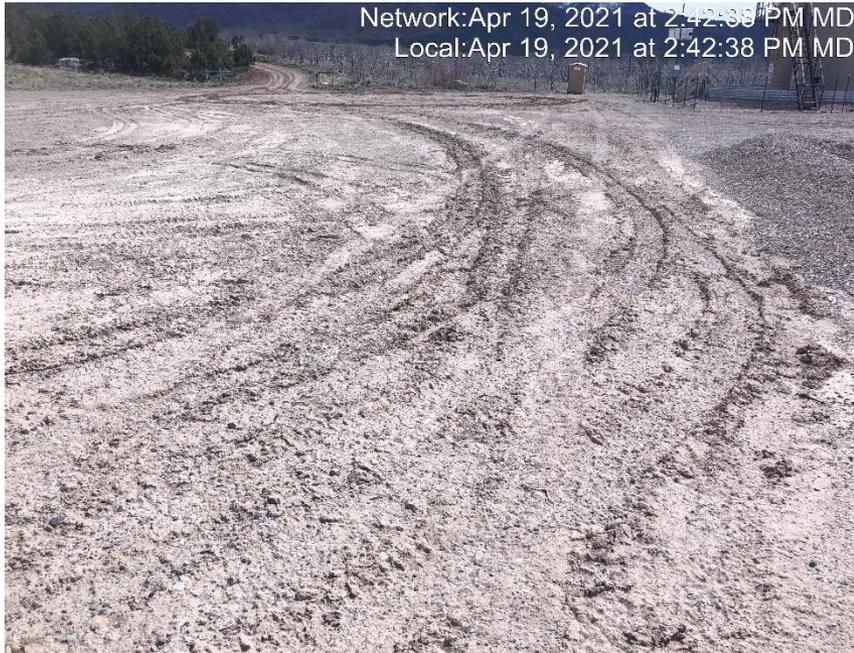
**Photo #3548 Location lacks stabilization.**

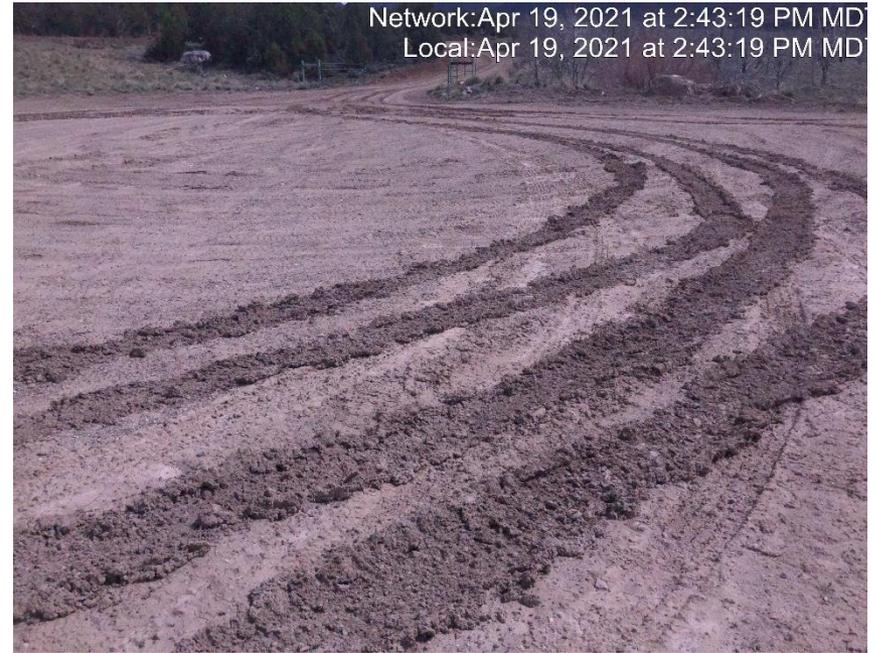
**Photo #3549 Location lacks stabilization.**

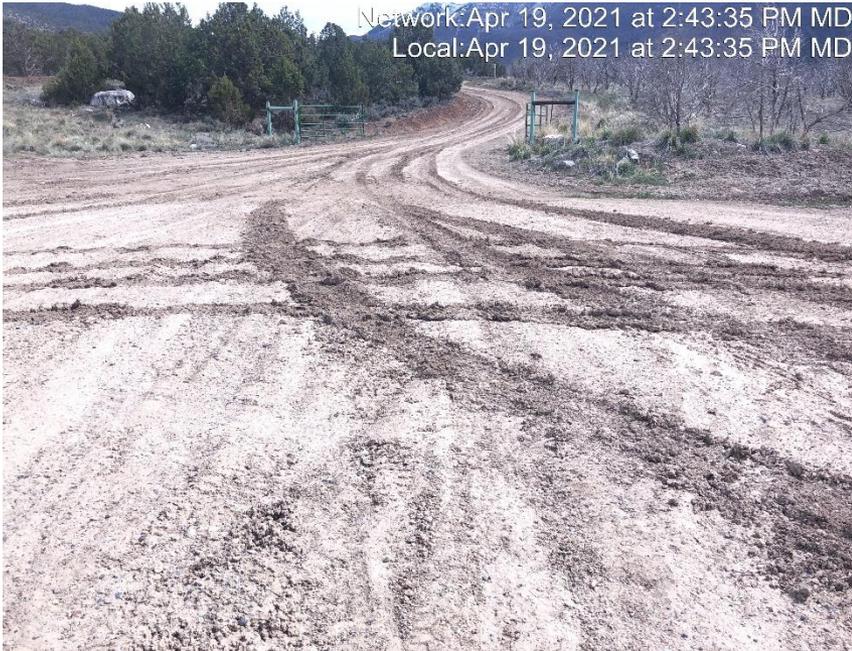
**Photo #3550 No form of tracking BMP at entrance to location.**

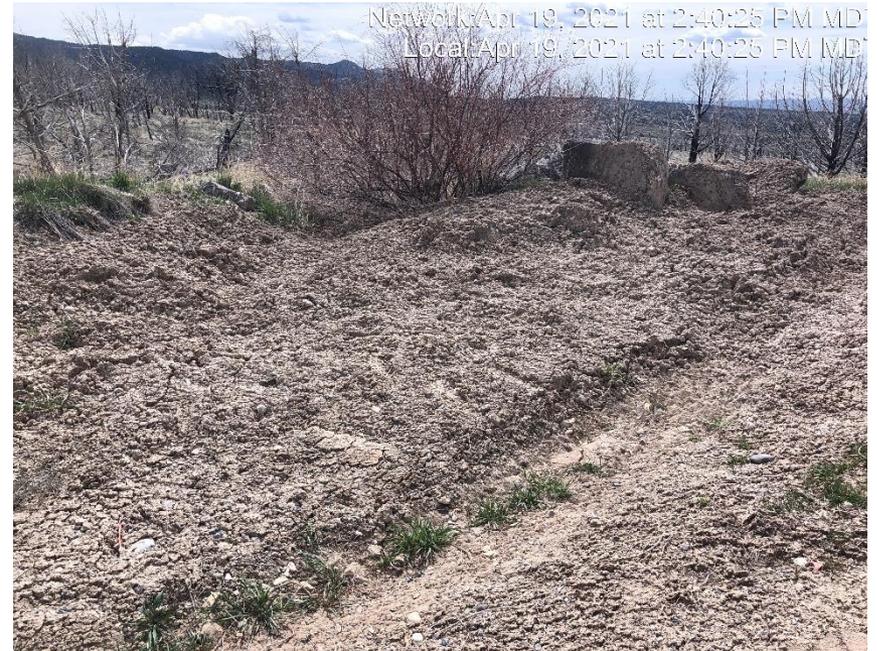
**Photo #3545 Sediment has been transported off location.**

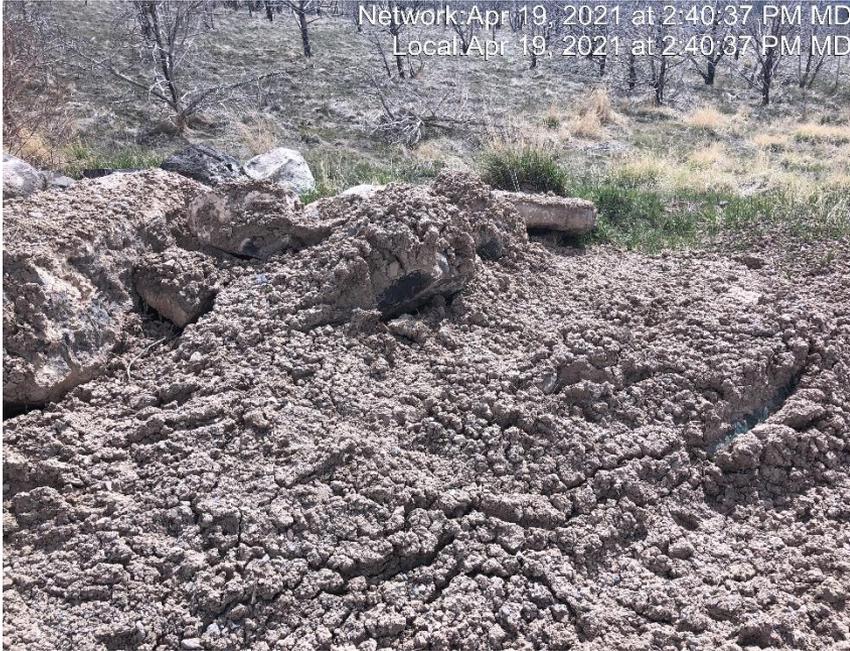
**Photo #3546 Sediment has been transported off location.**

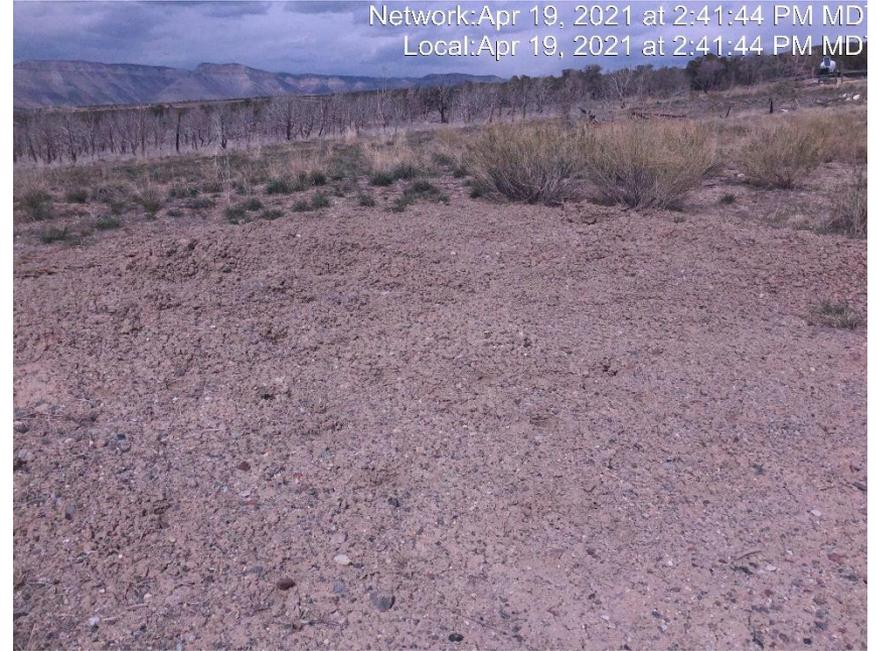
**Photo #3547 Sediment is choking off vegetation**
