COLORADO
Oil & Gas Conservation
Commission
Department of Natural Resources

Ant Hill Unit 18-43

API: 05-103-10296

Inspection: 701500398

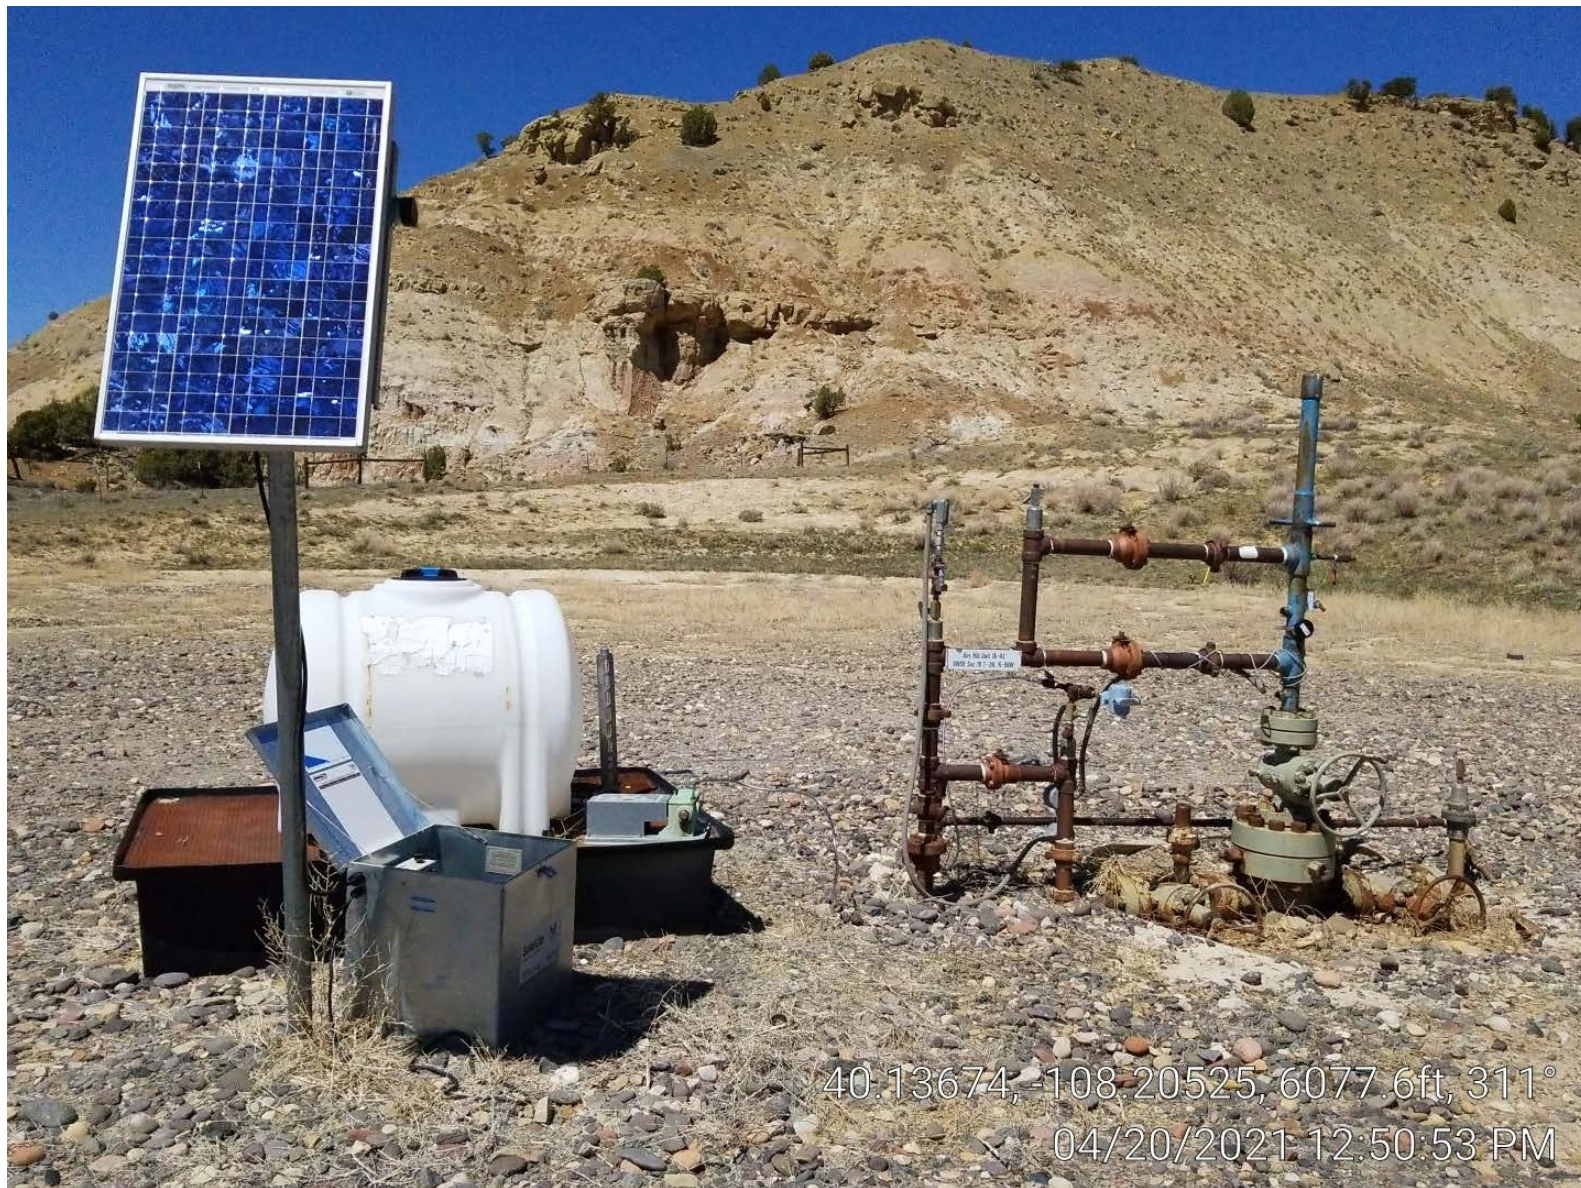
Photo 2. Well.

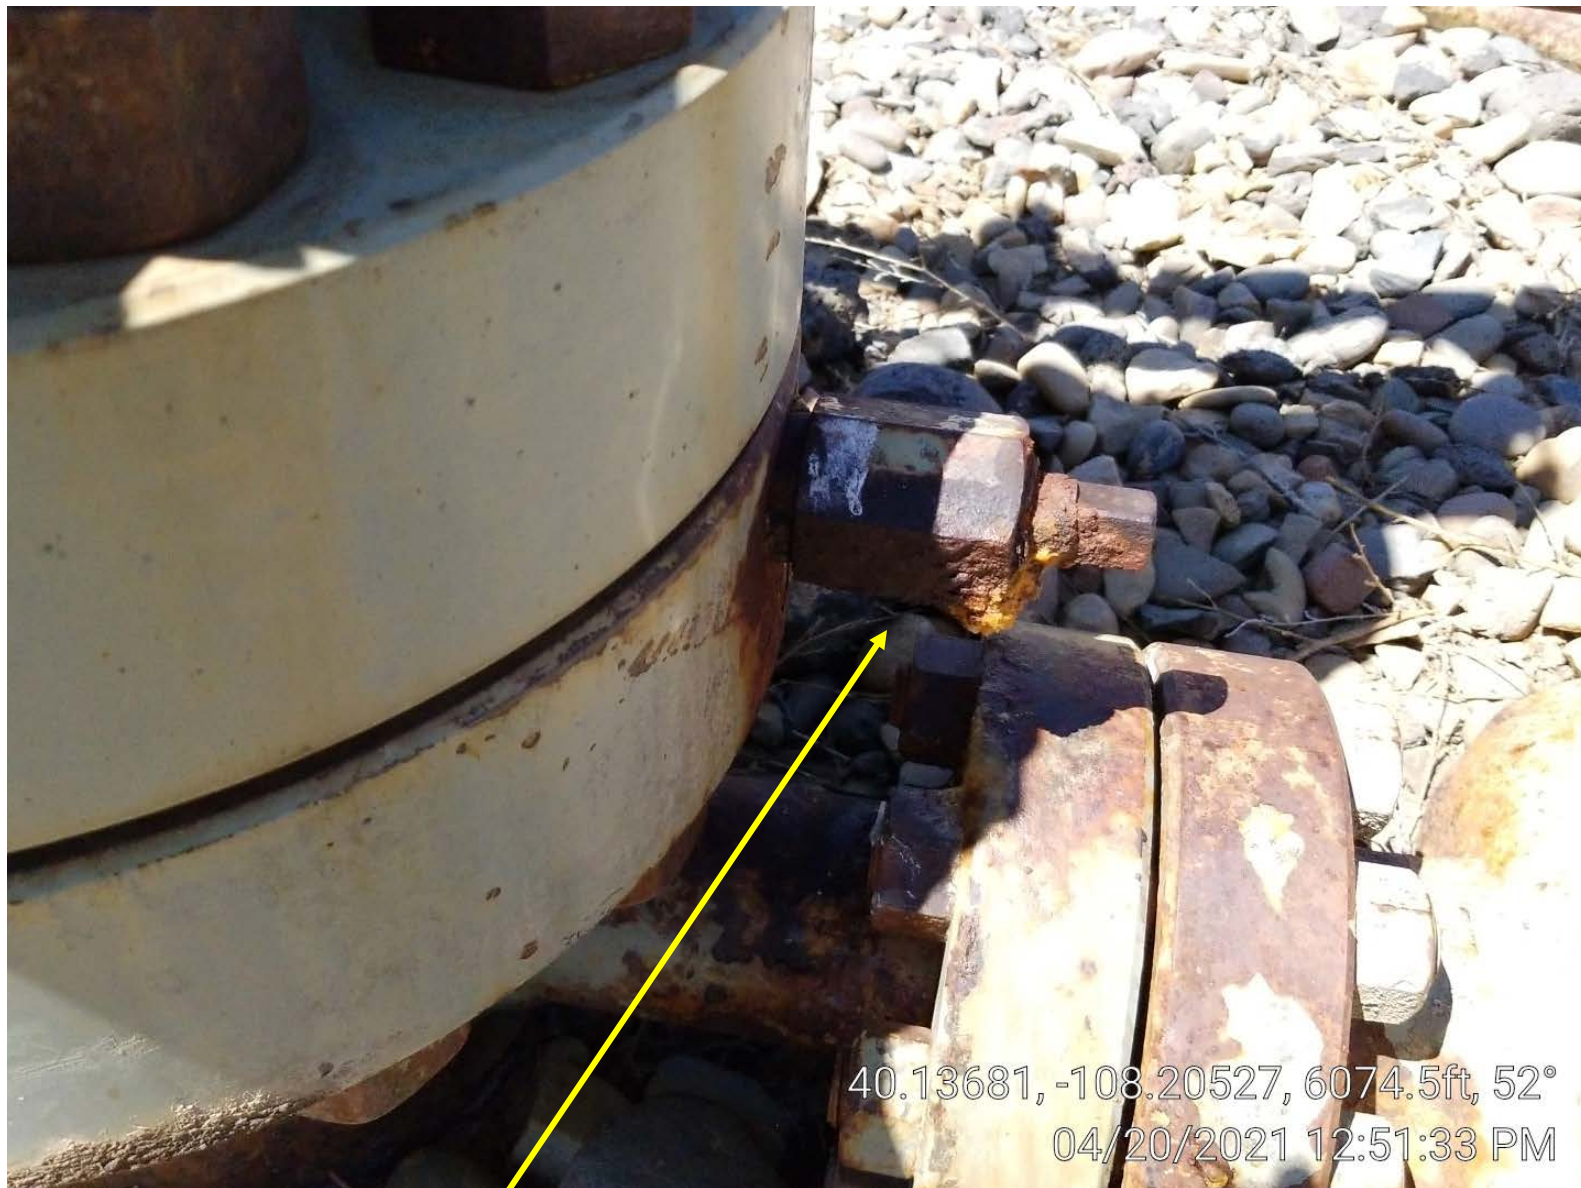
Photo 3. Well gas leak.

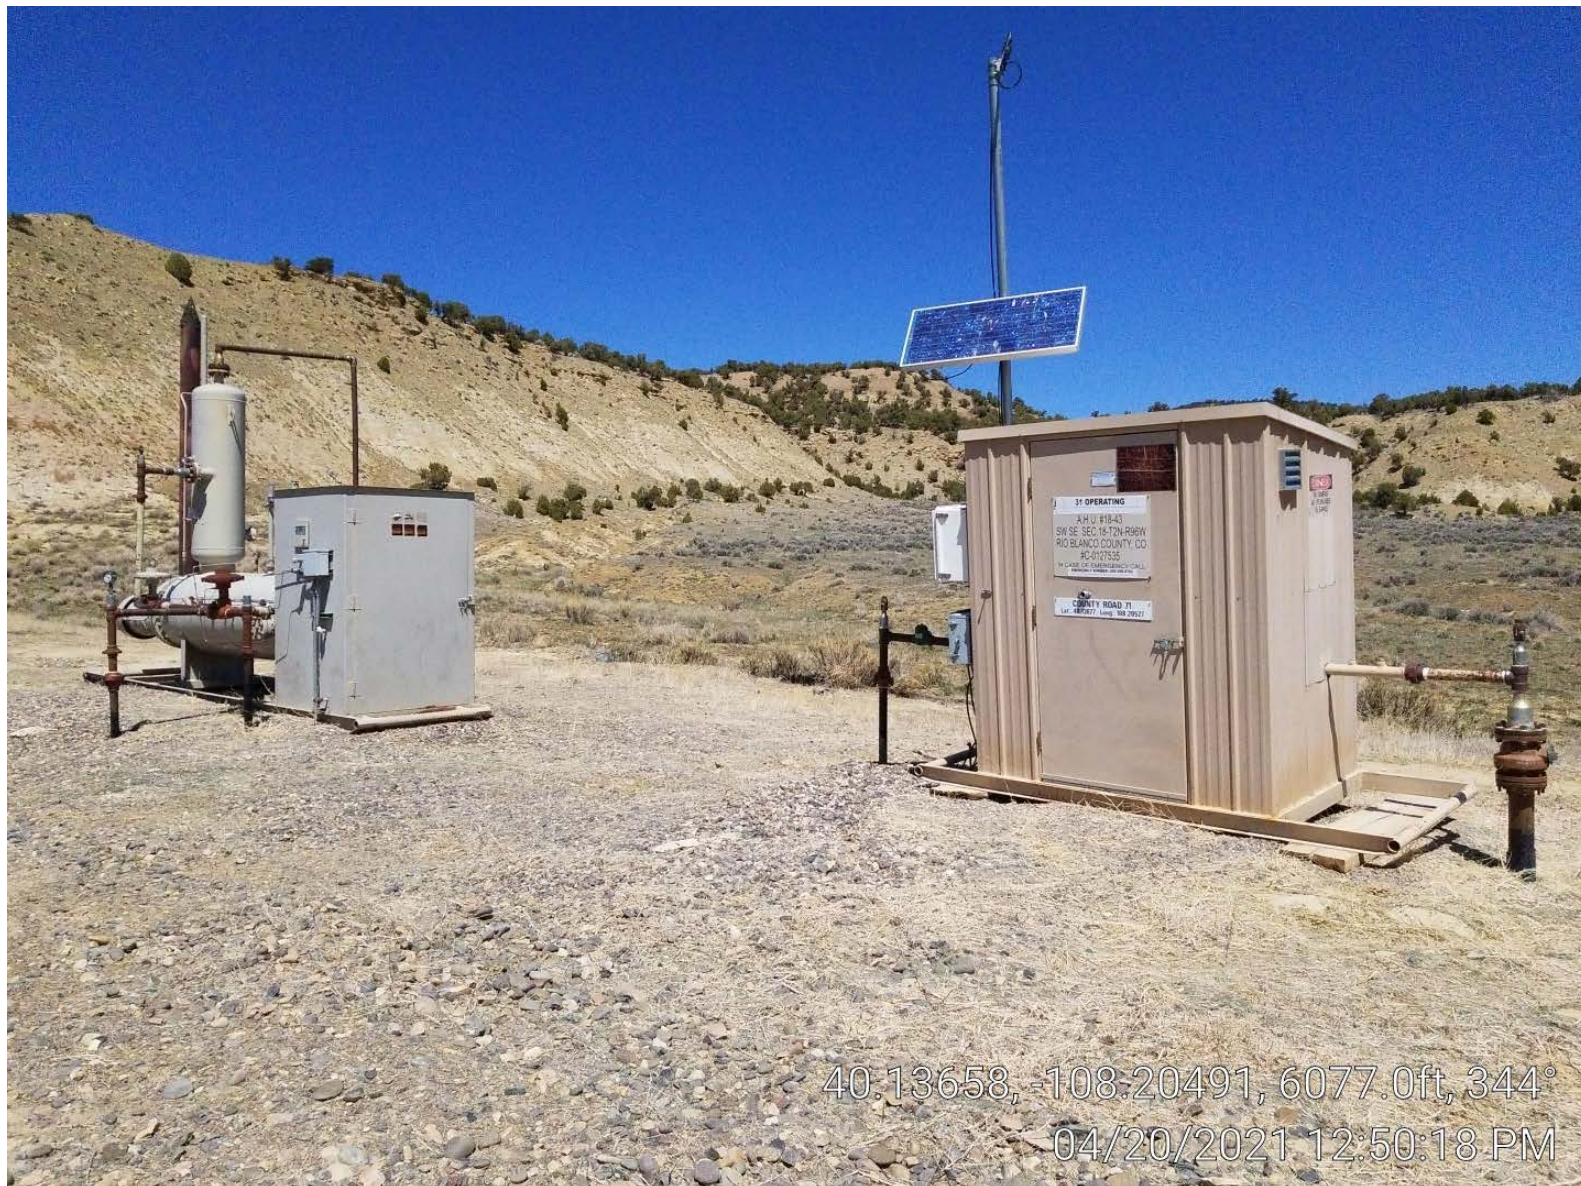
Photo 4. Separator & meter building.

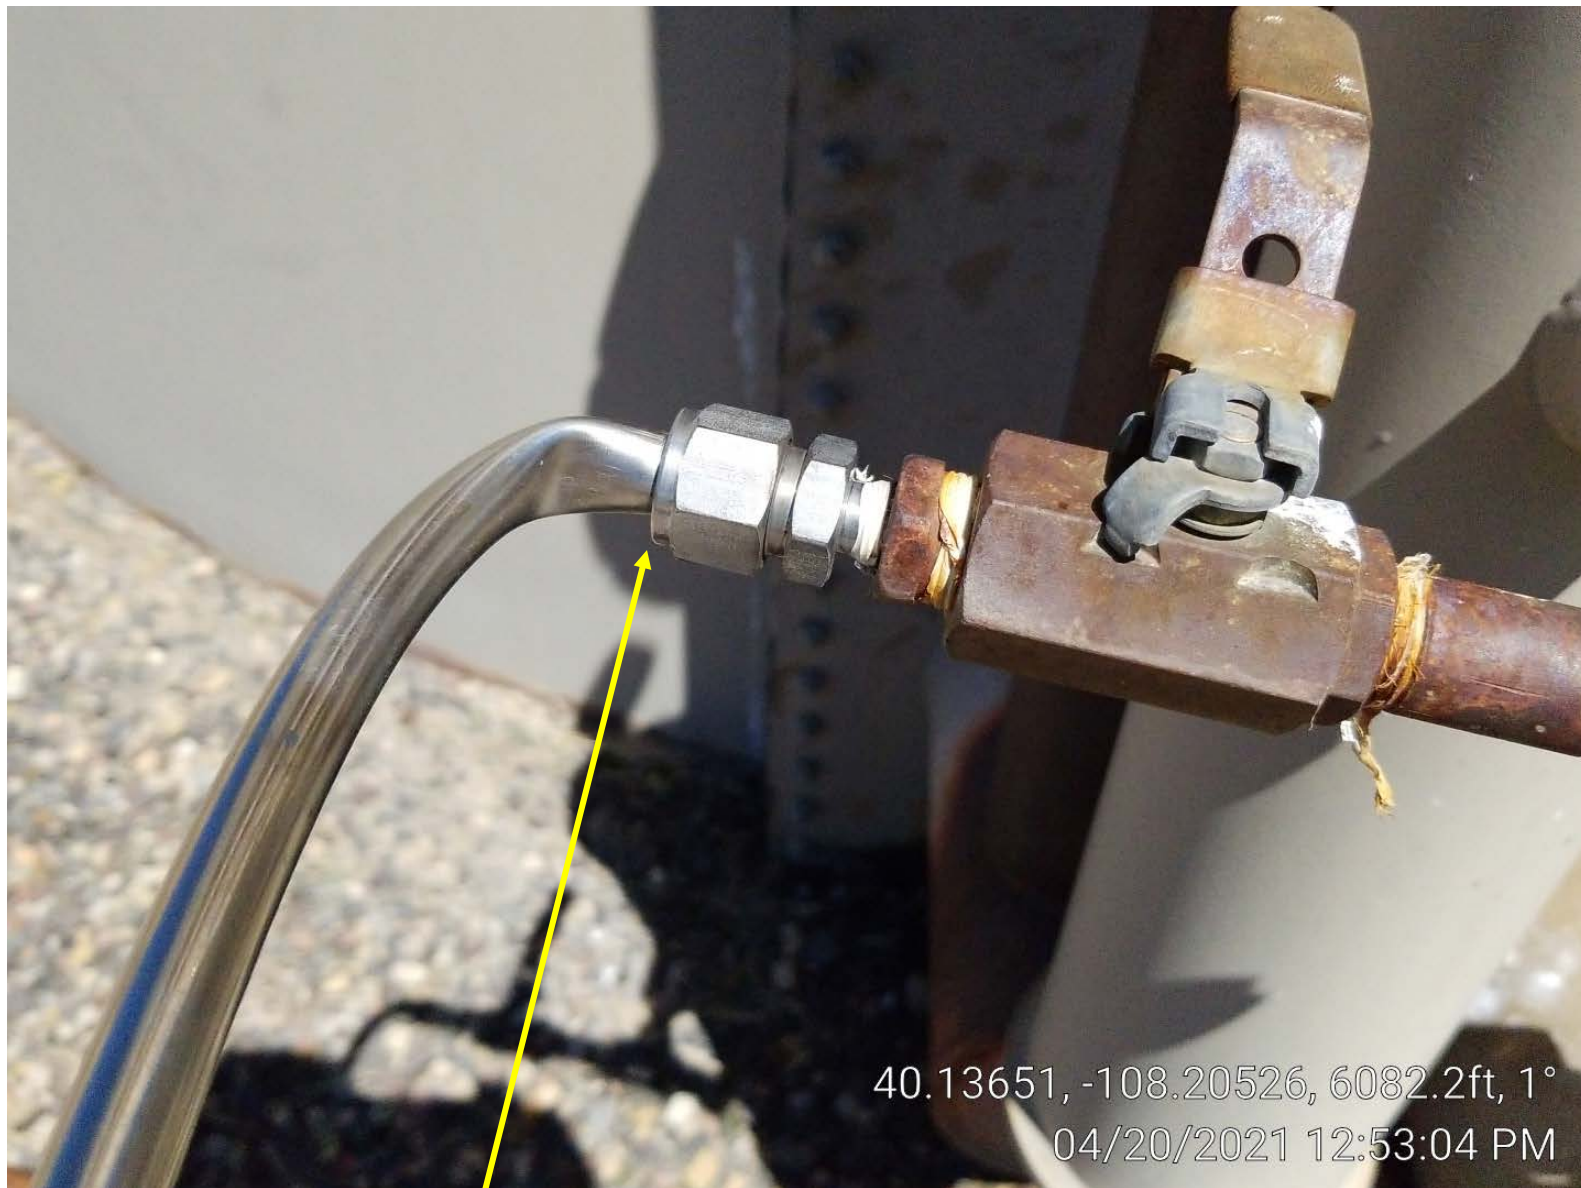
Photo 6. Gas leak at tank.

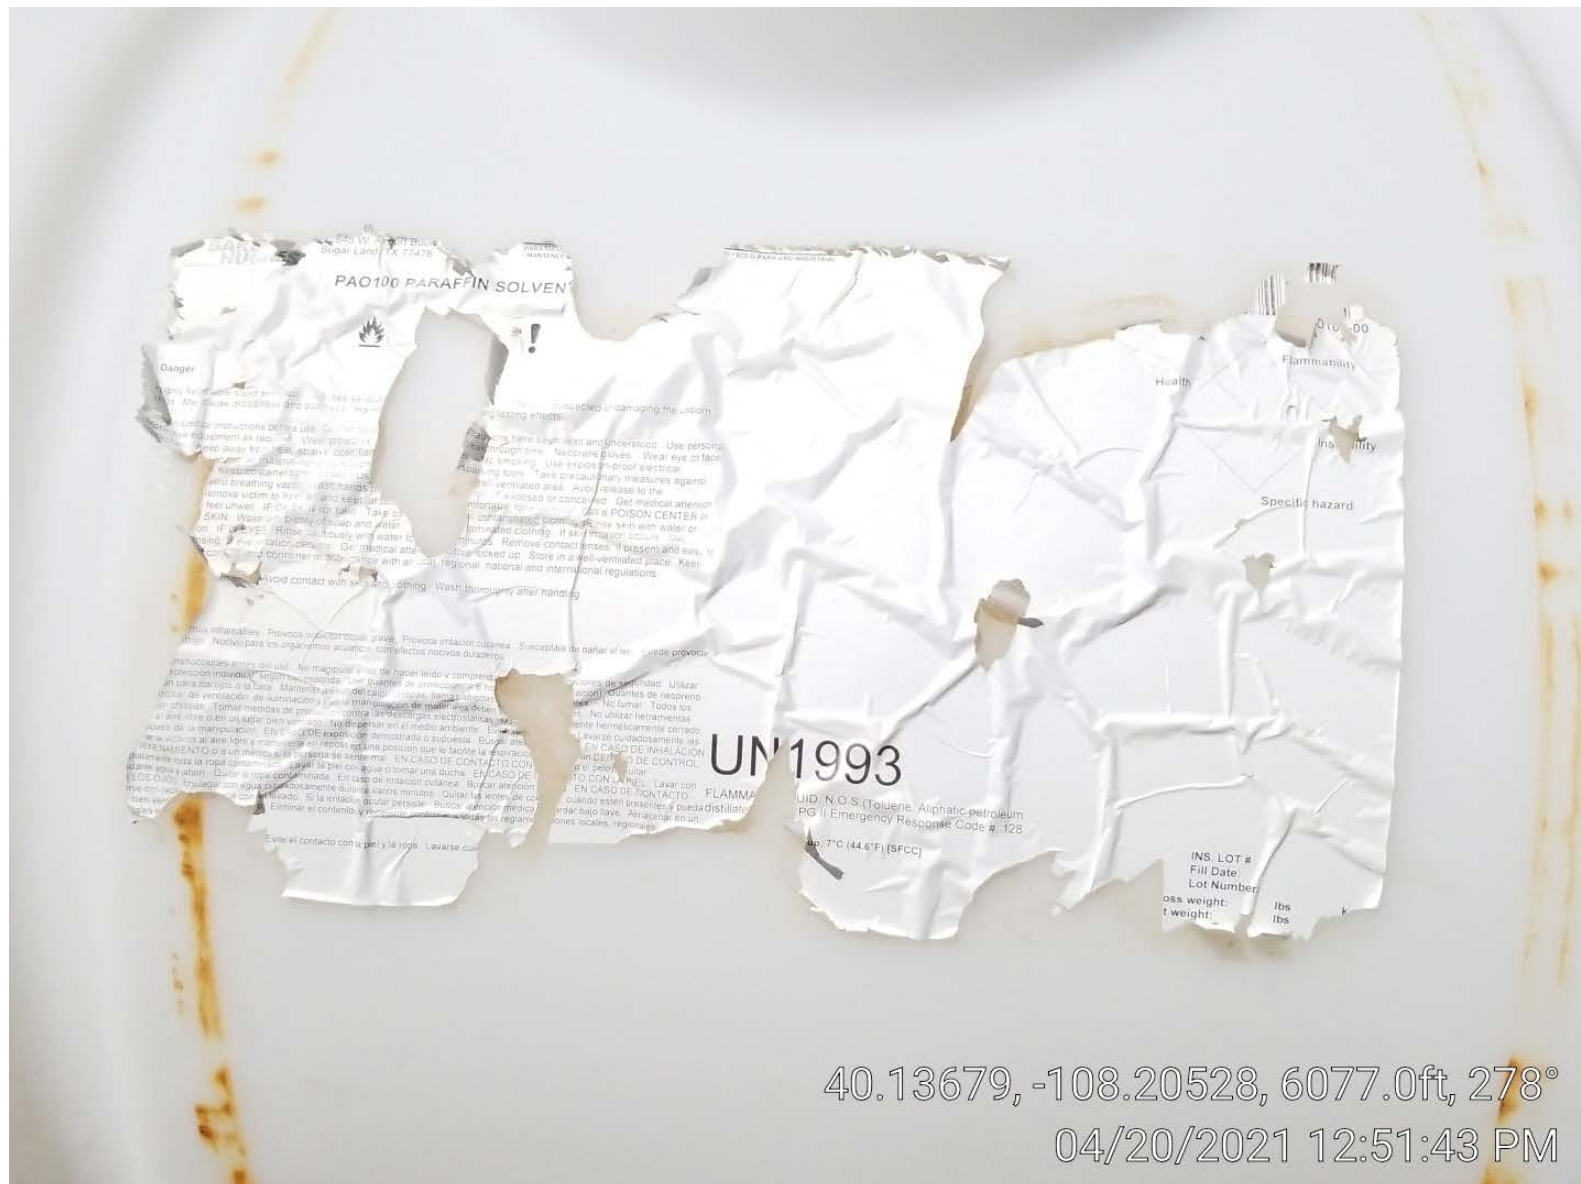
Photo 7. Chemical label.

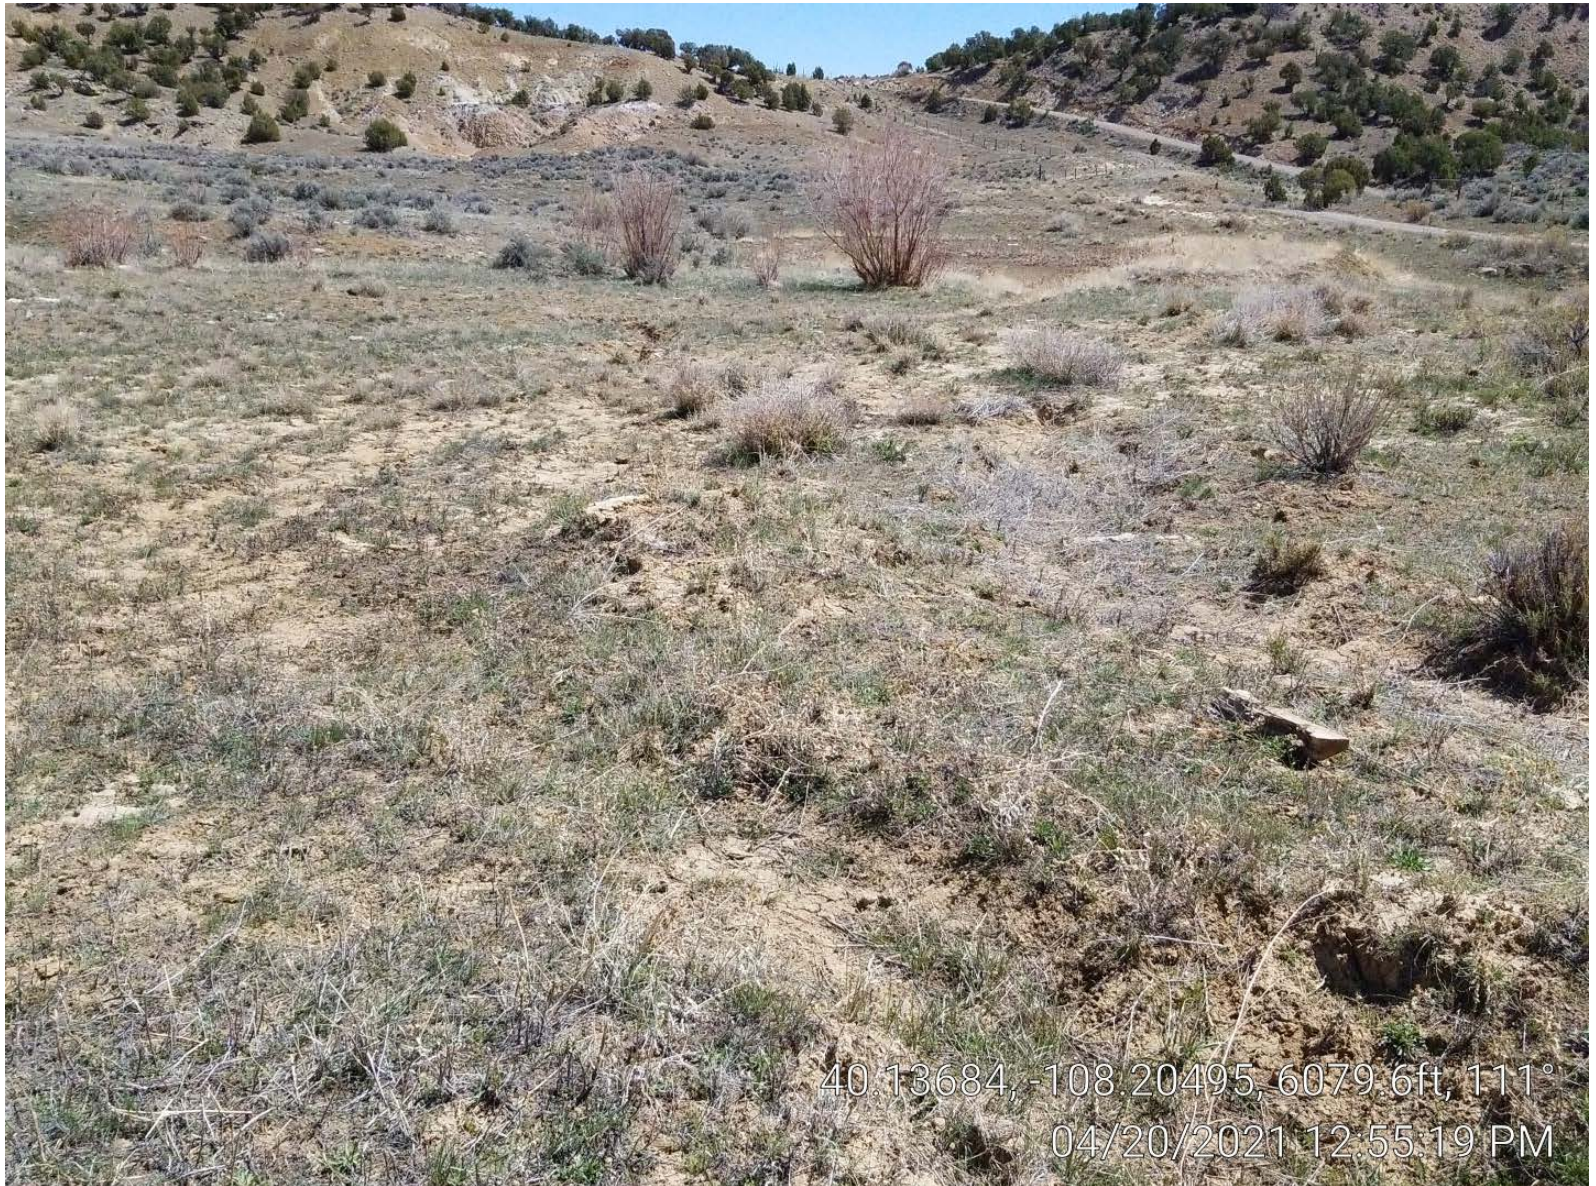
Photo 8. Sediment flow coming off location.
