Colorado Oil and Gas Conservation Commission

TEP Federal PA 31-26 Issue Report

Created on April 21, 2021

Captured: April 16, 2021

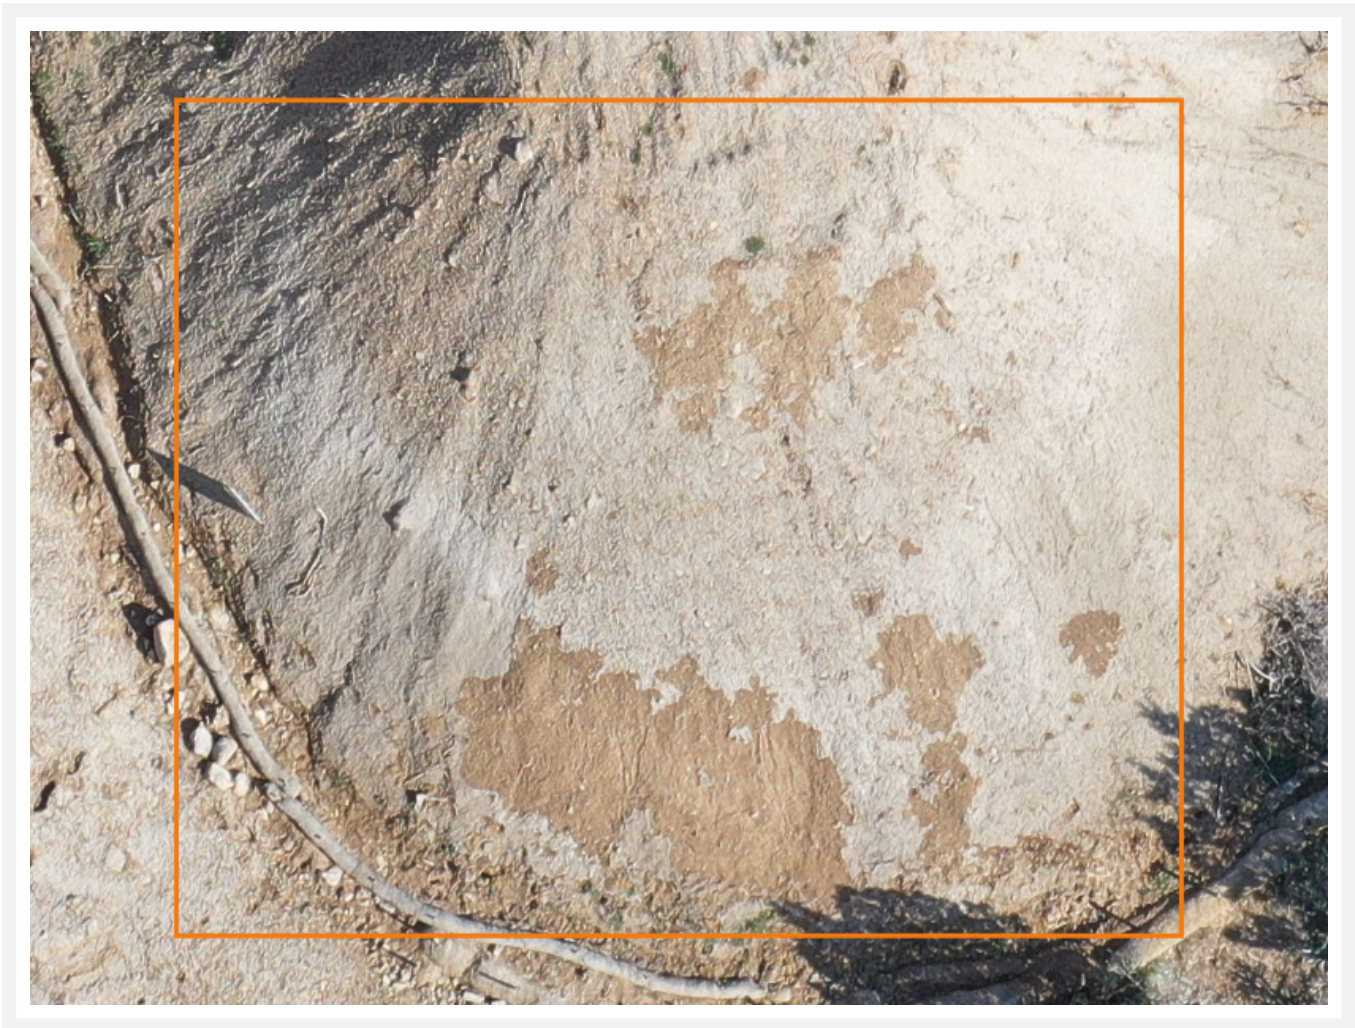
1 - Erosion **OPEN**

Stabilization control measure at topsoil pile degrading.

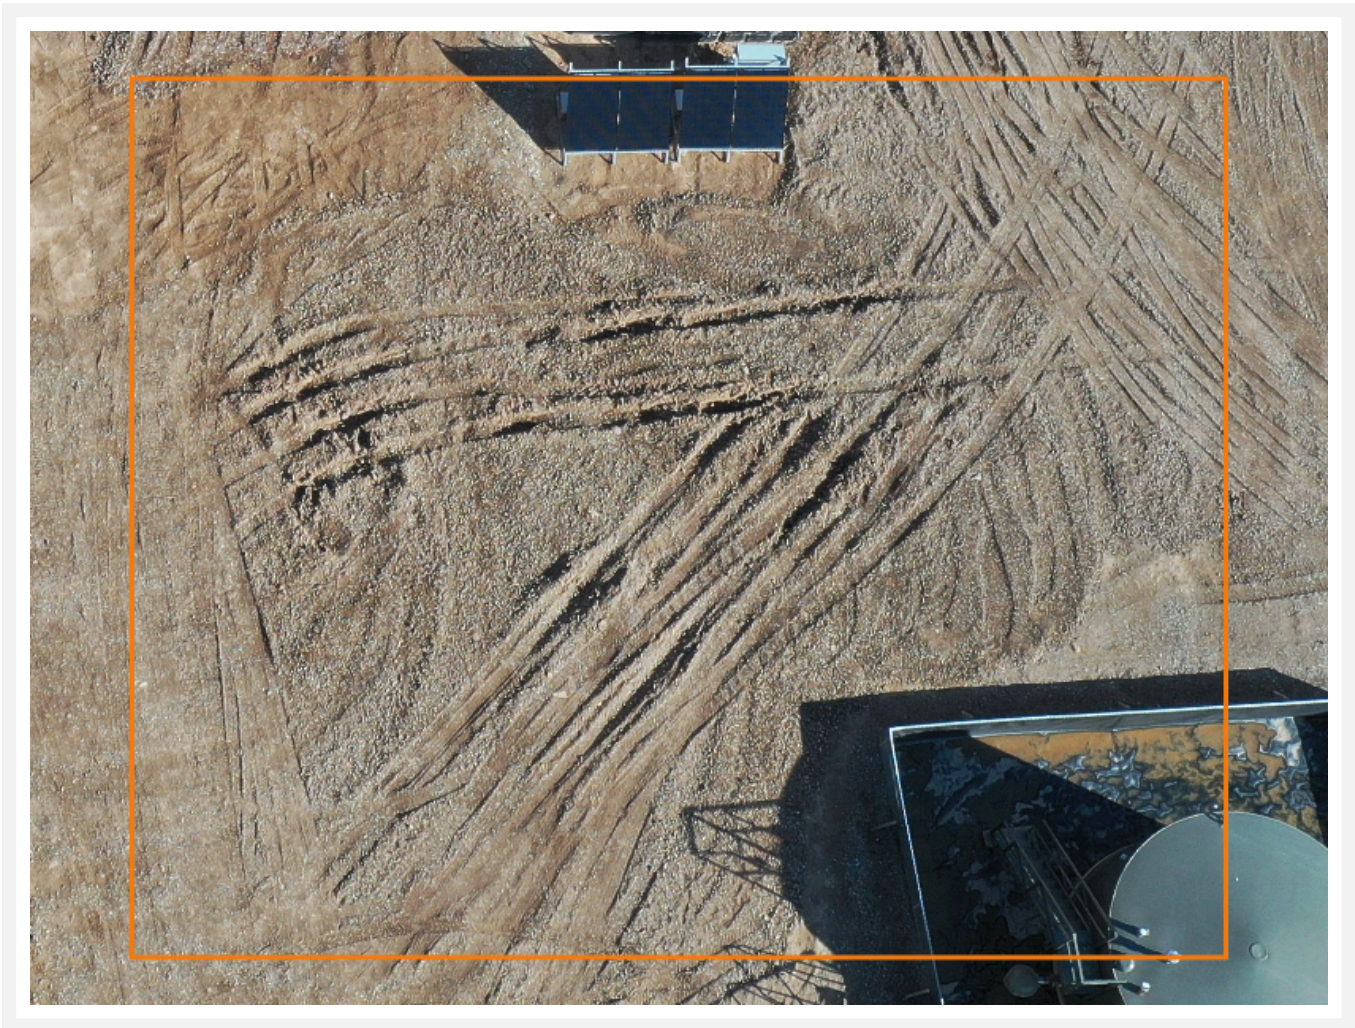
2 - Erosion **OPEN**

Pad stabilization issues remain evident

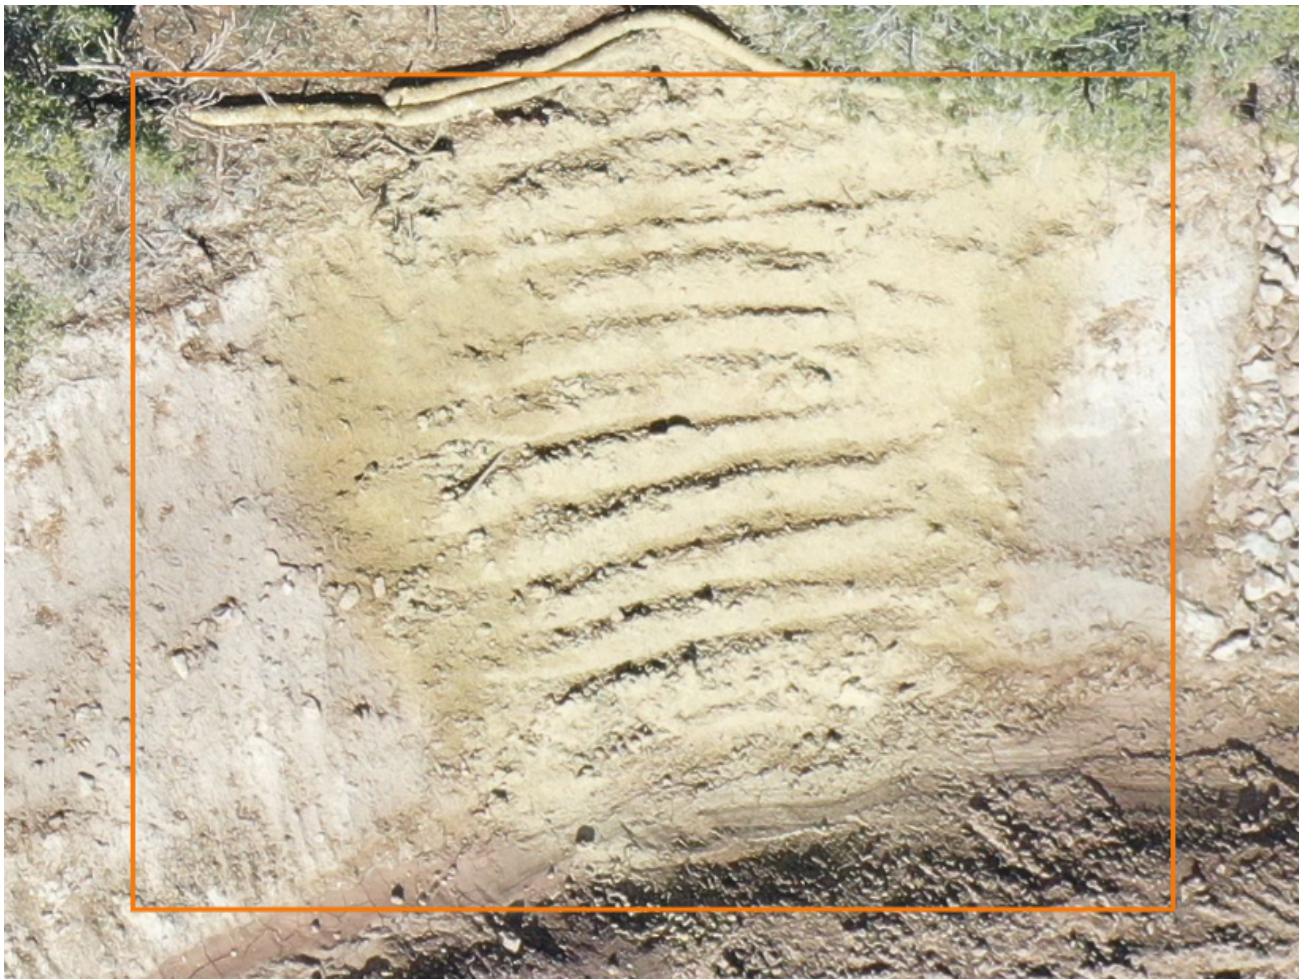
3 - Erosion **OPEN**

Terrace grading installed along area of cut slope that receives concentrated flows. Operator has installed erosion logs as a runoff control measure and hydromulch to the terraced slope. Soils along terrace are unconsolidated and not sufficiently stabilized. Straw wattles are not an appropriate control measure for areas with concentrated flows; runoff controls remain missing or insufficient.

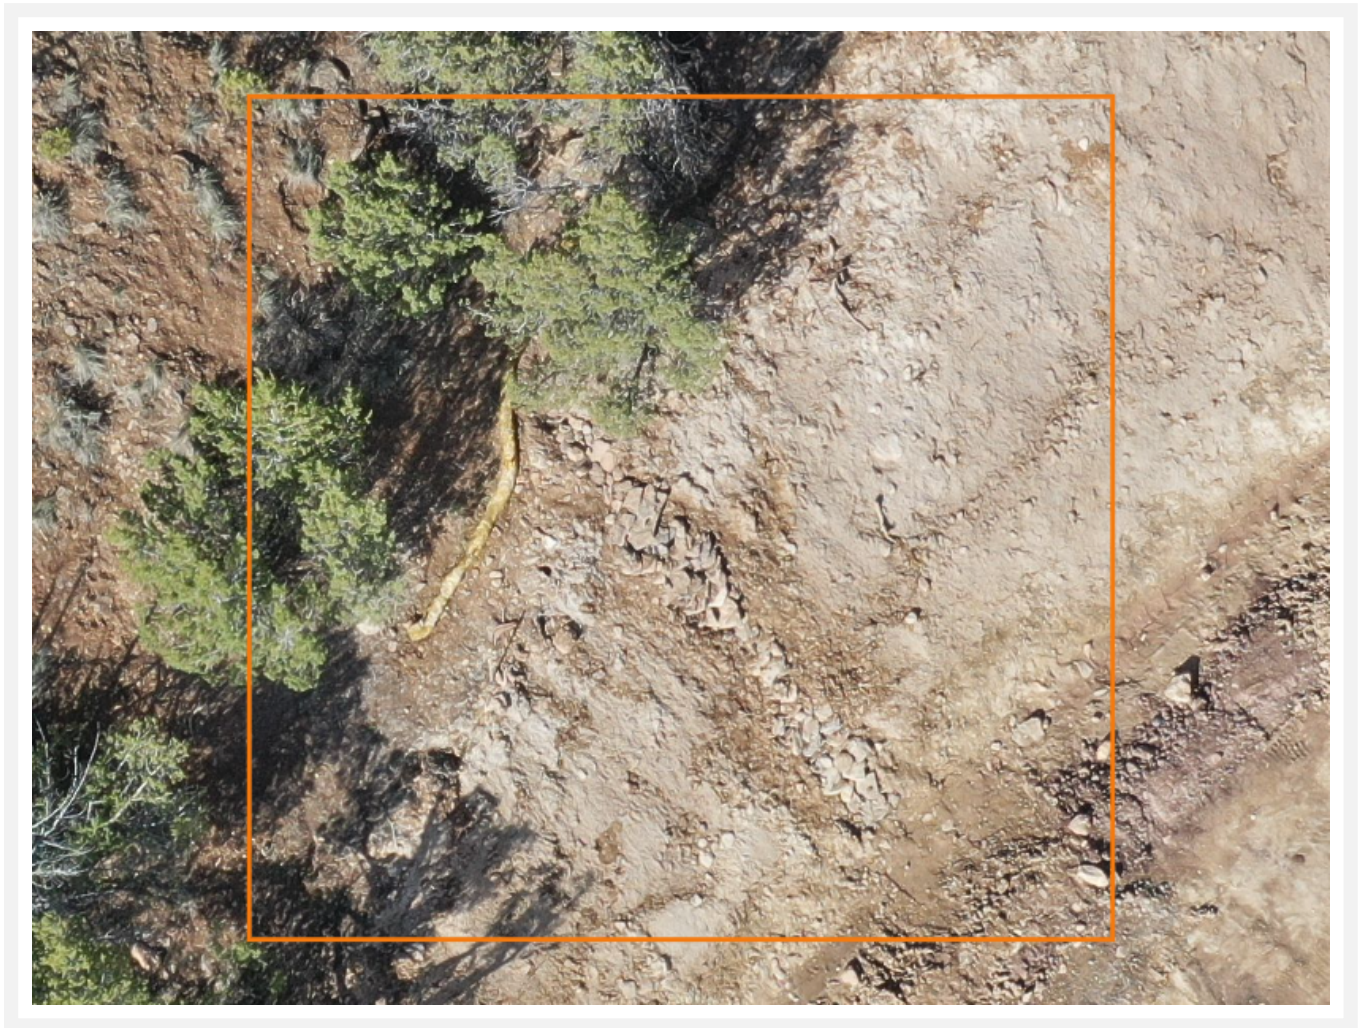
4 - Erosion OPEN

Operator has implemented rock armoring along areas of the cut slope that receive concentrated runoff flows; control measure does not appear to be appropriate in size, and has not been installed with geotextile lining in accordance with good engineering practices. An erosion log has been installed as a runoff control; straw wattles are not an appropriate control measure for areas with concentrated flows; runoff controls remain missing or insufficient on the Location

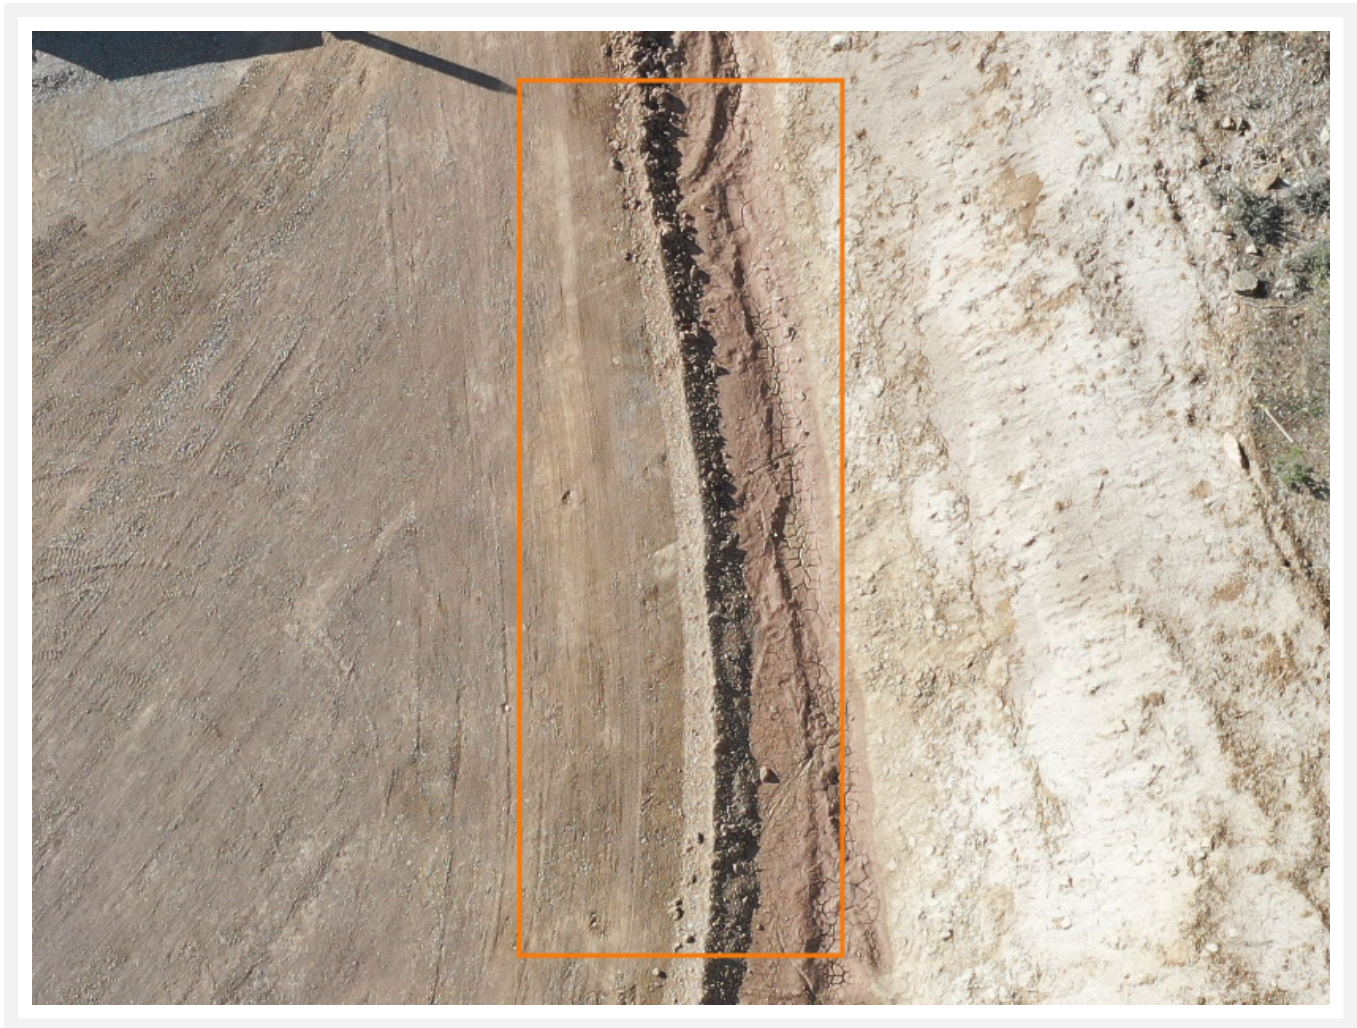
5 - Erosion **OPEN**

Berm has been constructed along perimeter of the current production area; berm remains improperly constructed per good engineering practices; berm is not compacted.

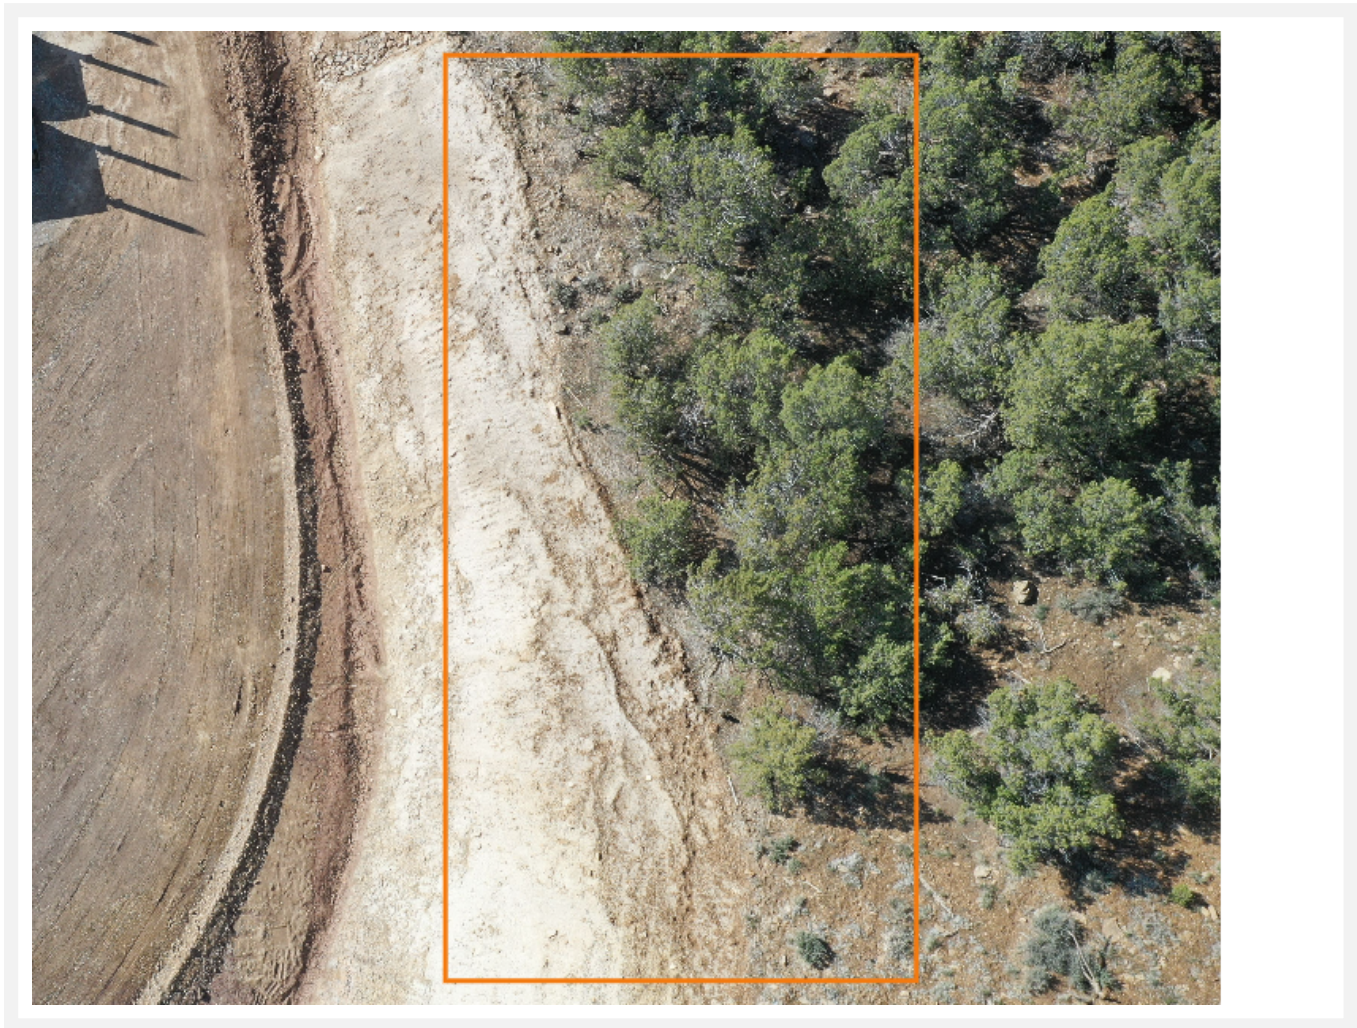
6 - Erosion **OPEN**

Example where runoff control measures have not been installed; runoff control measures remain missing or insufficient on the Location.

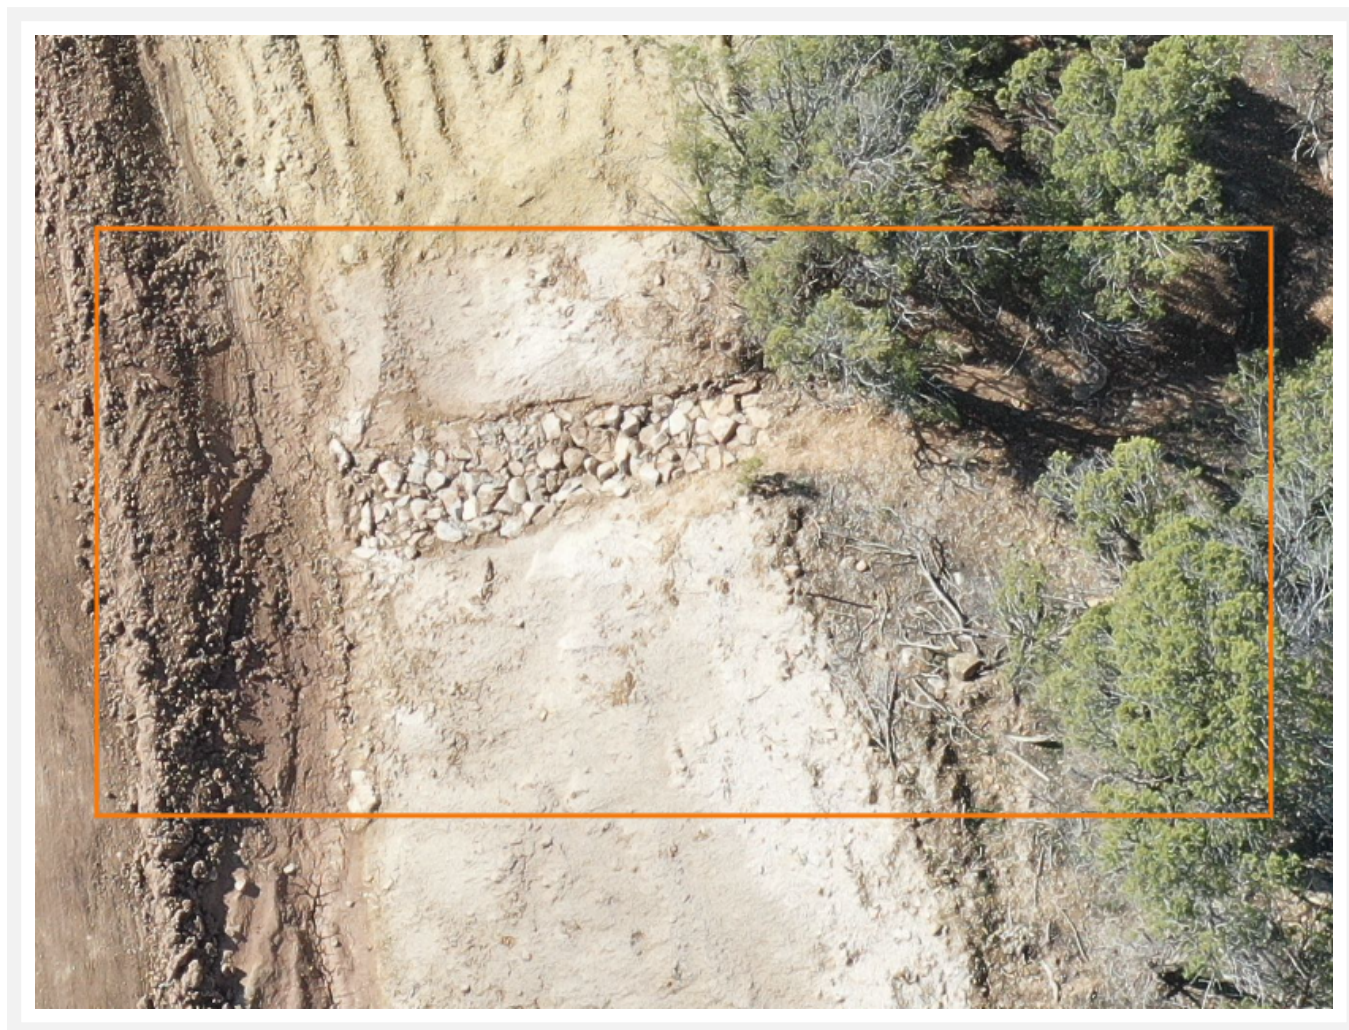
7 - Erosion OPEN

Operator has implemented rock armoring along areas of the cut slope that receive concentrated runoff flows; control measure has not been installed in accordance with good engineering practices; control measure has not been installed with geotextile lining; slope protection insufficient.

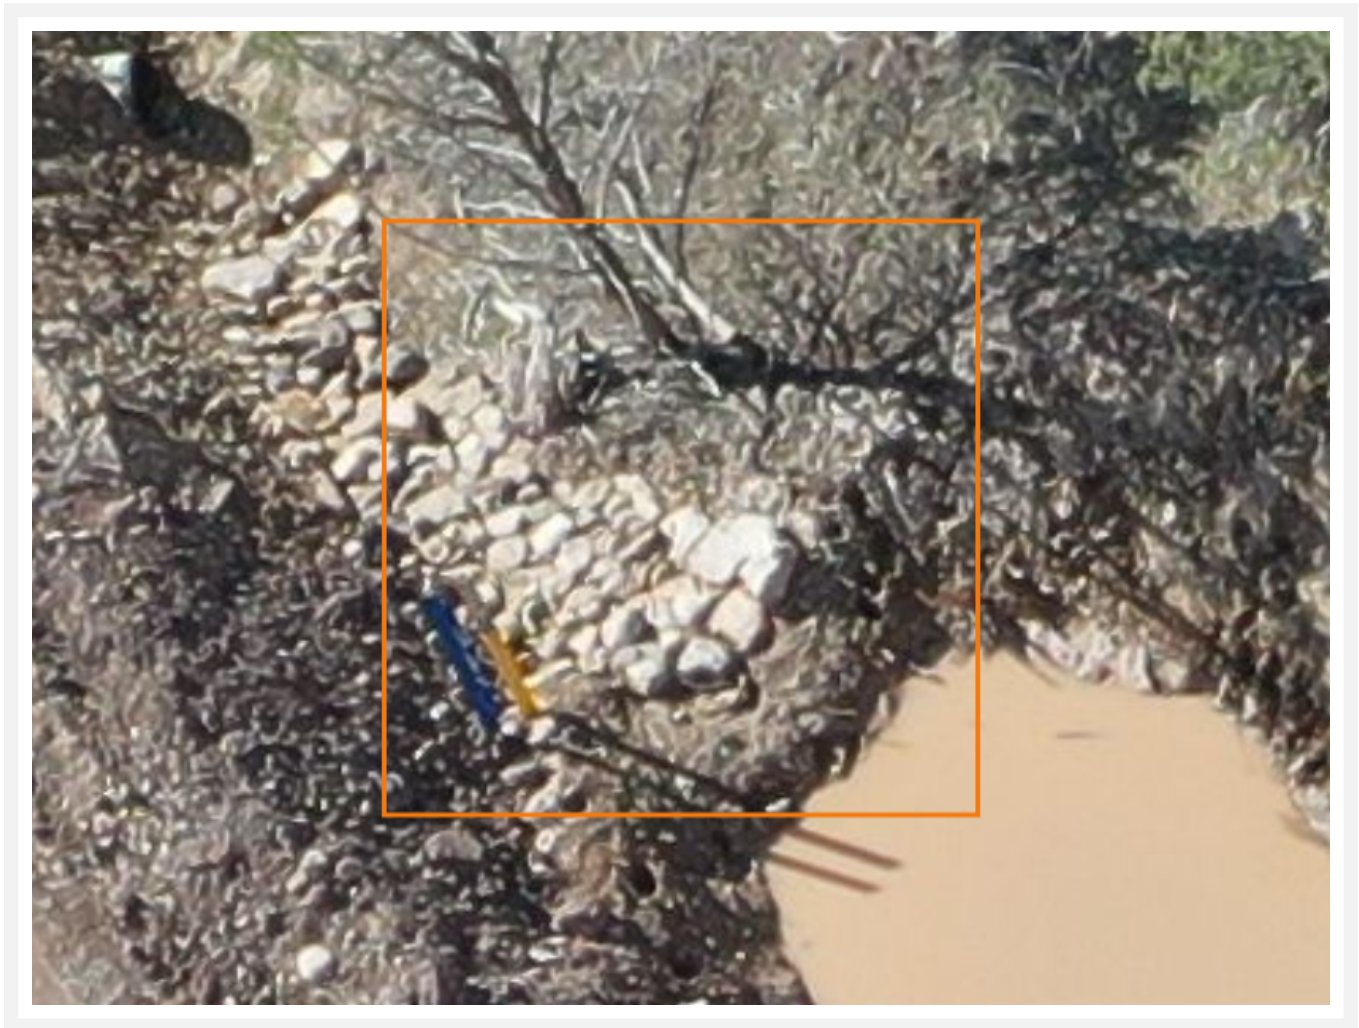
8 - Erosion OPEN

Sediment trap outlet has not been installed with a geotextile liner per good engineering practices. Additionally, runoff concentrated flow is coming from an ~12 acre area; sediment trap does not appear to be sufficient in size.

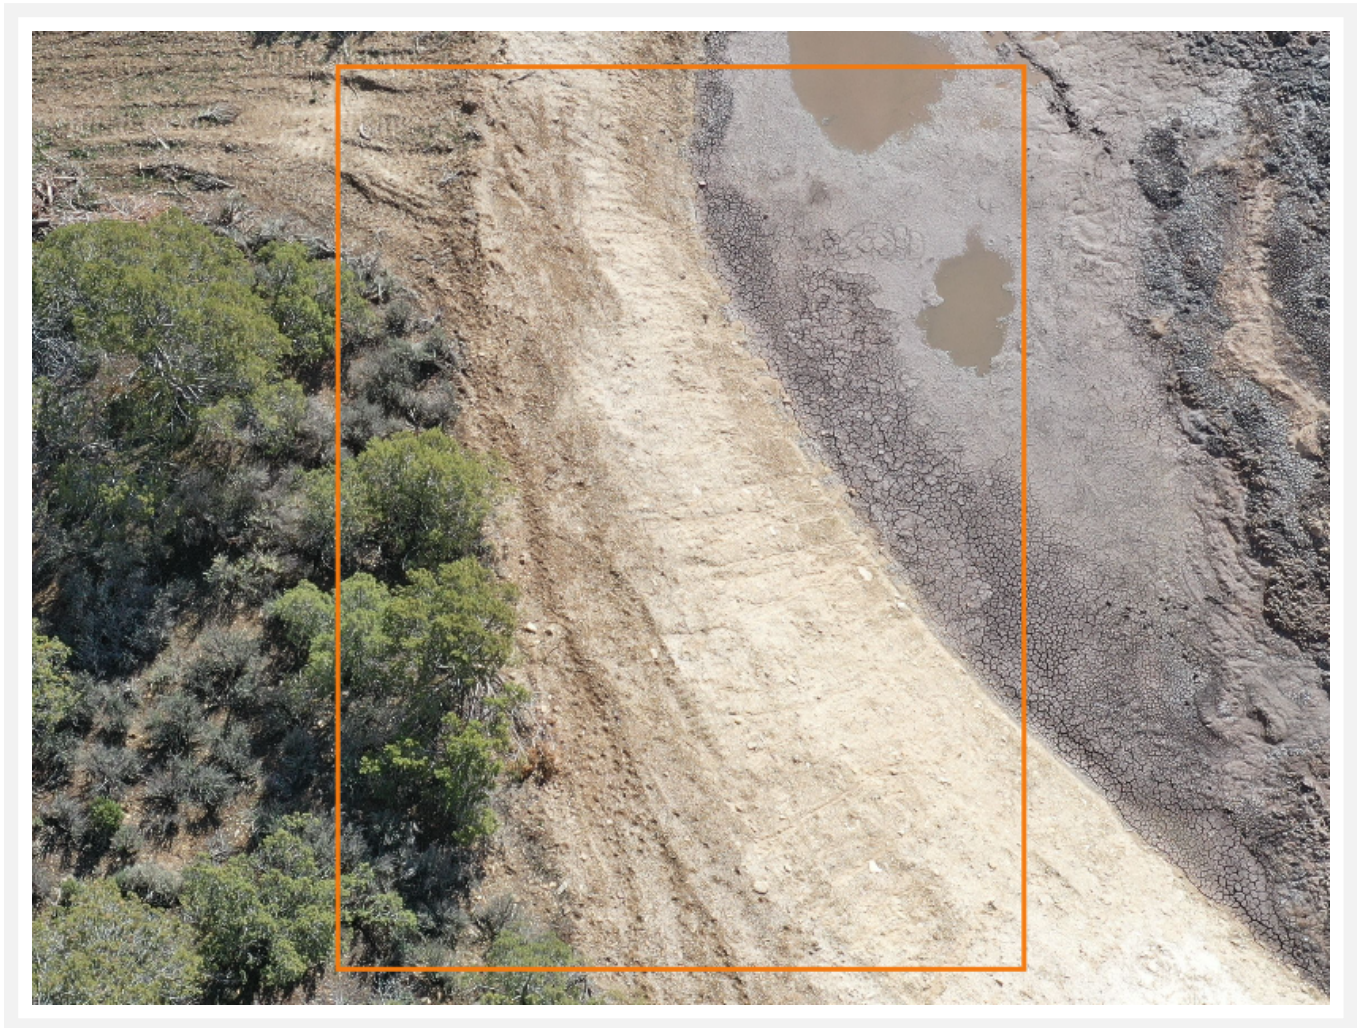
9 - Erosion OPEN

Rill erosion on cut slopes. Areas also provide example where runoff control measures remain missing or insufficient.

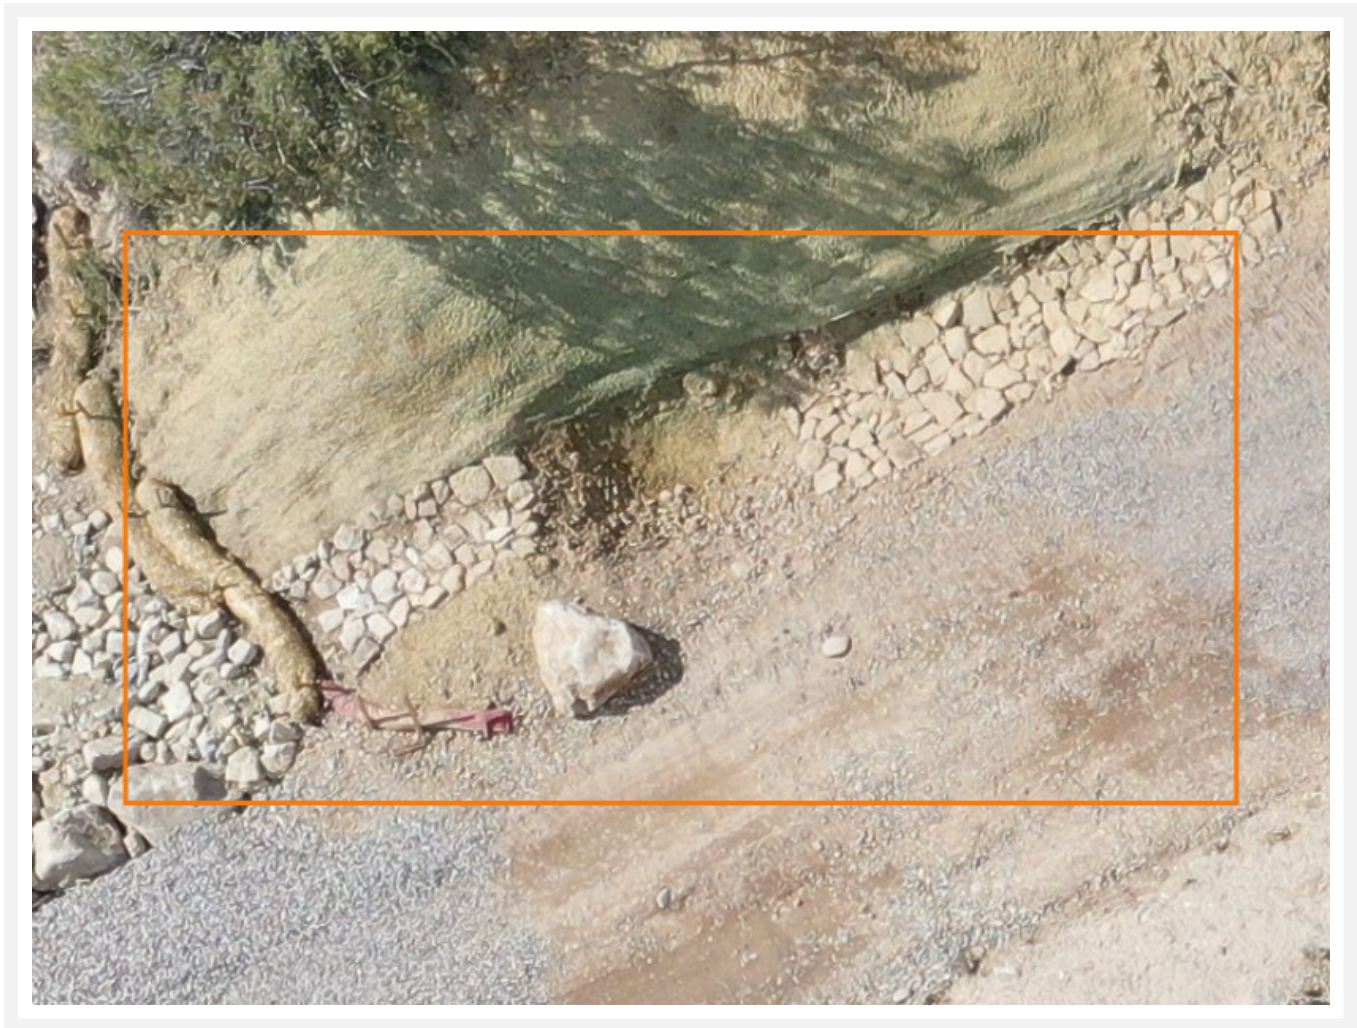
10 - Erosion **OPEN**

Operator has implemented sediment traps along access road; control measures has not been installed with a geotextile liner in accordance with good engineering practices.

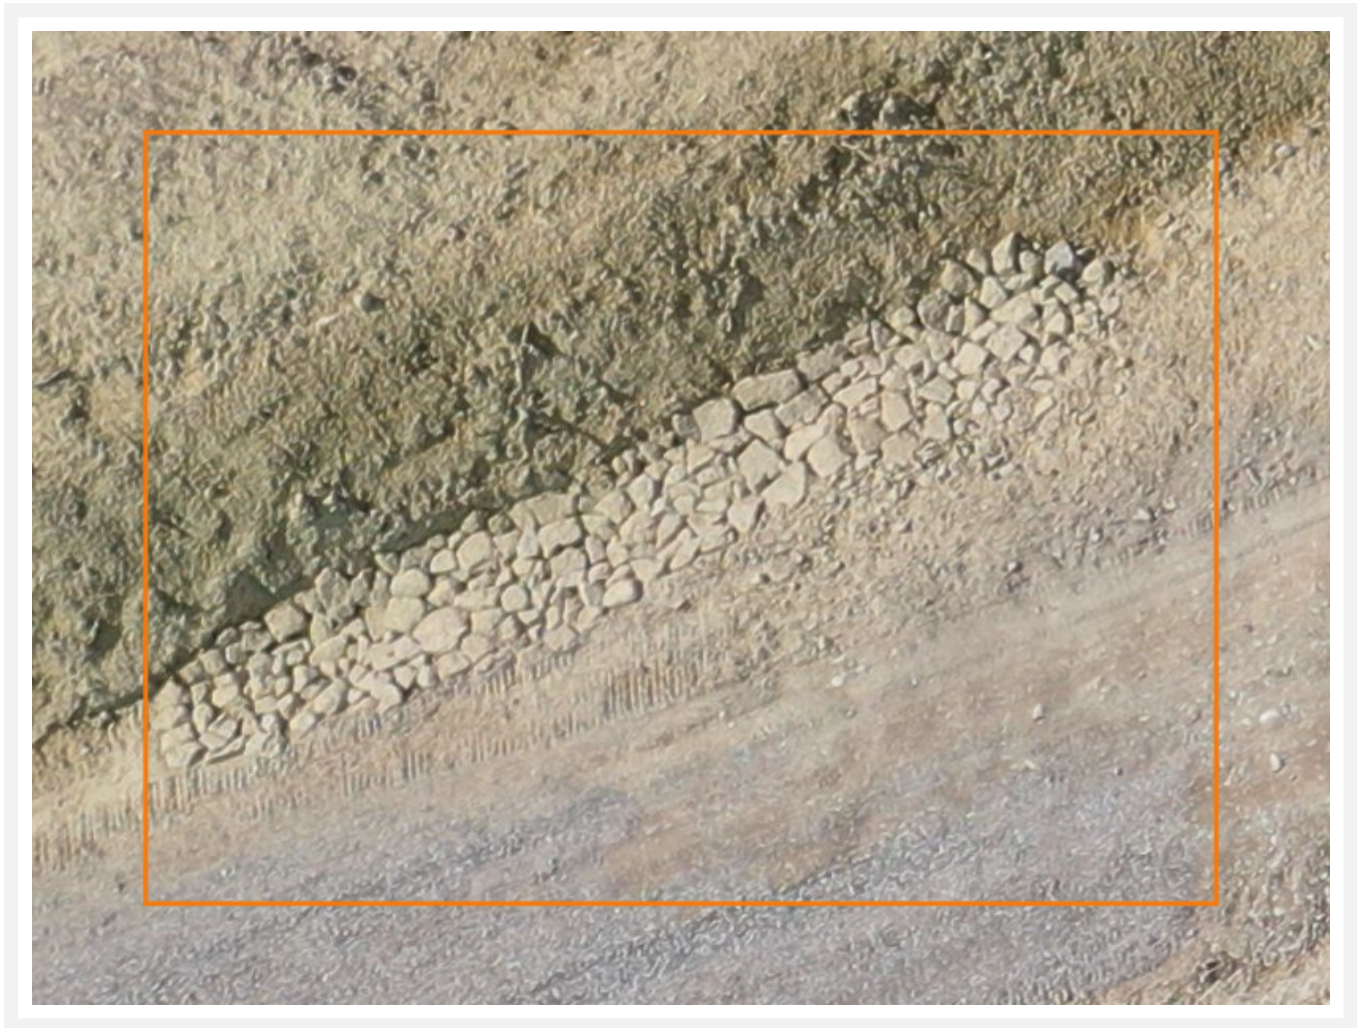
11 - Erosion OPEN

Operator has implemented sediment traps along access road; control measures has not been installed with a geotextile liner in accordance with good engineering practices.

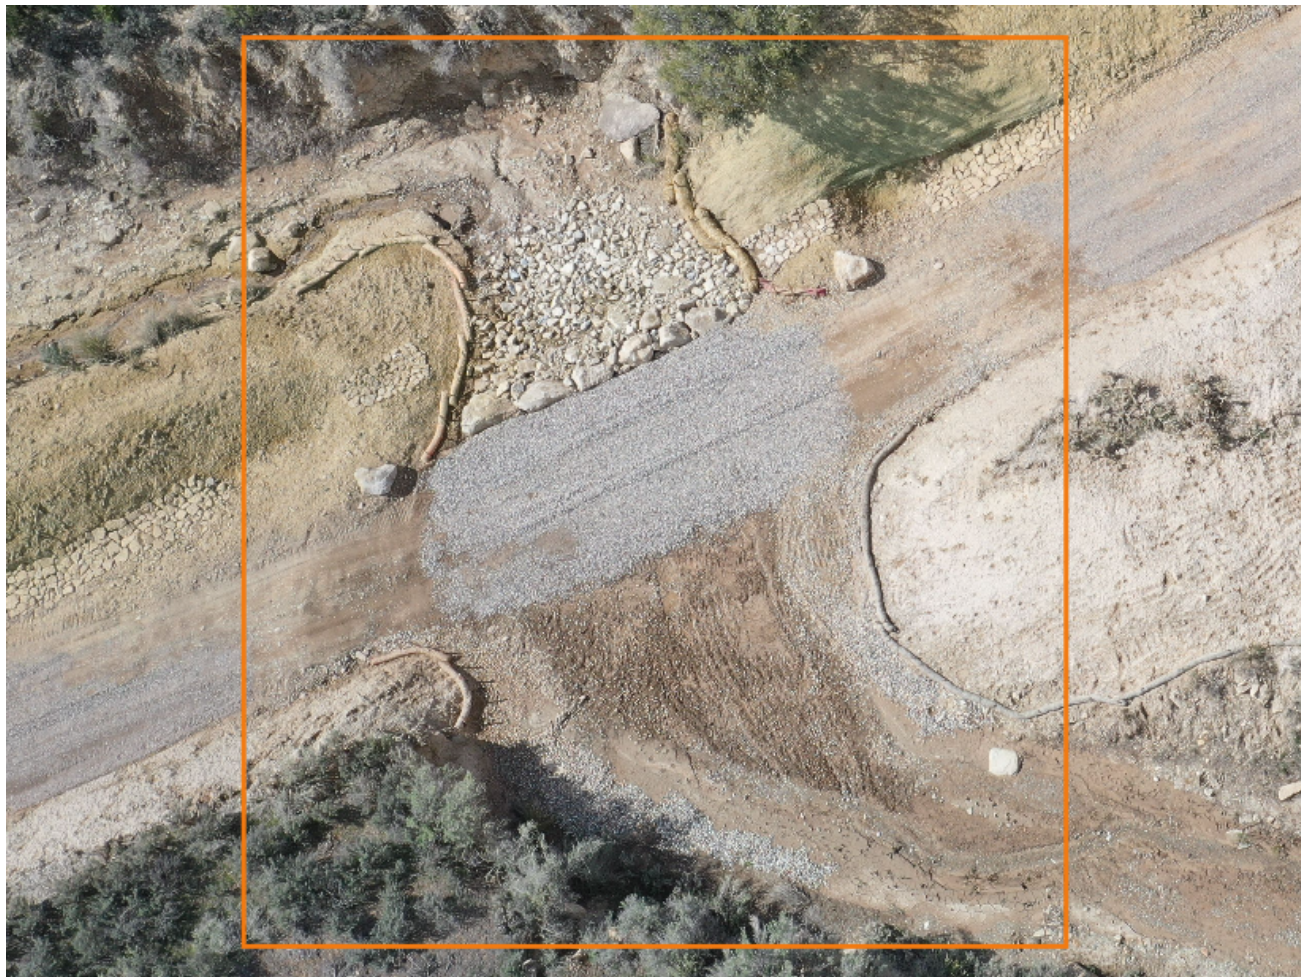
12 - Erosion OPEN

Additional work performed at stream crossing; it is unclear if work conducted will provide long term stabilization to the channel, however, control measures remain inadequate/insufficient to prevent sediment/pollutant discharge from vehicles and equipment traveling through the intermittent stream and drainage.

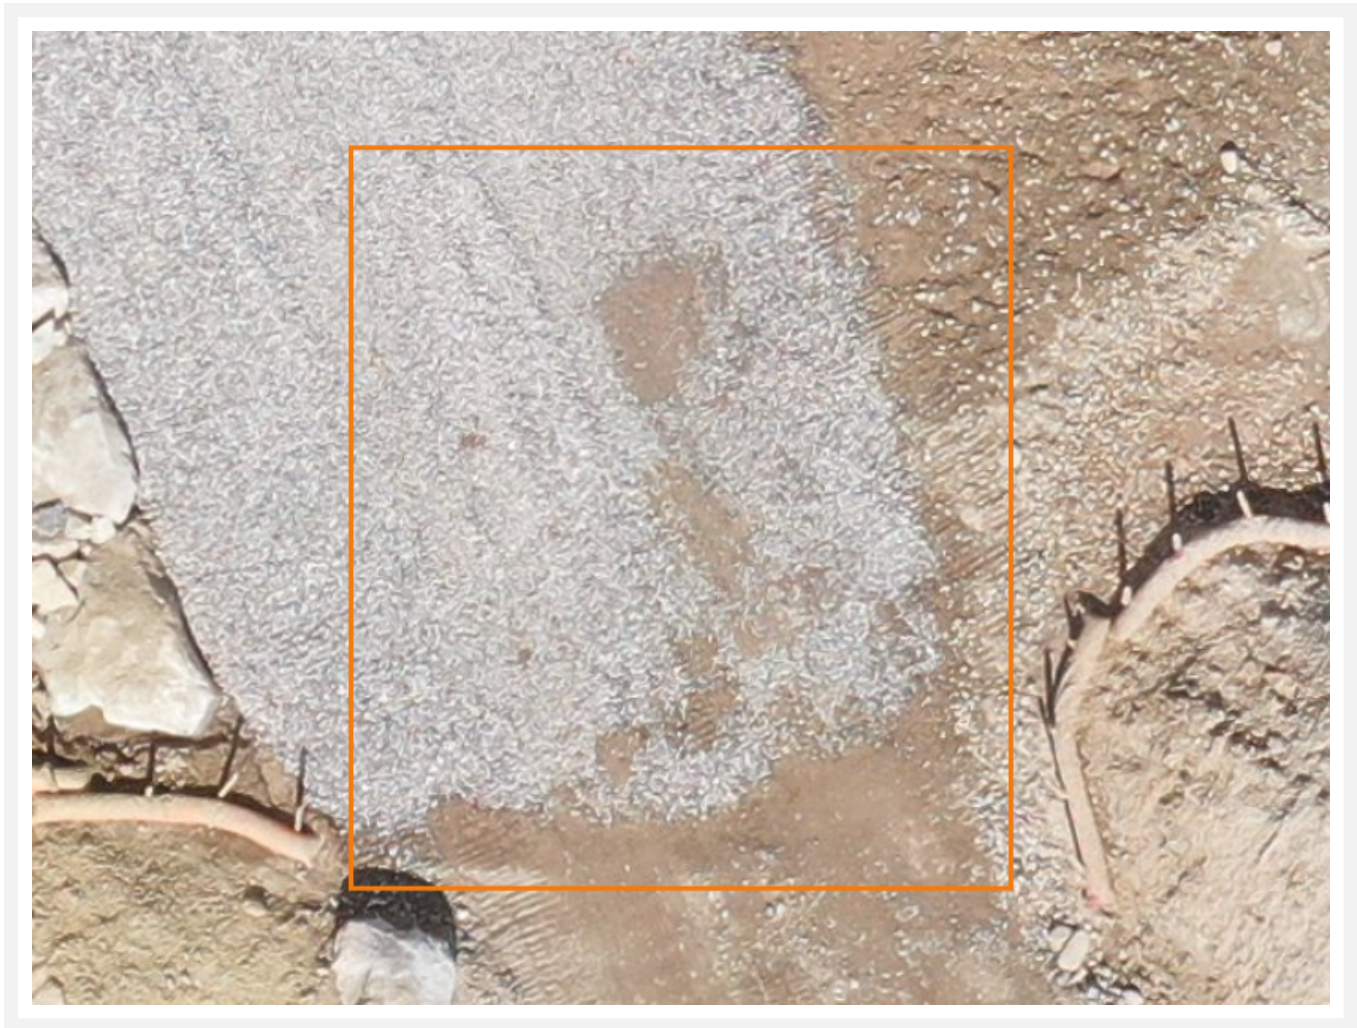
13 - Erosion **OPEN**

Sediment deposition observed in the gravel placed at the stream crossing; control measures remain inadequate/insufficient to prevent sediment/pollutant discharge from vehicles and equipment traveling through the intermittent stream and drainage.

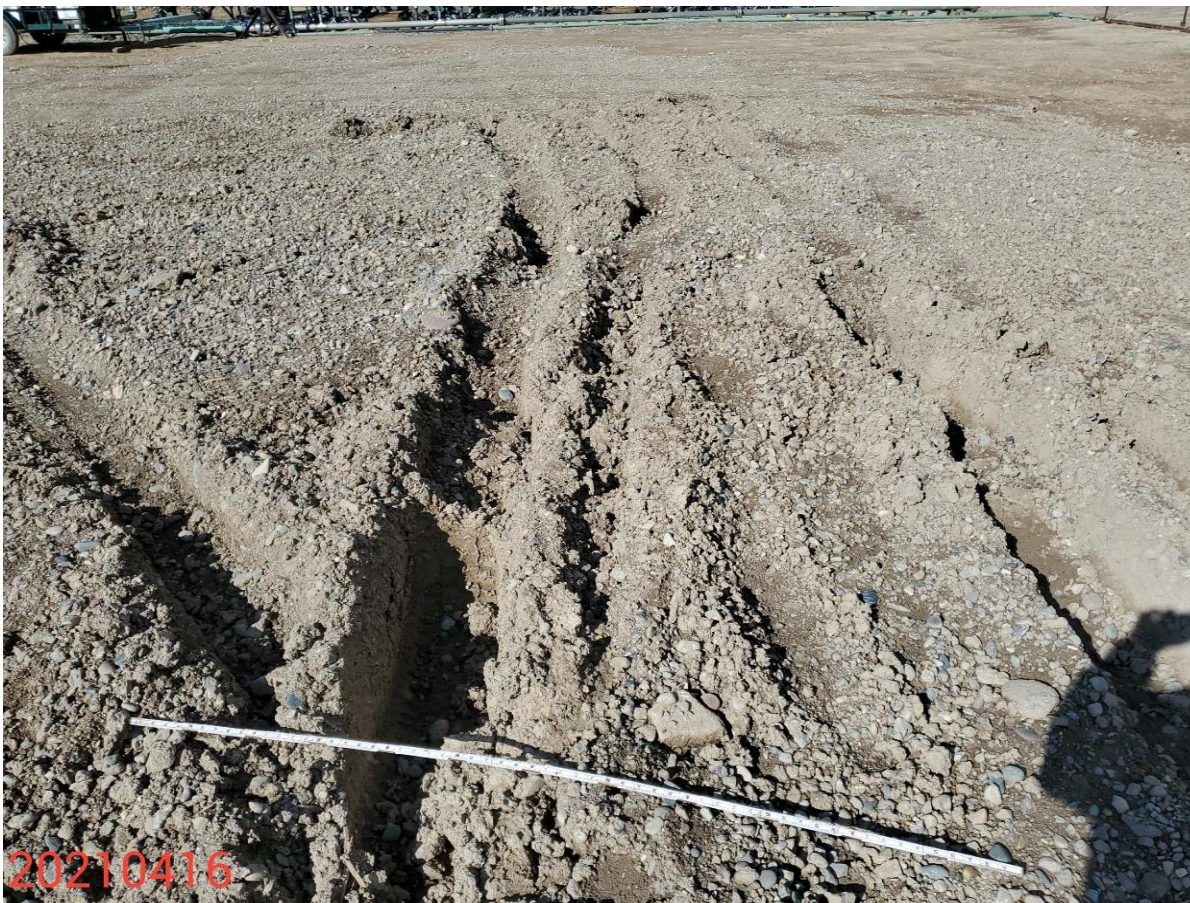
Photo 1: Photo taken from the Location. Photo shows control measures to stabilize/protect unpaved areas of the Location remain missing or insufficient. 6 foot measuring stick for reference.

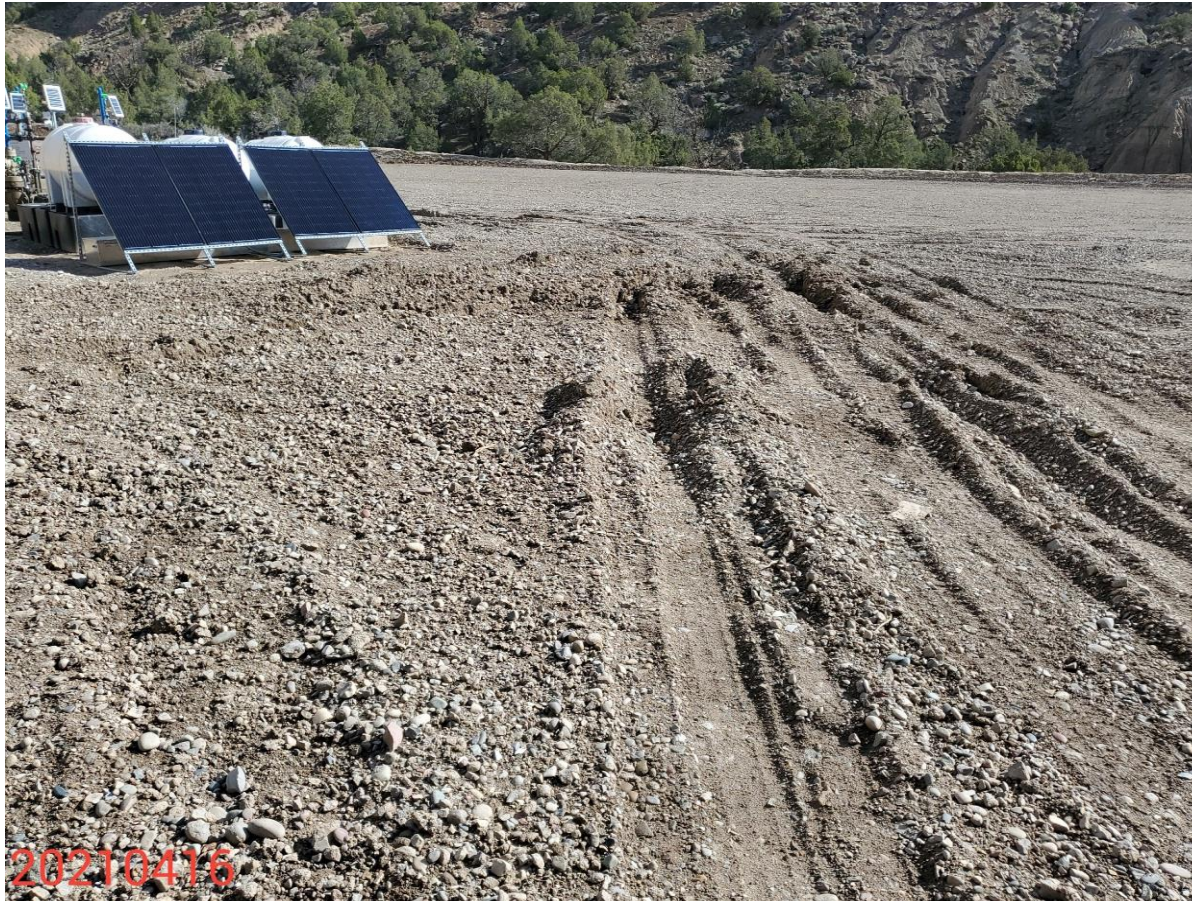
Photo 2: Photo taken from the Location, facing northeast. Photo shows control measures to stabilize/protect unpaved areas of the Location remain missing or insufficient.

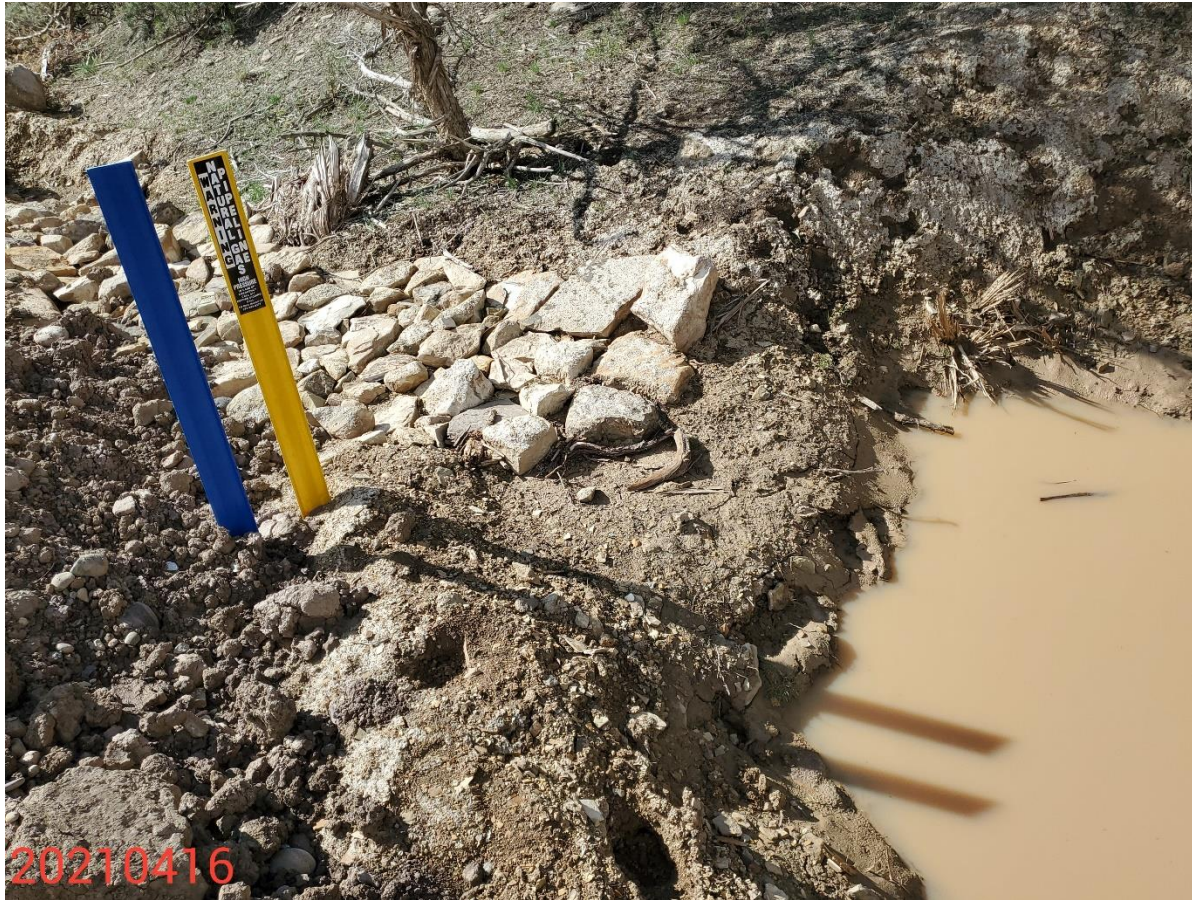
Photo 3: Photo shows sediment trap on the southwest end o the Location. Outlet at trap has not been installed in accordance with good engineering practices.

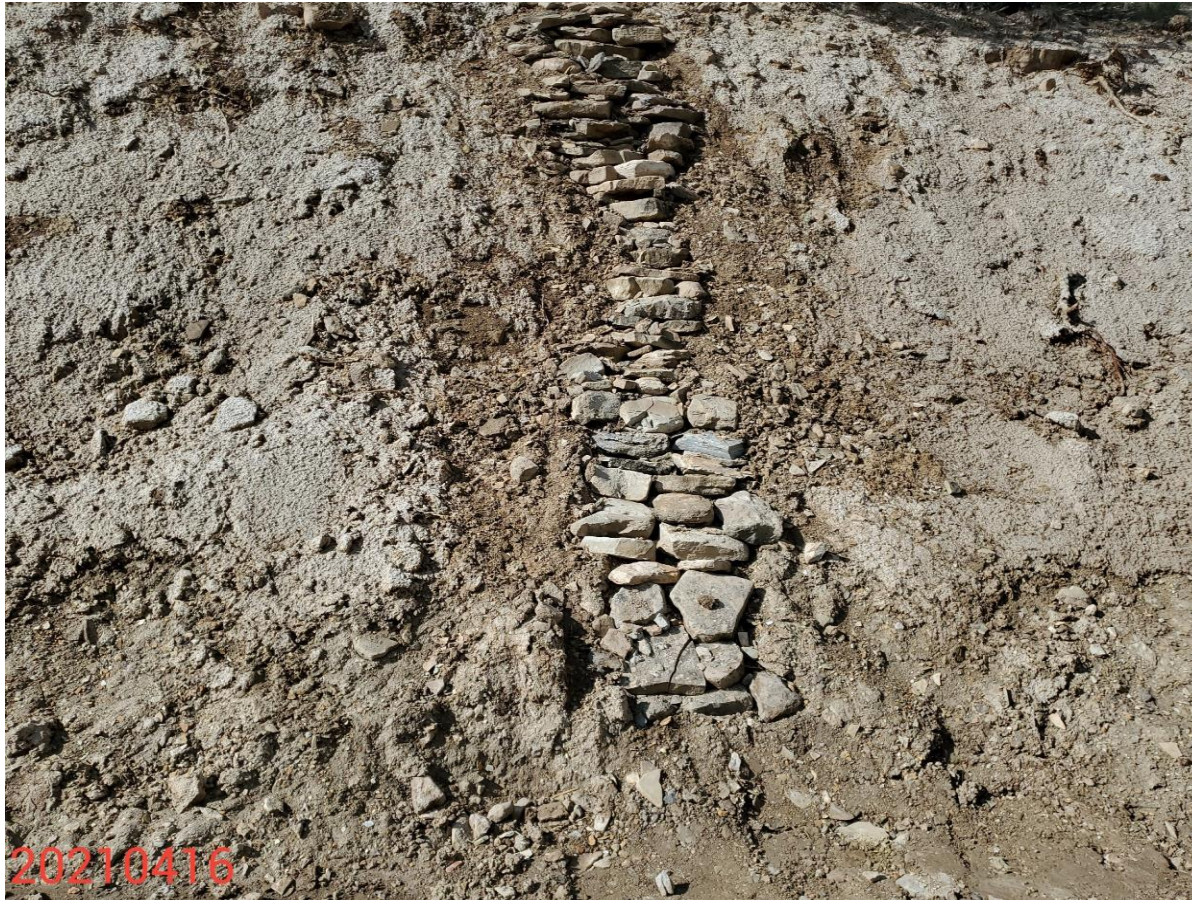
Photo 4: Photo taken from the cut slope on the southwest end of the Location. Photo shows Operator has implemented rock armoring along areas of the cut slope where erosion degradation was previously observed; control measure does not appear to be appropriate in size to stabilize the slopes, and has not been installed with geotextile lining in accordance with good engineering practices.
