Colorado Oil and Gas Conservation Commission

TEP Federal PA 31-26 Issue Report

Created on April 21, 2021

Captured: April 16, 2021

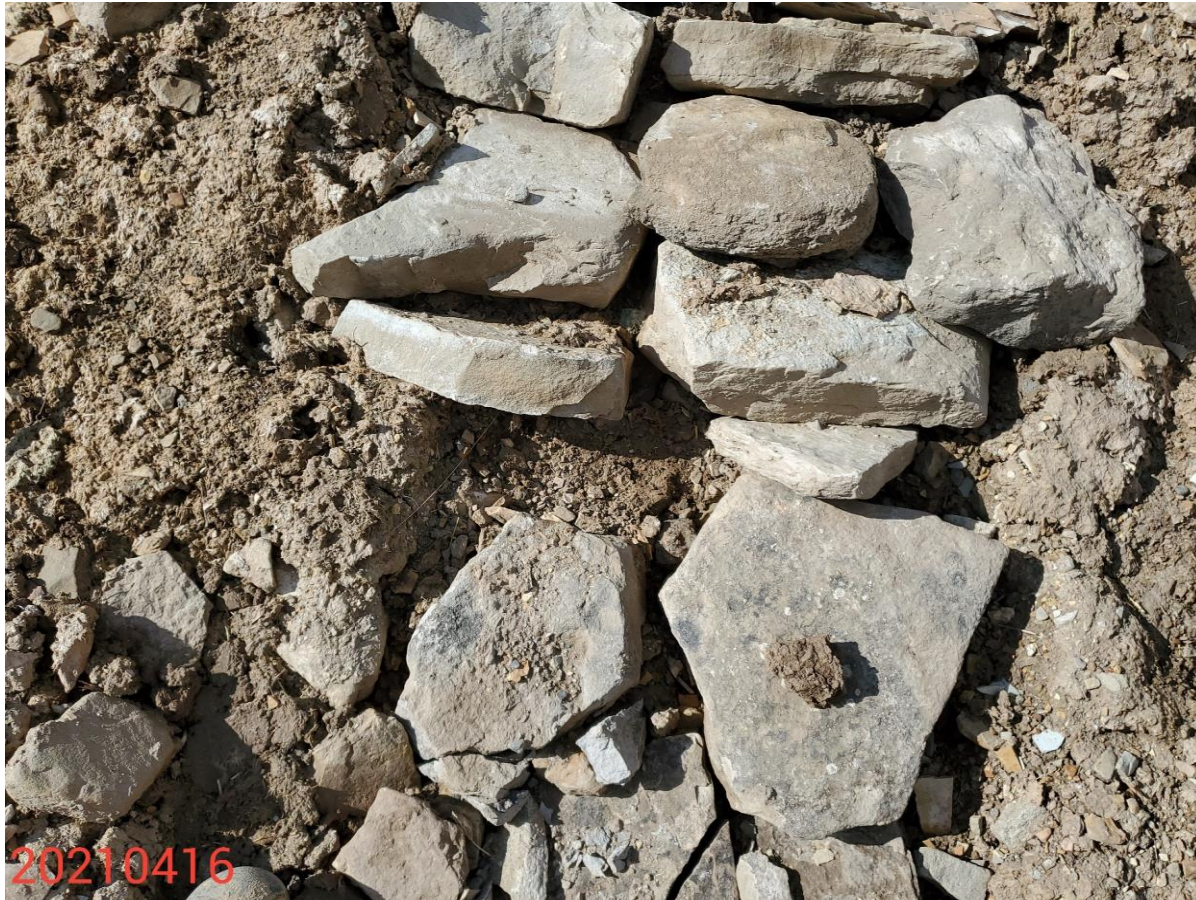
Photo 5: Continued from photo 4. Photo shows control measure has not been installed in accordance with good engineering practices; BMP insufficient to stabilize slopes.

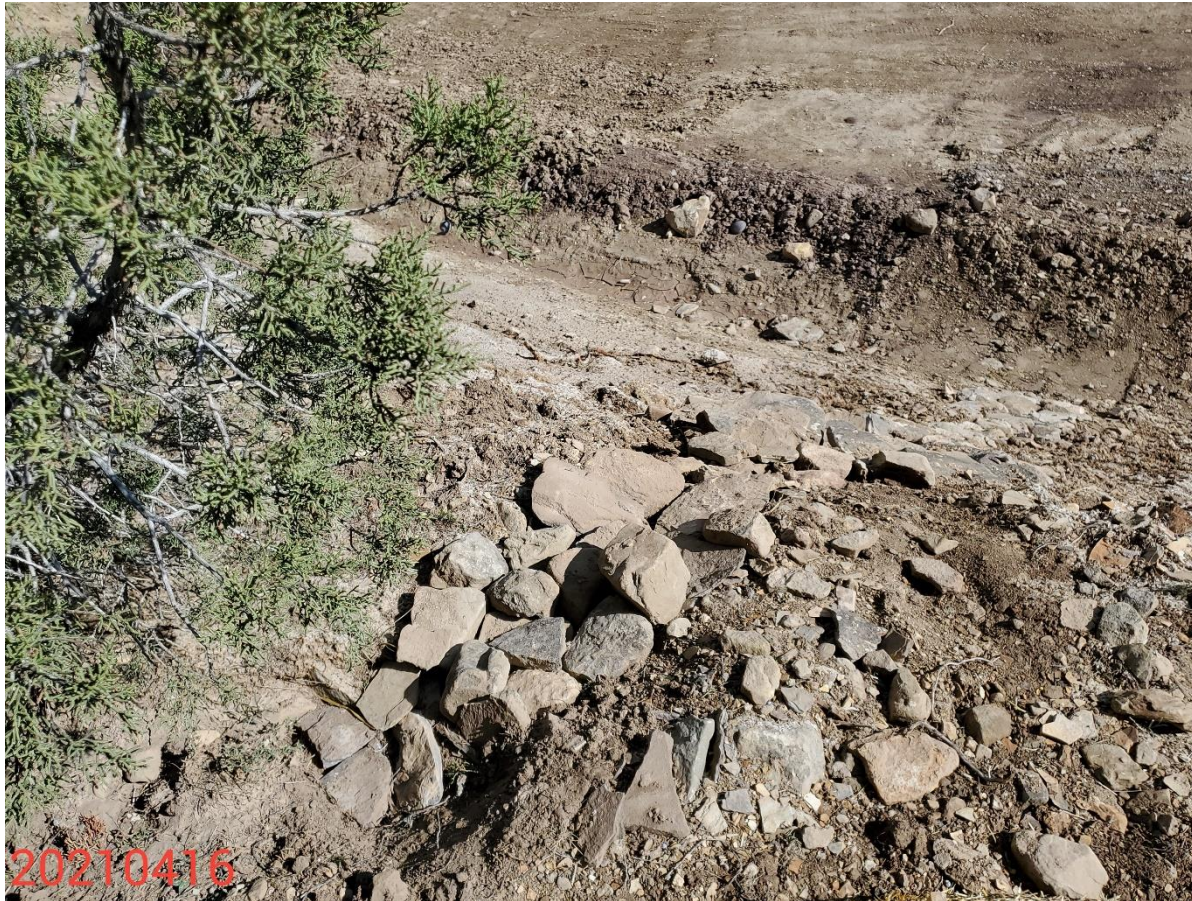
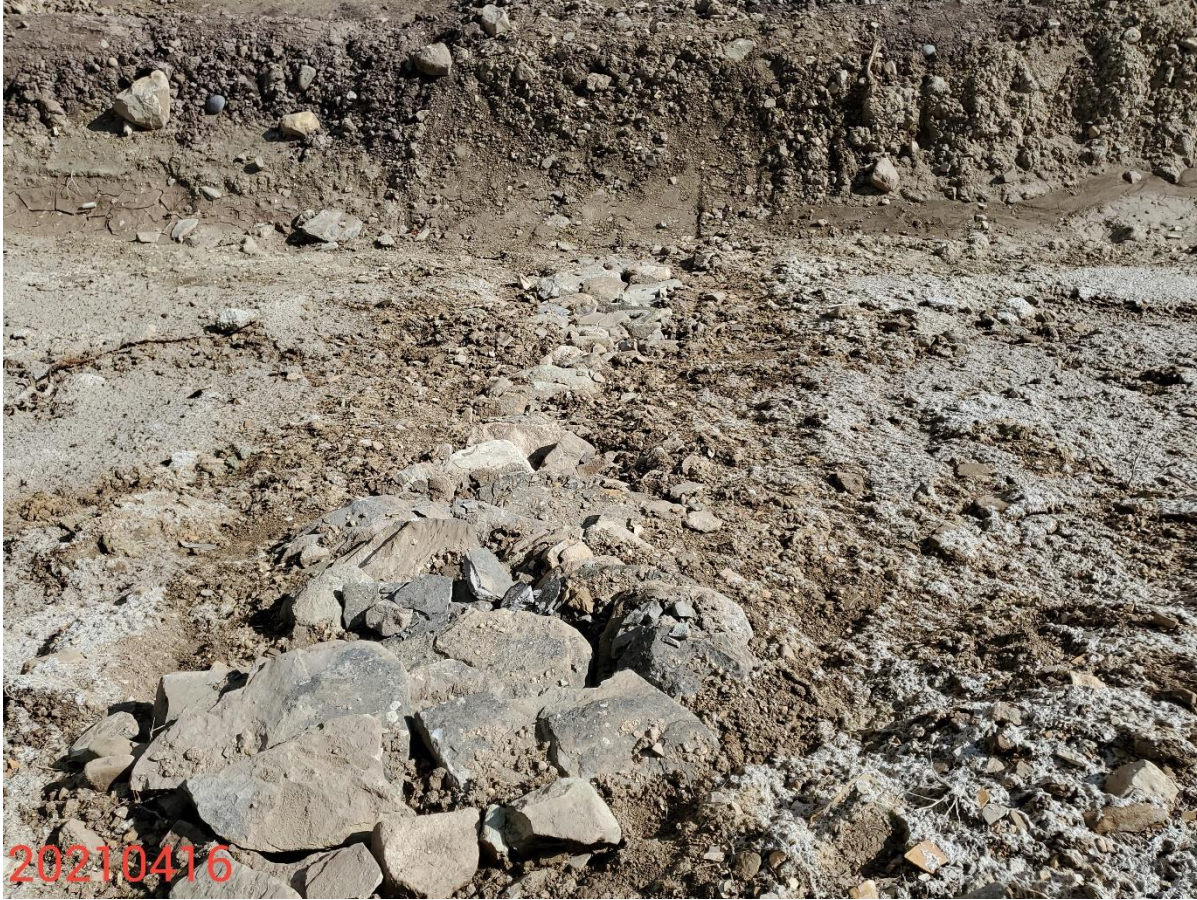
Photo 6: Photo taken from the cut slope on the southwest end of the Location, facing northeast. Photo shows Operator has implemented rock armoring along areas of the cut slope where erosion degradation was previously observed; control measure does not appear to be appropriate in size to stabilize the slopes, and has not been installed with geotextile lining in accordance with good engineering practices. .

Photo 7: See comments under photo 6.

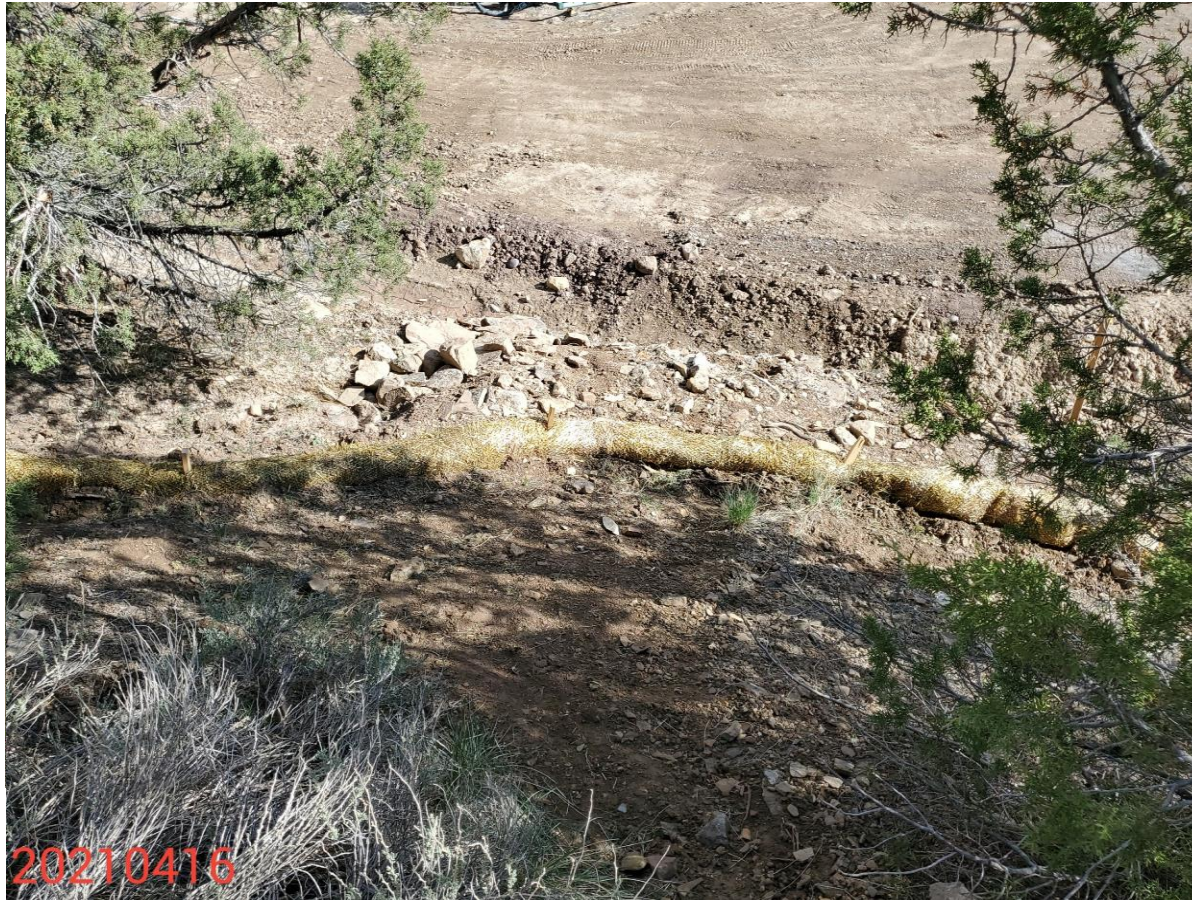
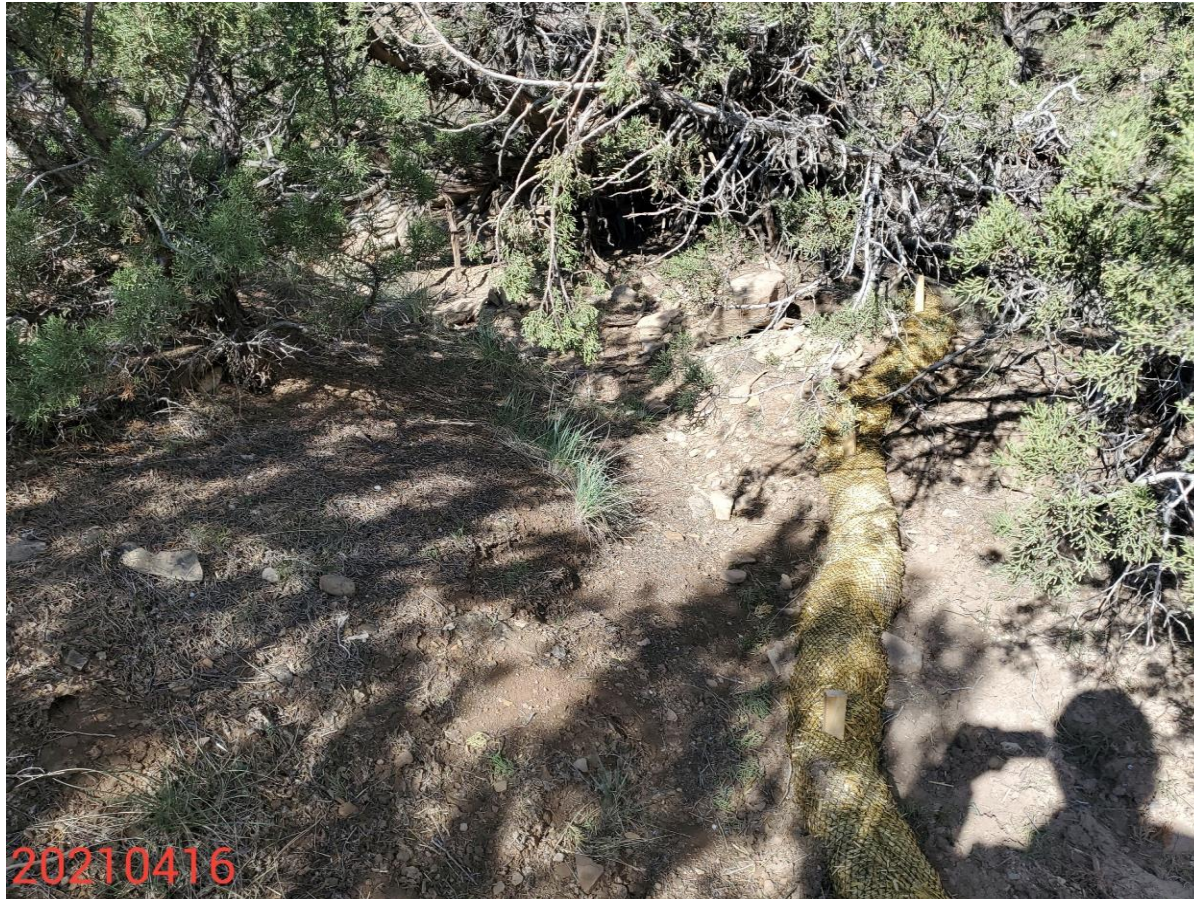
Photo 8: Continued from photo 6. Photo shows Operator has implemented erosion logs as a run on control measure above the rock armoring; wattles are not an appropriate control measure for areas that receive concentrated flows; runon controls remain missing or insufficient on the Location.

Photo 9: See comments under photo 8.

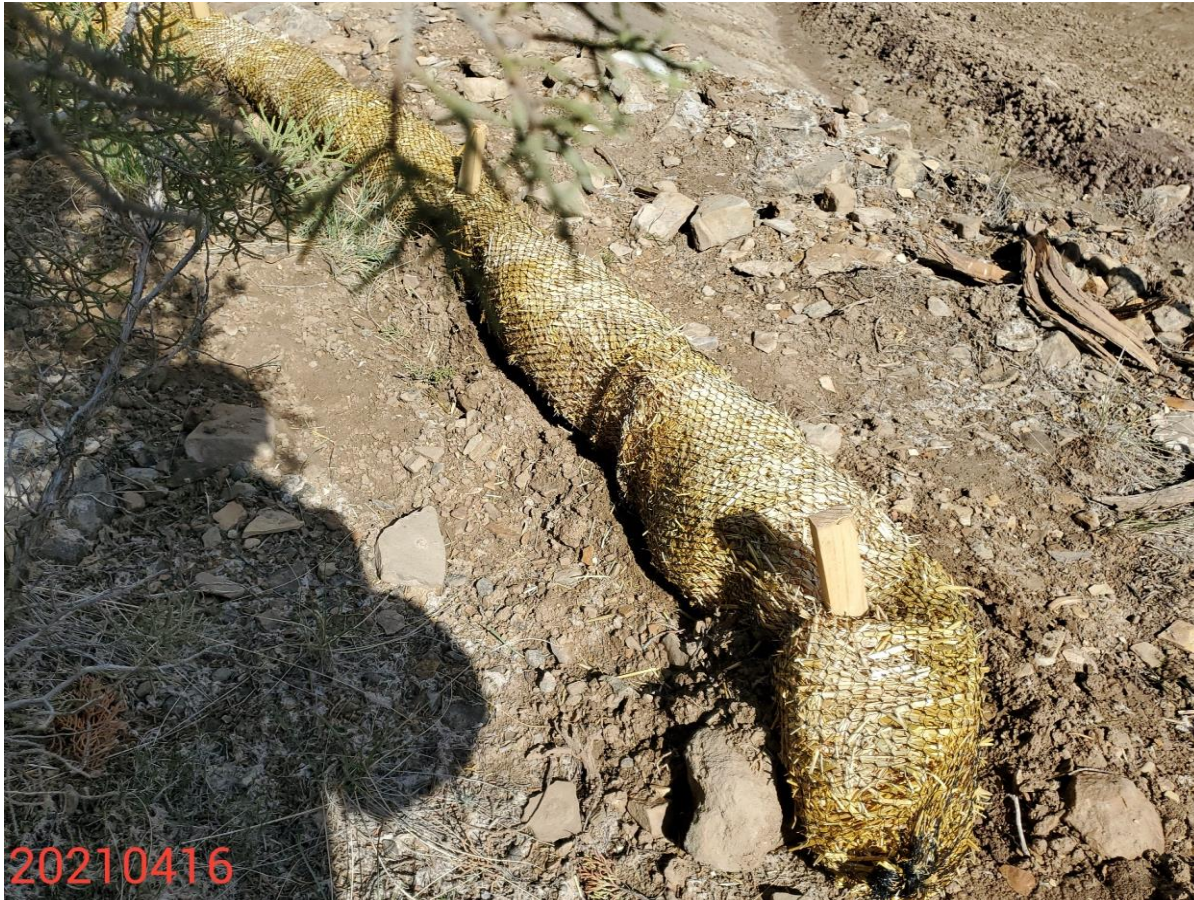
Photo 10: See comments under photo 8. Photo also shows that the erosion logs do not appear to have been properly backfilled to prevent water movement under the control measure.

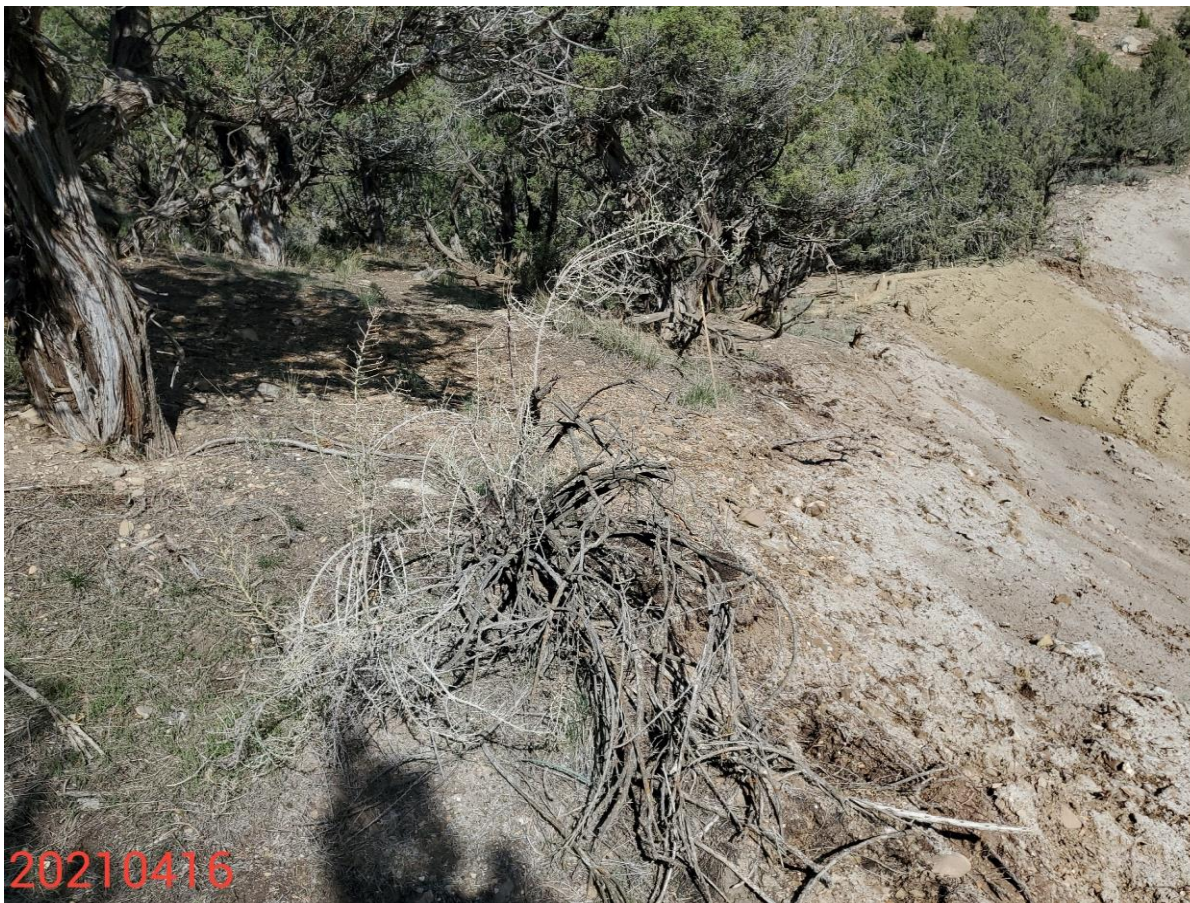
Photo 11: Photo taken from above the cut slope on the west end of the Location. Photo shows example of areas where runon control measures have not been installed; runon control measures remain missing or insufficient on the Location.

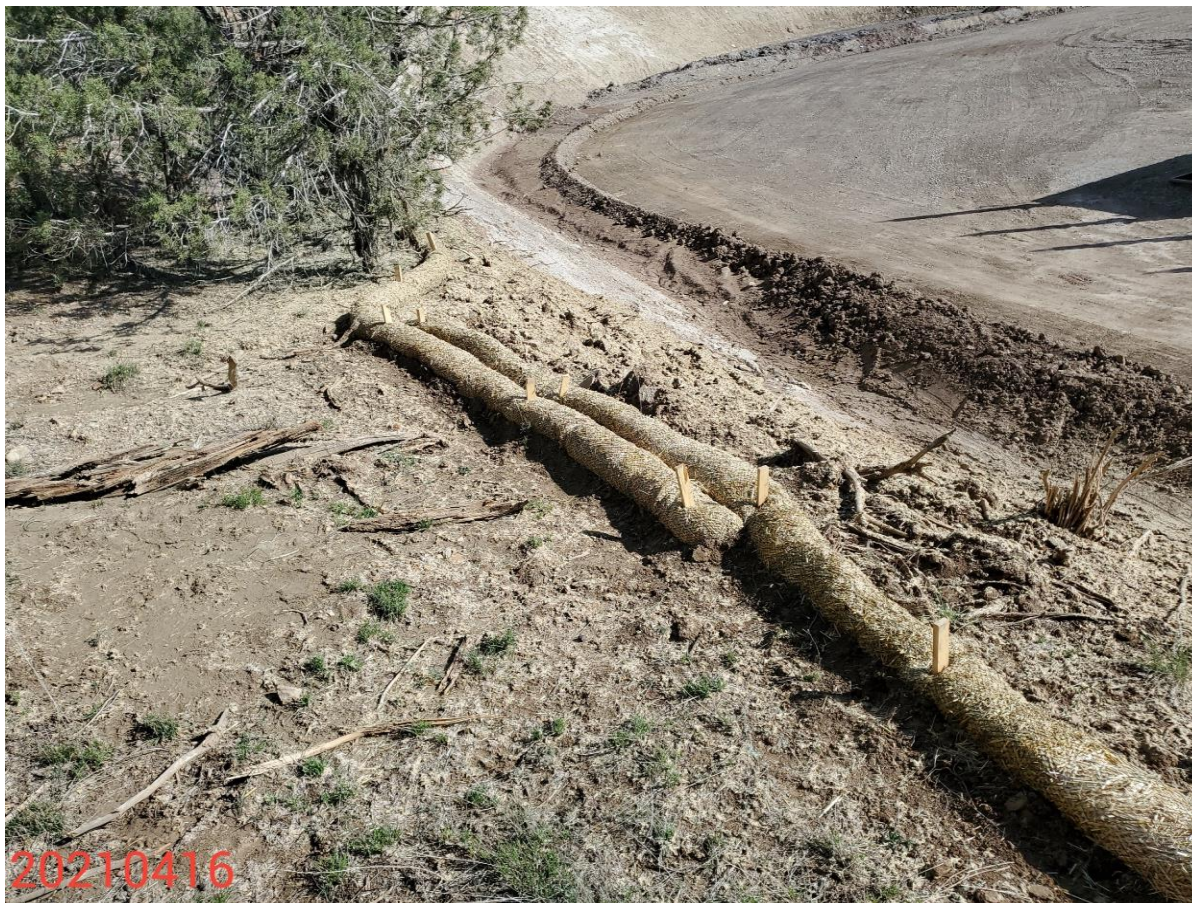
Photo 12: Photo taken from the cut slope on the west end of the Location. Photo shows area where terrace grading has been installed to address erosion concerns on the cut slope.

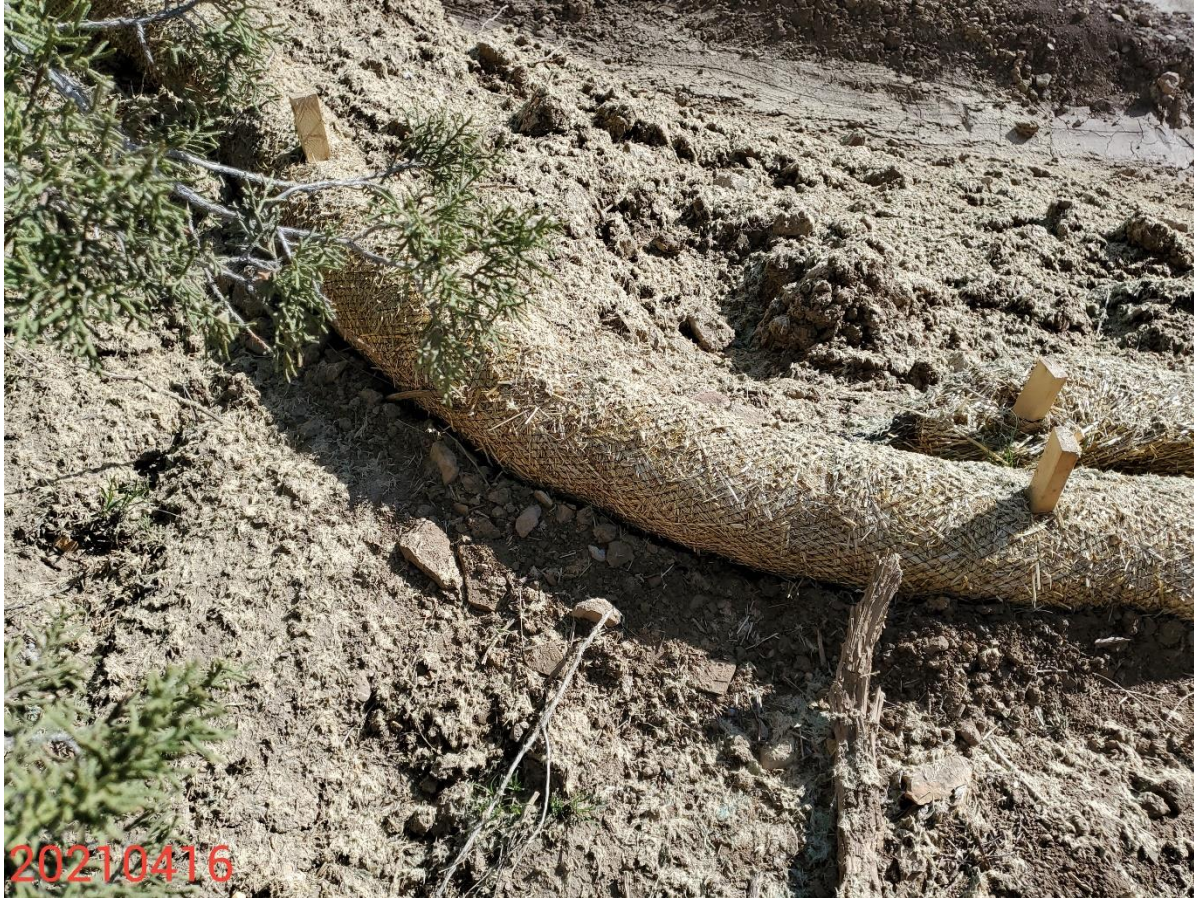
Photo 13: Continued from photo 12. Photo also shows areas of erosion logs that do not appear to have been properly backfilled to prevent water movement under the control measure.

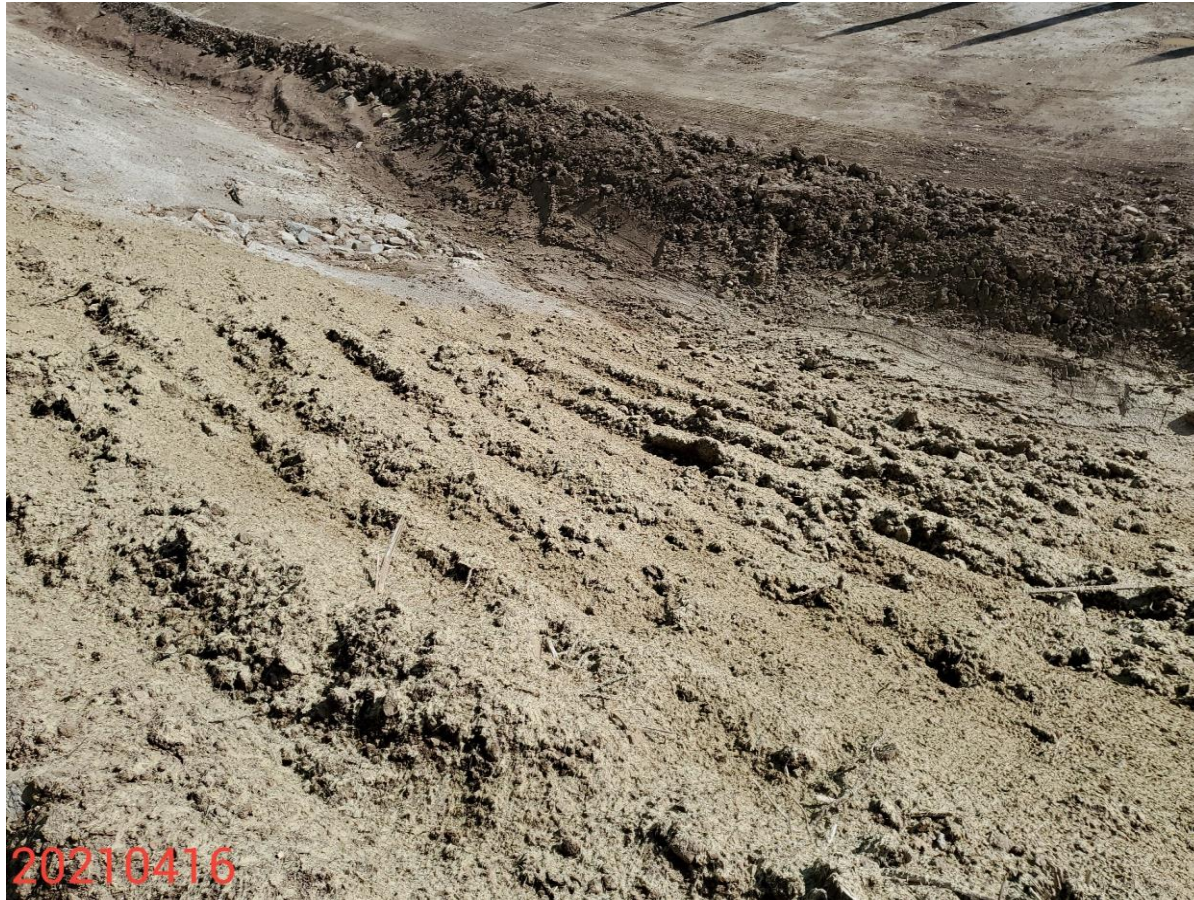
Photo 14: Photo taken from the cut slope on the west end of the Location. Photo shows area where terrace grading has been installed to address erosion concerns on the cut slope. Though hydromulch has been used in conjunction with terracing, soils remain insufficiently stabilized and protected.

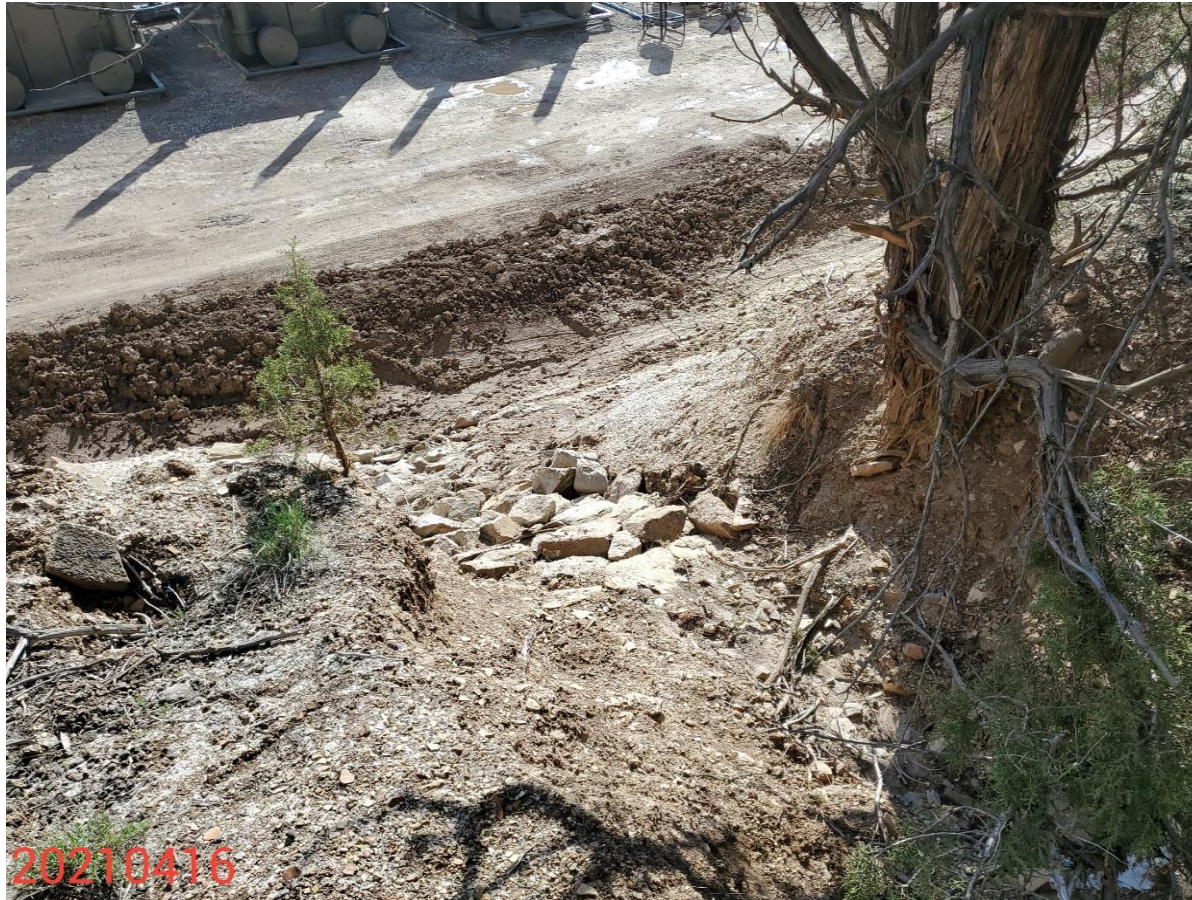
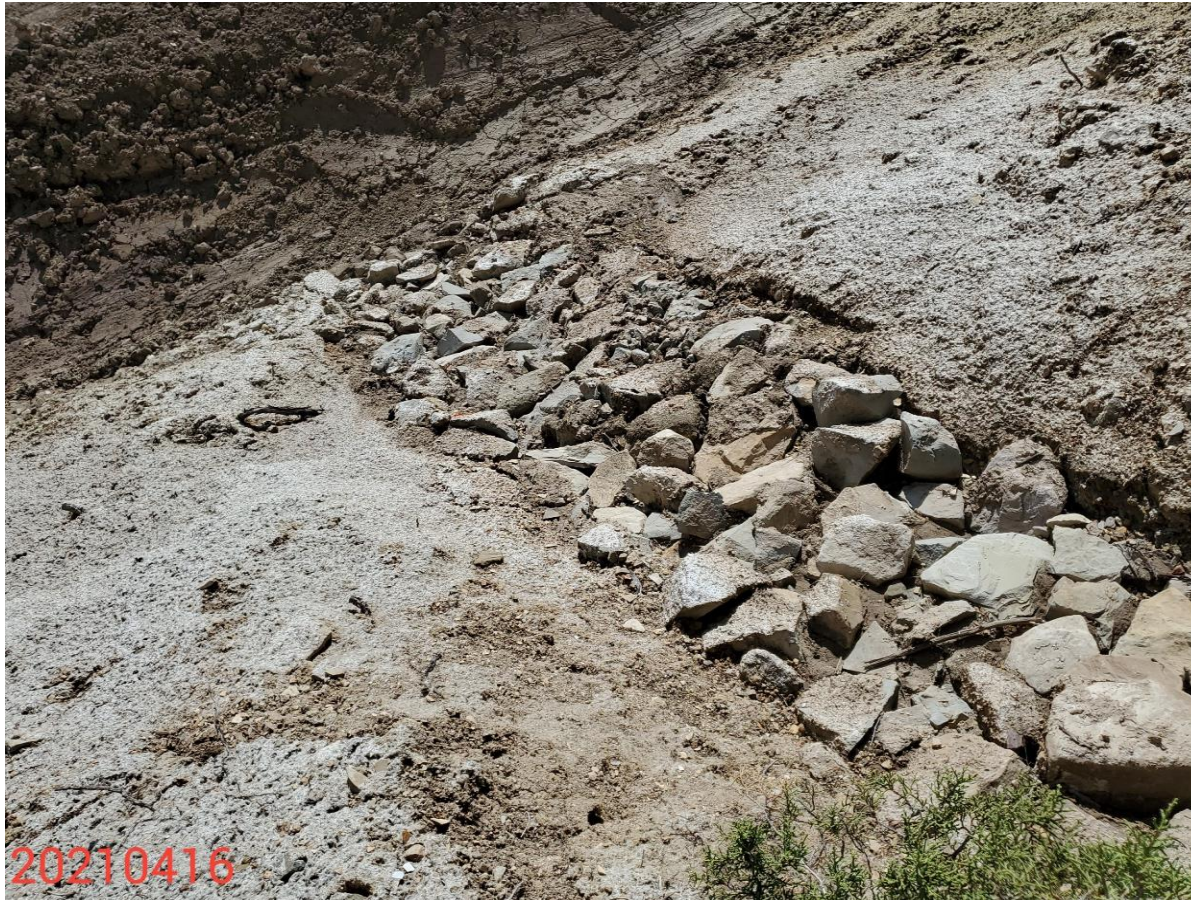
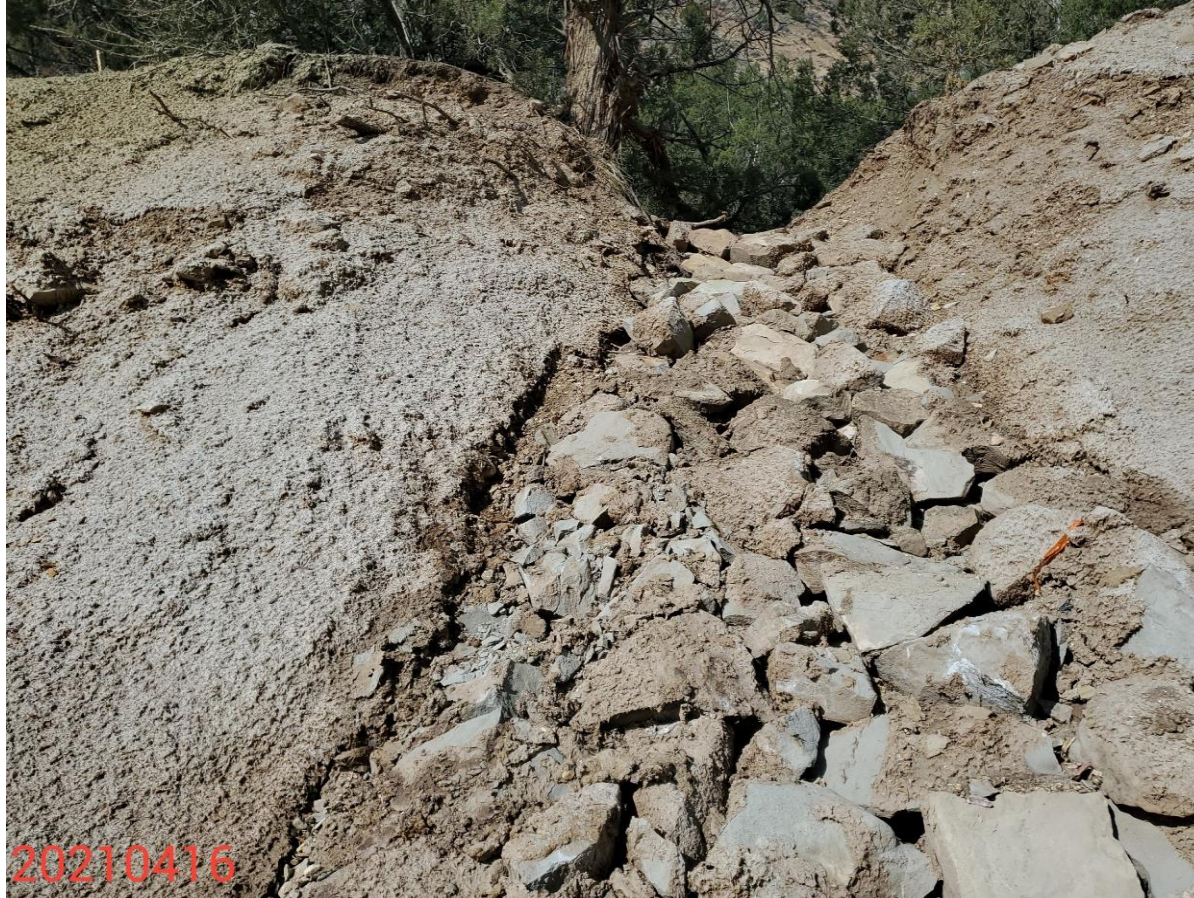
Photo 15: Photo taken from the cut slope on the west end of the Location. Photo shows Operator has implemented rock armoring on areas that receive concentrated runoff flows. Photo shows control measure has not been installed in accordance with good engineering practices; control measure has not been installed with a geotextile lining; slope protection insufficient.

Photo 16: See comments under photo 15.

Photo 17: See comments under photo 15.

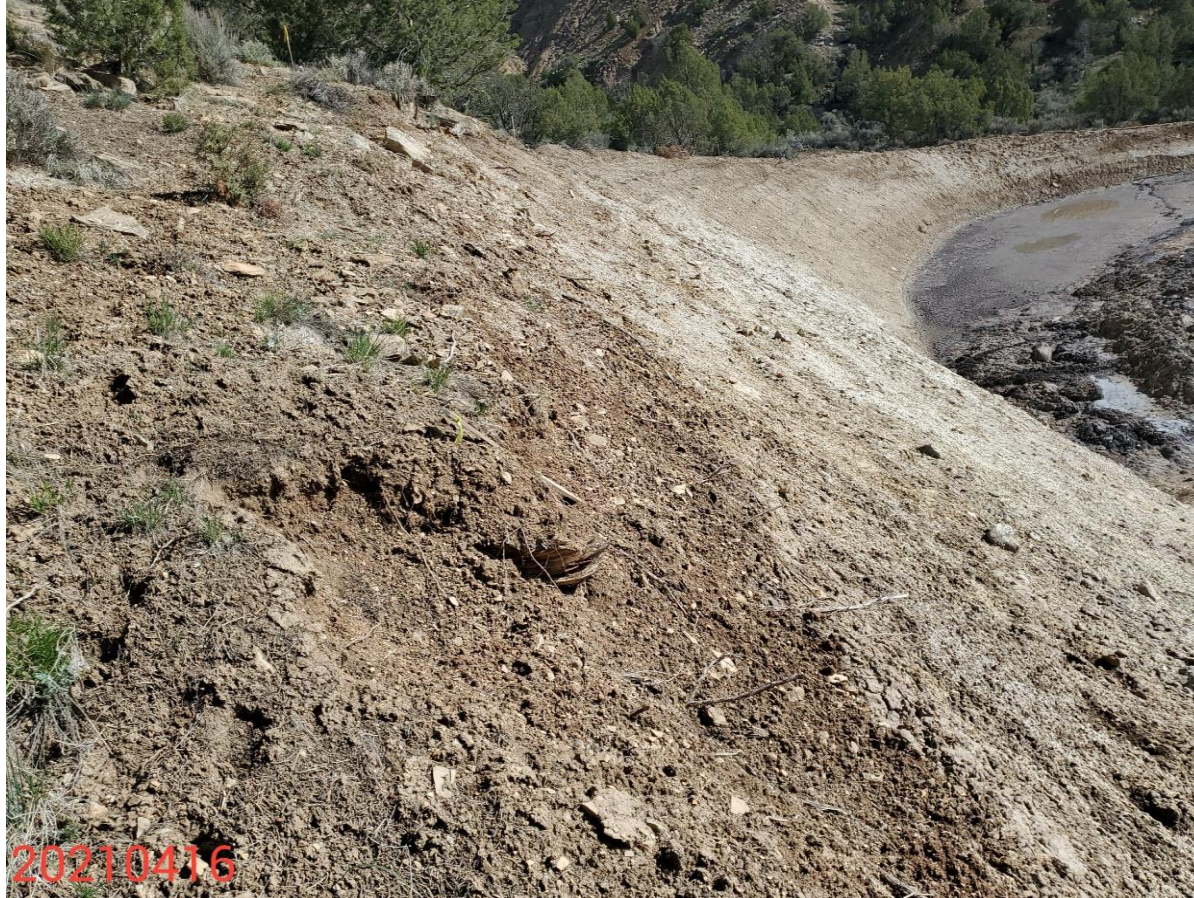
Photo 18: Photo taken from above the cut slope on the west end of the Location. Photo shows example of areas where runon control measures have not been installed; runon control measures remain missing or insufficient on the Location.

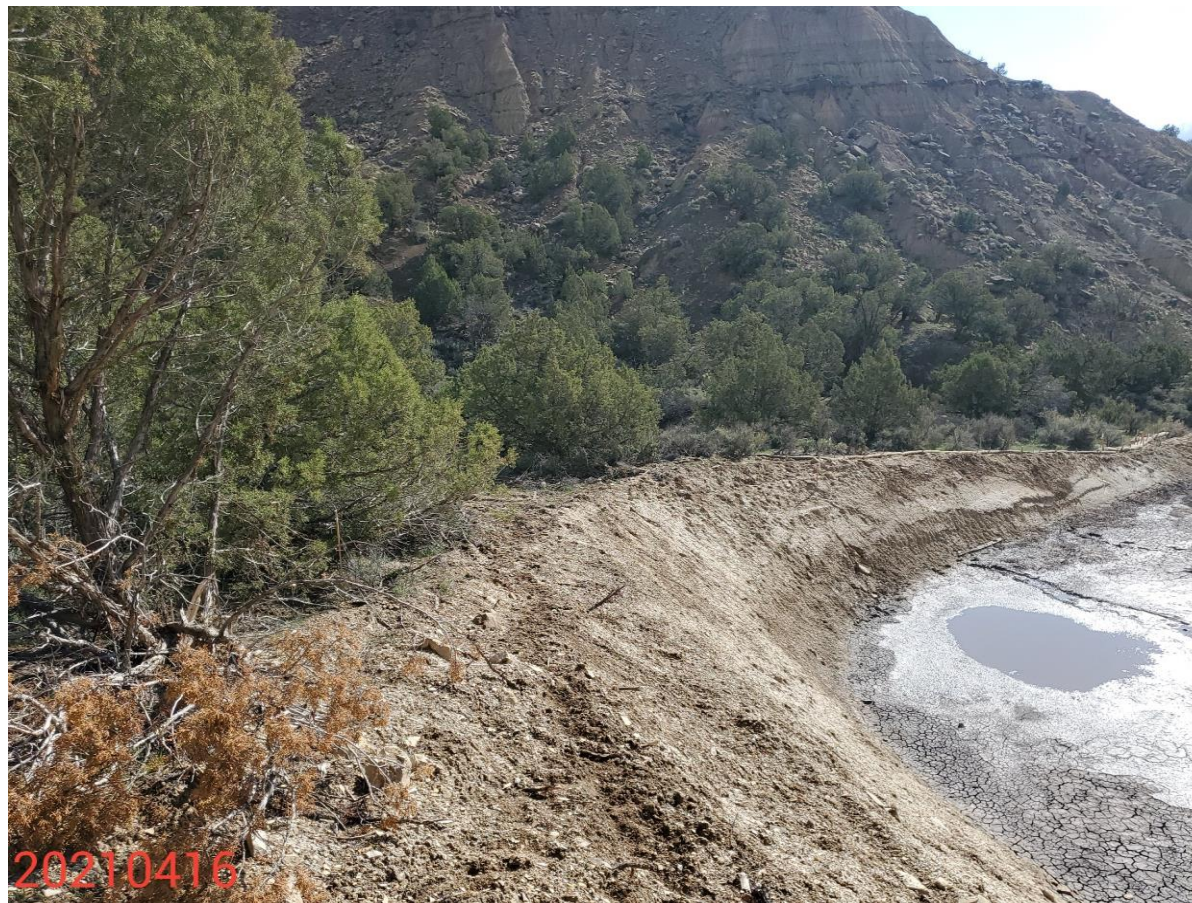
Photo 19: Photo taken from above the cut slope on the west end of the Location. Photo shows example of areas where runon control measures have not been installed; runon control measures remain missing or insufficient on the Location.

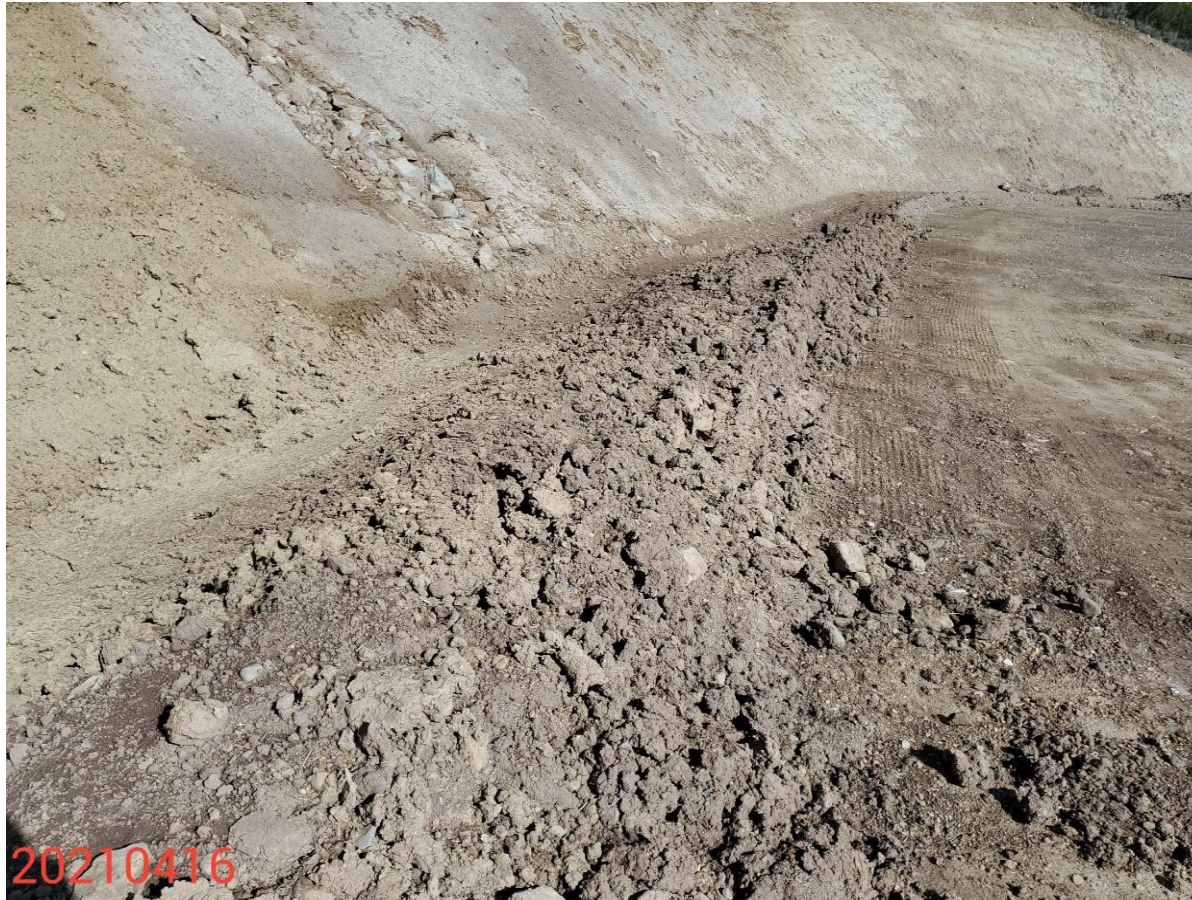
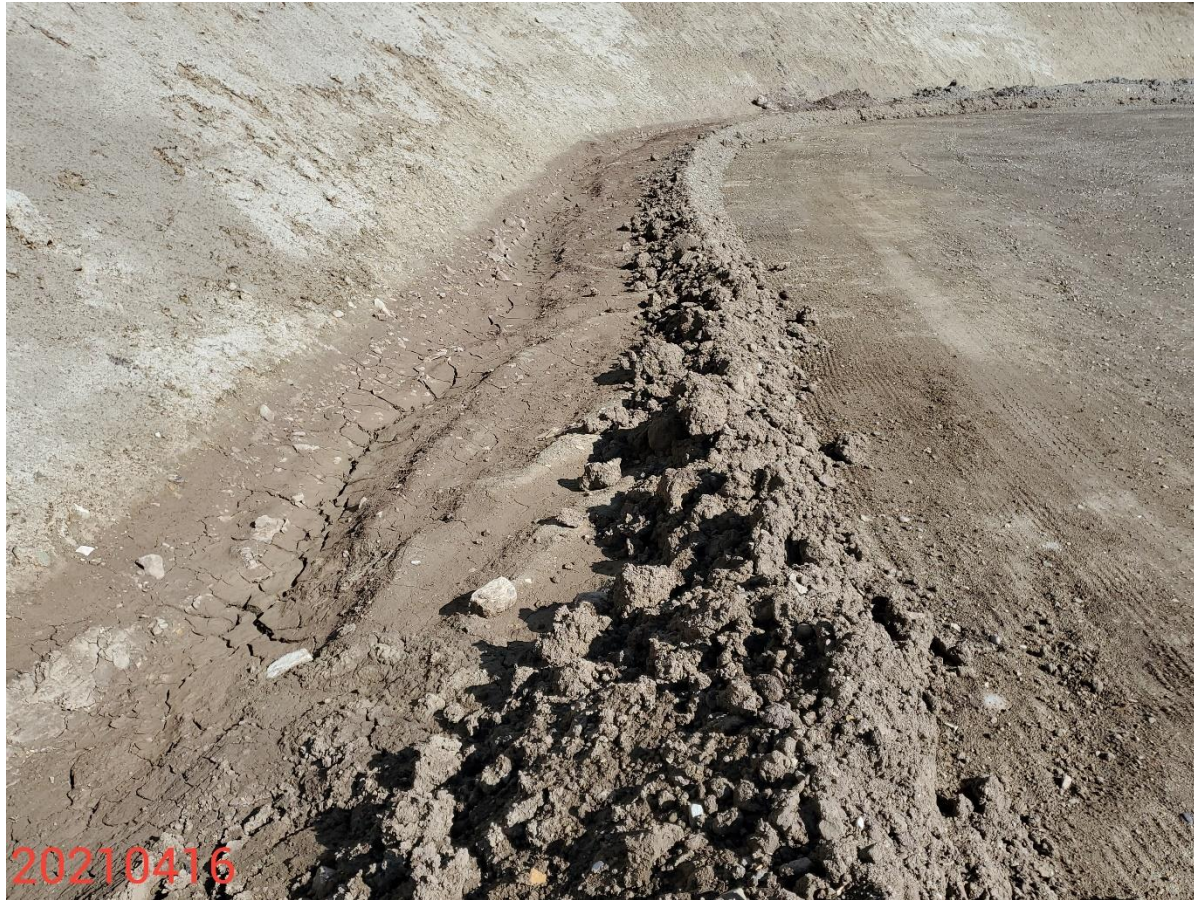
Photo 20: Photo shows Operator has installed a berm along the perimeter of the production areas; berm remains improperly constructed per good engineering practices; berm has not been properly compacted; loose soils at berm is considered a pollutant source that will contribute to sediment-laden stormwater discharge.

Photo 21: See comments under photo 20.

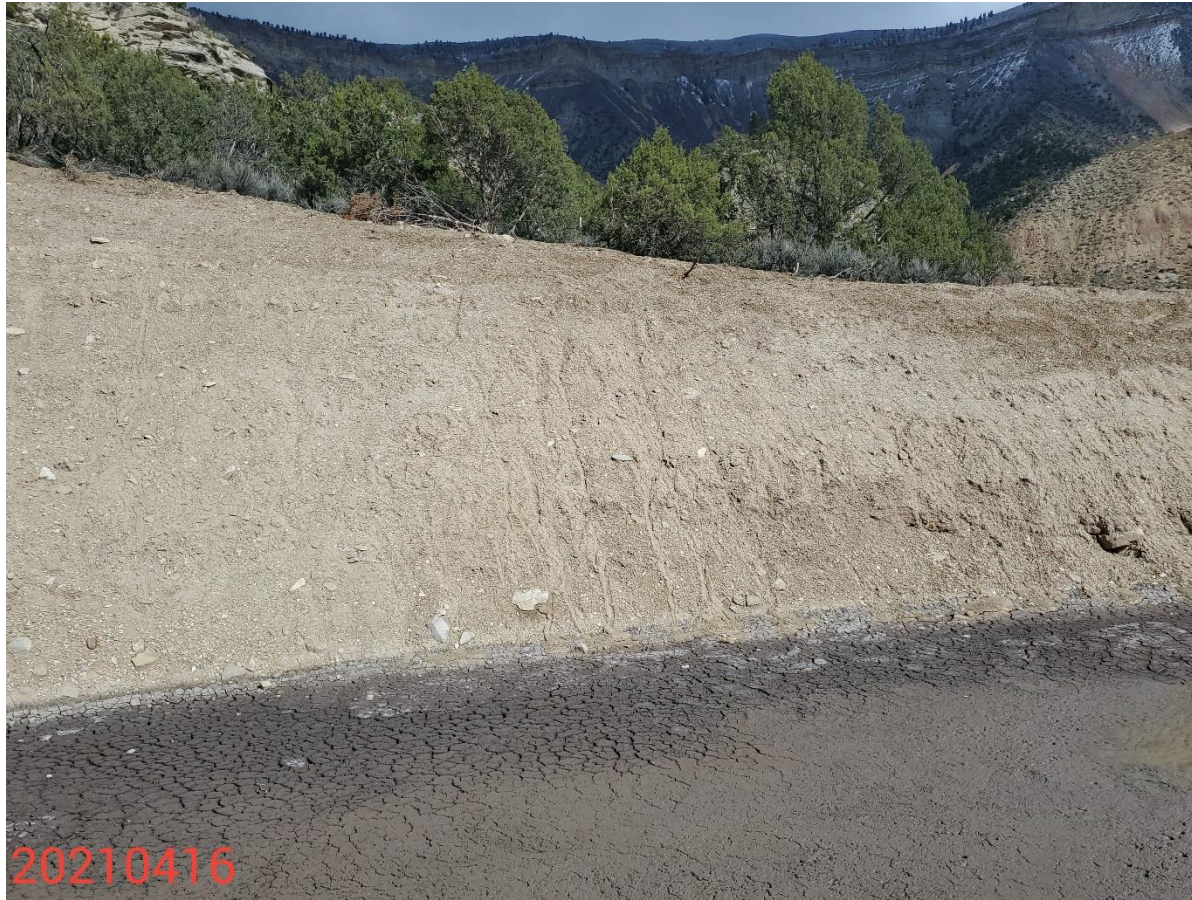
Photo 22: Photo taken from the cut slope on the north end of the Location. Photo shows rill erosion; control measures to stabilize and protect slopes of the Location, and manage runoff remain missing or insufficient.

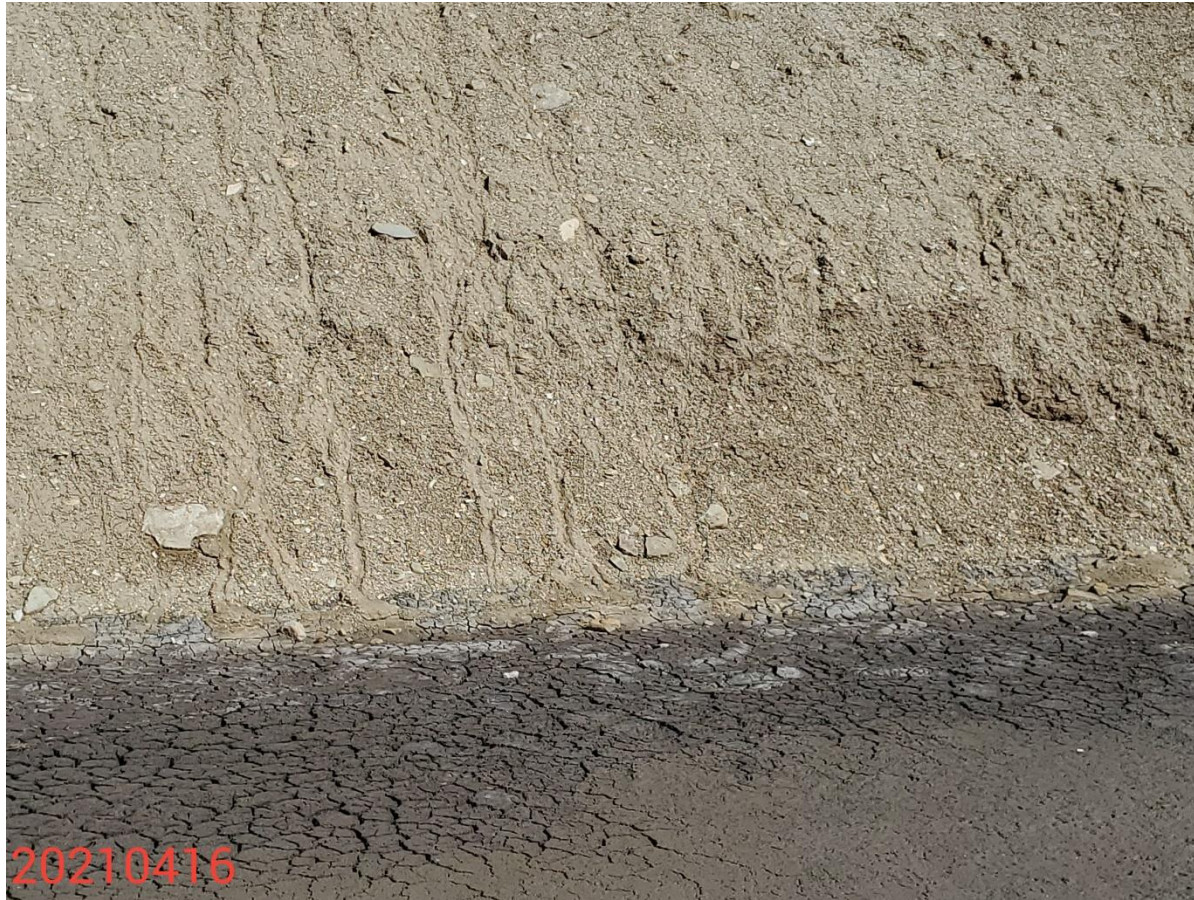
Photo 23: Continued from photo 22. Photo shows sediment deposition due to erosion at the cut slopes.

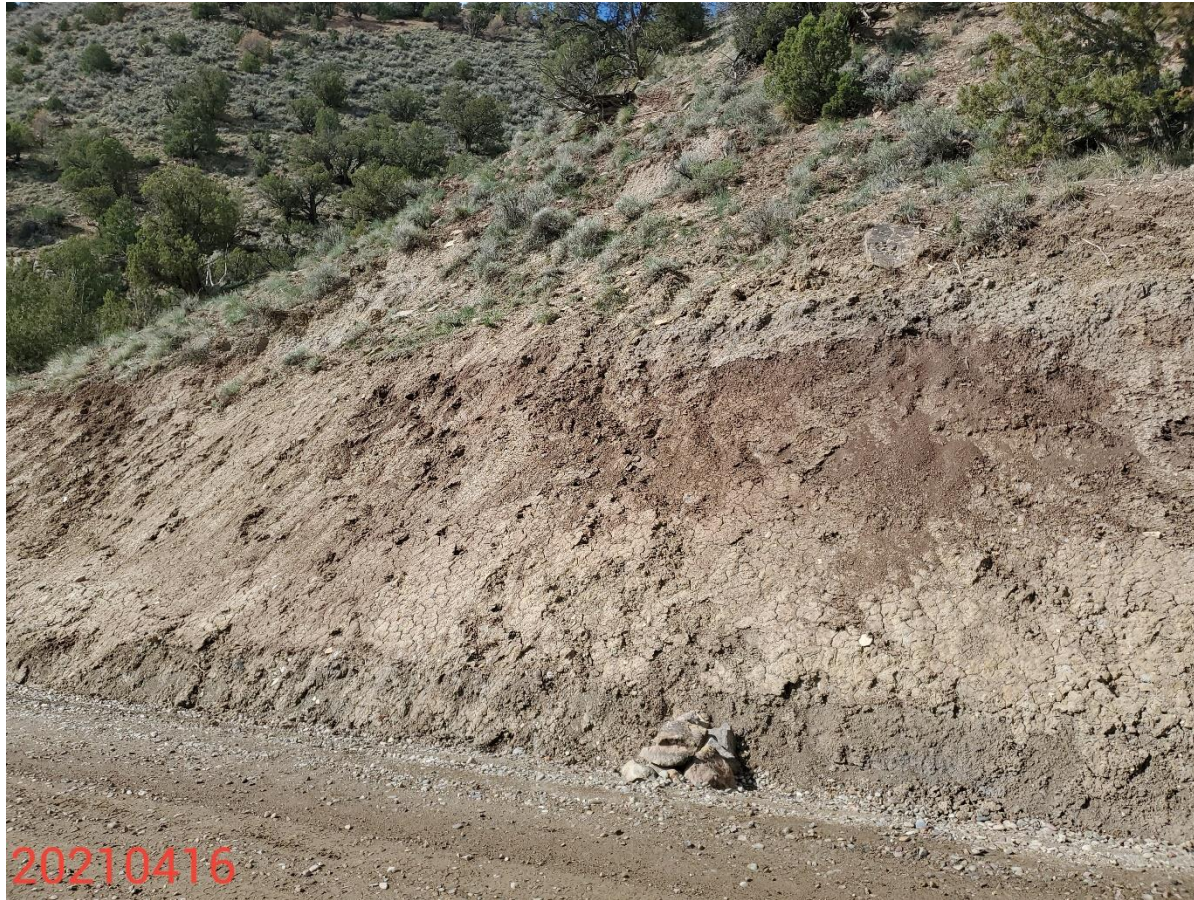
Photo 24: Photo taken from the access road. Photo shows control measures to stabilize/protect slopes remain missing or insufficient.
