Colorado Oil and Gas Conservation Commission

TEP Federal PA 31-26 Issue Report

Created on April 21, 2021

Captured: April 16, 2021

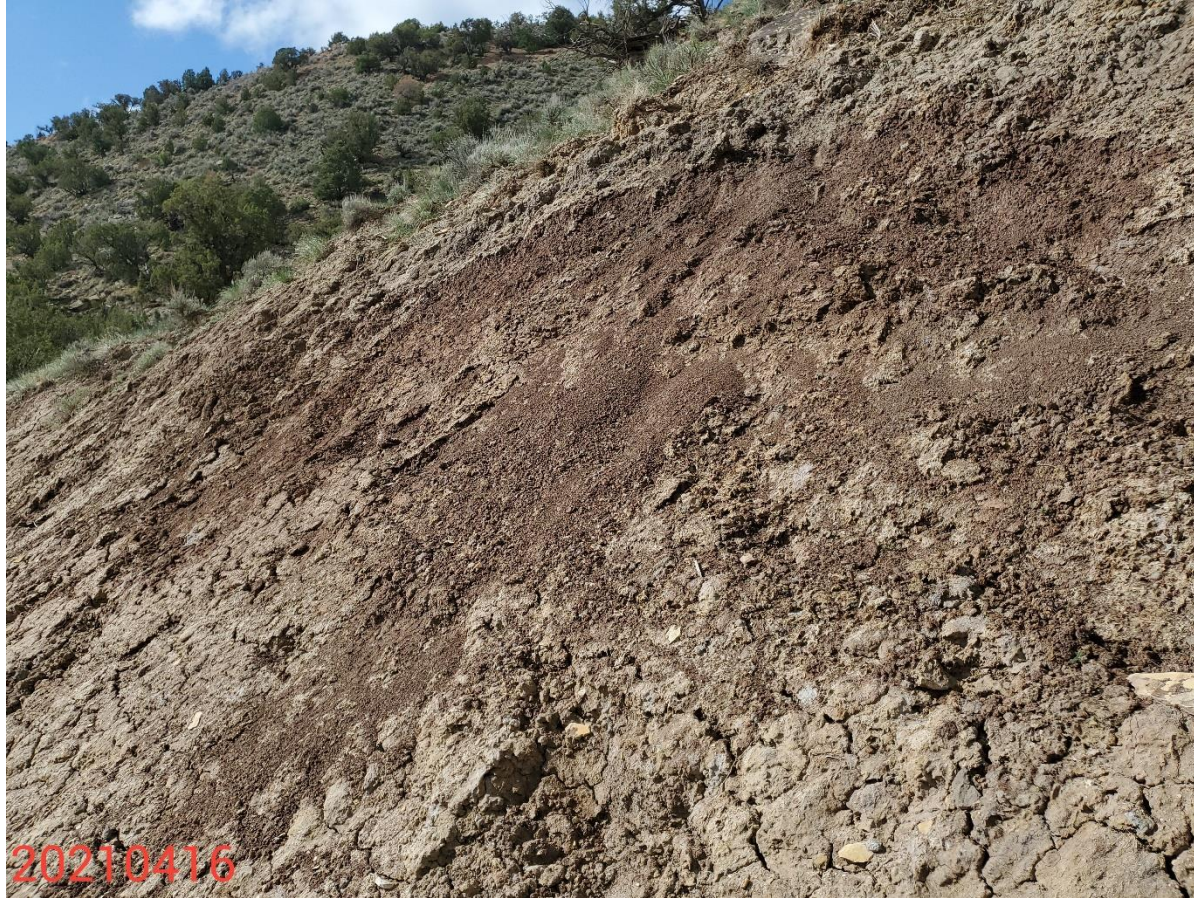
Photo 25: Photo taken from the access road. Photo shows control measures to stabilize/protect slopes remain missing or insufficient.

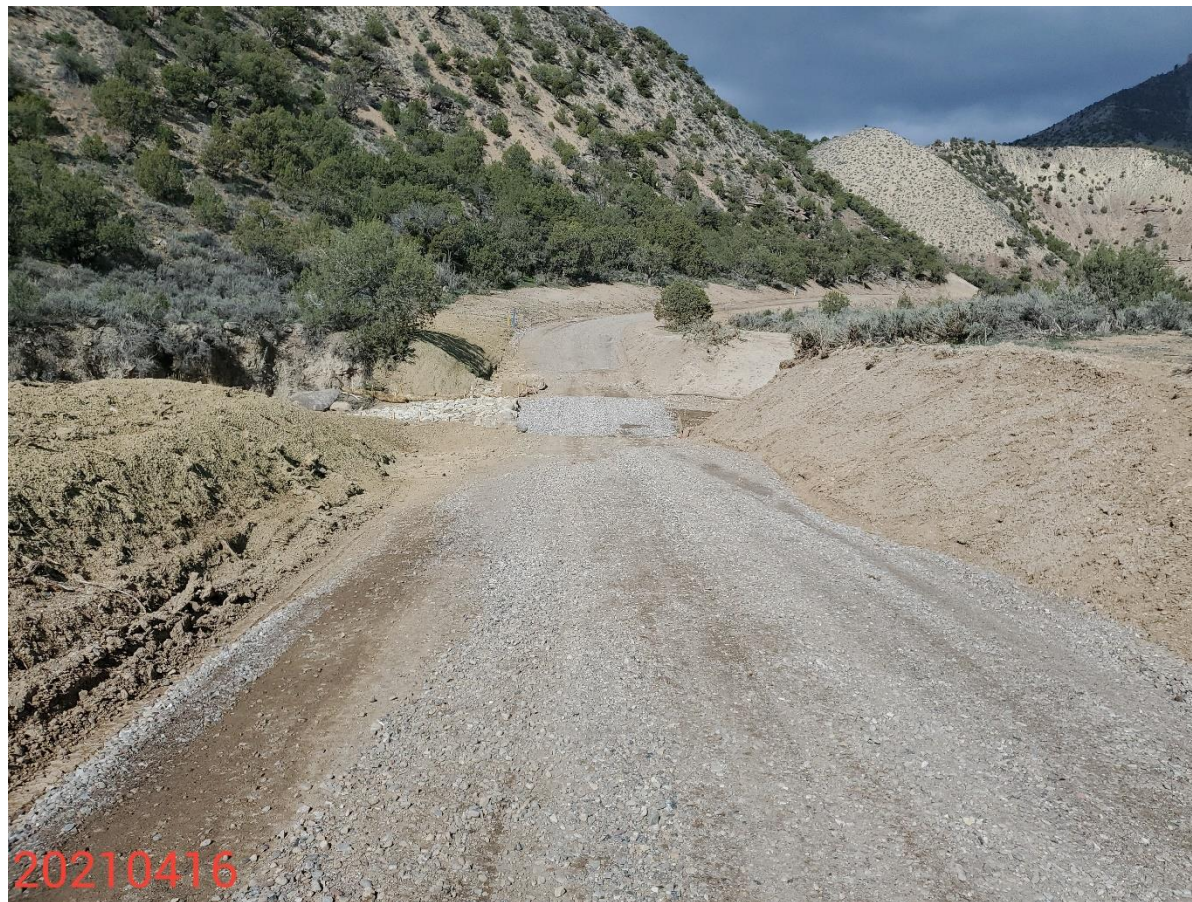
Photo 26: Photo taken from the stream crossing along the access road. Photo shows additional work has been performed at the stream crossing; it is unclear if work conducted will provide long term stabilization to the channel, however, control measures to prevent sediment/pollutant discharge from vehicles and equipment traveling through the intermittent stream and drainage remain missing or insufficient.

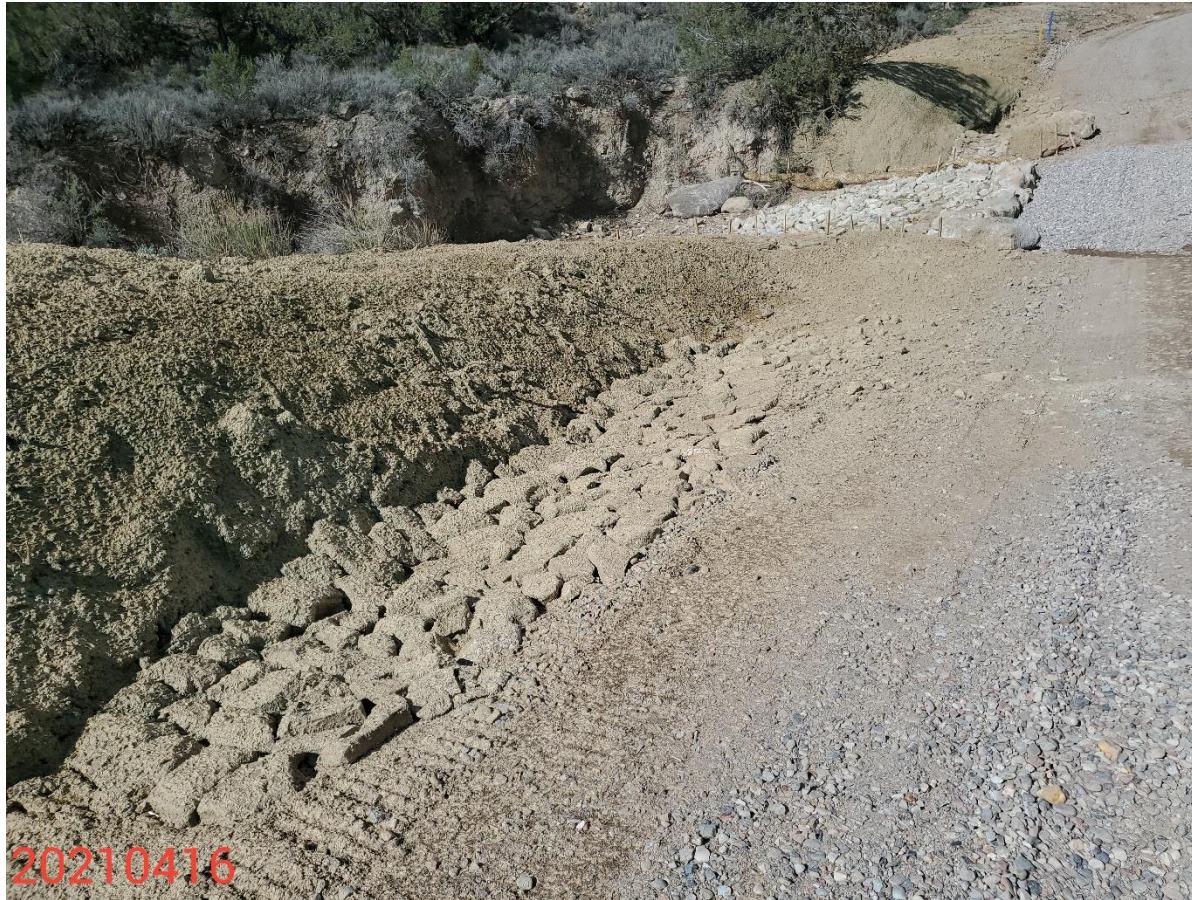
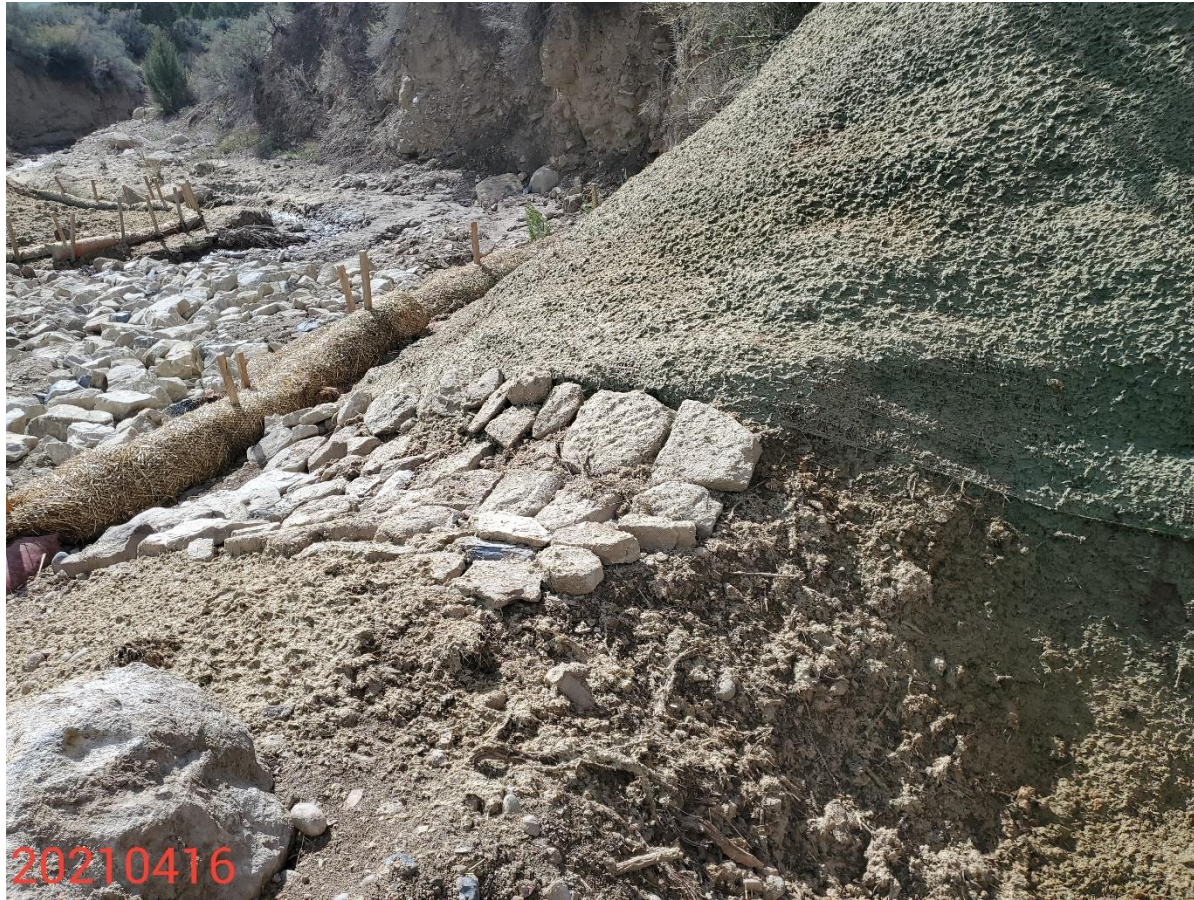
Photo 27: Photo shows Operator has implemented sediment traps along the access road; control measures have not been installed with a geotextile liner in accordance with good engineering practices.

Photo 29: See comments under photo 27.

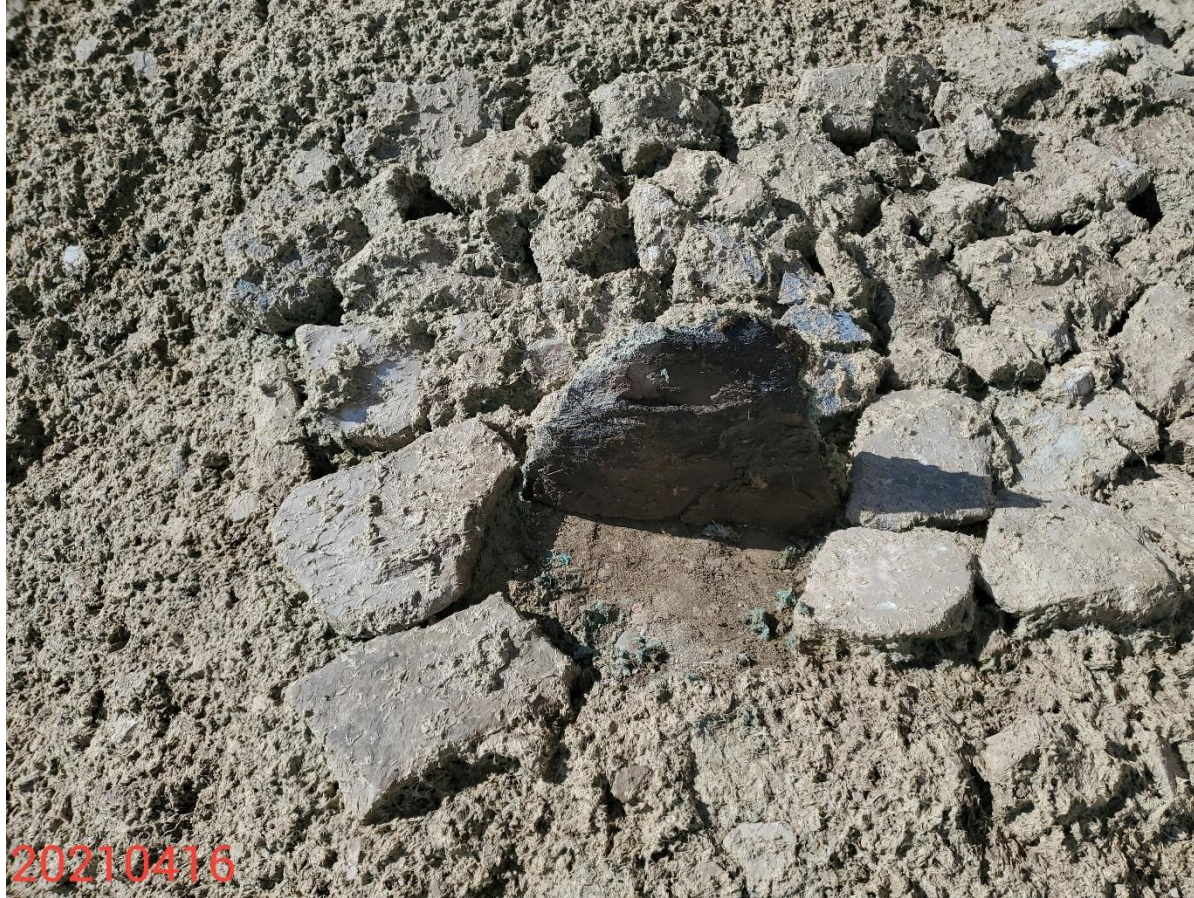
Photo 28: Continued from photo 27. Photo shows Operator has implemented sediment traps along the access road; control measures have not been installed with a geotextile liner in accordance with good engineering practices.

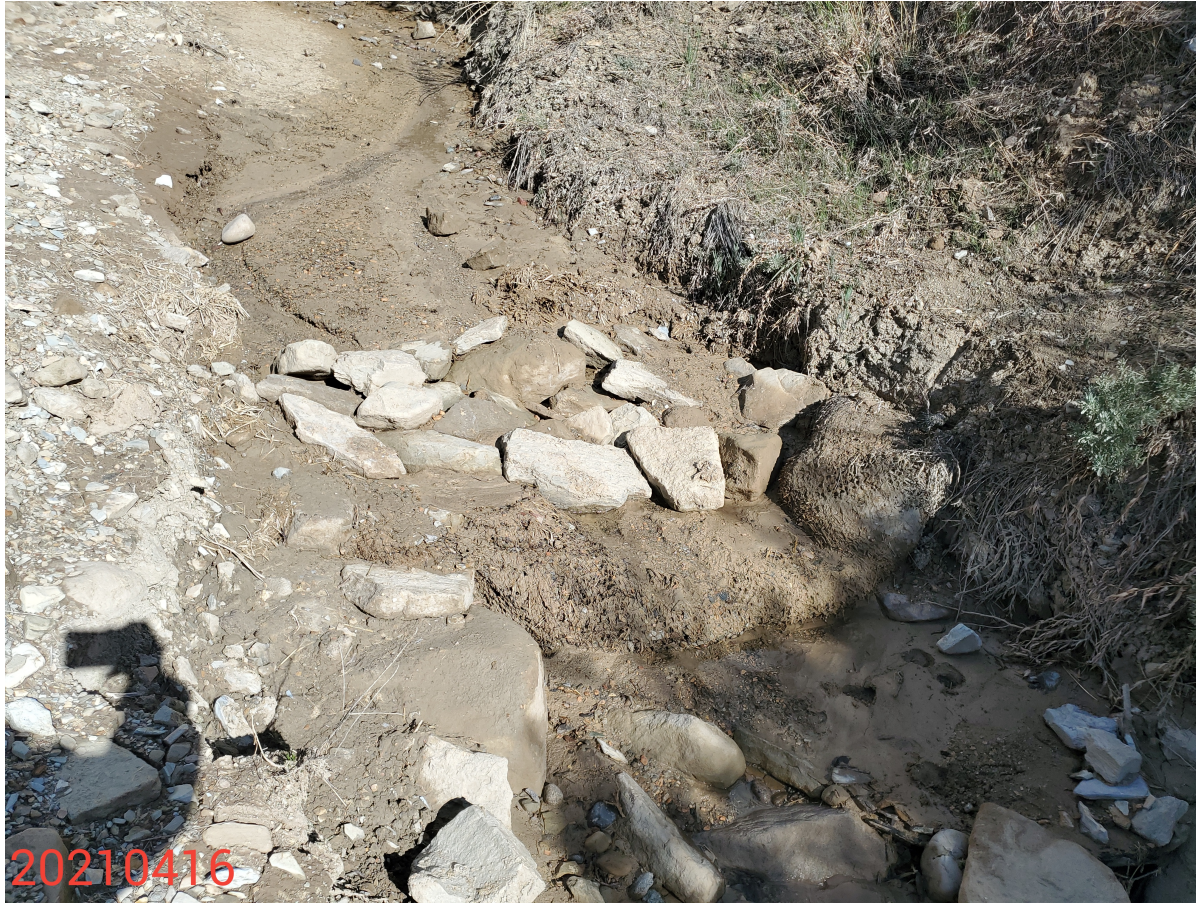
Photo 32: Photo taken downstream from the road crossing. Photo shows wattle control measure within channel that has filled with sediment and requires removal.
