Inspection Photos
Operator: Catamount Energy
API: 007-06207
Date: 4/20/2021

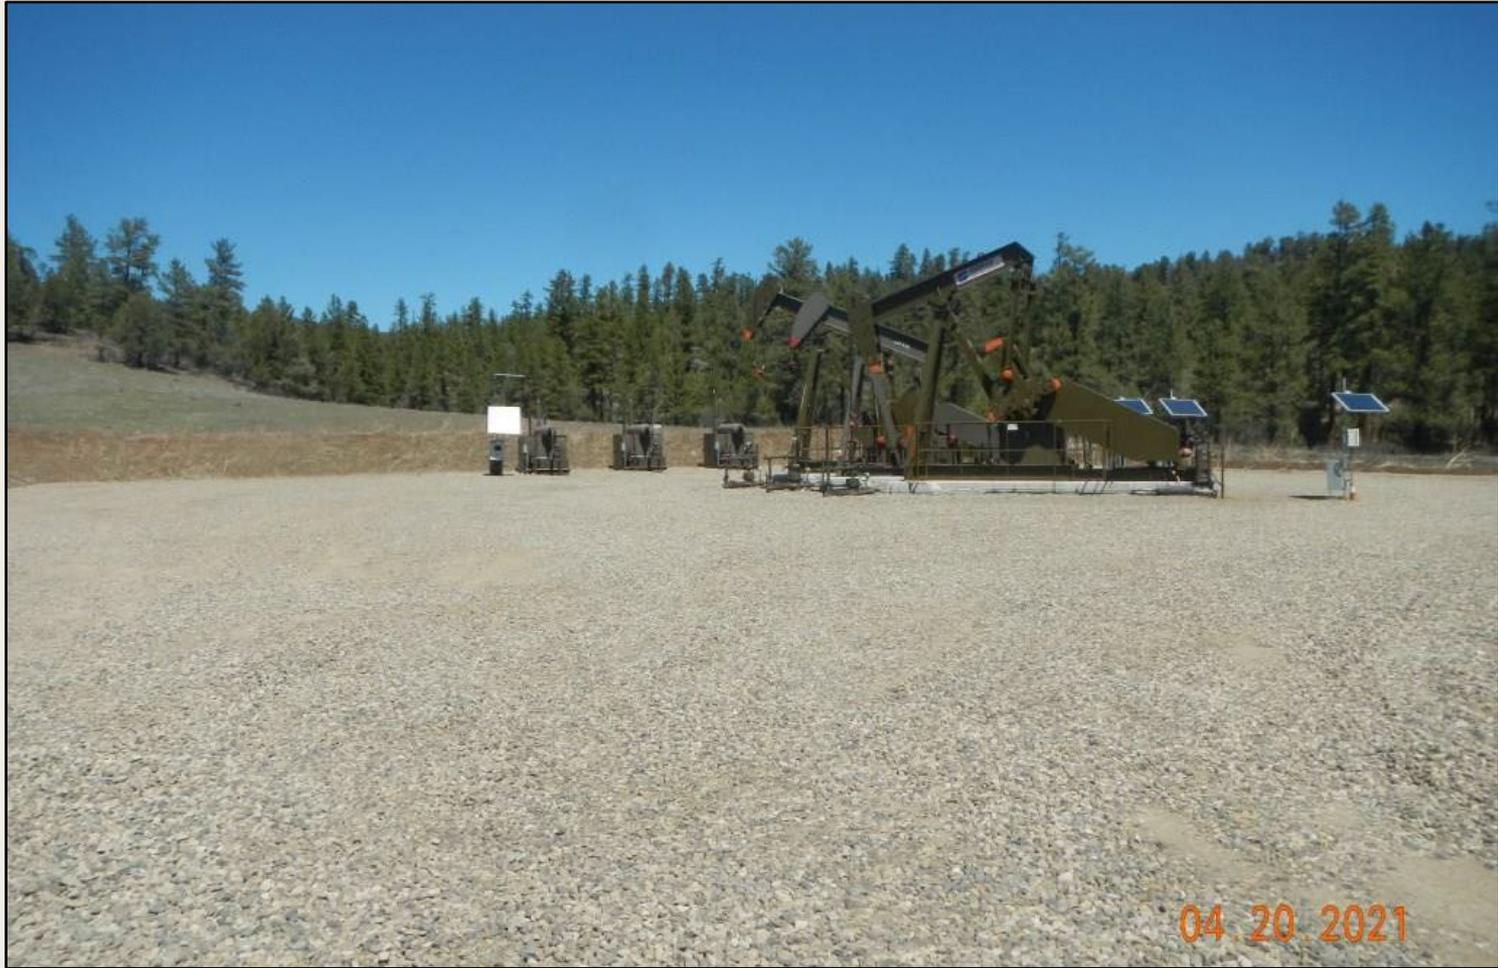
Photo 1. View of the project area from the well pad entrance facing center.

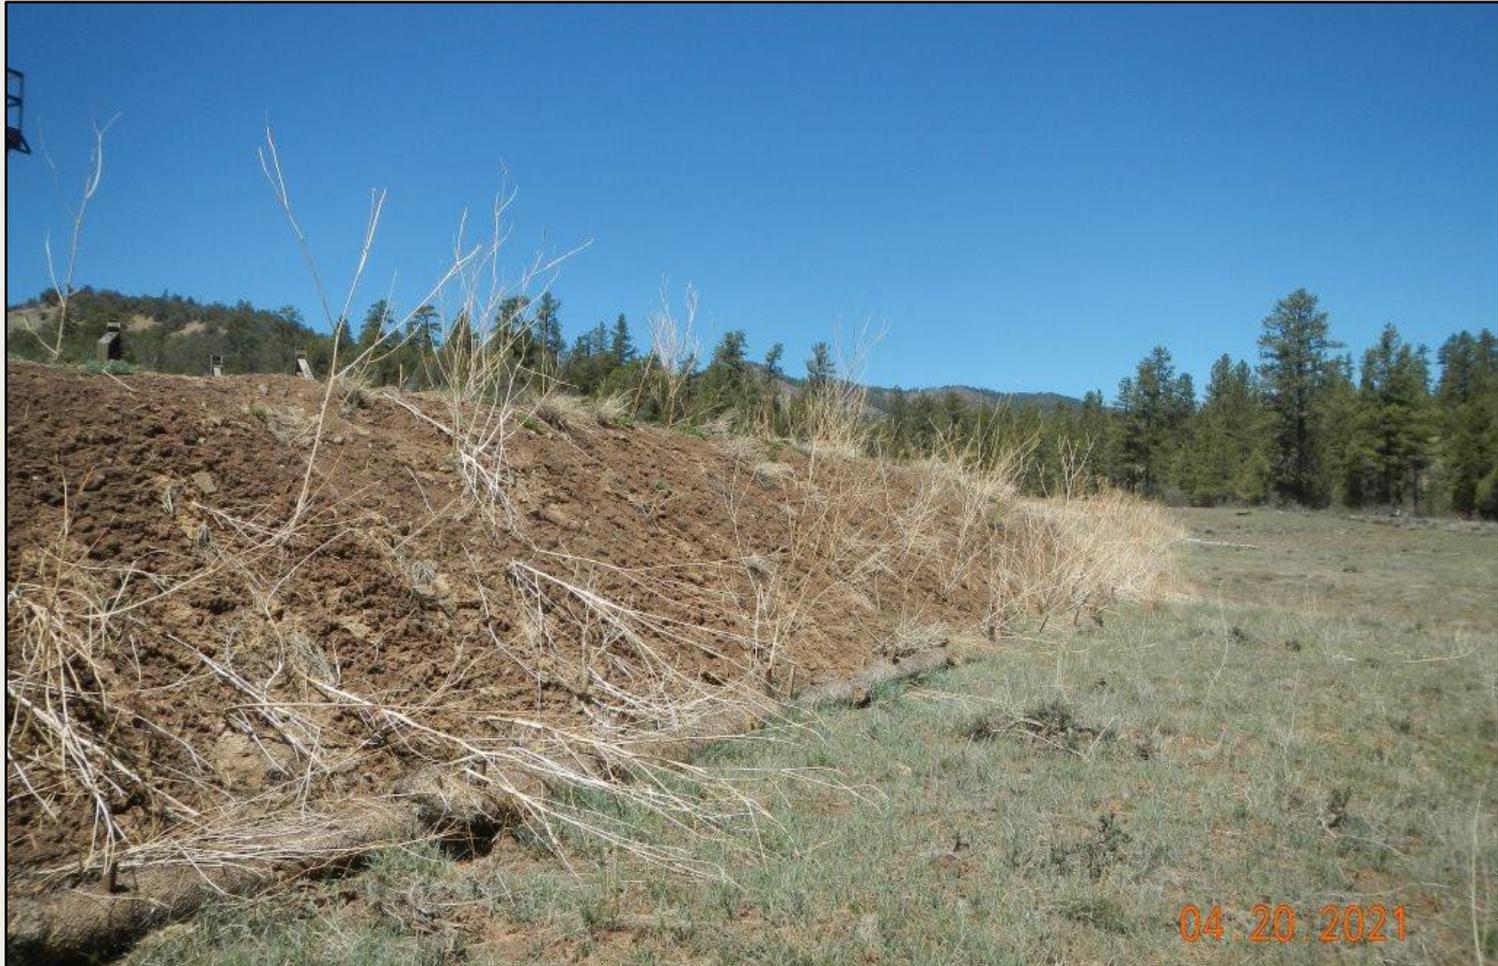
Photo 2. View of the eastern fill slope from the southeastern corner facing northward. Revegetation is in an early reclamation condition. Small grasses such as squirreltail and western wheatgrass, as well as clover (likely melilotus) observed within the reclamation areas.

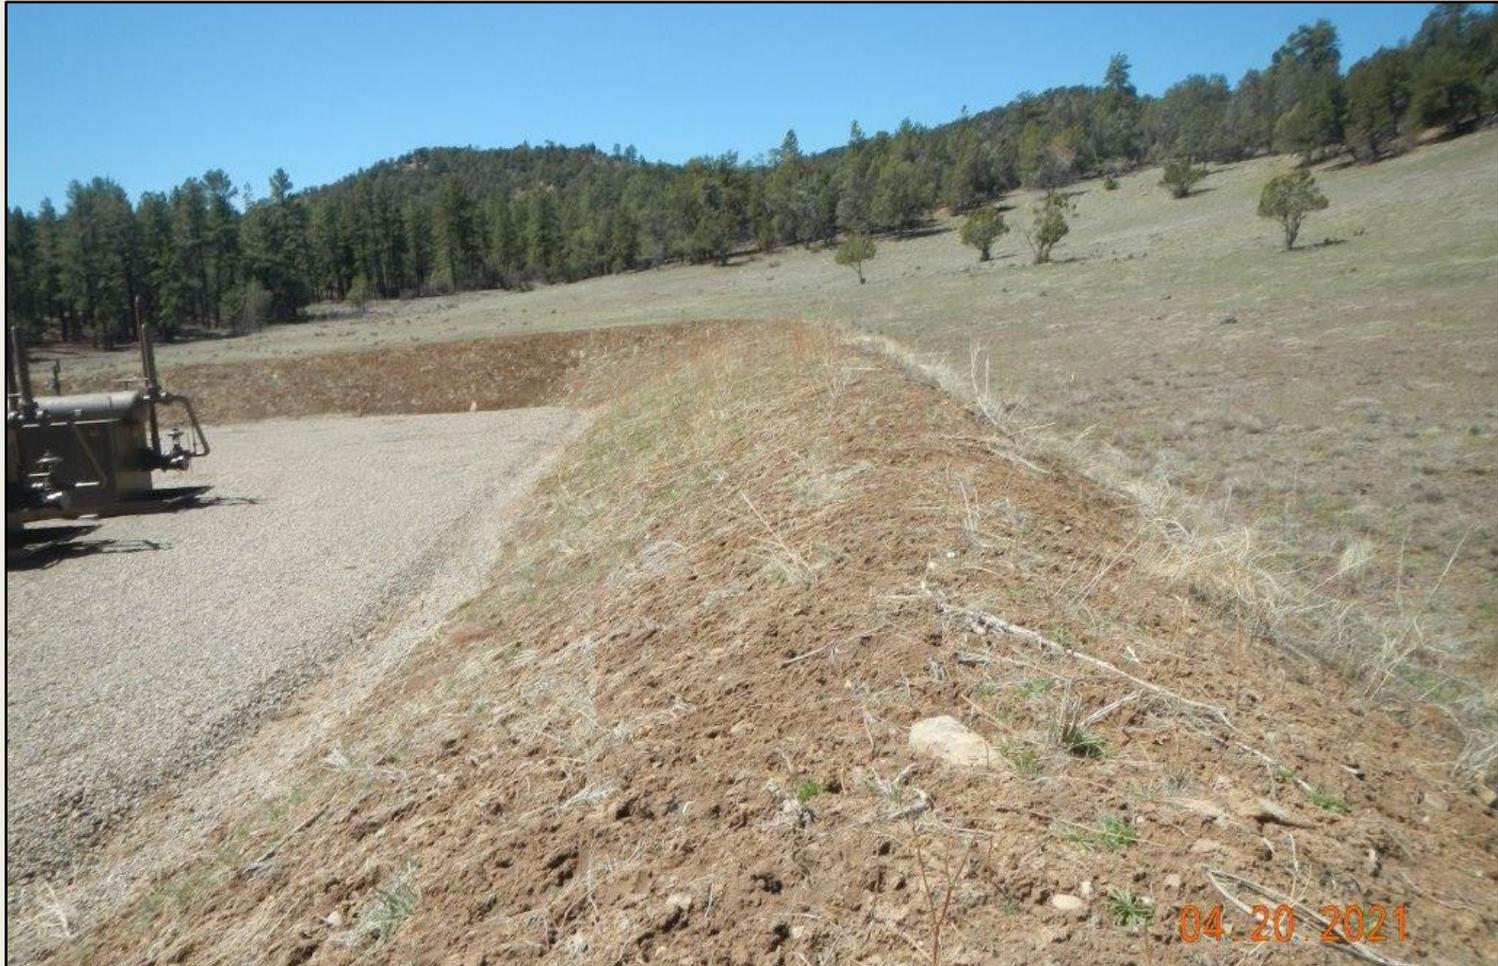
Photo 3. View of the northern project area facing westward. .

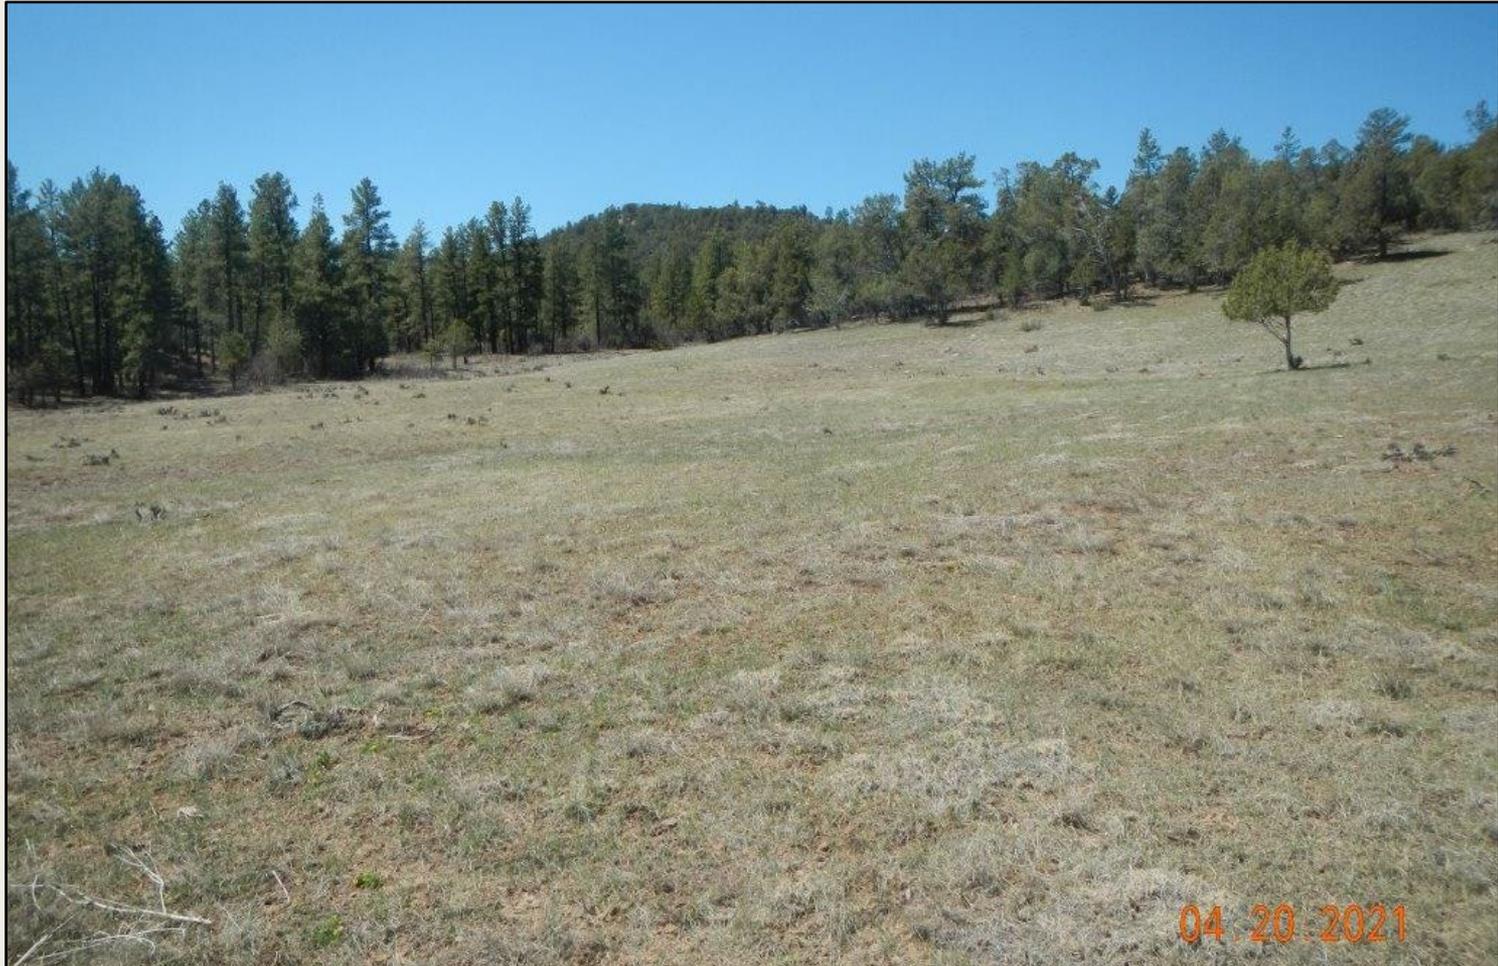
Photo 4. View of reference area vegetation comprised of Ponderosa pine savanna with western wheatgrass, squirreltail, black sagebrush, locoweed, brittle prickly pear, and bisquitroot.
