Inspection Photos

Operator: Catamount Energy
API: 007-06137
Date: 4/20/2021

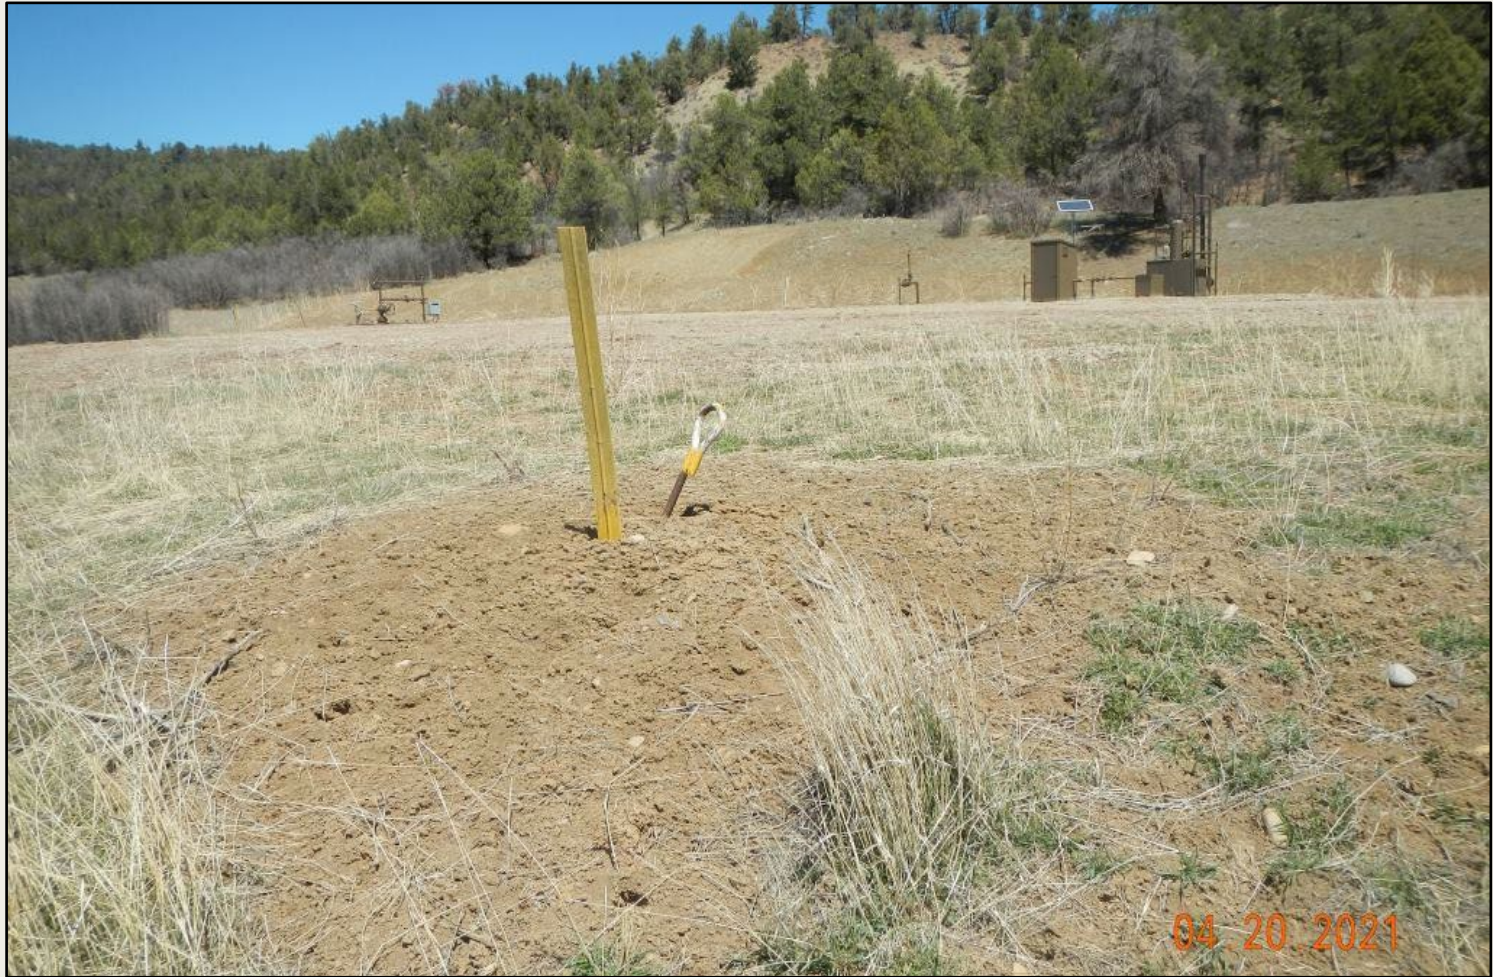
Photo 1. View of the project area from the southwestern corner facing center.

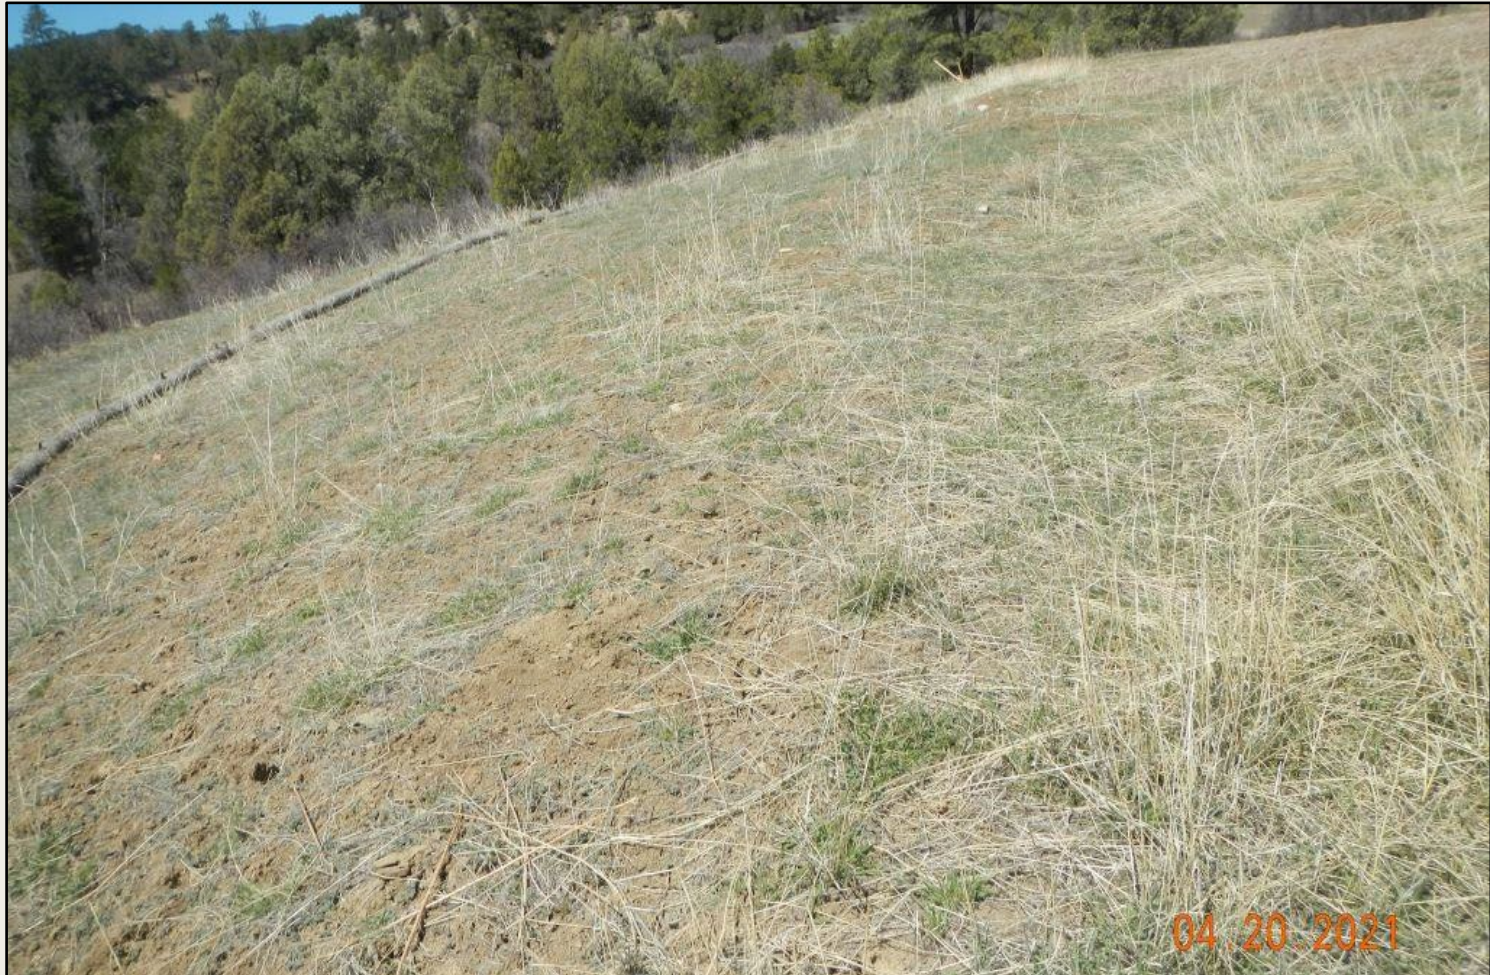
Photo 2. View of the western fill slope from the southwestern corner facing northward. Vegetation remains in-tact here, with grasses such as western wheatgrass.

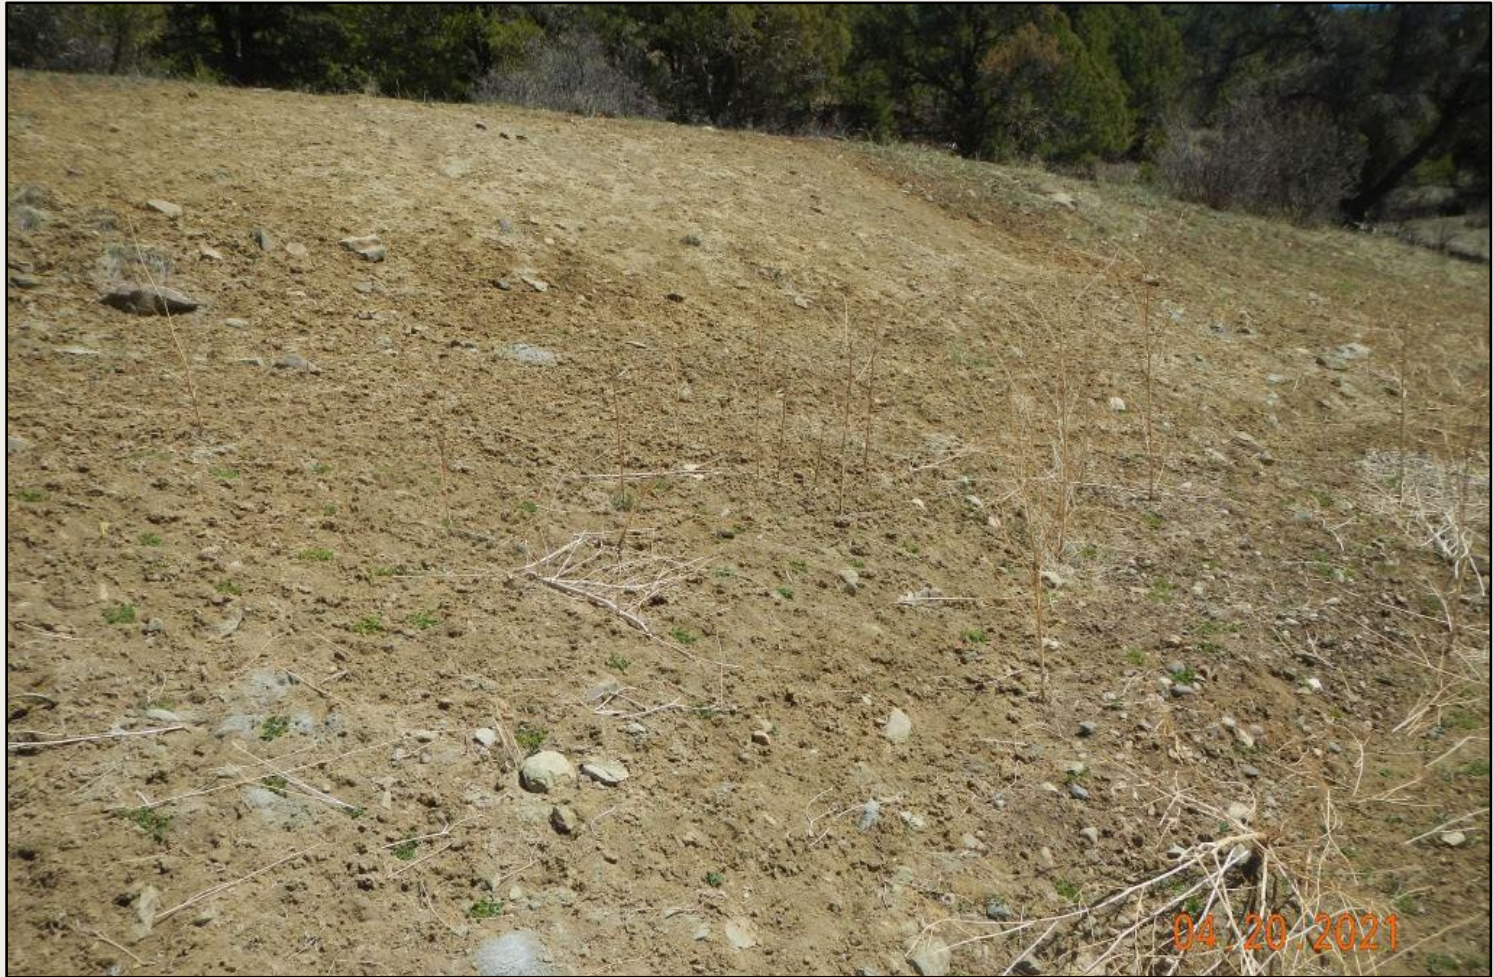
Photo 3. View of the eastern project area facing southward. Revegetation is in an early reclamation condition. Small grasses such as squirreltail and western wheatgrass, as well as clover (likely melilotus) observed within the reclamation areas.

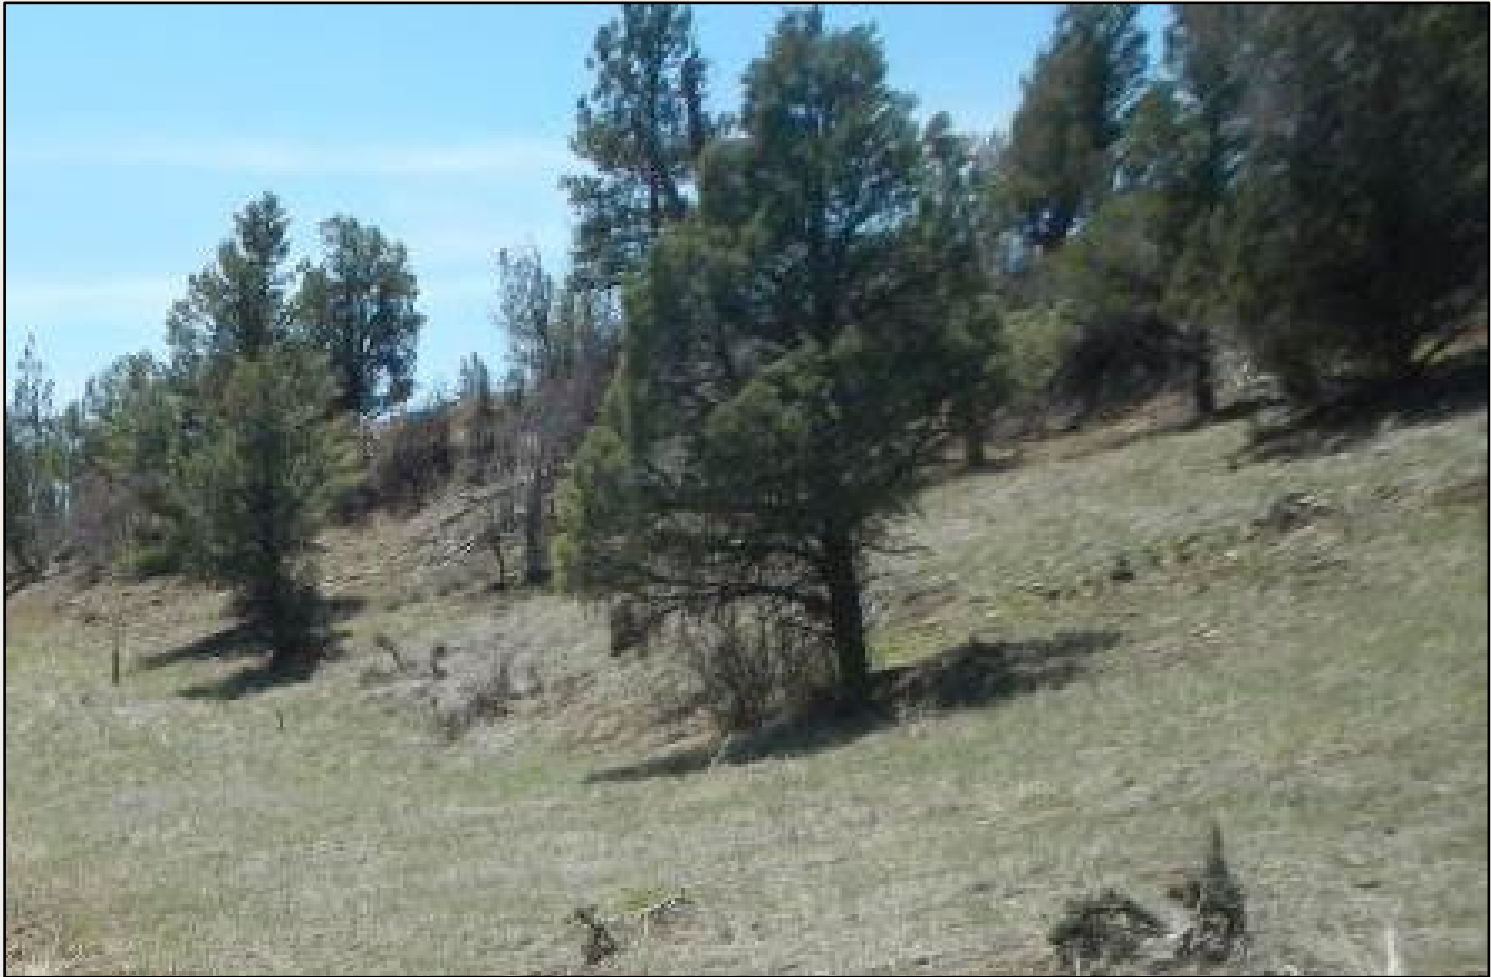
Photo 4. View of reference area vegetation comprised of Ponderosa pine and gambel oak woodland with understory of sagebrush and western wheatgrass.
