**Inspection Photos**  
**Location Name: Alfred Herman #1**  
**Location ID: 332917**

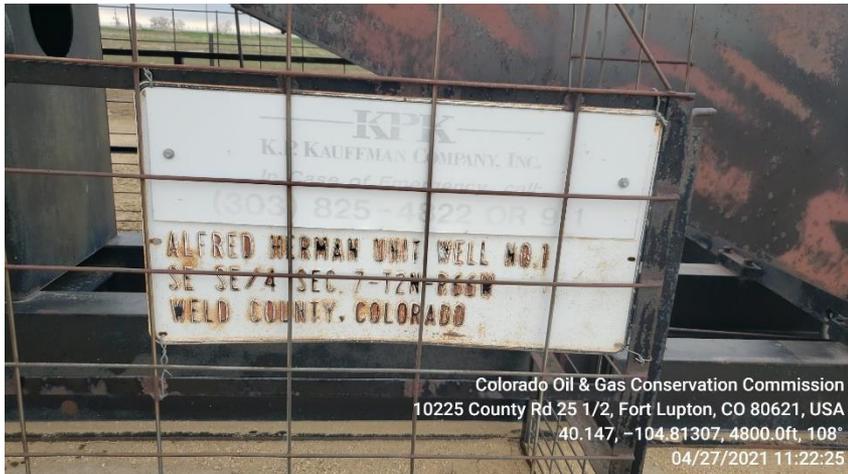
**Photo 1 WH sign**

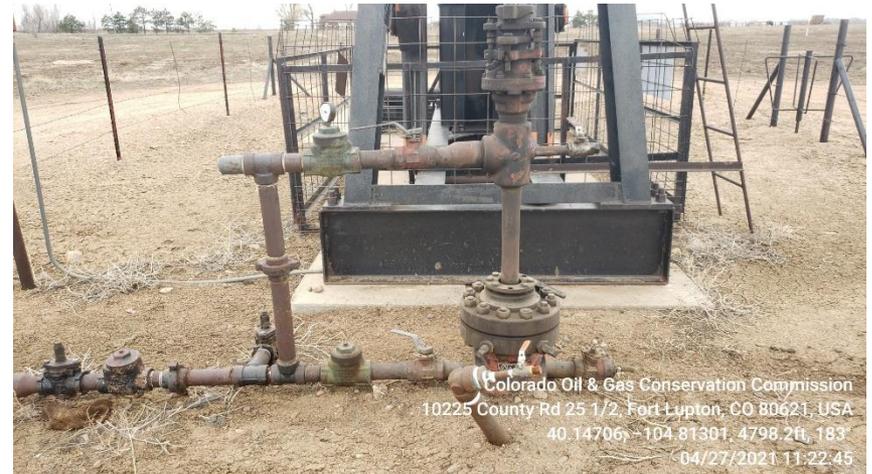
**Photo 2 WH**

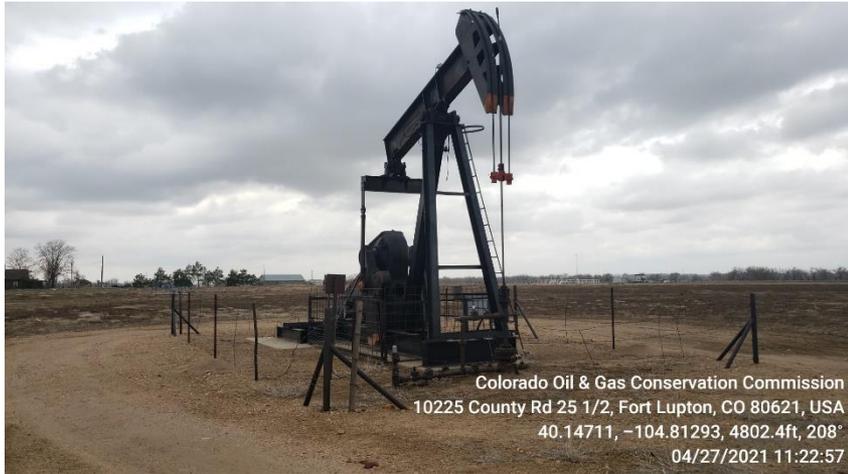
**Photo 3 Pump Jack**

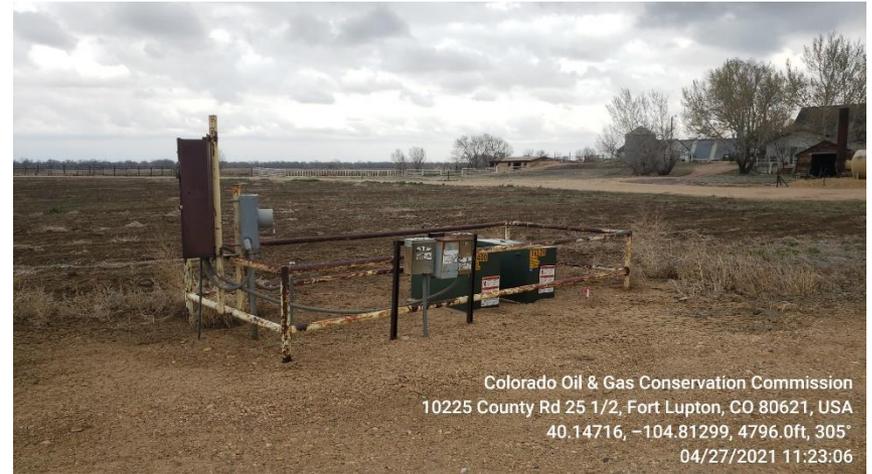
**Photo 4 ancillary equipment**

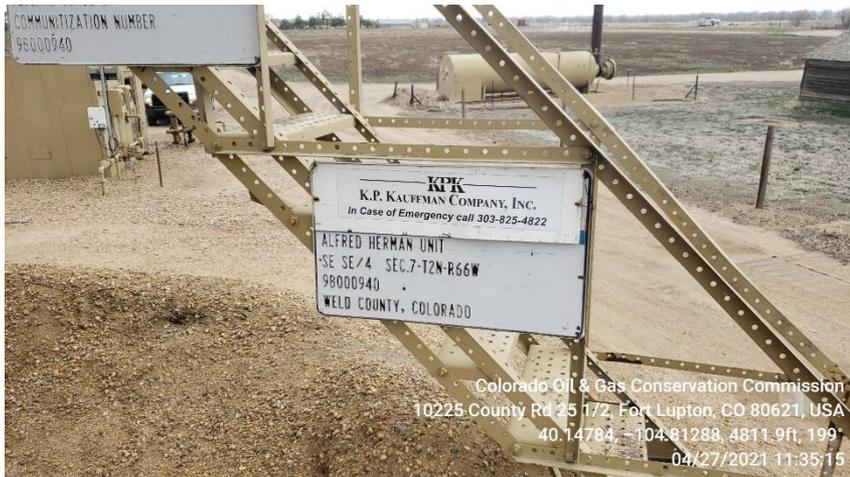
Photo 5 TB sign

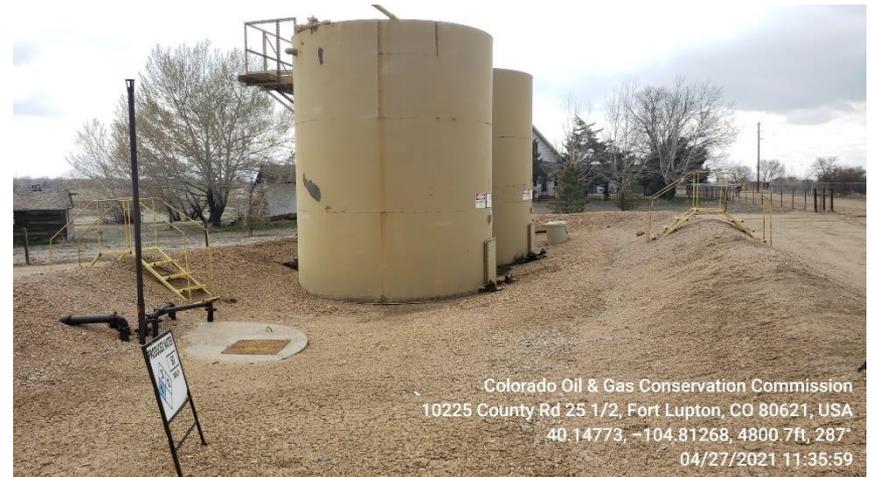
Photo 6 TB

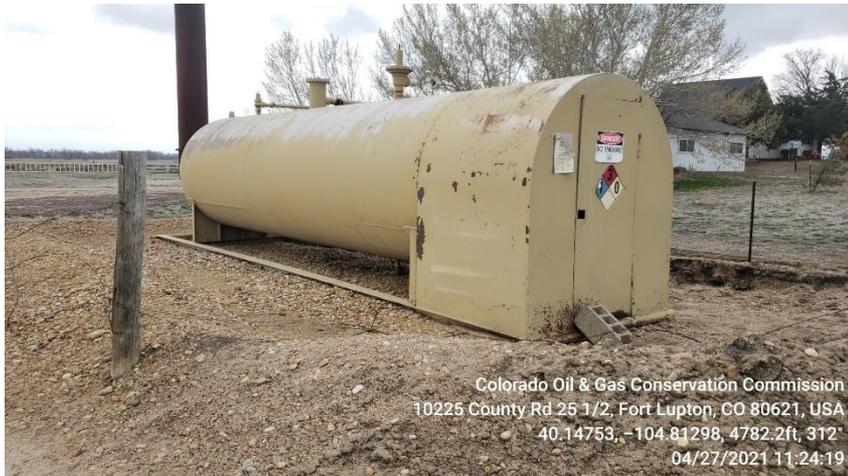
**Photo 7 Horizontal Heated Separator**

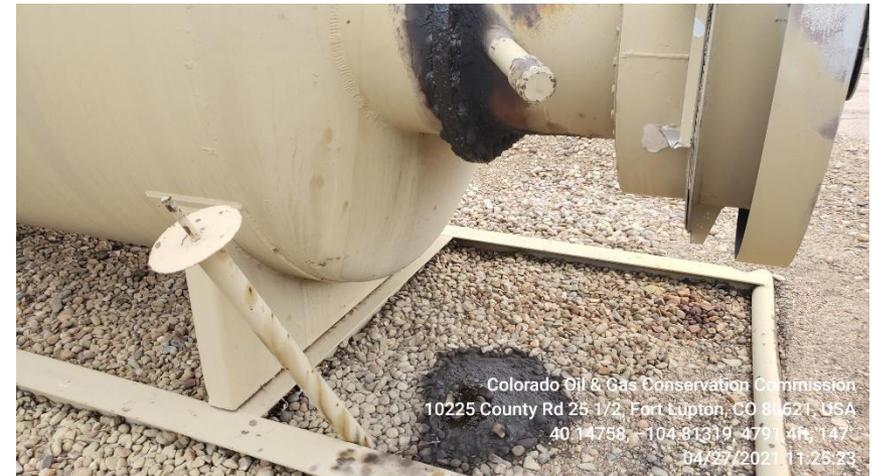
**Photo 8 Stained soil under Horiz. Heated Sep**

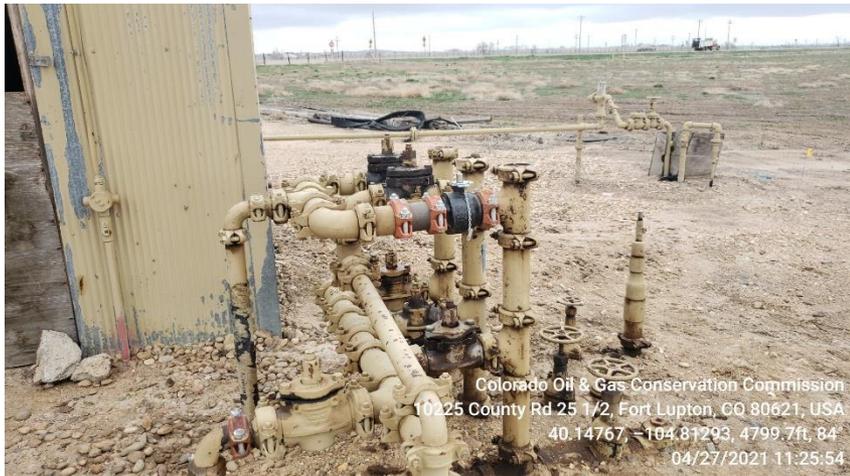
**Photo 9 Flow line manifold**

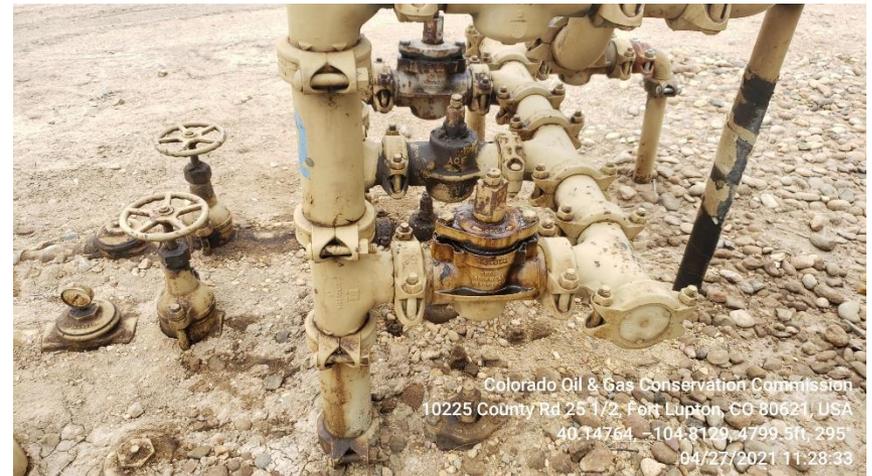
**Photo 10 Stained soil around flow line manifold**

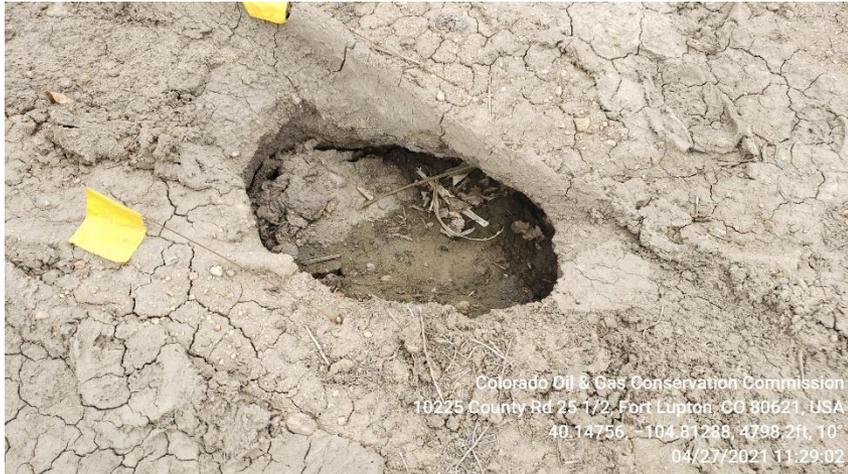
**Photo 11 sink hole south of separator house**

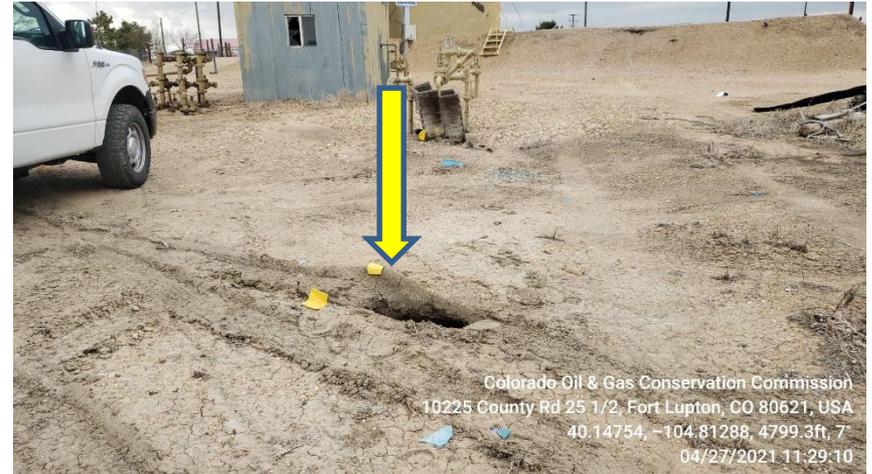
**Photo 12 sink hole south of separator house**

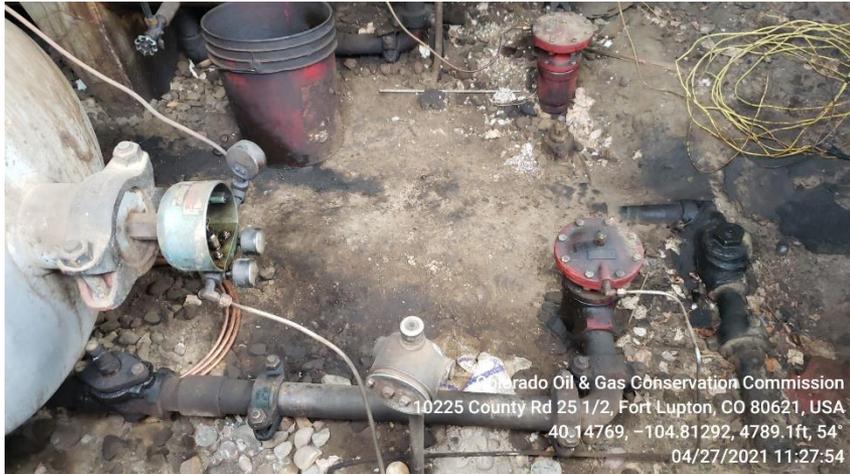
**Photo 13 Stained soil inside Horiz. Sep. house**

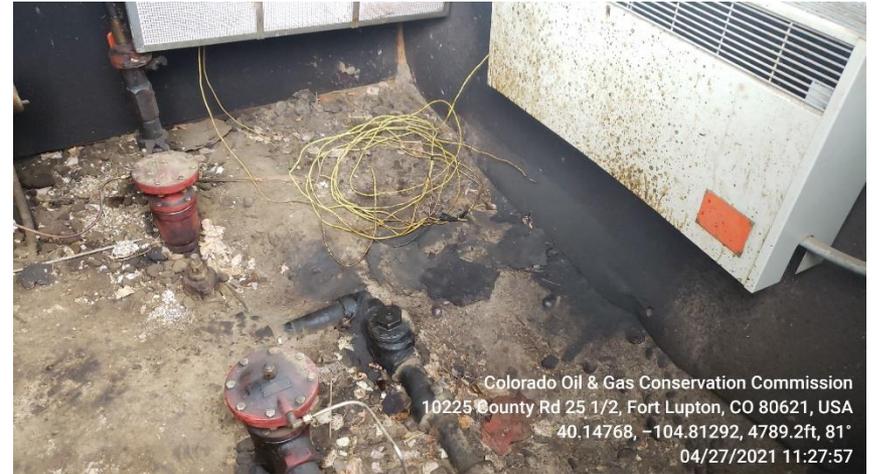
**Photo 14 Stained soil inside Horiz. Sep. house**

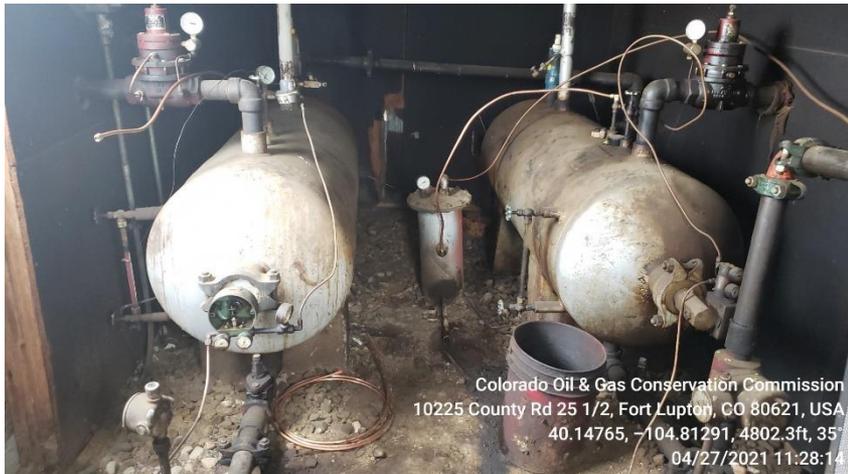
**Photo 15 Stained soil inside Horiz. Sep. house**

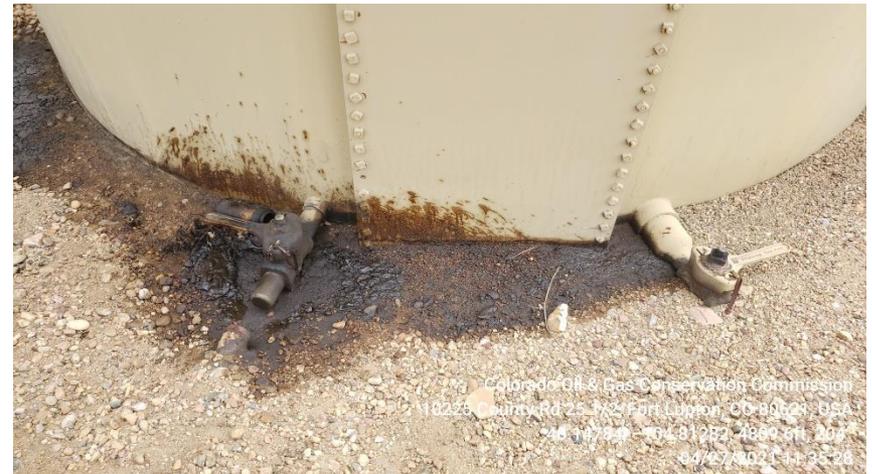
**Photo 16 Stained soil by crude oil tank valve**

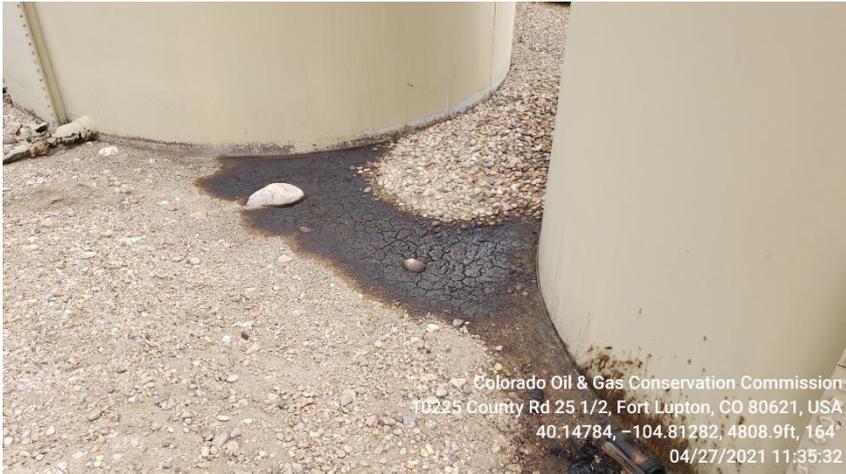
**Photo 17 Stained soil between crude oil tanks**

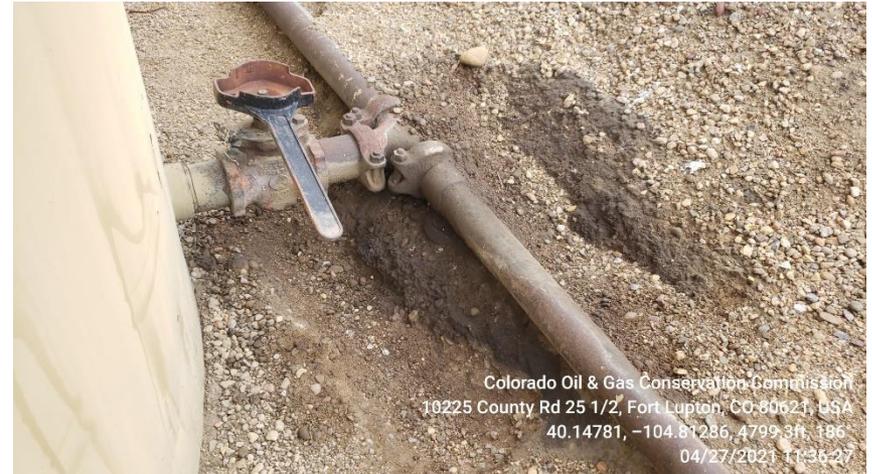
**Photo 18 Stained soil by crude oil tank valve**

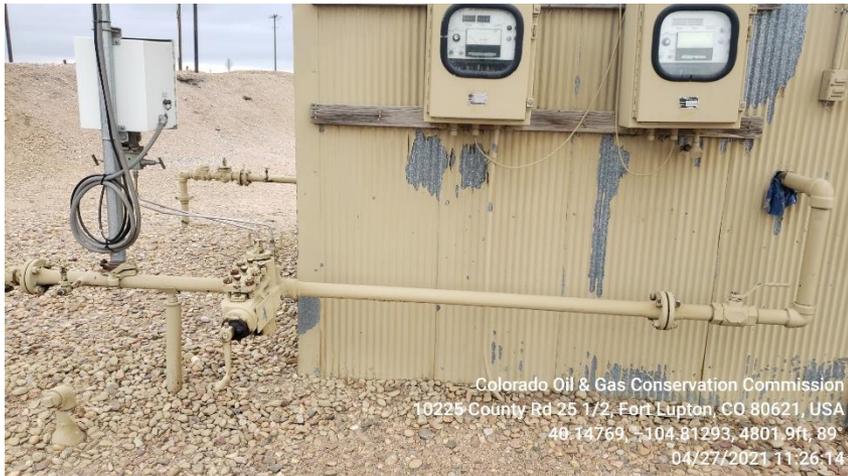
**Photo 19 Gas Meter Run no card indicating calibration status**

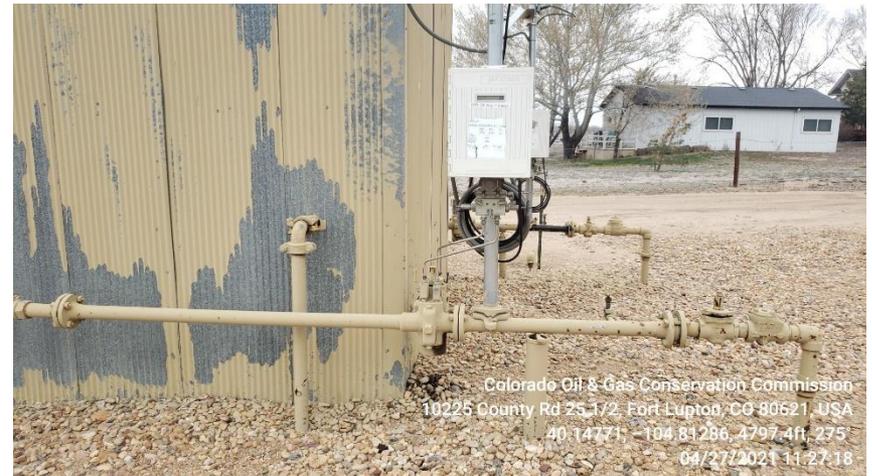
**Photo 20 Gas Meter Run no card indicating calibration status**

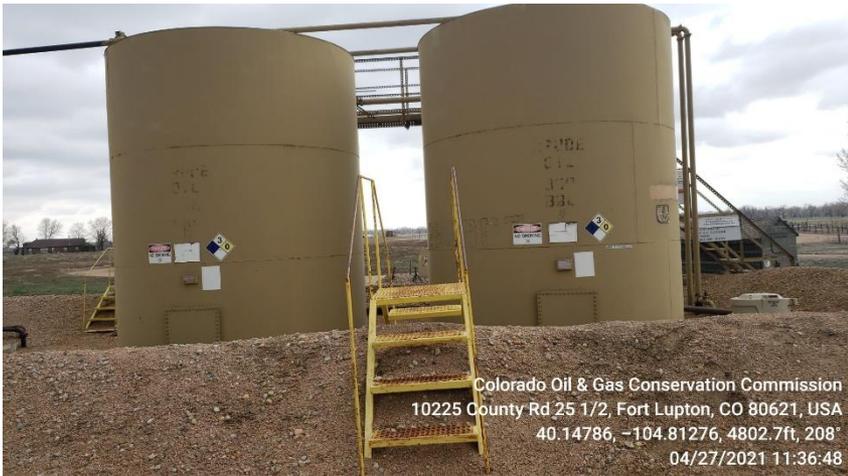
**Photo 21 Tank volume & placards faded.**
