TEP
KP 32-9
Location # 435118

COLORADO
Oil & Gas Conservation
Commission
Department of Natural Resources

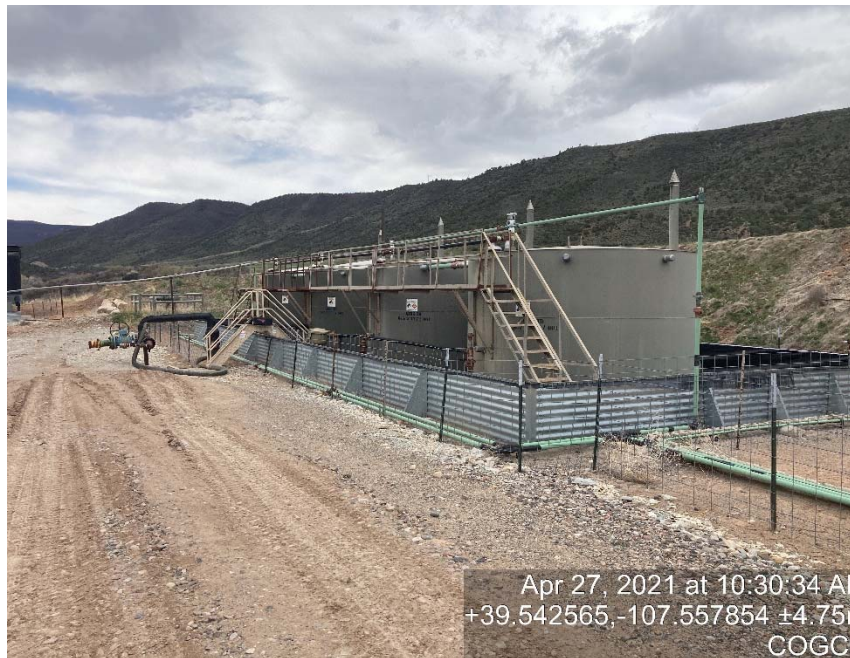
Location/ No battery signage

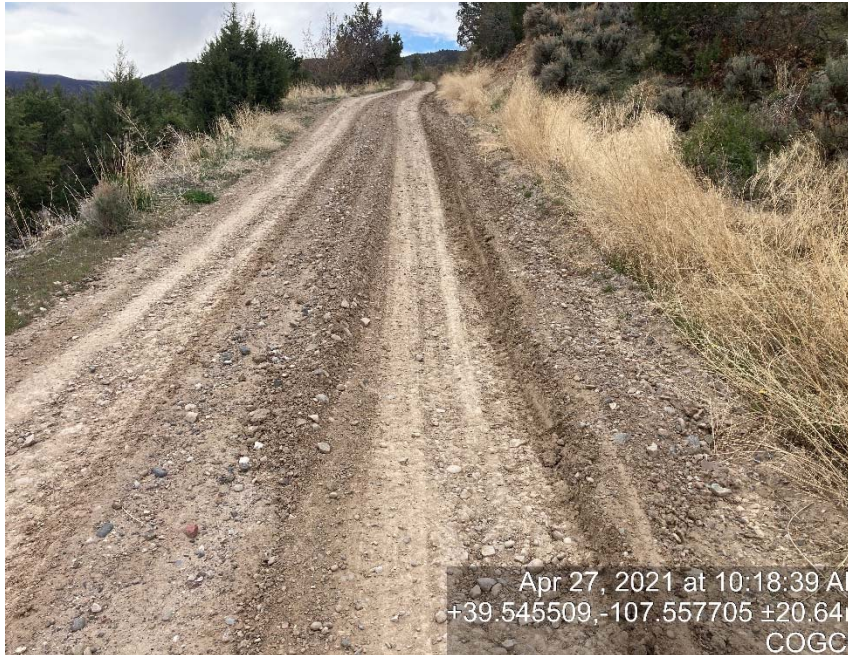
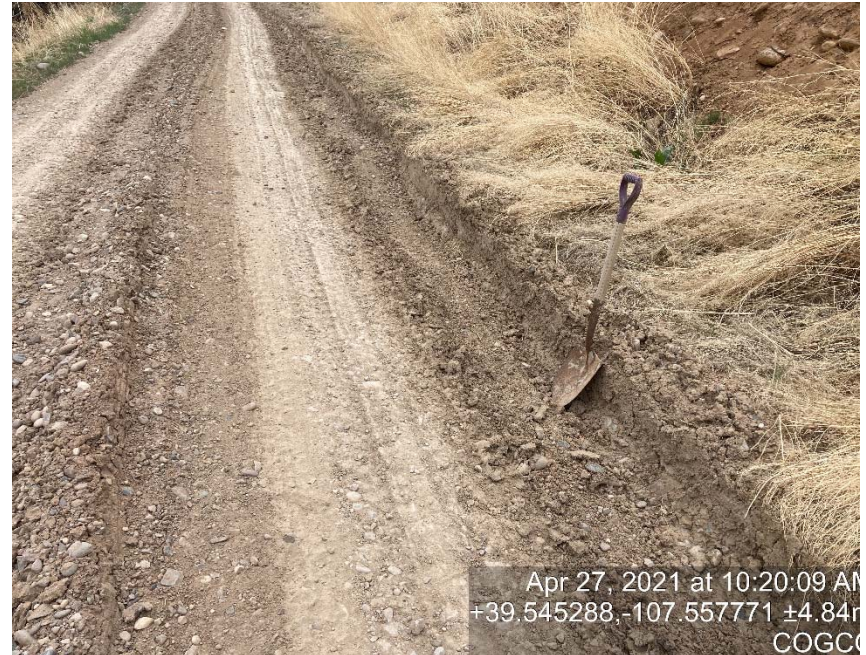
Lack of stabilization/compaction on access road

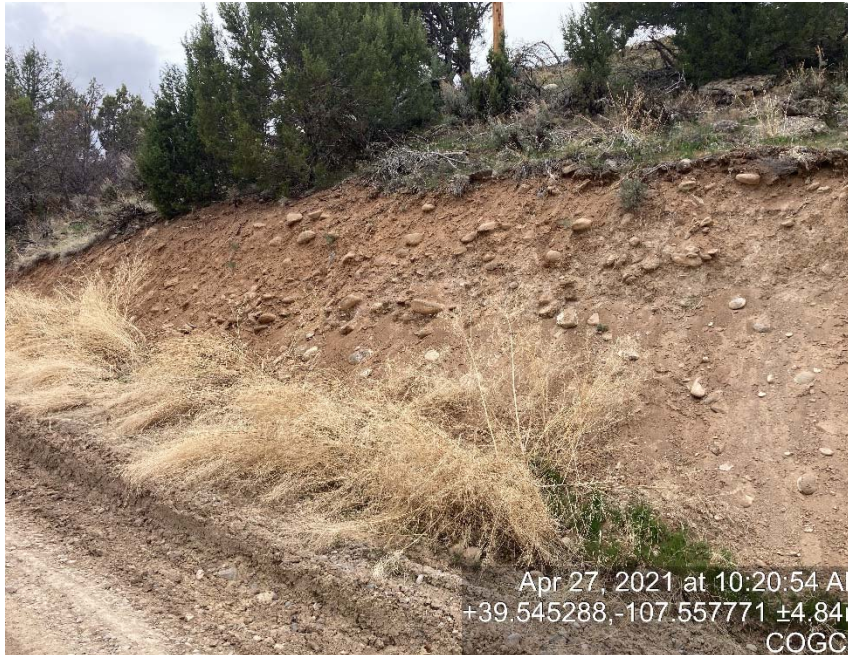
Cut slope on access road lacks stabilization

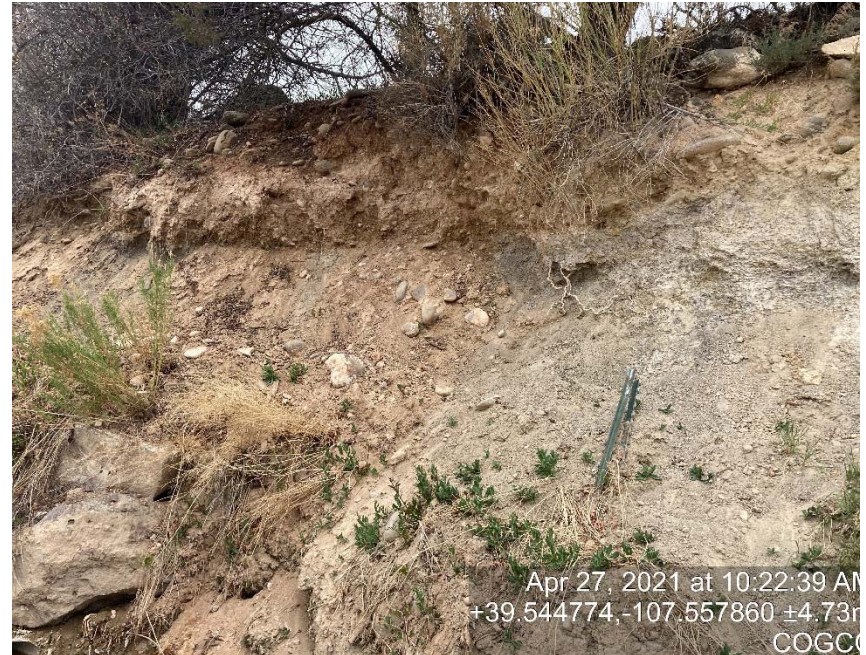
Cut slope on access road lacks stabilization. This photo is above culvert in next photos.

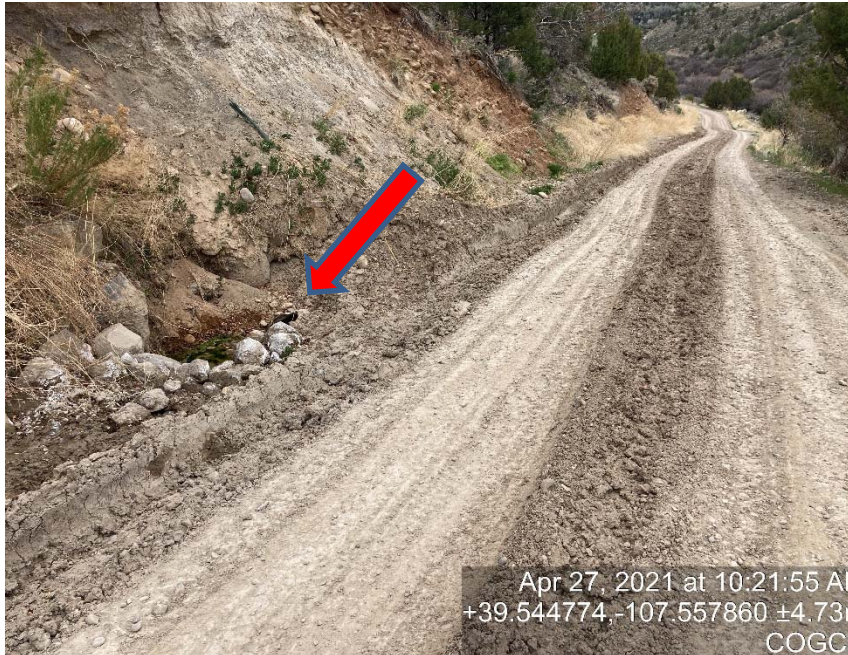
Inlet side of culvert on access road and lack of stabilization/compaction. Culvert is depicted by arrow

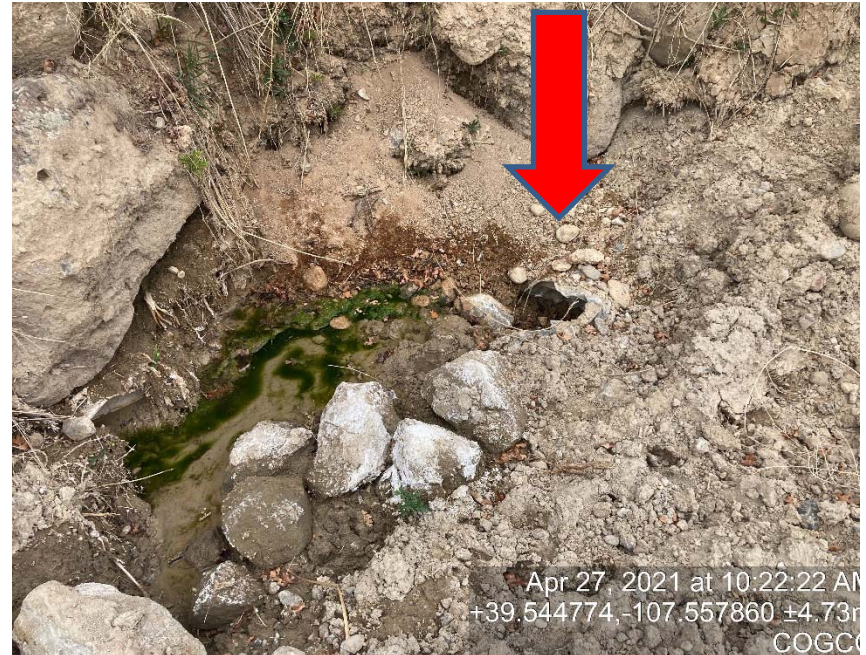
Inlet side of culvert on access road. Culvert is depicted by arrow

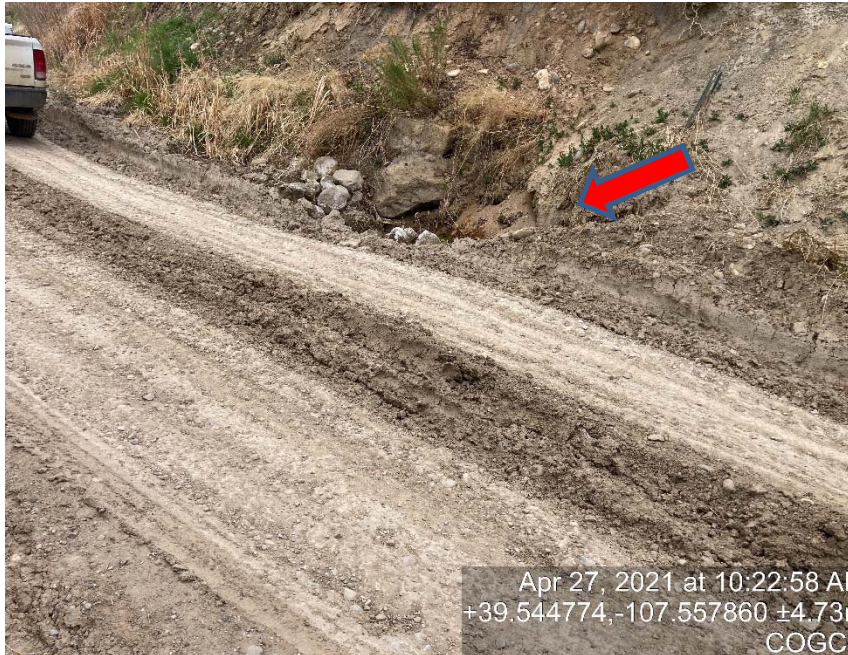
Inlet side of culvert on access road and lack of stabilization/compaction. Culvert is depicted by arrow

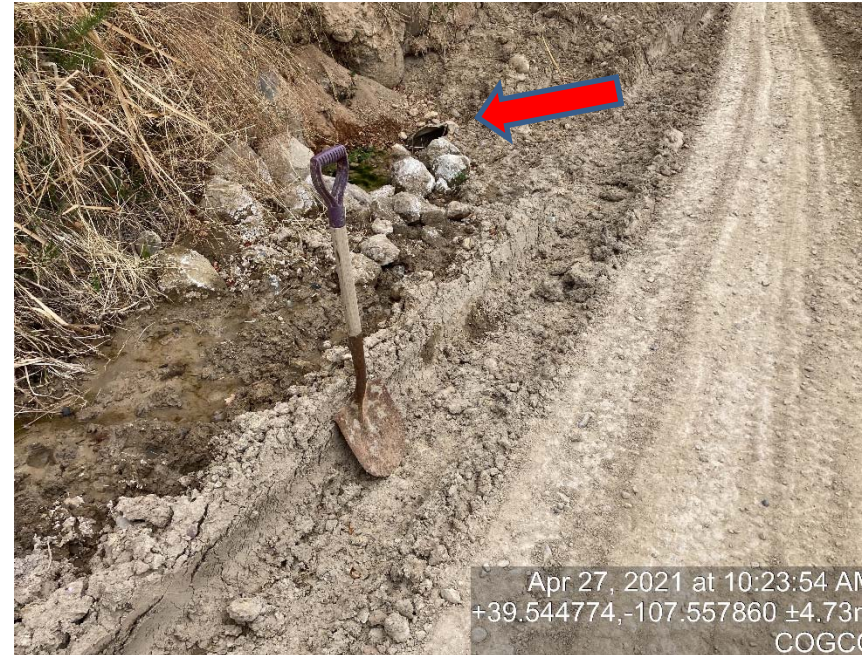
Inlet side of culvert on access road and lack of stabilization/compaction. Culvert is depicted by arrow

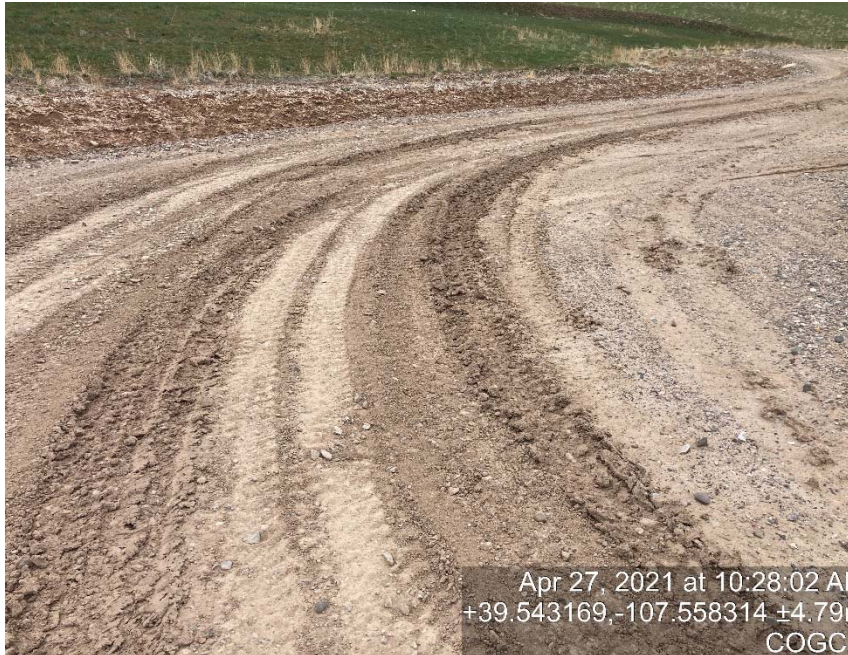
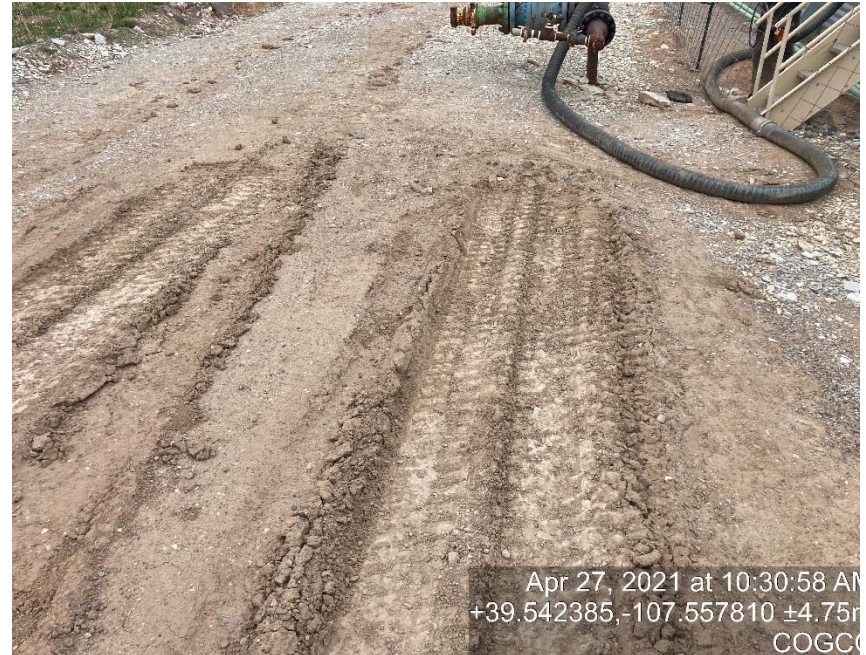
Lack of stabilization/compaction

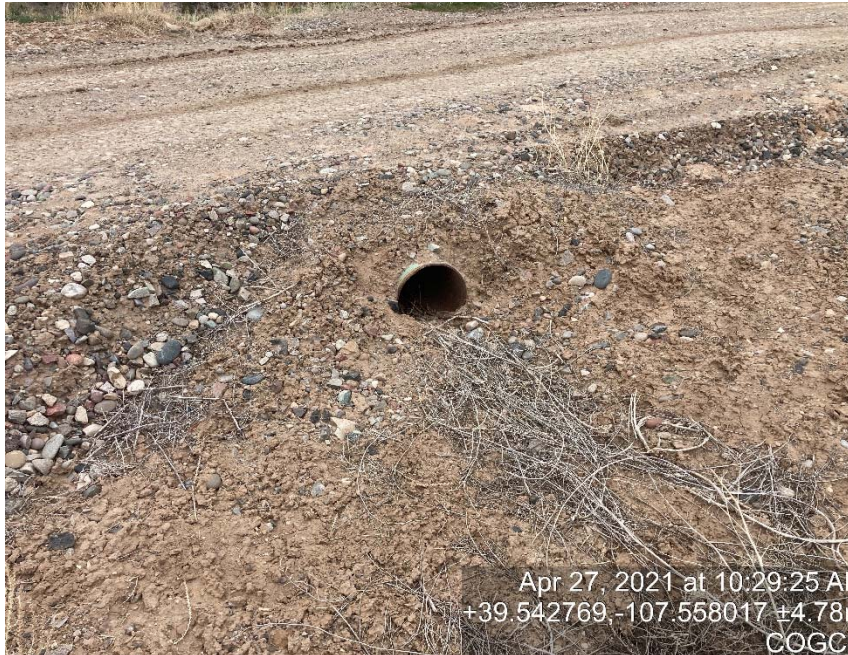
Inlet side of culvert on location

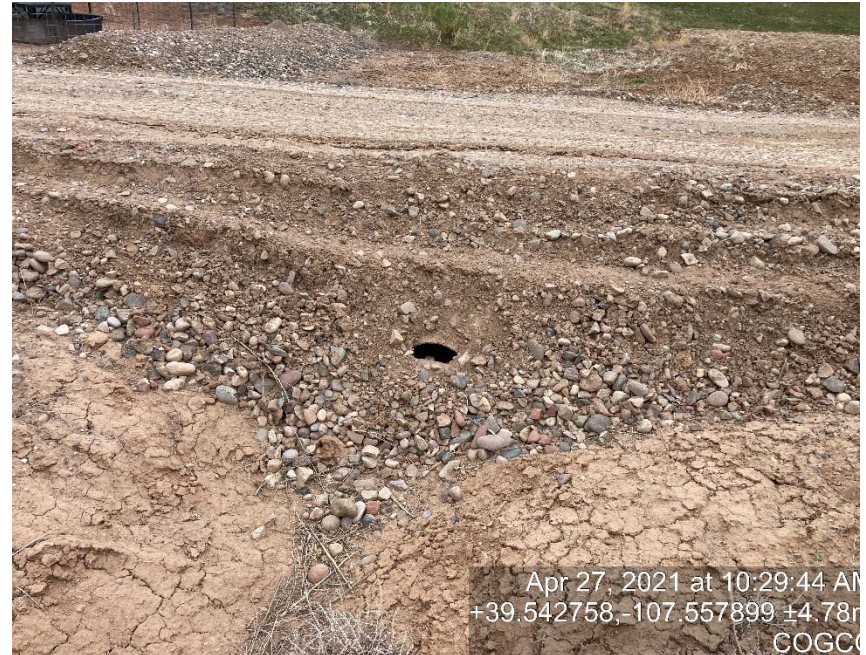
Outlet side of culvert on location

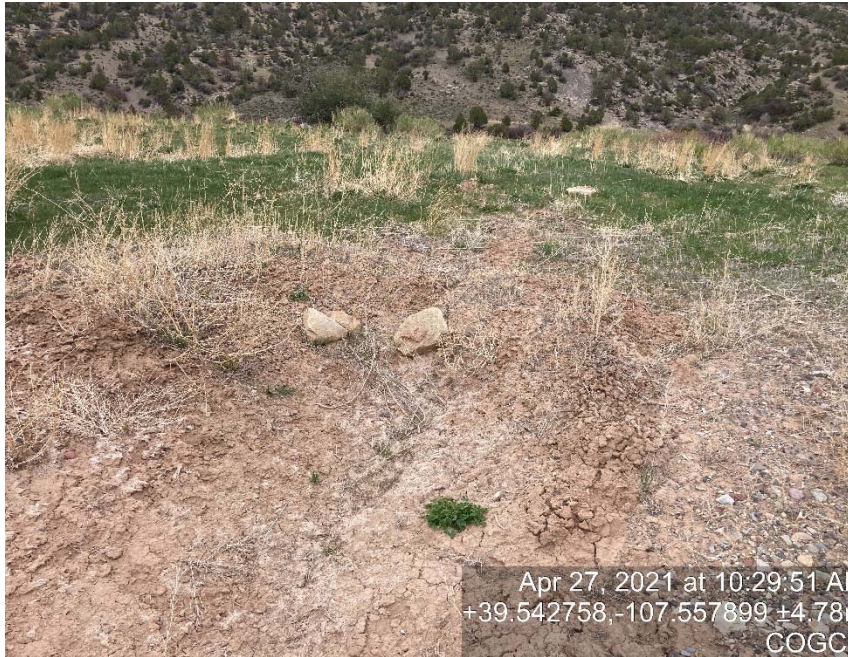
Sediment trap on outlet side of culvert on location
