TEP
KP 24-23
Location # 324439

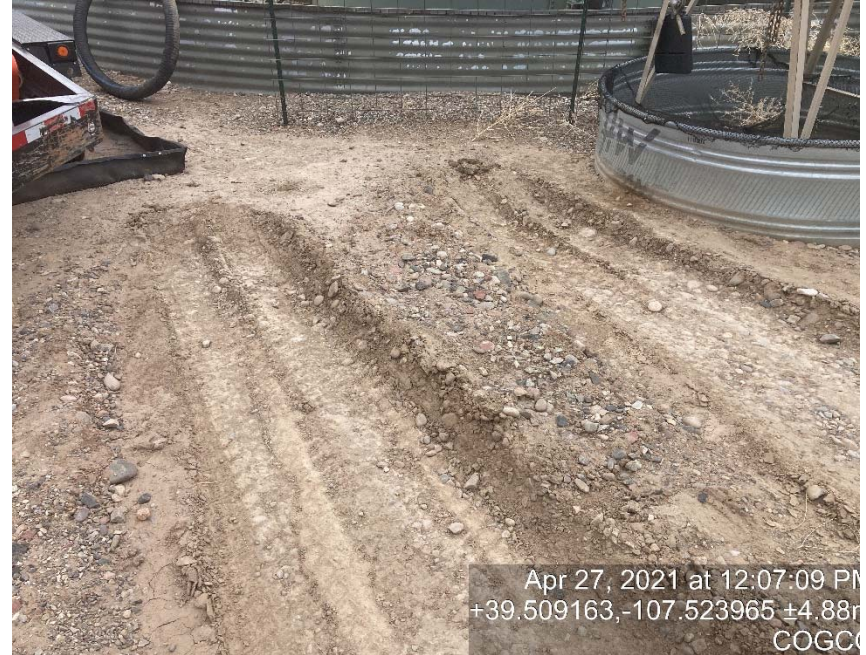
Lack of stabilization/compaction

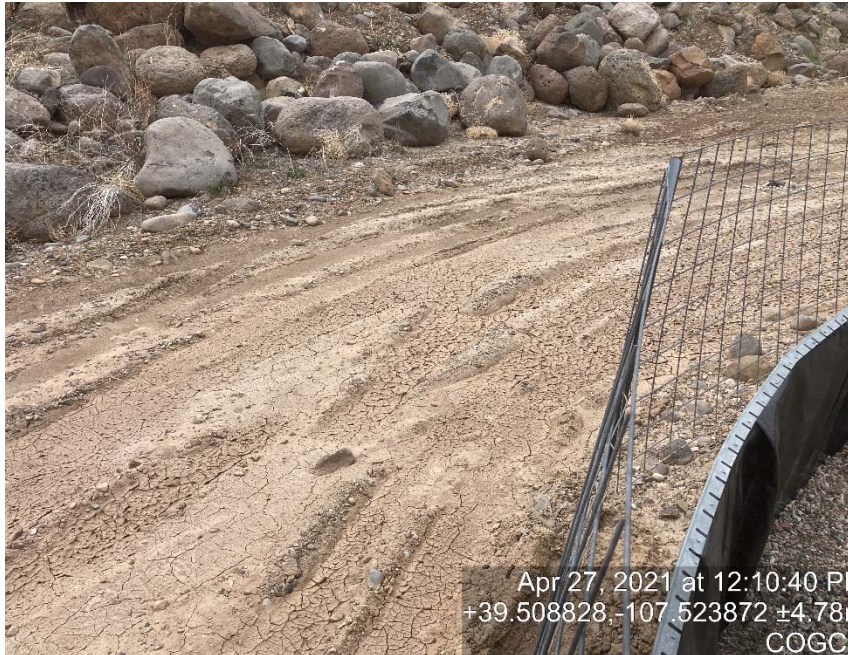
Lack of stabilization/compaction

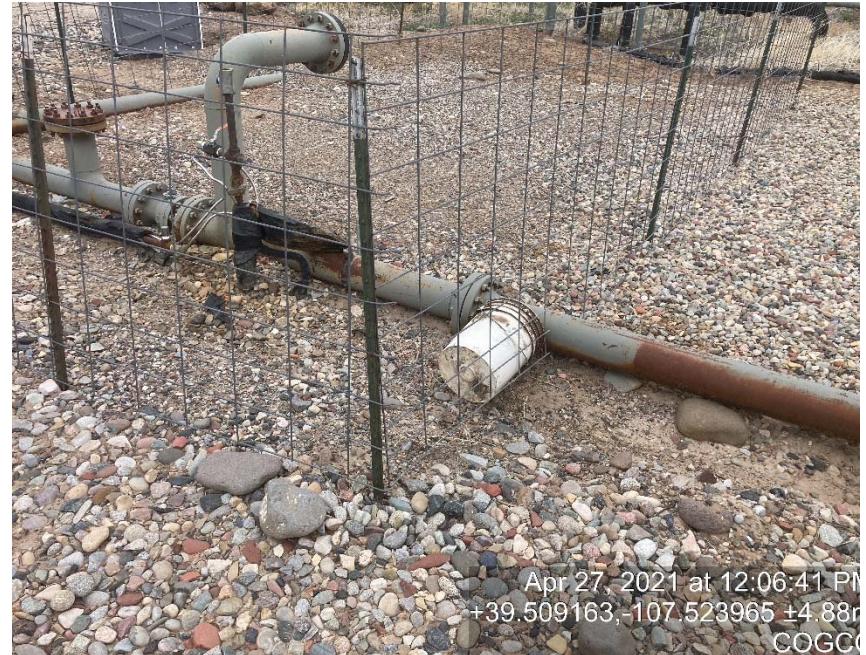
Debris

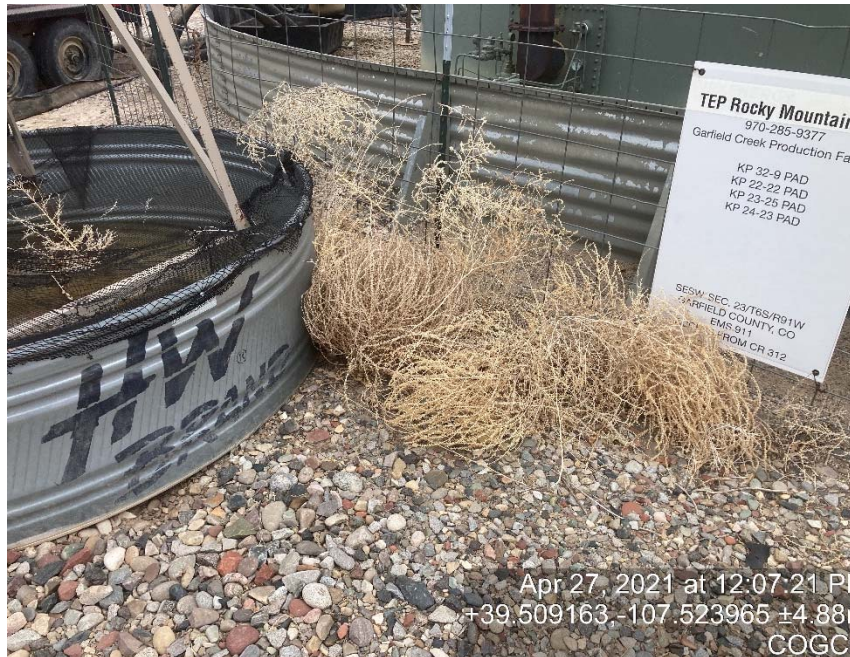
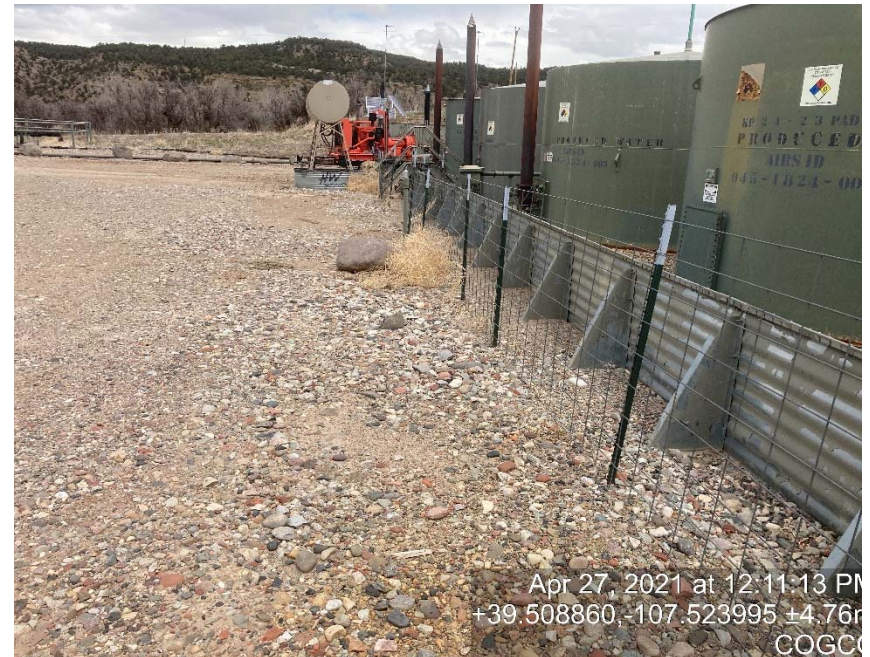
Debris

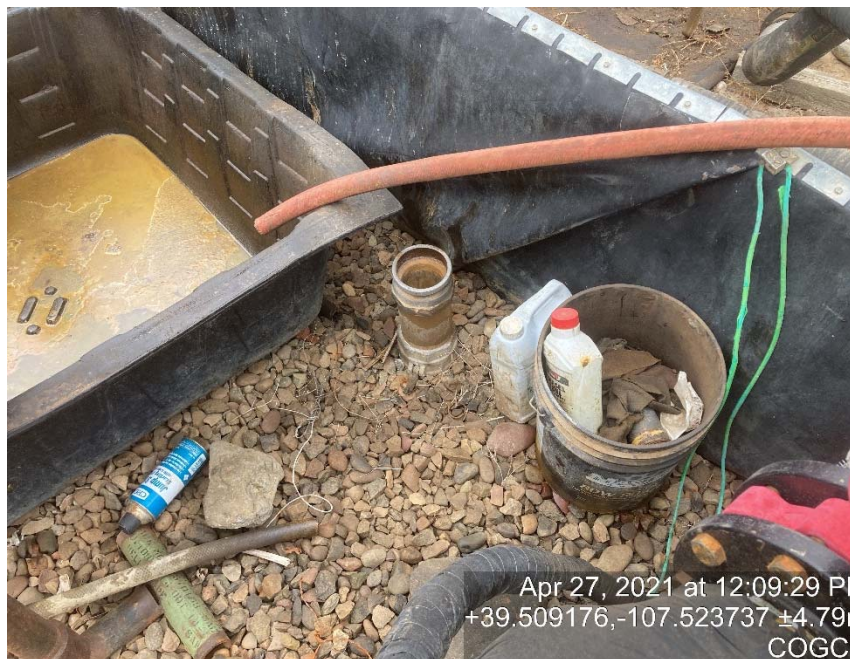
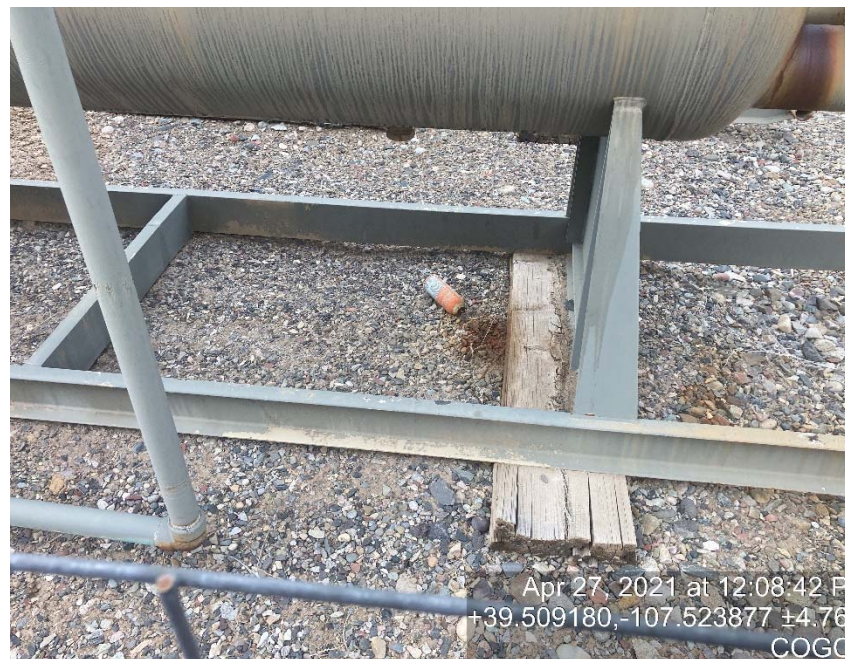
Debris

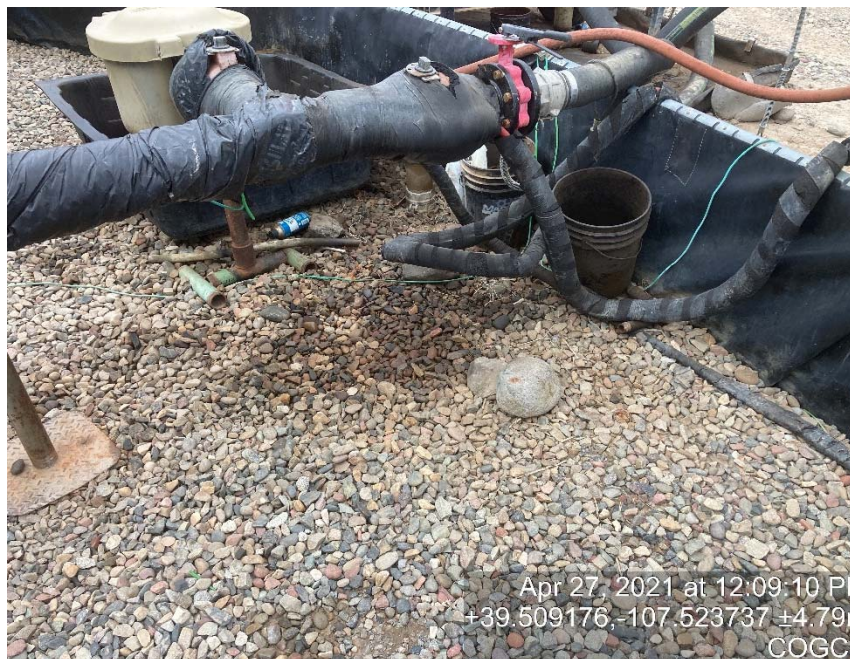
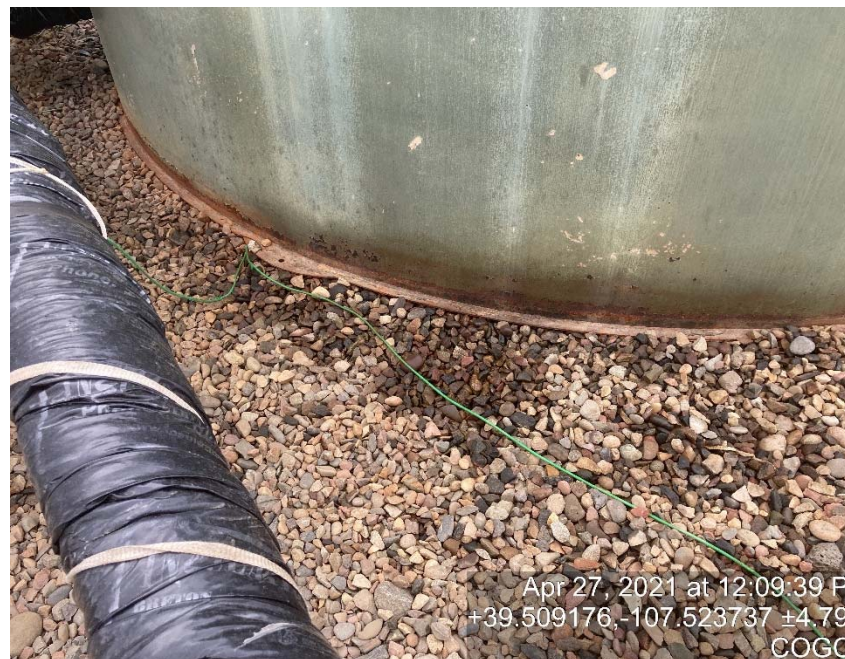
Staining

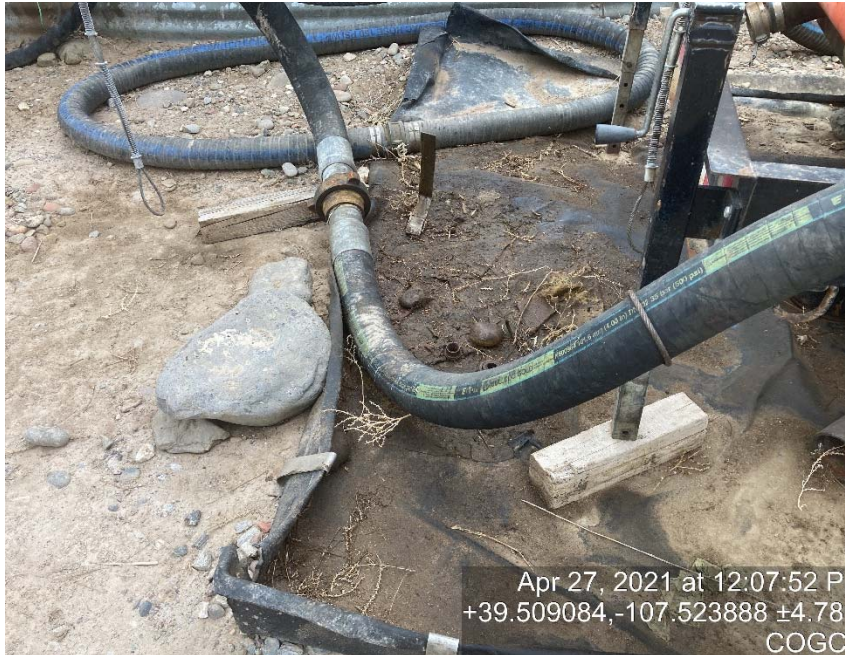
Staining and secondary containment failing
