**Inspection Photos (04/27/2021)**  
**Location Name: UPRR 43 Pan Am G Consolidation No. 2**  
**Remediation No. 16131 - Spill/Release ID 478086**

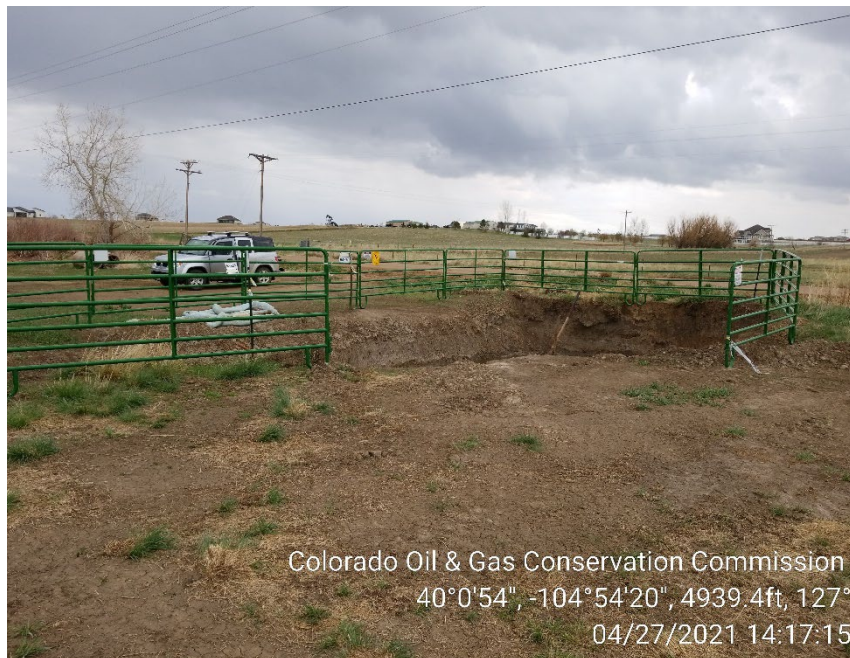
**Open excavation with a gap in steel panel fencing.**

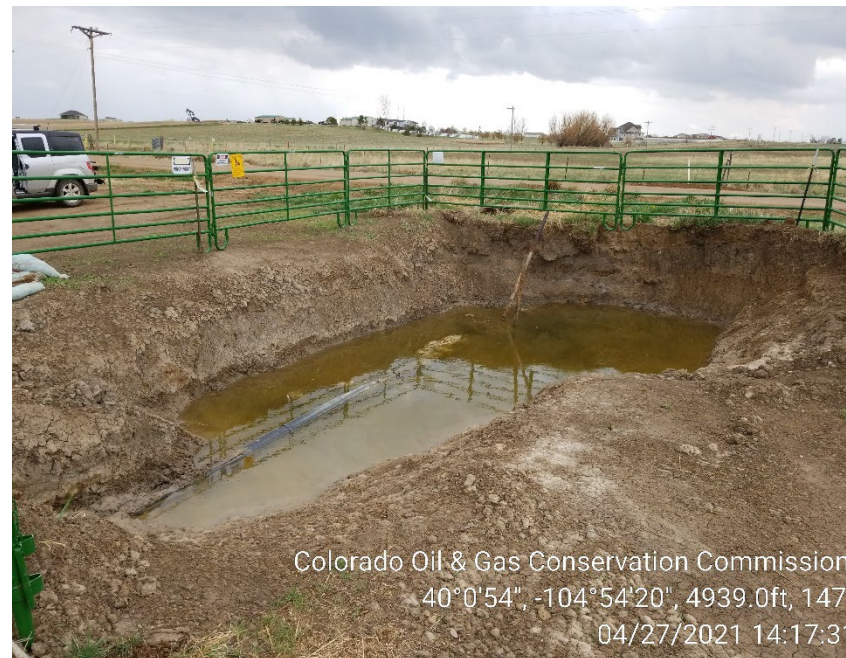
**Open excavation flooded with groundwater.  
Gap in steel panel fencing.**
