**Inspection Photos (04-27-2021)**  
**Location Name: Paul Heinze No. 1 Flowline**  
**Spill/Release ID 479232**

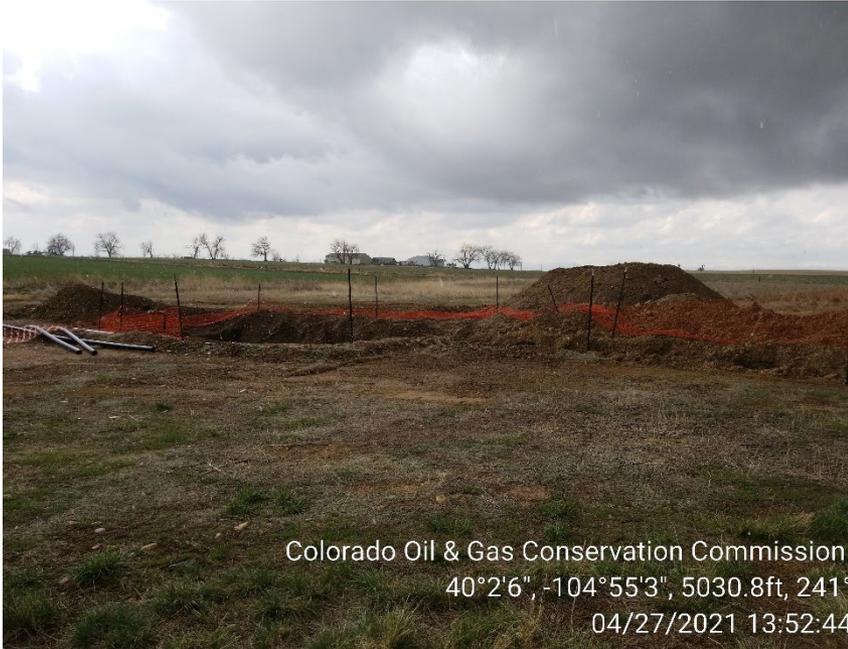
**Inadequate fencing around open excavation**

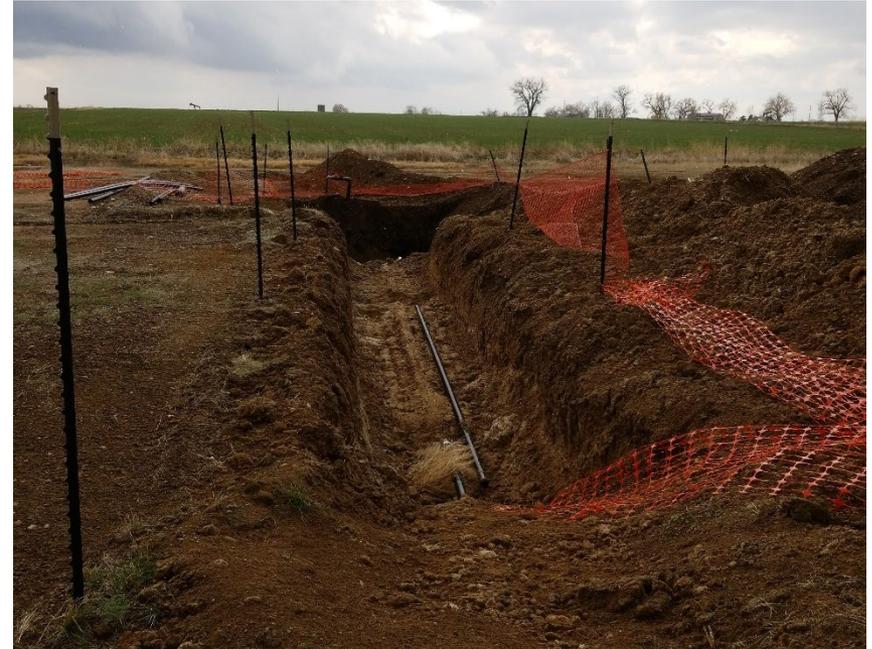
**Inadequate Fencing & storm water BMPs**

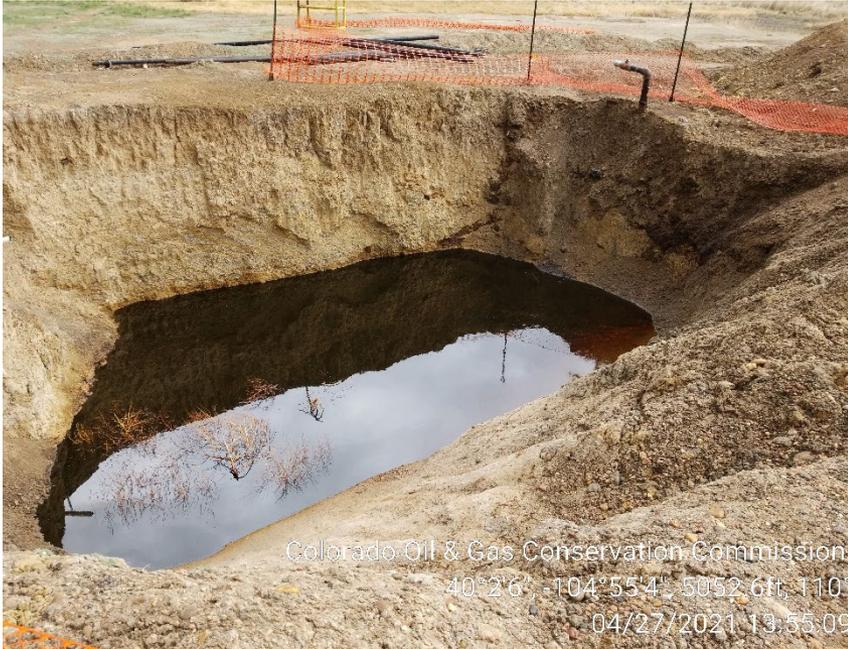
**Open excavation flooded with groundwater**

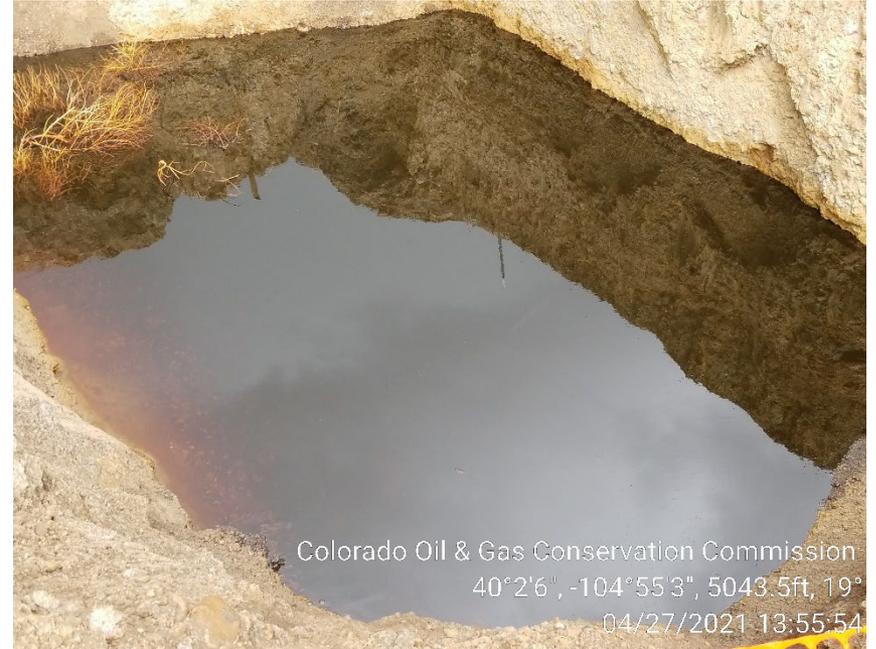
**Oil floating on groundwater in the excavation**

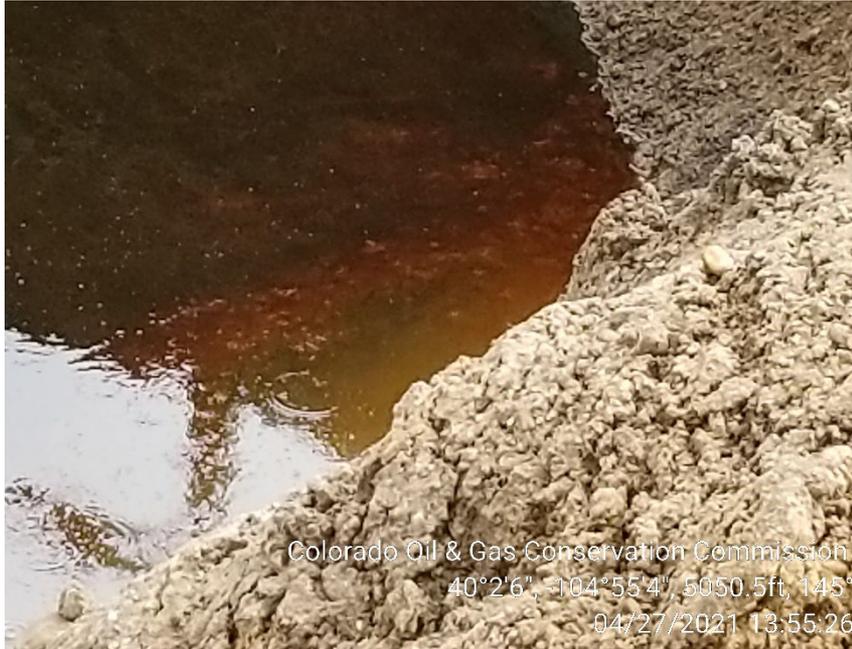
**Close up of oil floating on groundwater in the excavation**
