Inspection Photos
Location Name: James S Haley Trustee B #2 Flowline
Spill ID 478014 Remediation #16137

Inspection Photos
Location Name: Peltier #2 Flowline
Spill ID 478542

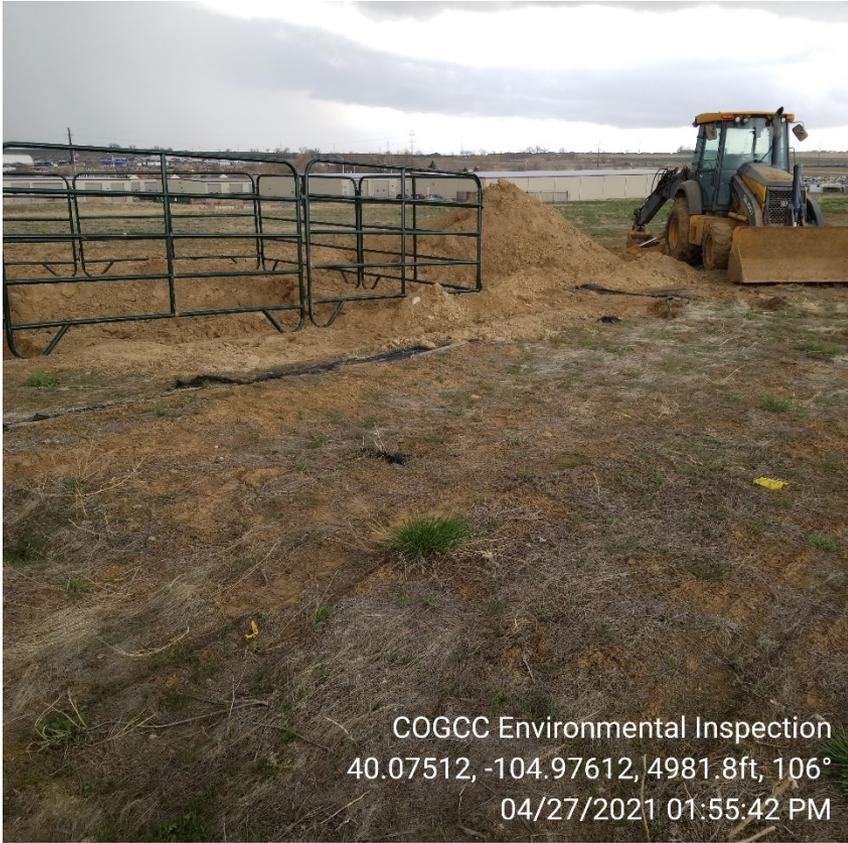
Photo 1 – Excavation Fencing and stockpiles.

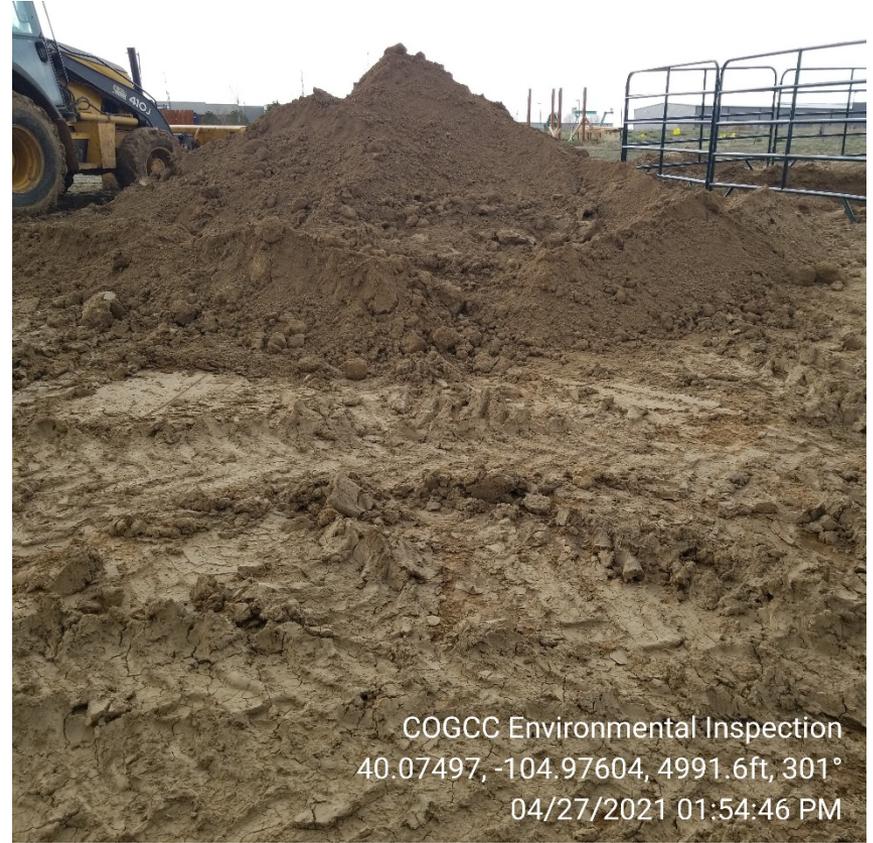
Photo 2 – Impacted soils stockpile; stormwater BMP's not correctly constructed and will channel runoff.

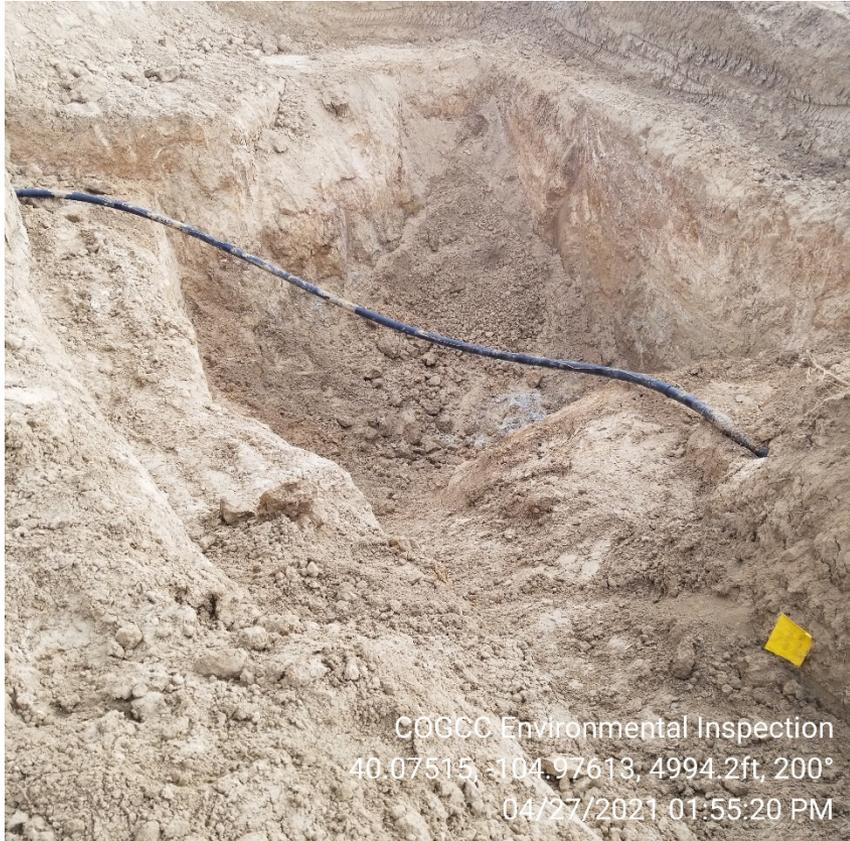
Photo 3 – Flowline visible in excavation, impacted soils visible.

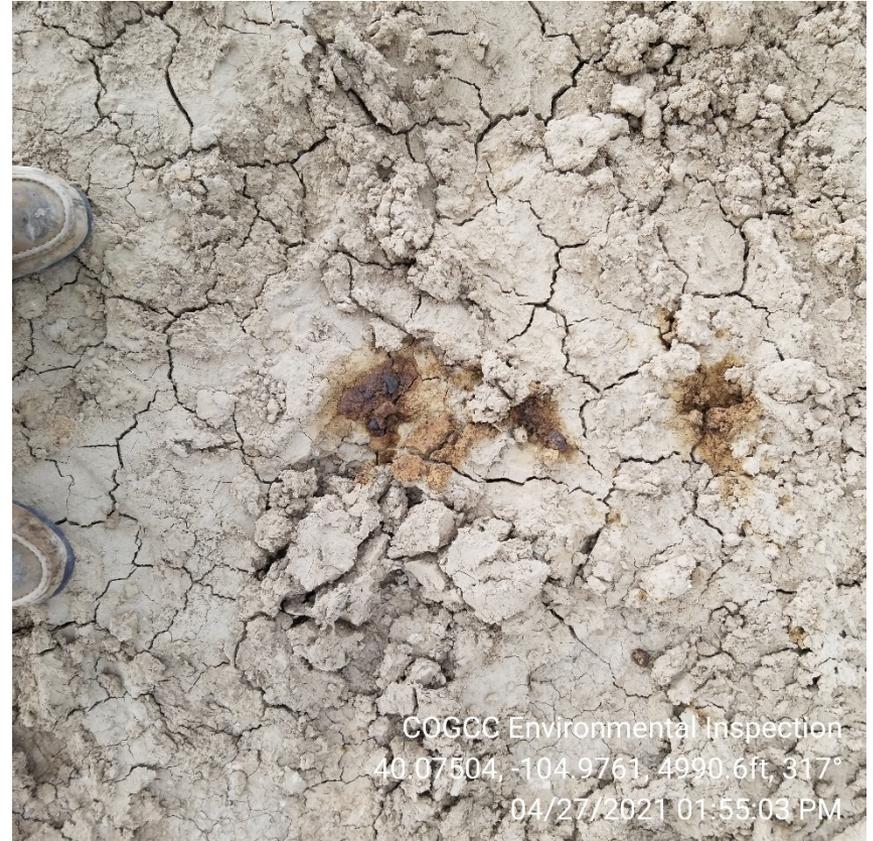
Photo 4 – Leaking oil from excavation equipment.

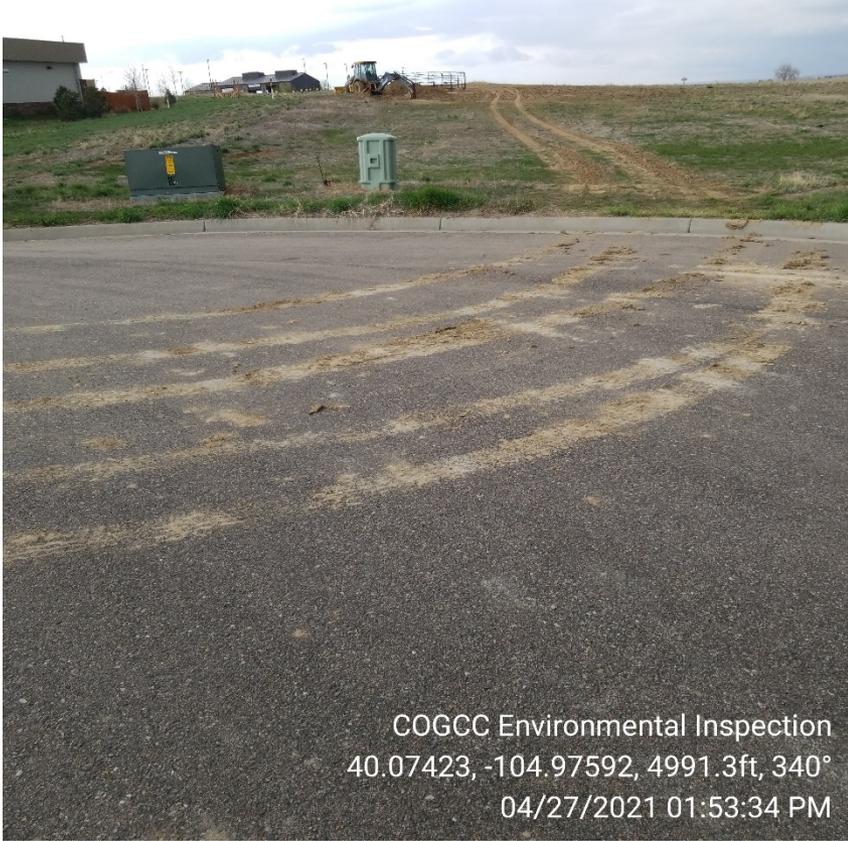
Photo 5 – Mud tracked from location onto public maintained road.
