Inspection Photos
Location Name: Cosslet A 9 Flowline
Spill ID 478542

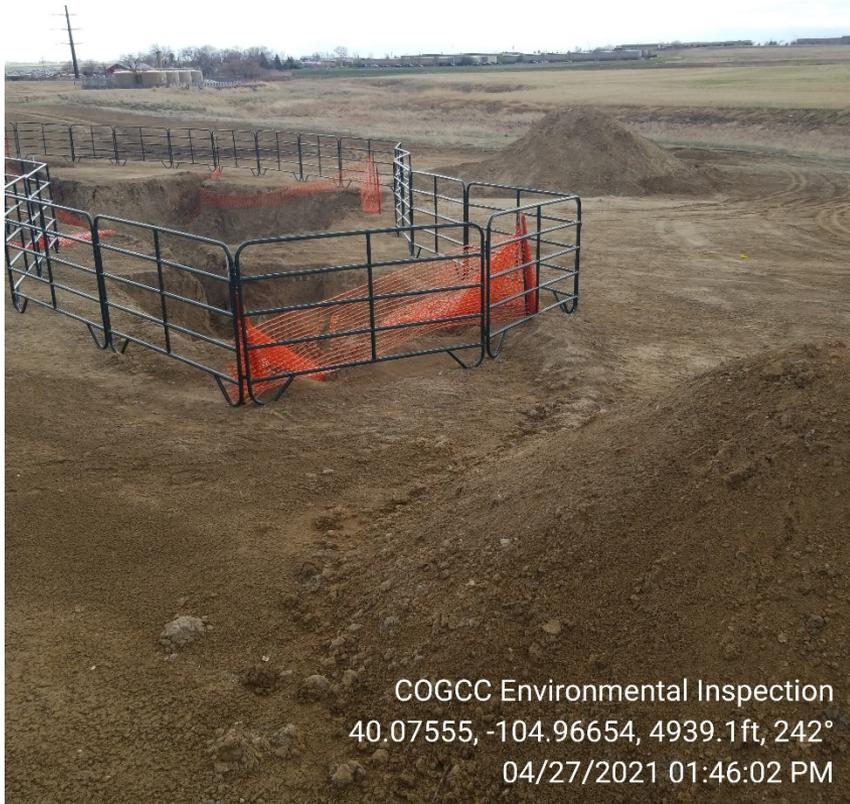
Photo 1 – Location photo; impacted soils and trash remain on location.

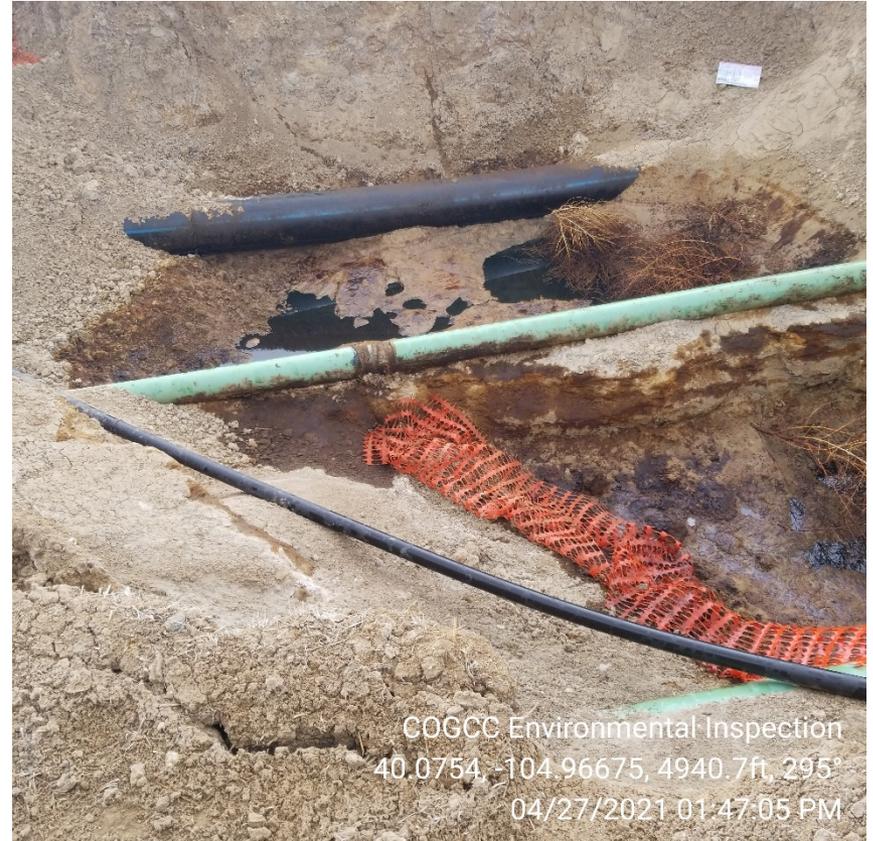
Photo 2 – Free product remains in excavation; depth to groundwater has been gradually lowering (naturally).
