Inspection Photos
Operator: Dugan Production
API: 067-06494
Date: 4/22/2021

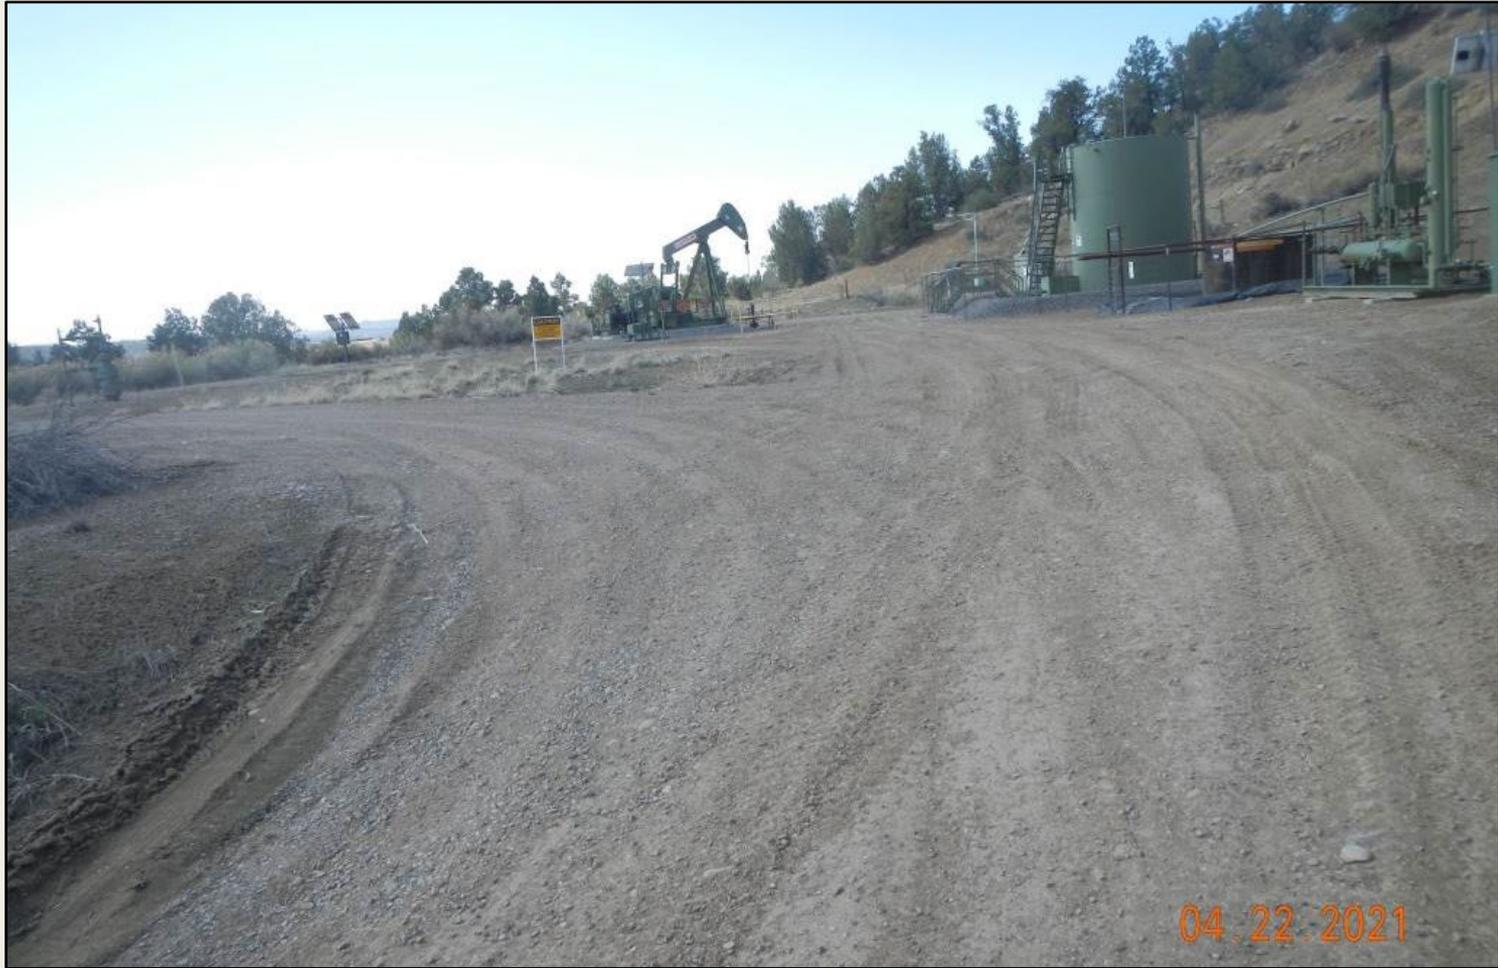
Photo 1. View of the project area from the well pad entrance facing center.

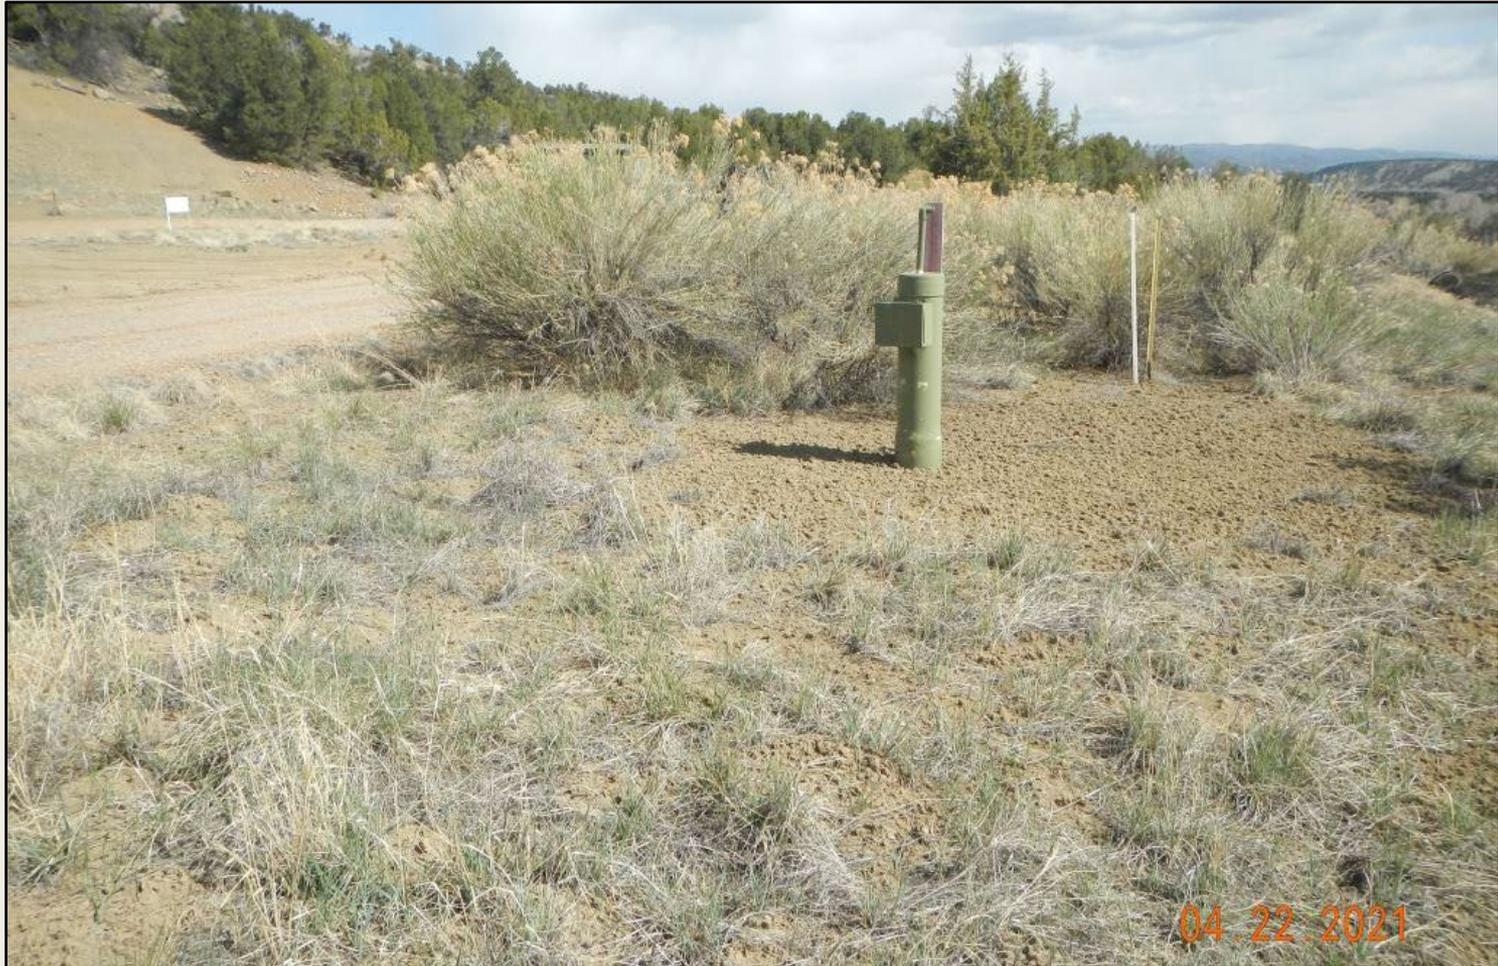
Photo 2. View of the eastern fill slope from the southeastern corner facing northward. Revegetation appears to be progressing with sand dropseed, Indian ricegrass, western wheatgrass, and rubber rabbitbrush.

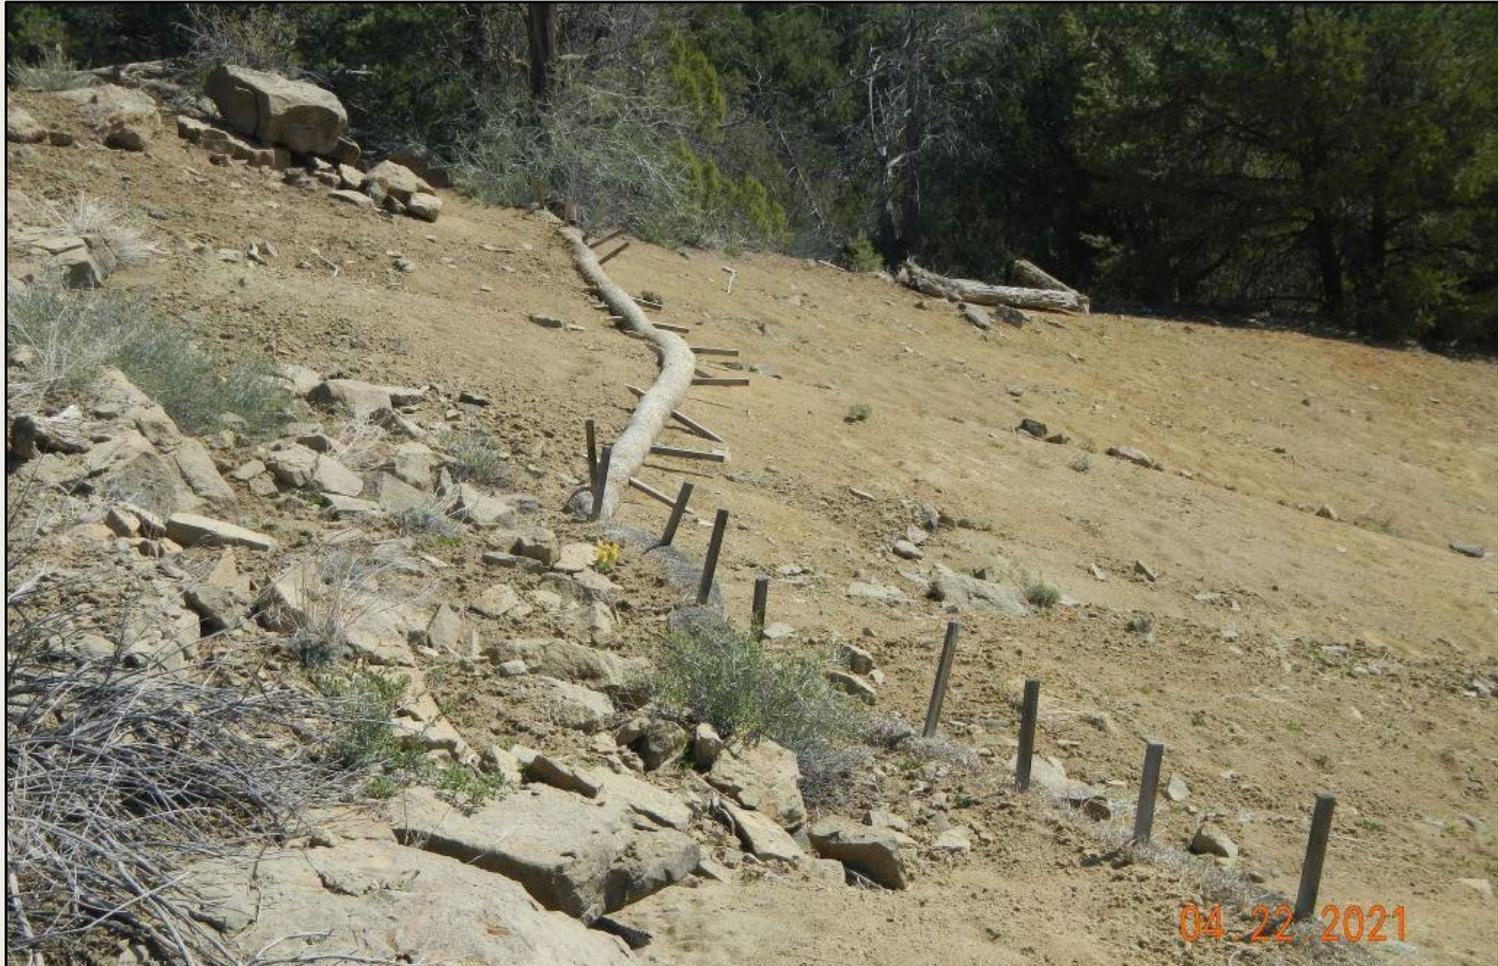
Photo 3. View of wattles at the top of the eastern cut-slope that need maintenance.

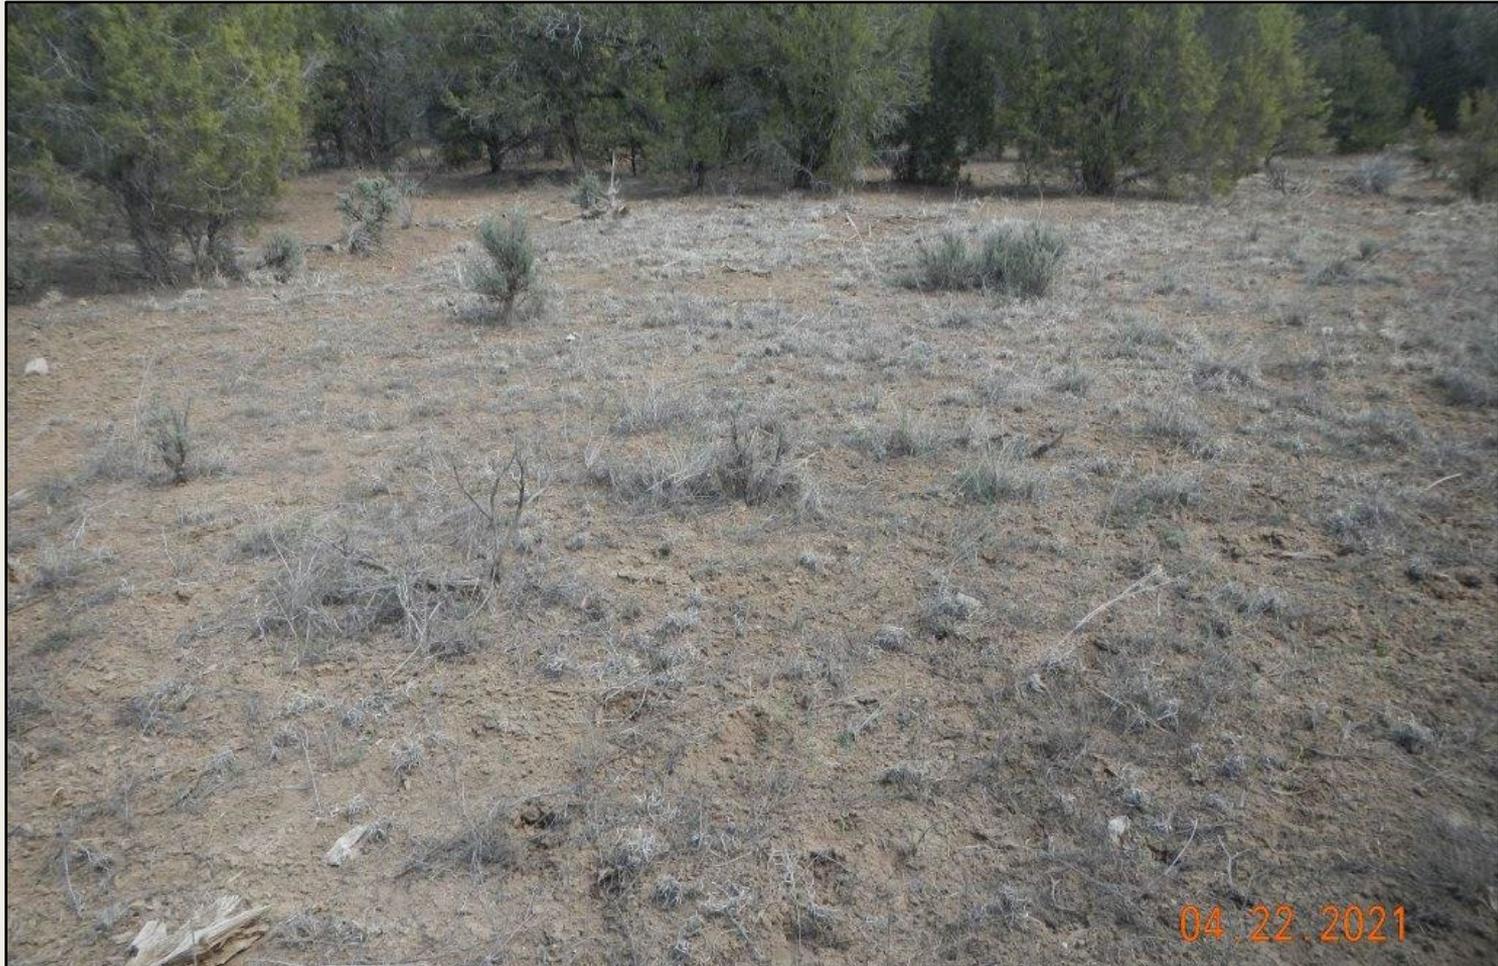
Photo 5. View of reference area comprised of pinyon and juniper woodland with sagebrush shrubland, blue grama, Indian ricegrass, and mat penstemon.
