Inspection Photos
UPRR 43 PAN AM G Consolidation #2
Remediation Project #16131/Spill ID 478086 (CL)

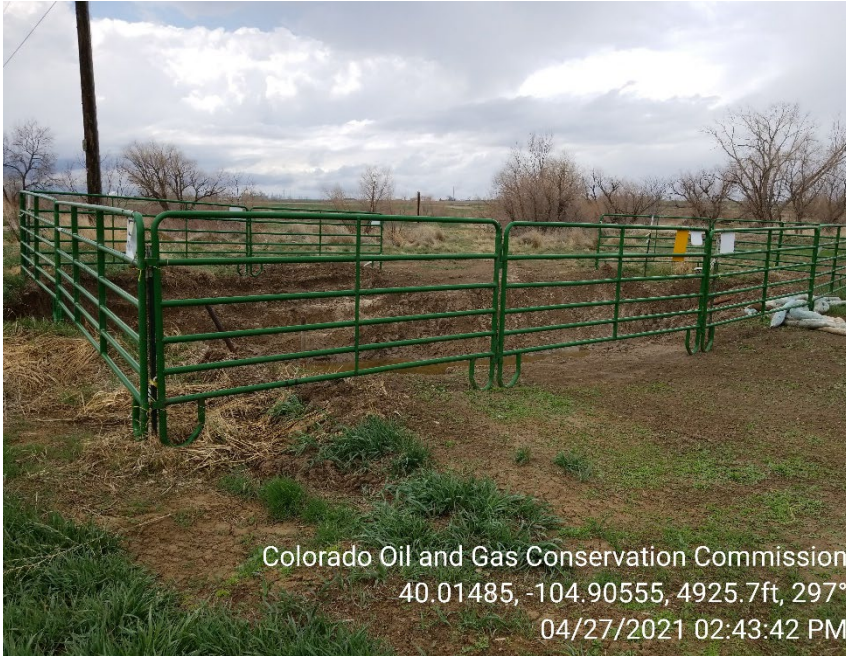
Photo 1 – Spill area with open excavation.

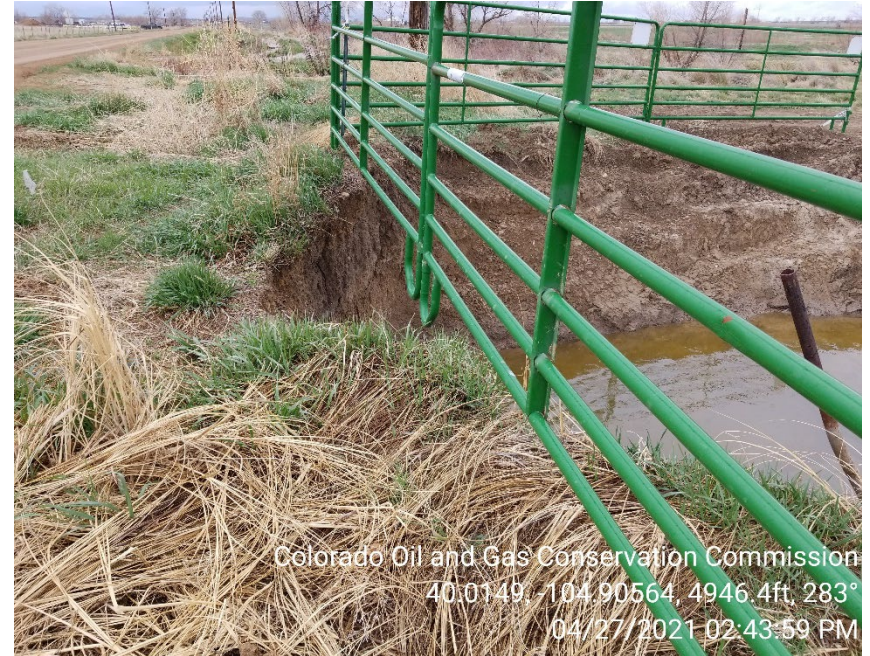
Photo 2 – Fencing around open excavation does not adequately protect access to the site.

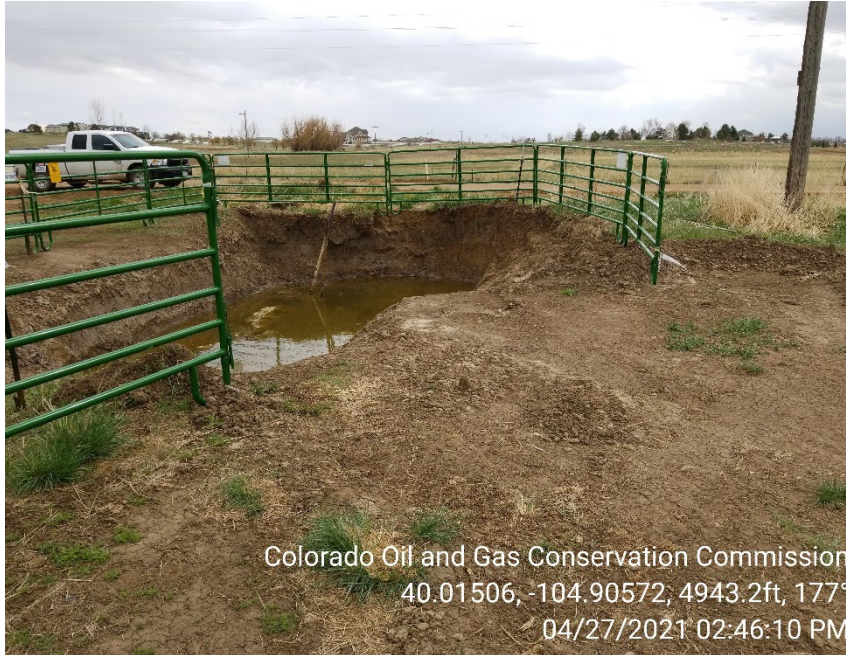
Photo 3 – Fencing around open excavation does not adequately protect access to the site.

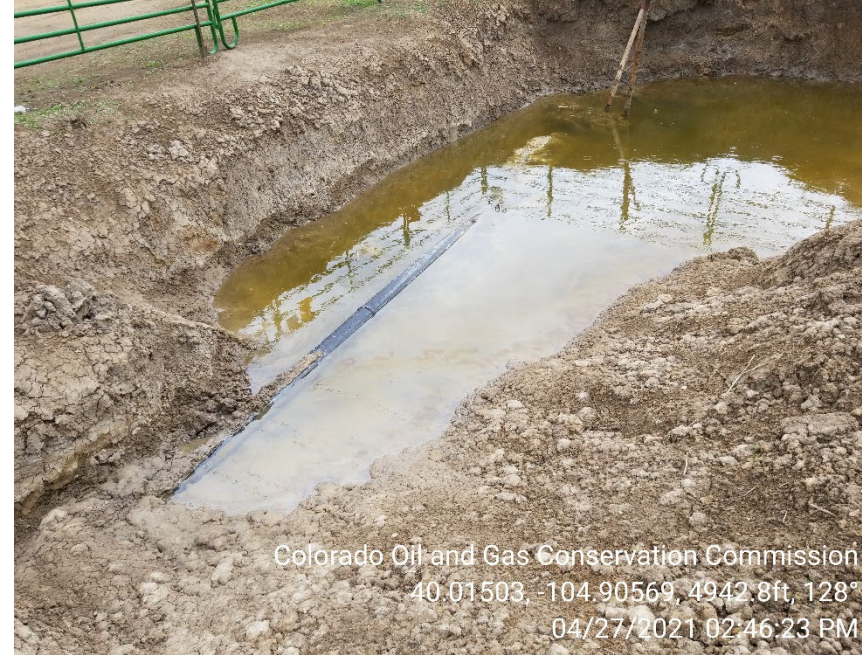
Photo 4 – Open excavation. Hydrocarbon sheen observed on groundwater.

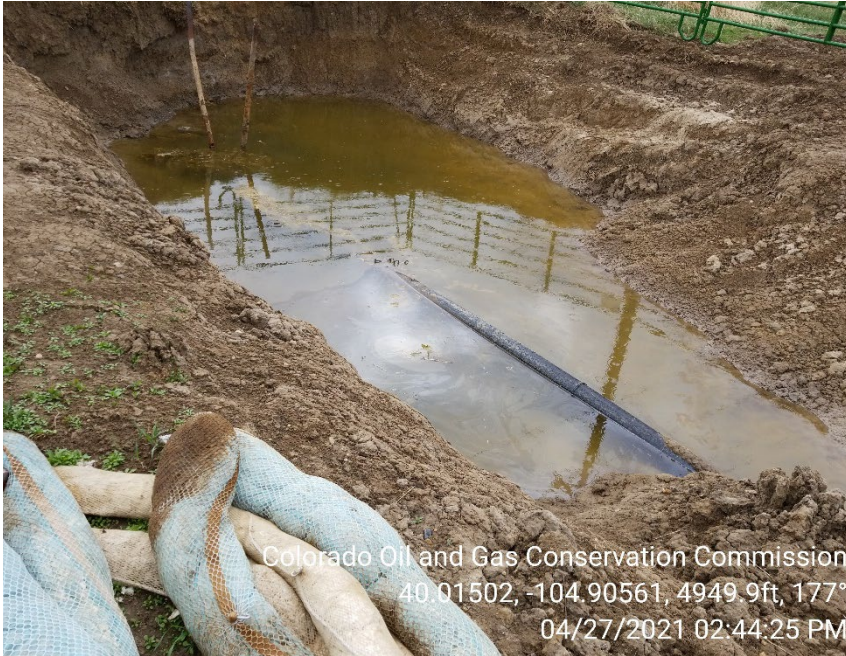
Photo 5 –Open excavation. Hydrocarbon sheen observed on groundwater.

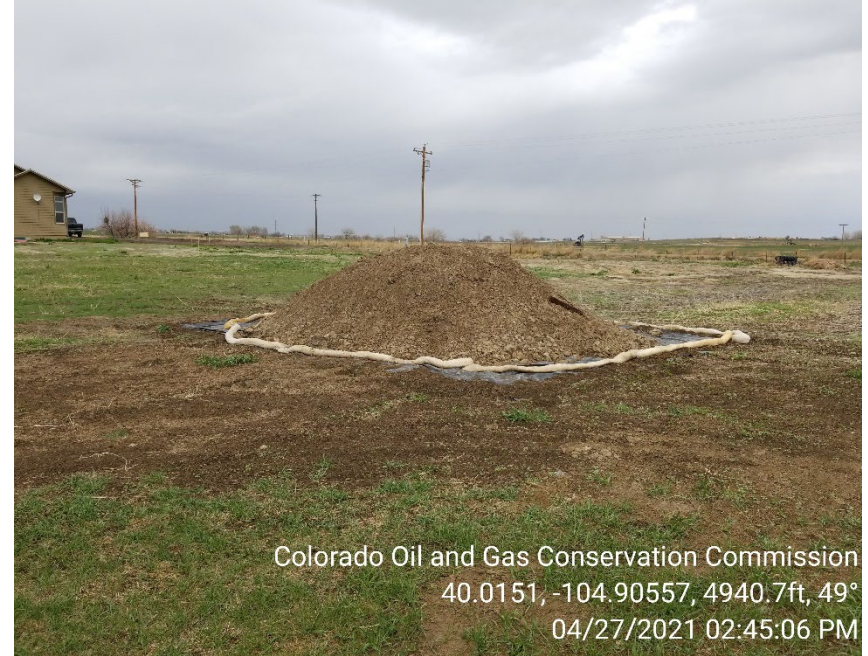
Photo 6 – Soil stored on location. Lining present under soil stockpile but BMPs are inadequate to prevent stormwater runoff.

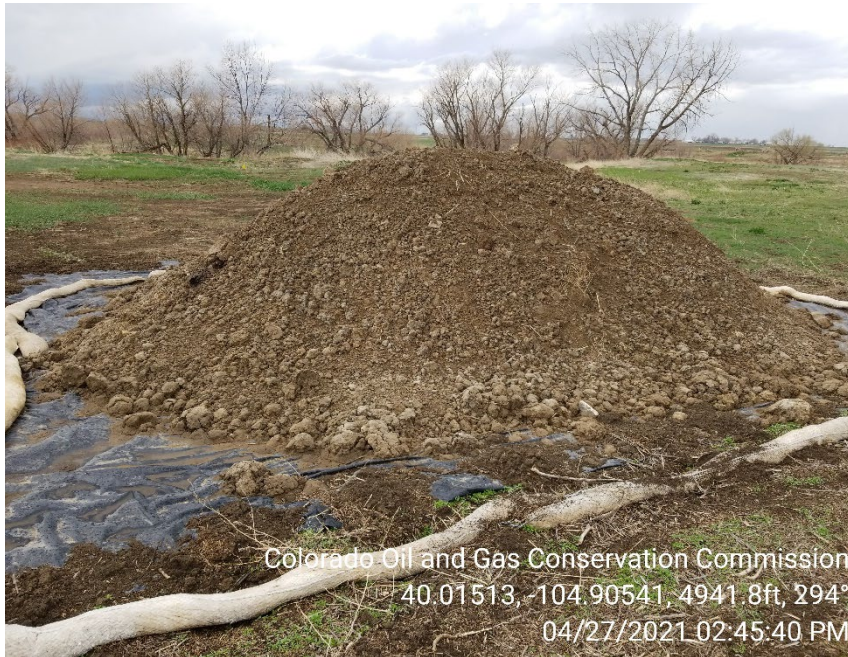
Photo 7 – BMPs are inadequate around soils stockpile.

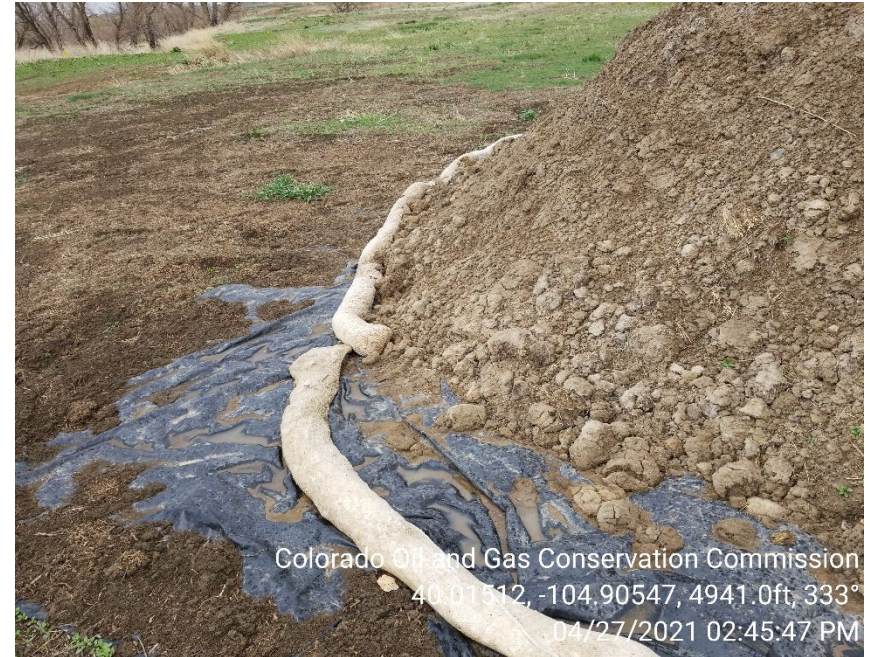
Photo 8 – BMPs are inadequate around soils stockpile.

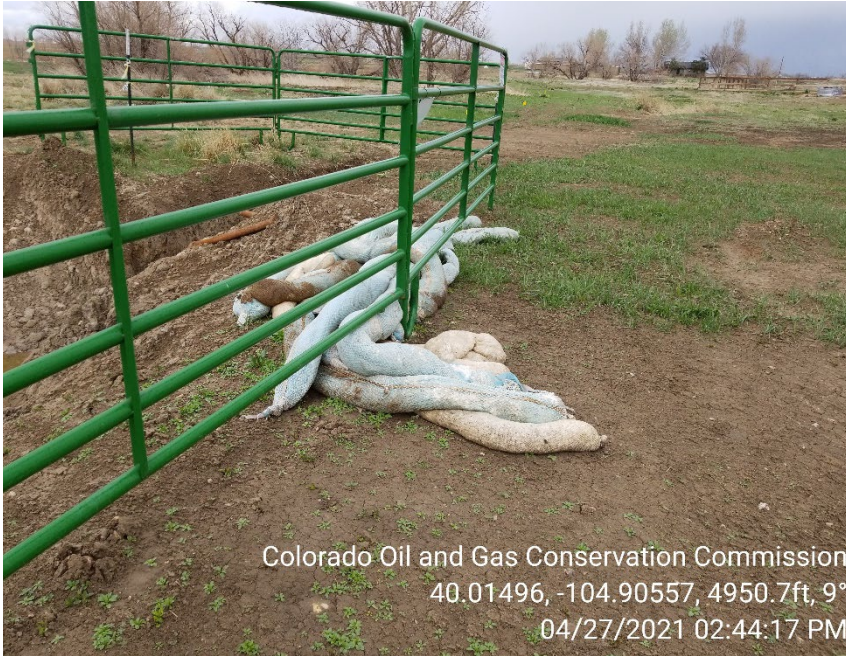
Photo 9 – Trash on location.

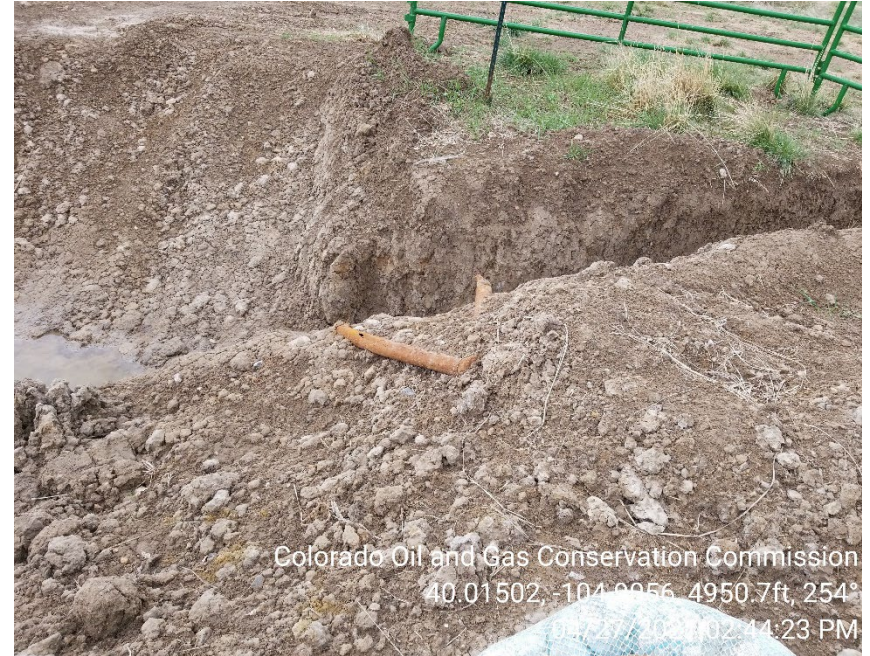
Photo 10 – Trash on location.
