Inspection Photos
KIEFER GEORGE W UT B #1A
Spill ID 479618 (AC)

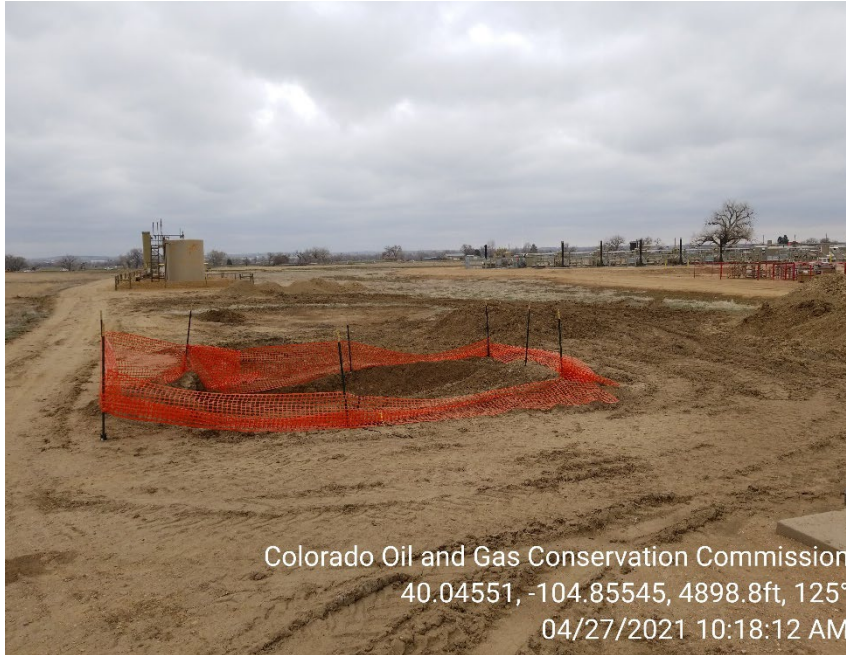
Photo 1 – Spill area. Fencing down around open excavation.

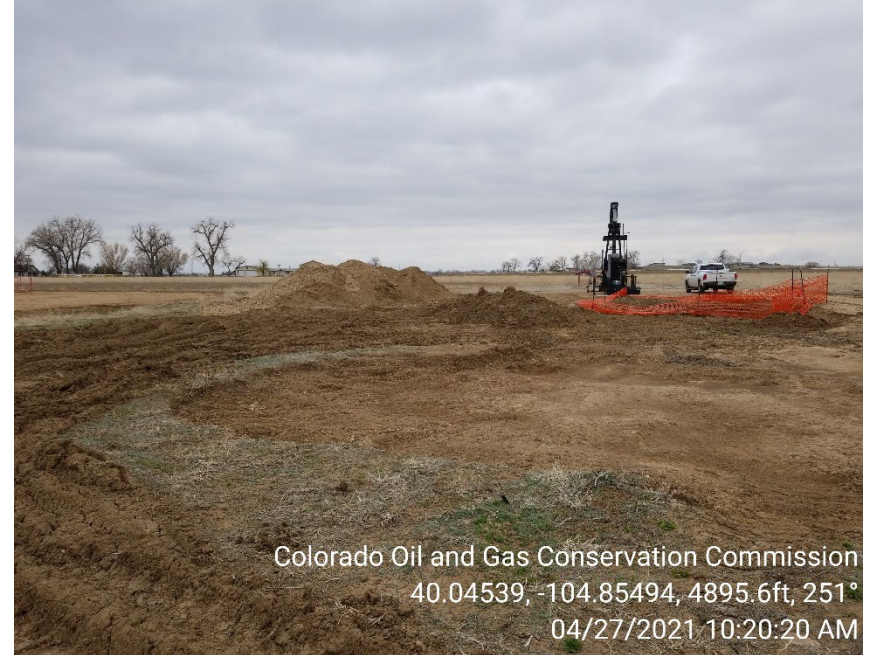
Photo 2 – Spill area. Area of surface scraping/disturbance extends east of open excavation.

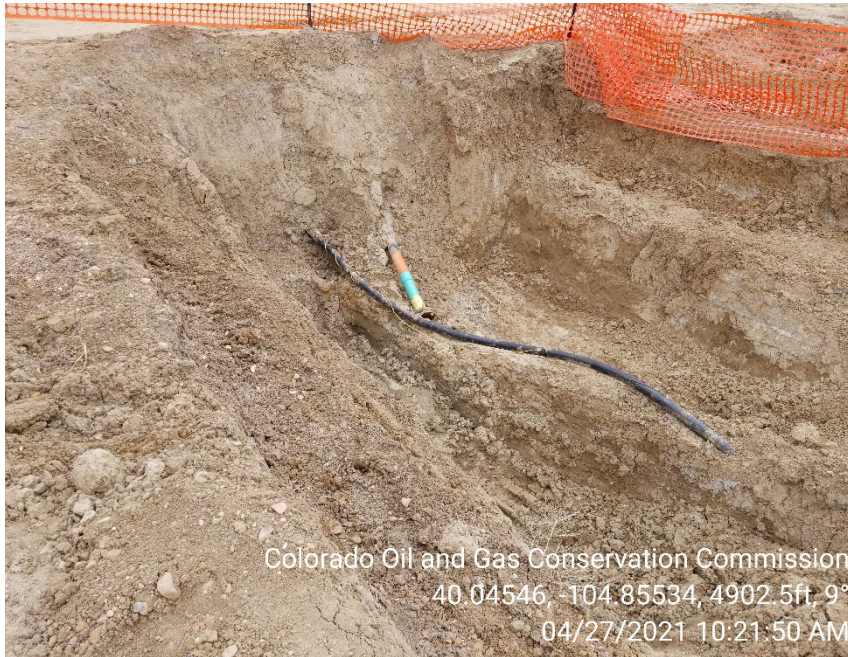
Photo 3 – Open excavation.

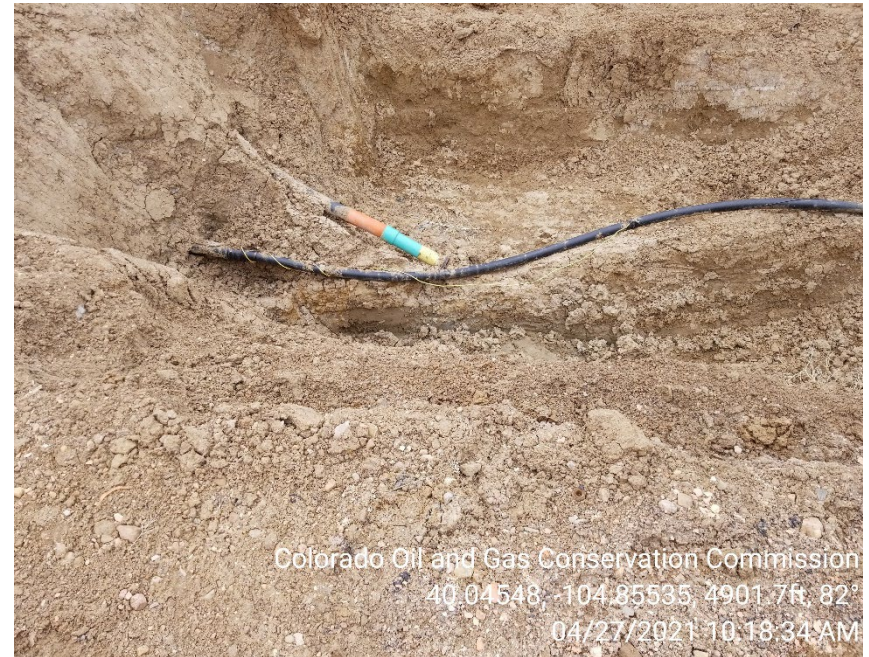
Photo 4 – Open excavation. Impacts appear to remain in situ below flowline repair.

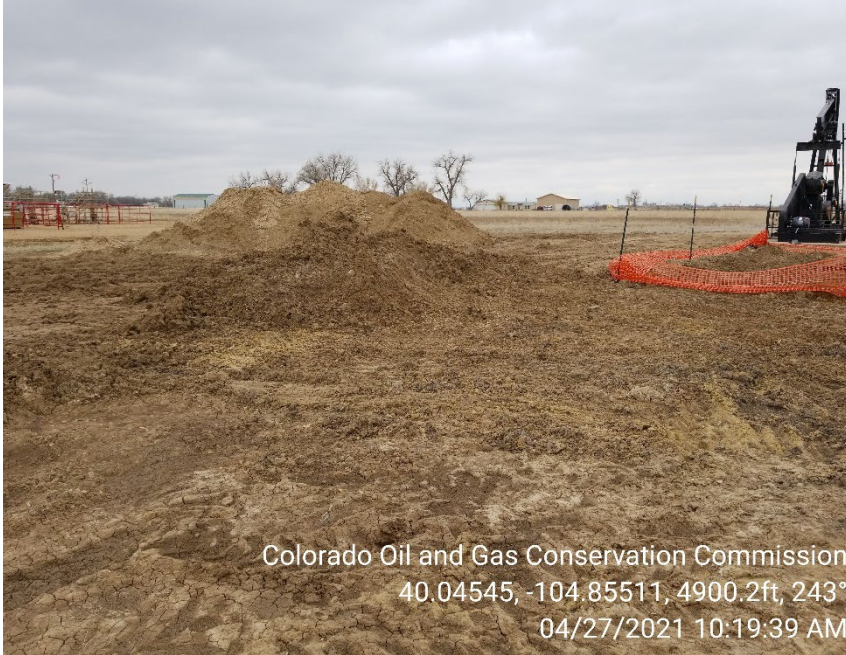
Photo 5 – Soil stored on location with inadequate BMPs.

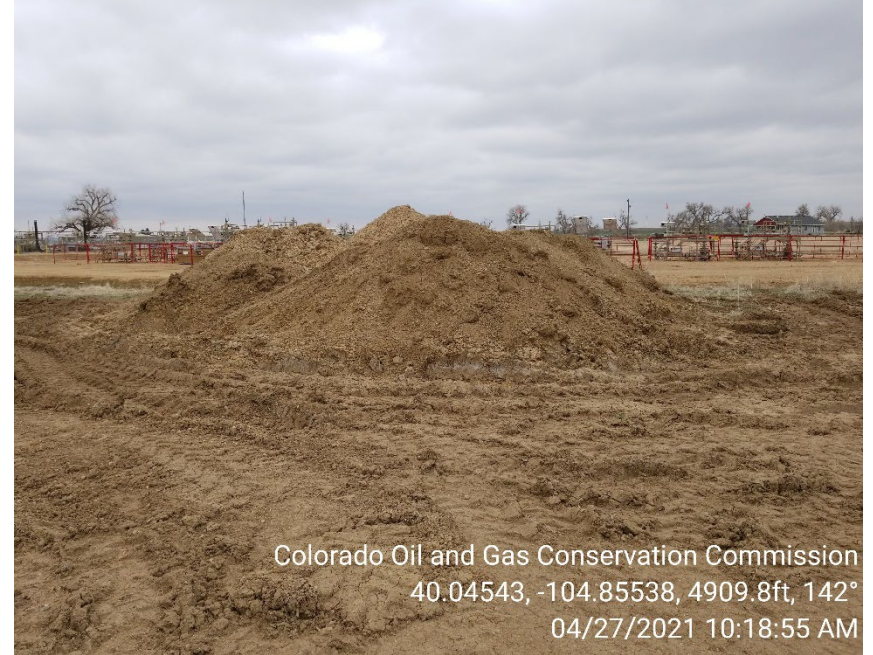
Photo 6 – Soil stored on location with inadequate BMPs.

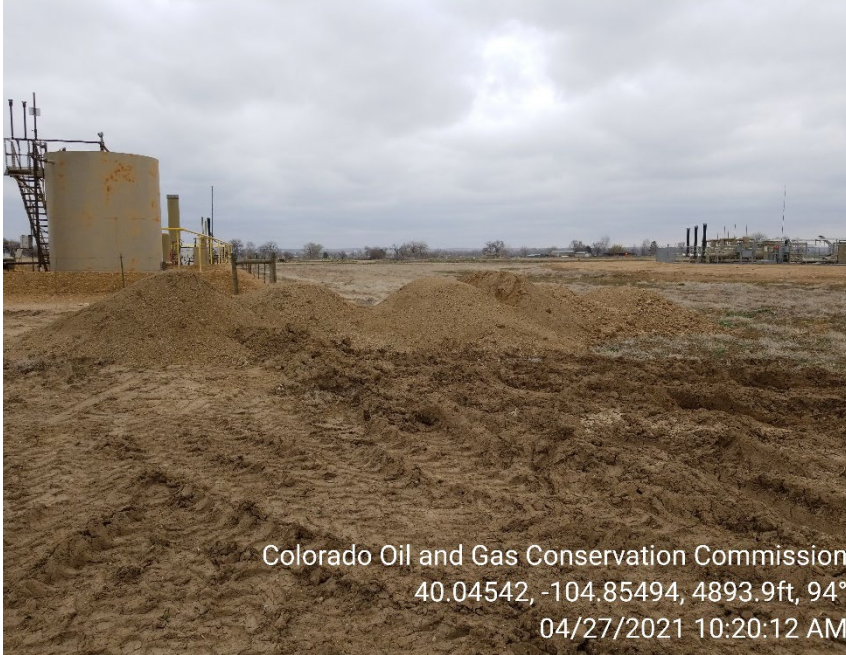
Photo 7 – Soil stored on location with inadequate BMPs.

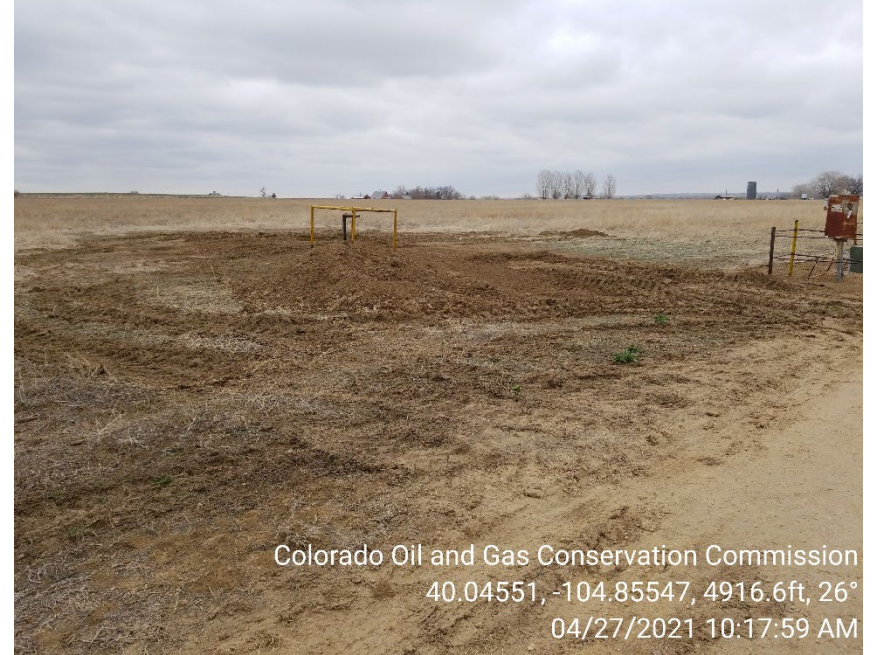
Photo 8 – Additional disturbed area north of open excavation
