Inspection Photos  
Operator: Simcoe  
API: 067-08496  
Date: 4/22/2021

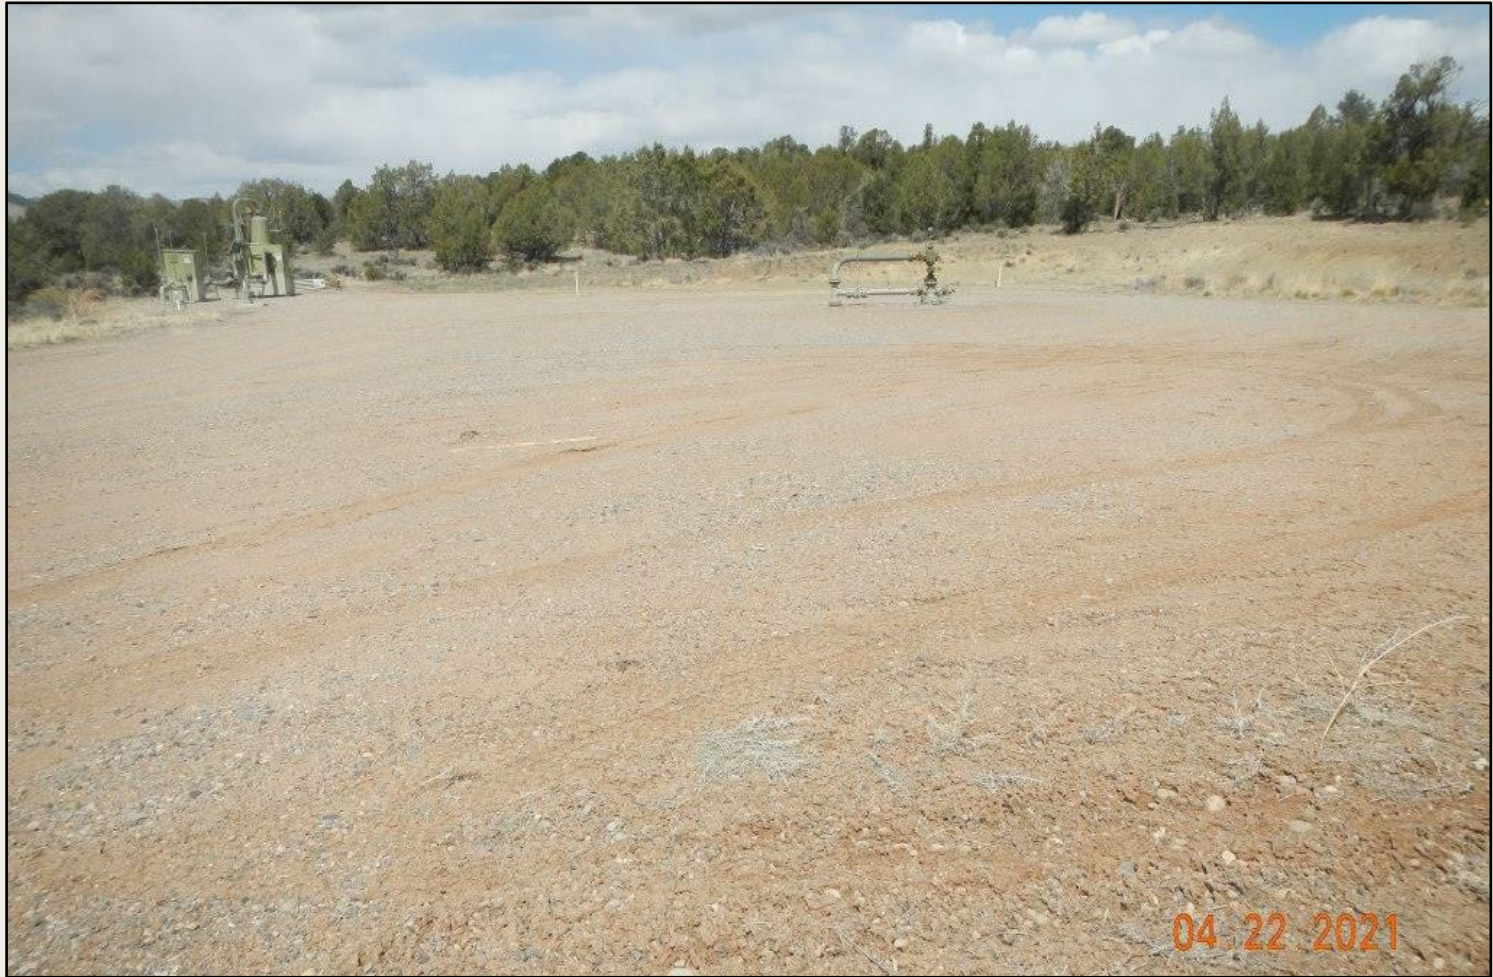
Photo 1. View of the project area from the well pad entrance facing center.

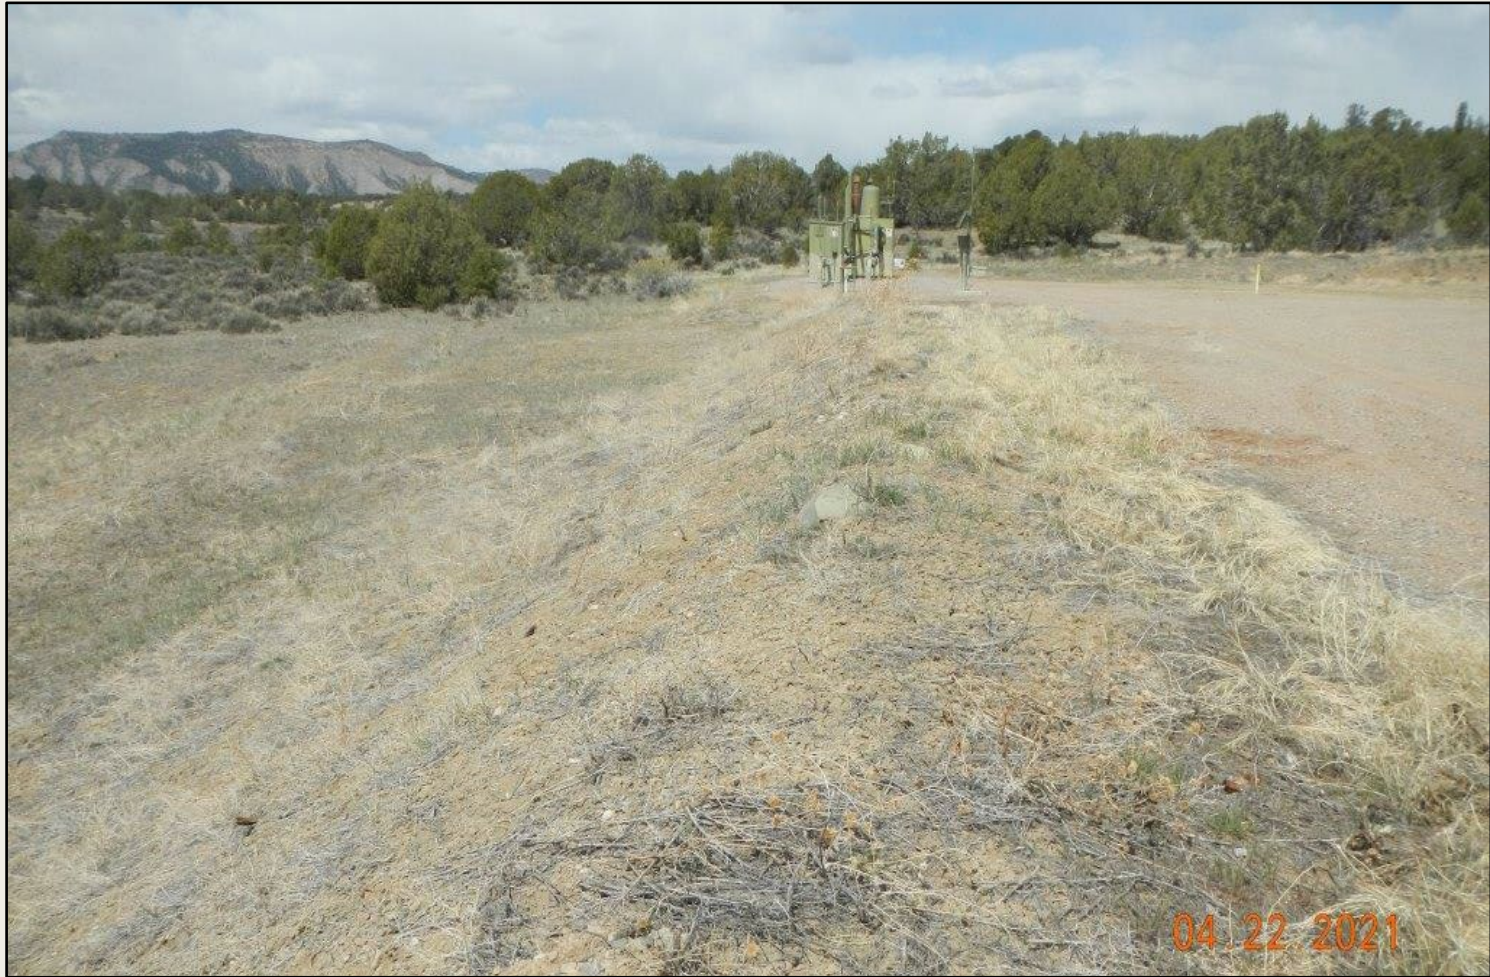
Photo 2. View of the southern fill slope from the southeastern corner facing westward. Revegetation is progressing in portions of the fill slope, largely with sand dropseed. Other portions remain sparse and weedy, and will require re-seeding if cover is not increasing during the growing season.

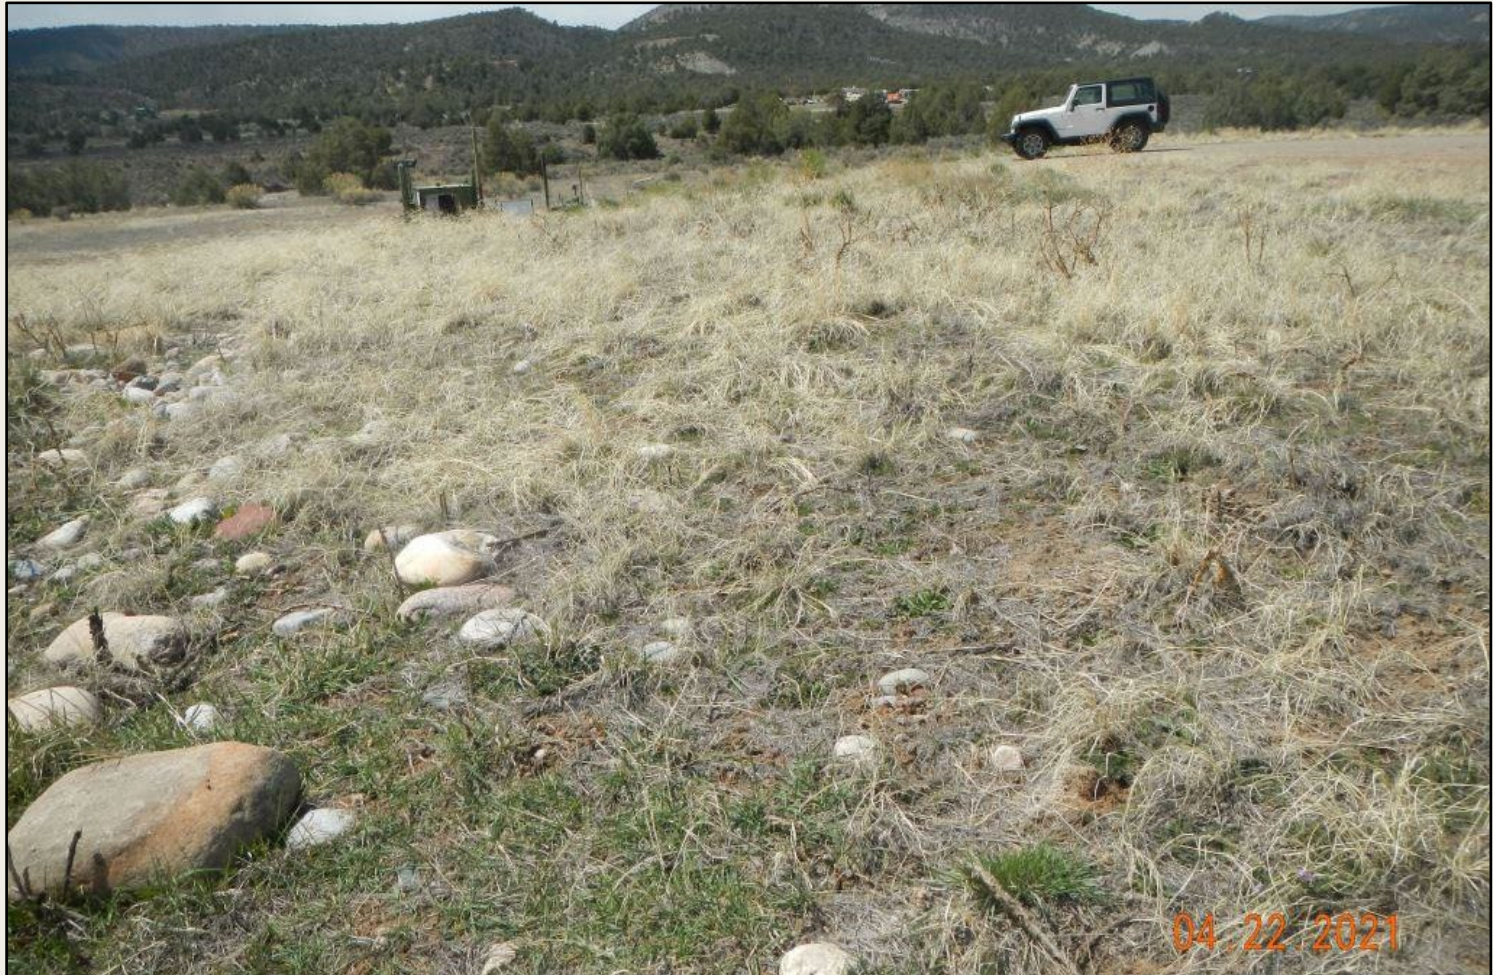
Photo 3. View of the eastern project area from the northeastern corner facing southward.

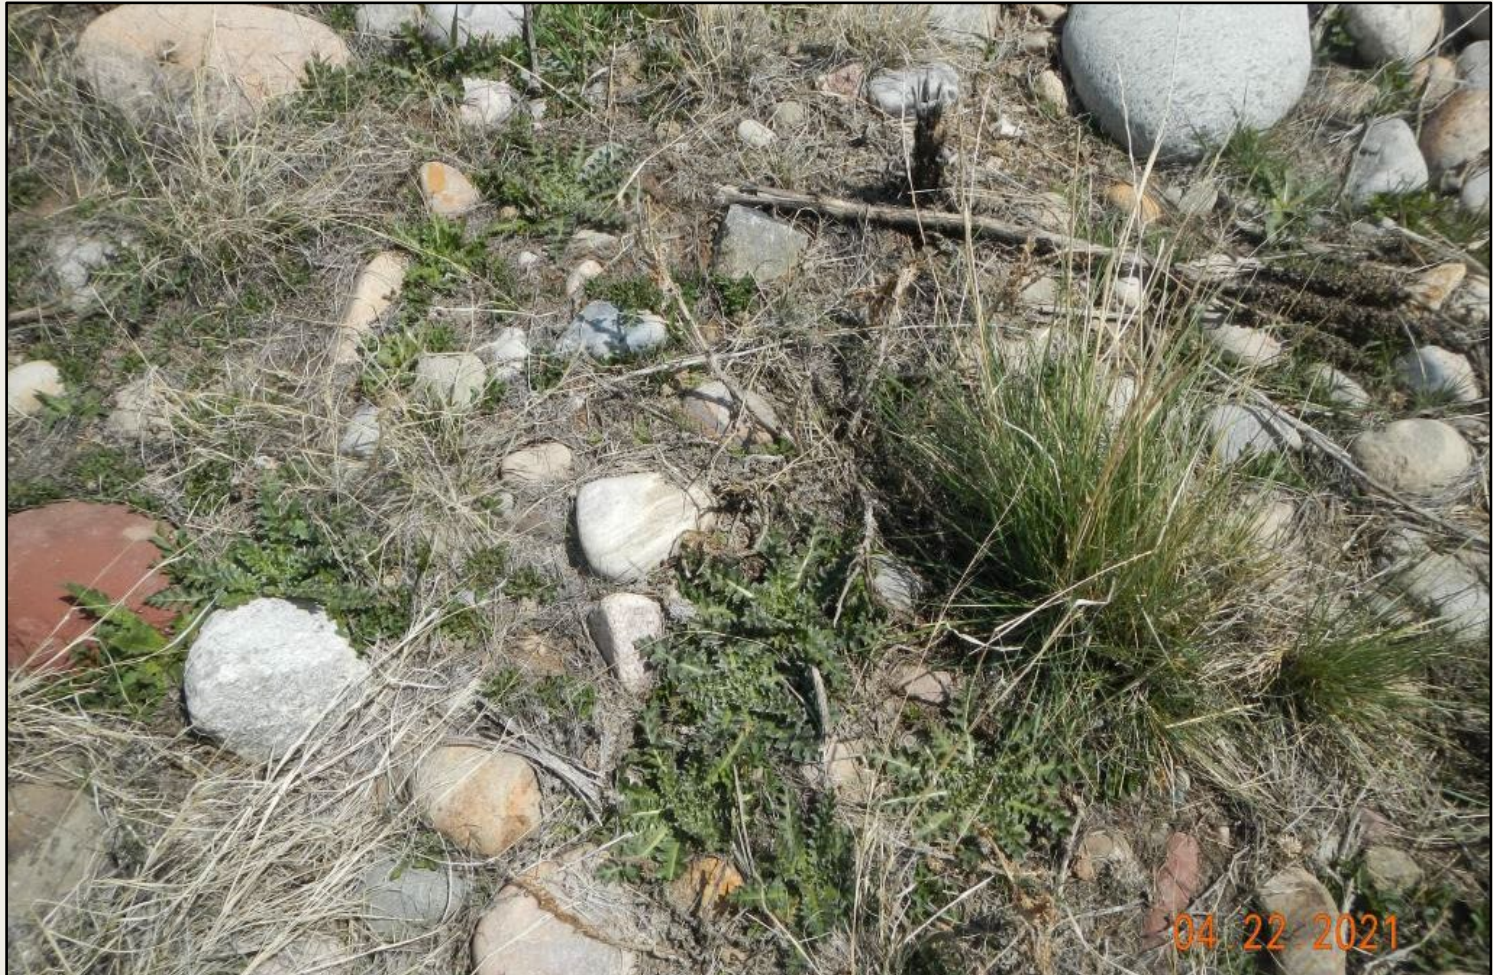
Photo 4. View of dense musk thistle rosettes within the eastern project area. Approximately 250 individuals observed.
