## Inspection Photos

Location Name: SG INTERESTS I LTD HENDERSON-611S90W /9SWNE

Location ID: 324477

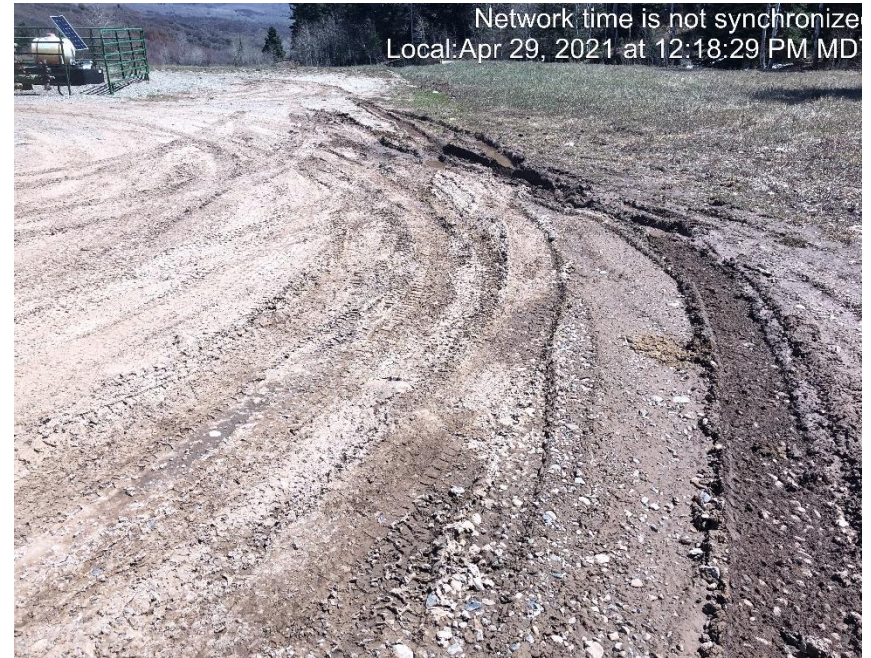
Photo #3672 location lacks stabilization.

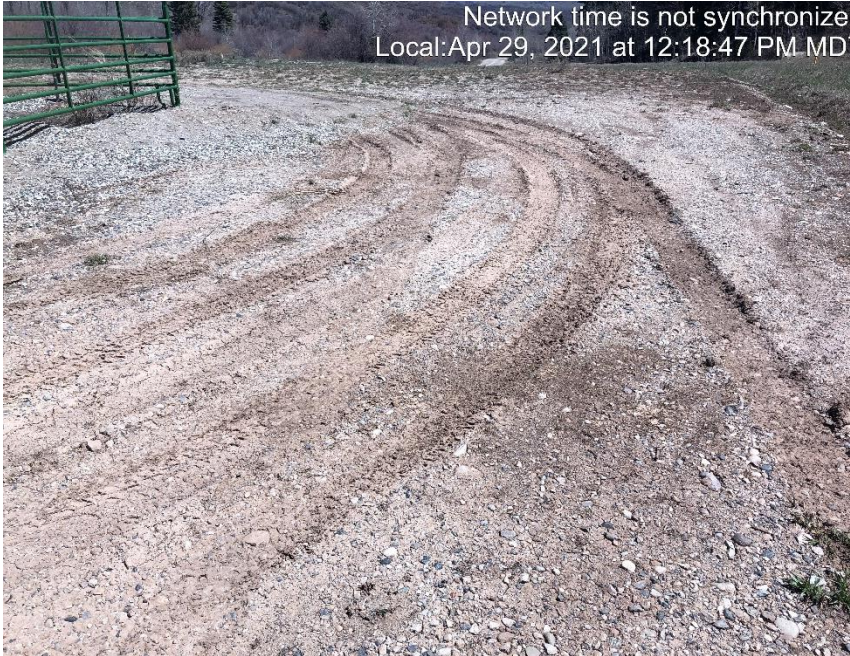
**Photo #3673 location lacks stabilization.**

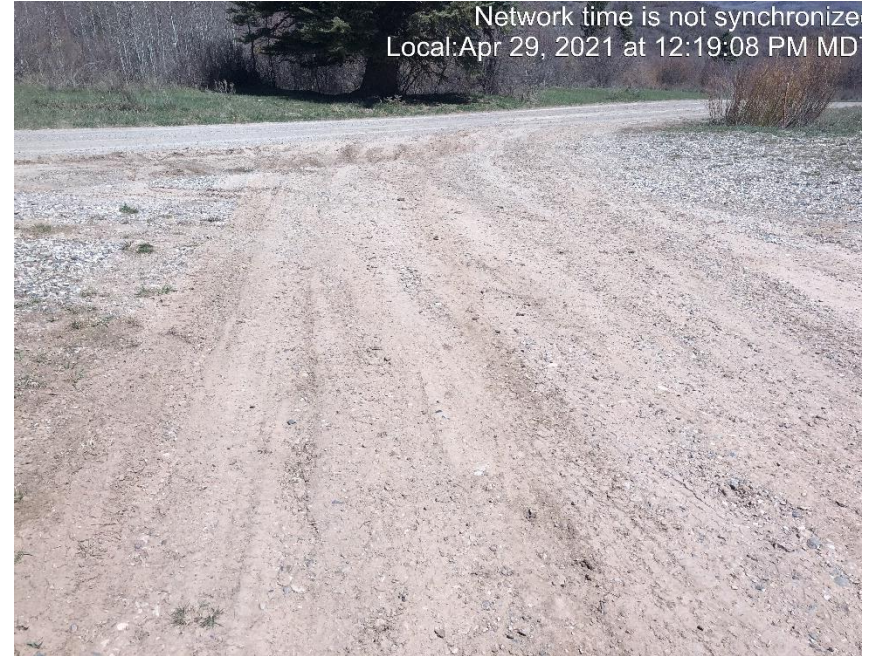
**Photo #3674 No form of tracking BMP at entrance to location.**

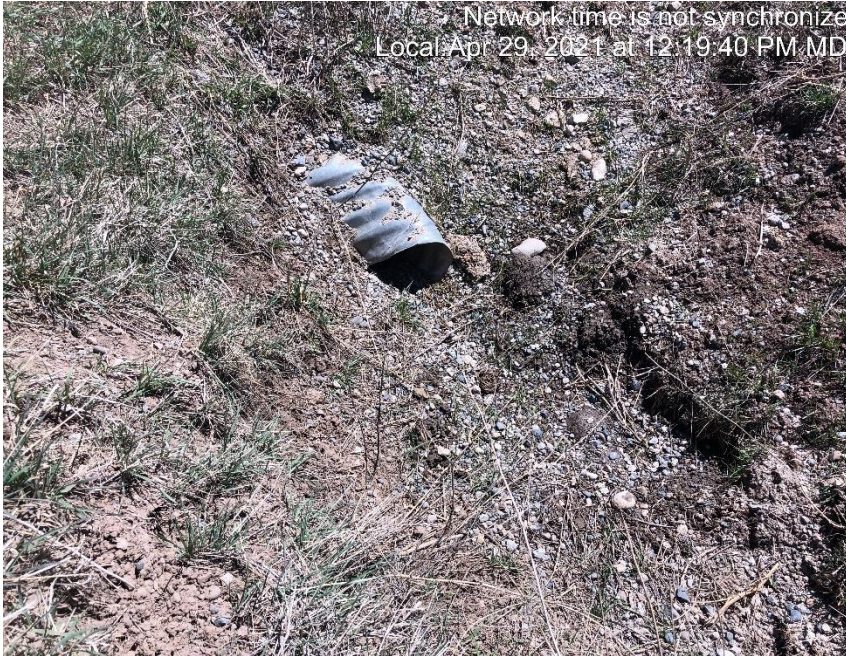
**Photo #3675 Culvert capacity reduced due to inlet being crushed.**
