**Inspection Photos**  
**Location Name: John Weigandt Consolidation**  
**Spill ID 465402**

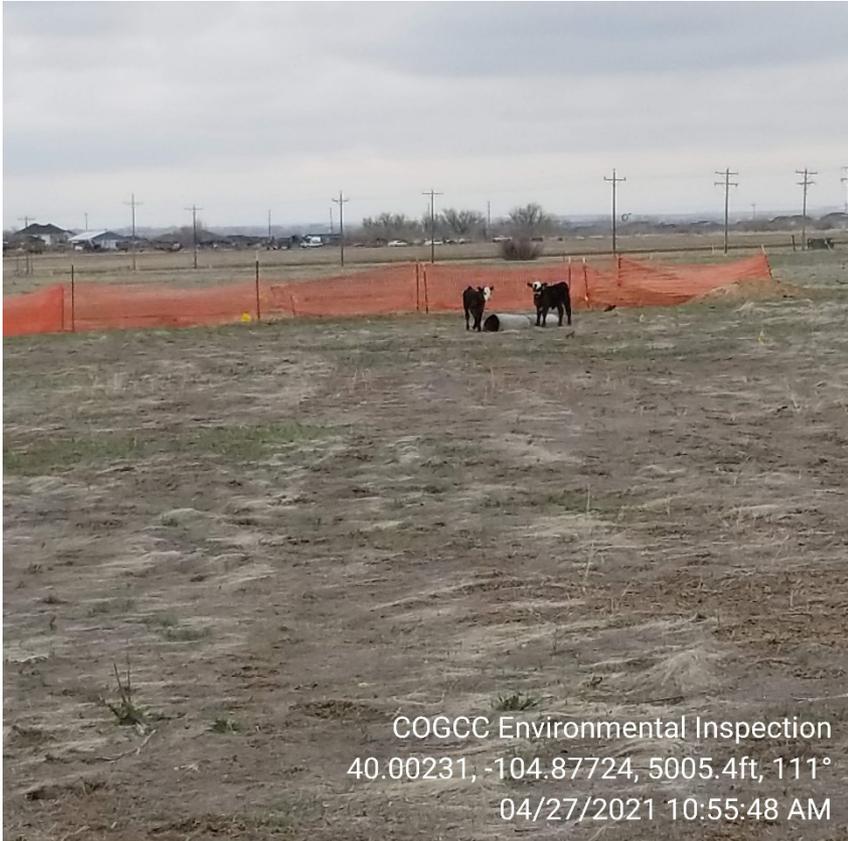
**Photo 1 – Livestock adjacent to excavation with inadequate fencing to control cattle.**

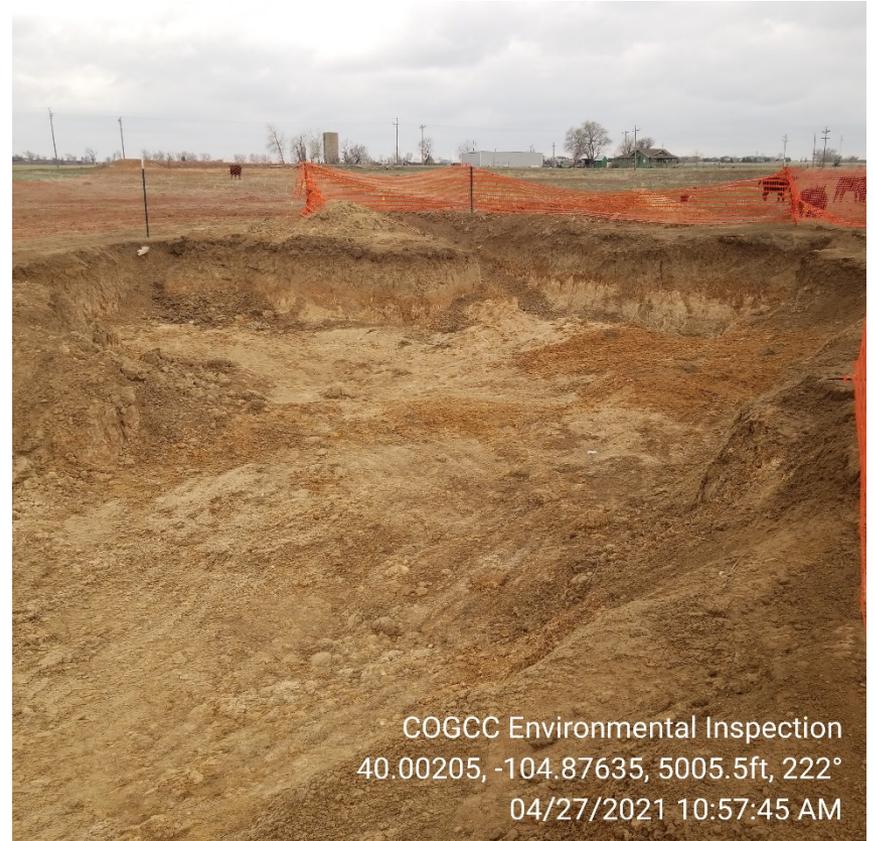
**Photo 2 – Excavation photo**

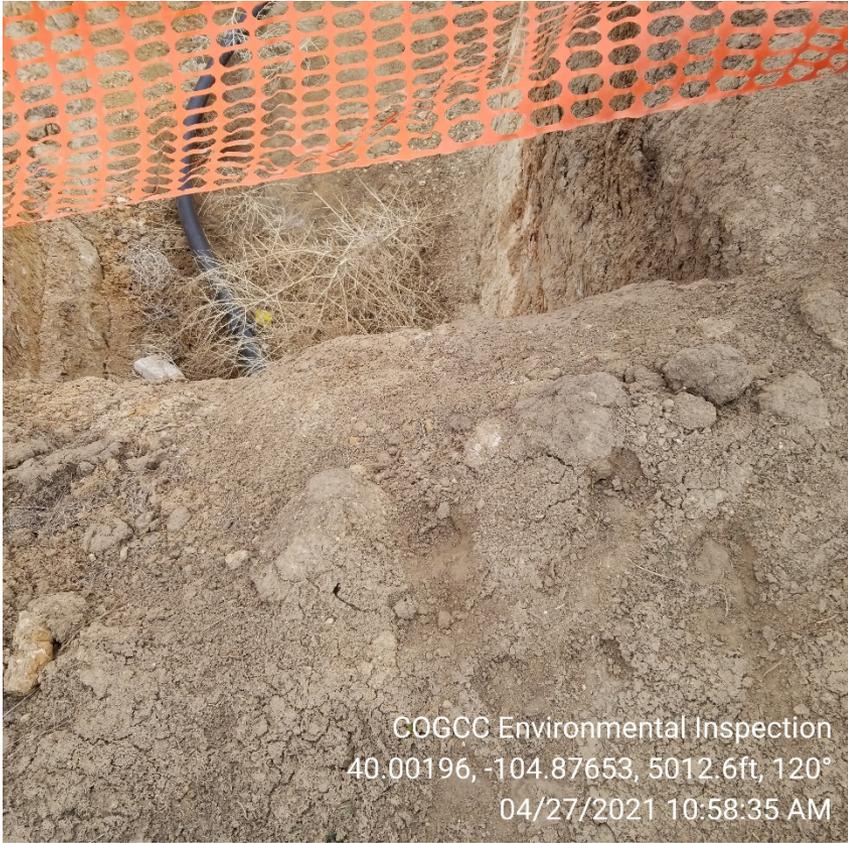
**Photo 3 – Inadequate fencing with gaps**

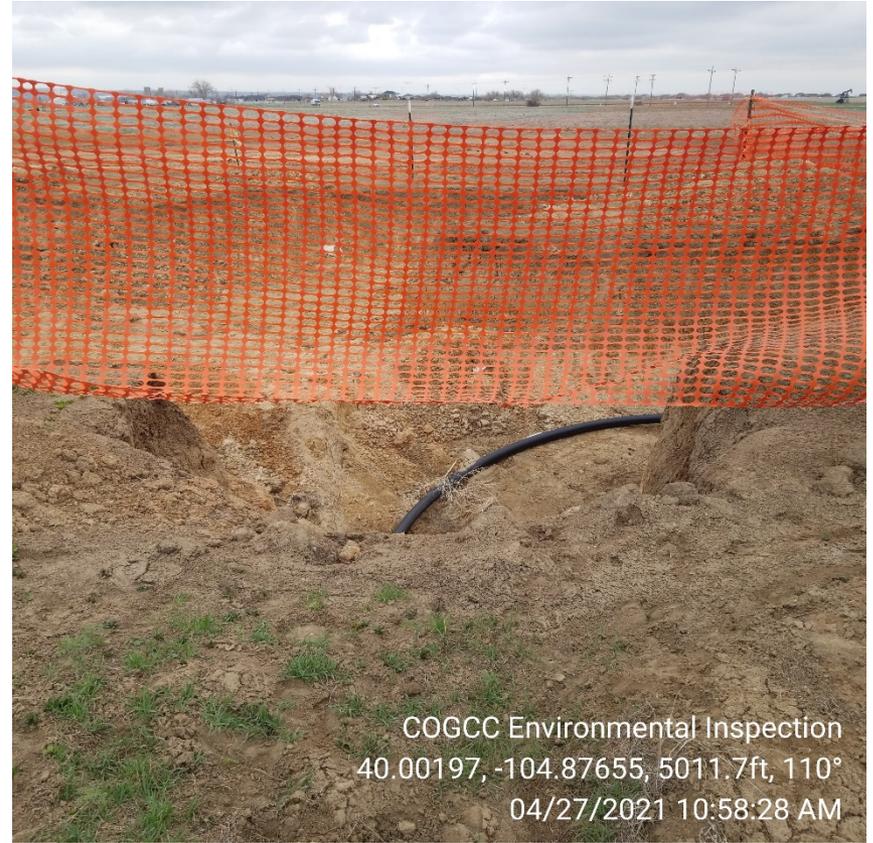
**Photo 4 – Inadequate fencing with gaps**

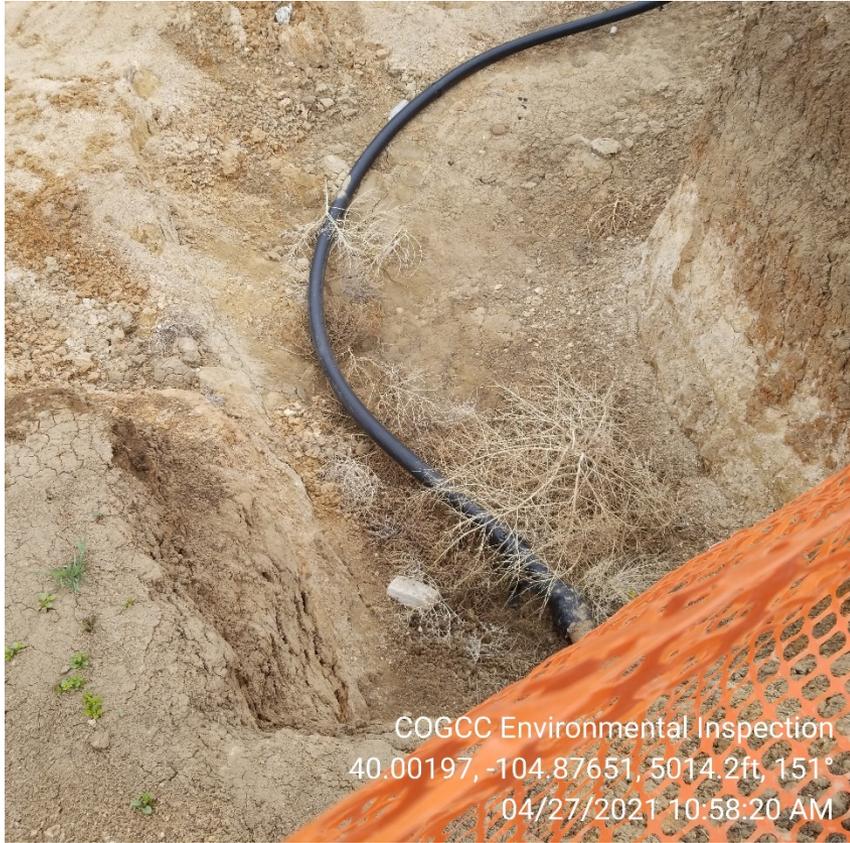
COGCC Environmental Inspection  
40.00197, -104.87651, 5014.2ft, 151°  
04/27/2021 10:58:20 AM

**Photo 5 –Flow line visible in excavation**

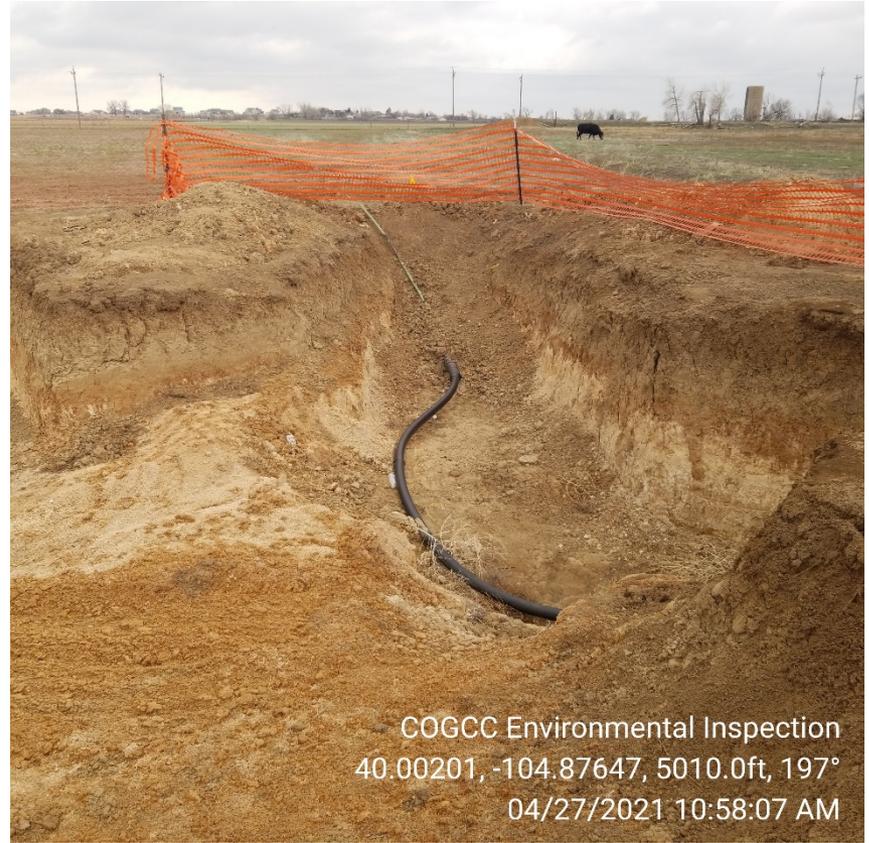
COGCC Environmental Inspection  
40.00201, -104.87647, 5010.0ft, 197°  
04/27/2021 10:58:07 AM

**Photo 6 – Flow line visible in excavation**

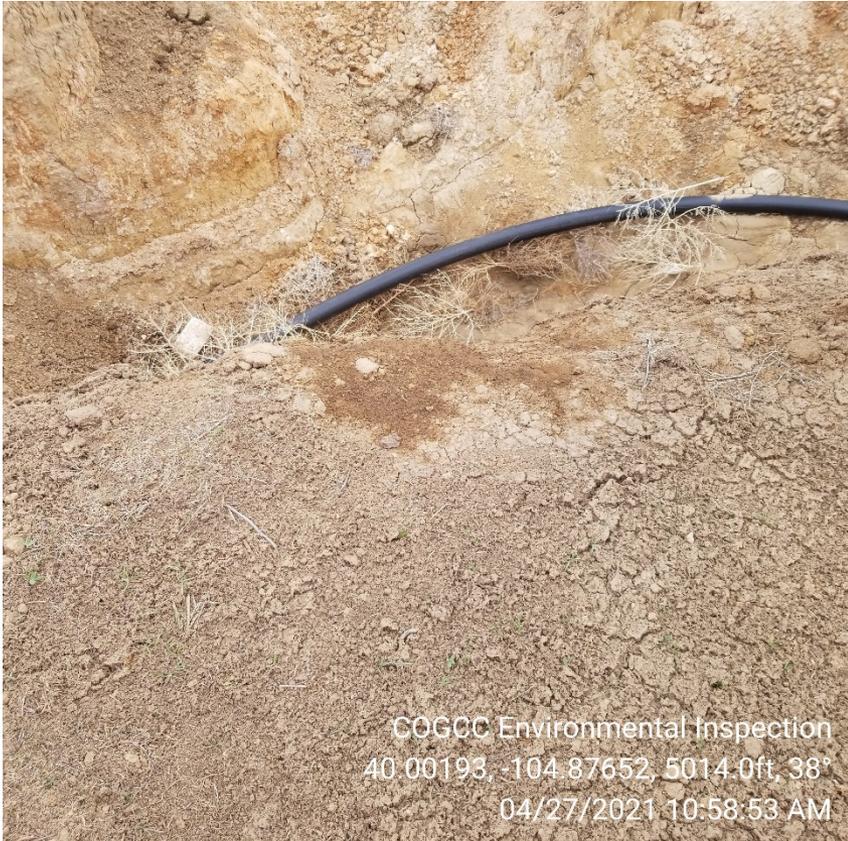
**Photo 7 – Flowline and stained soil in excavation**

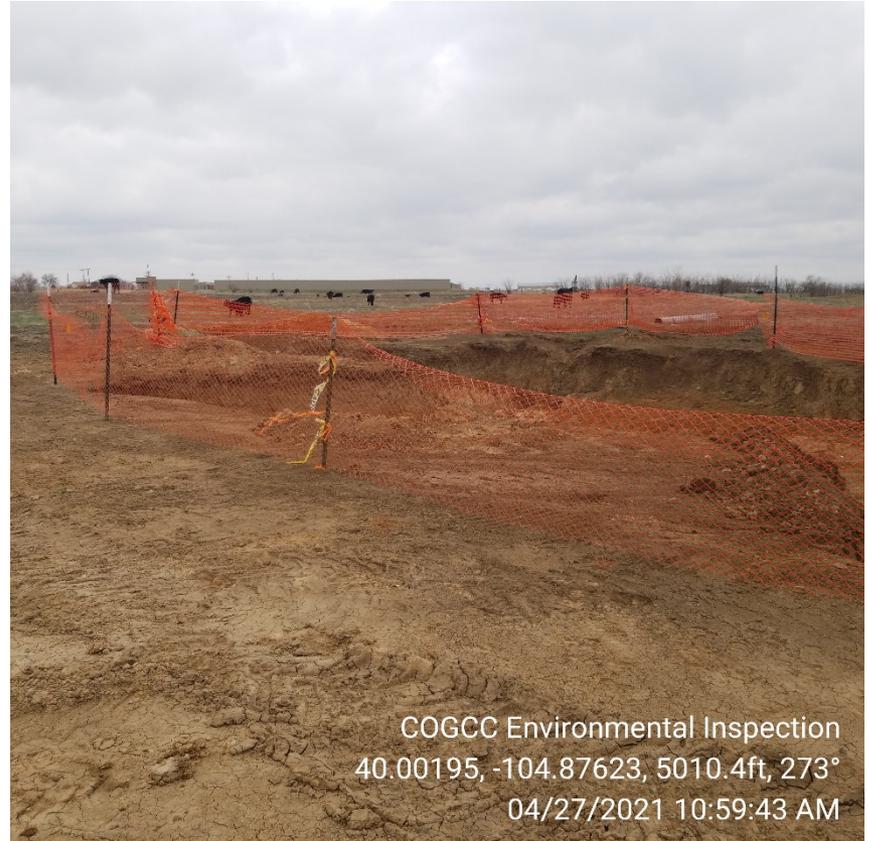
**Photo 8 – Location photo**

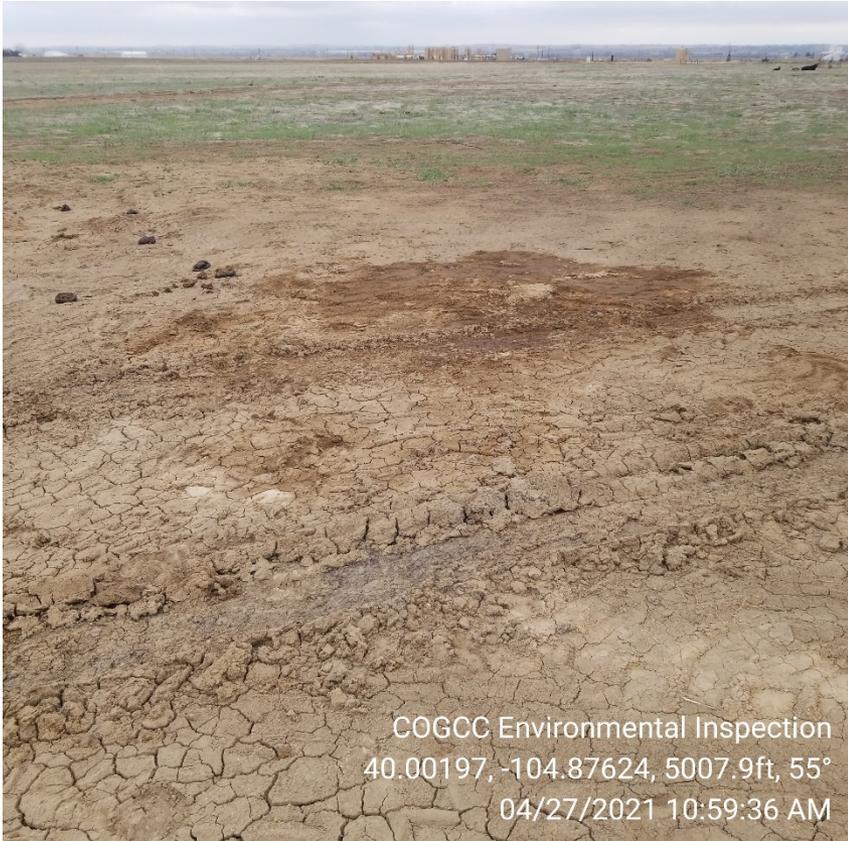
**Photo 9 – Stained soils remain on surface adjacent to excavation.**

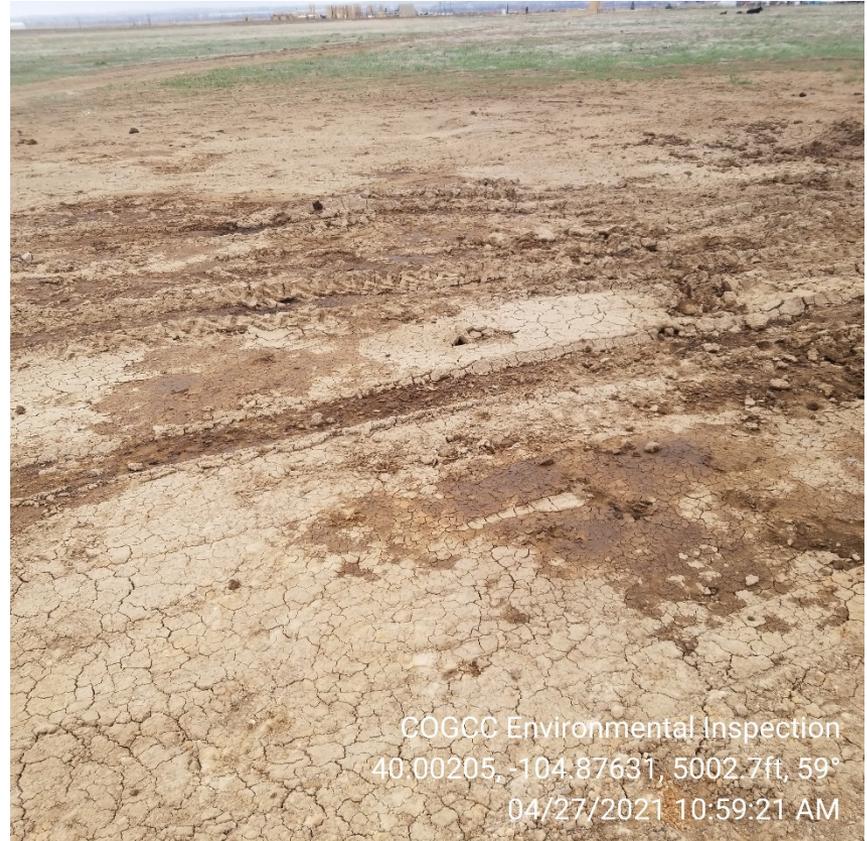
**Photo 10 – Stained soils remain on surface adjacent to excavation.**
