Inspection Photos

API: 071-07560

Operator: TIMBER CREEK OPERATING

Inspection Date: 4/30/2021

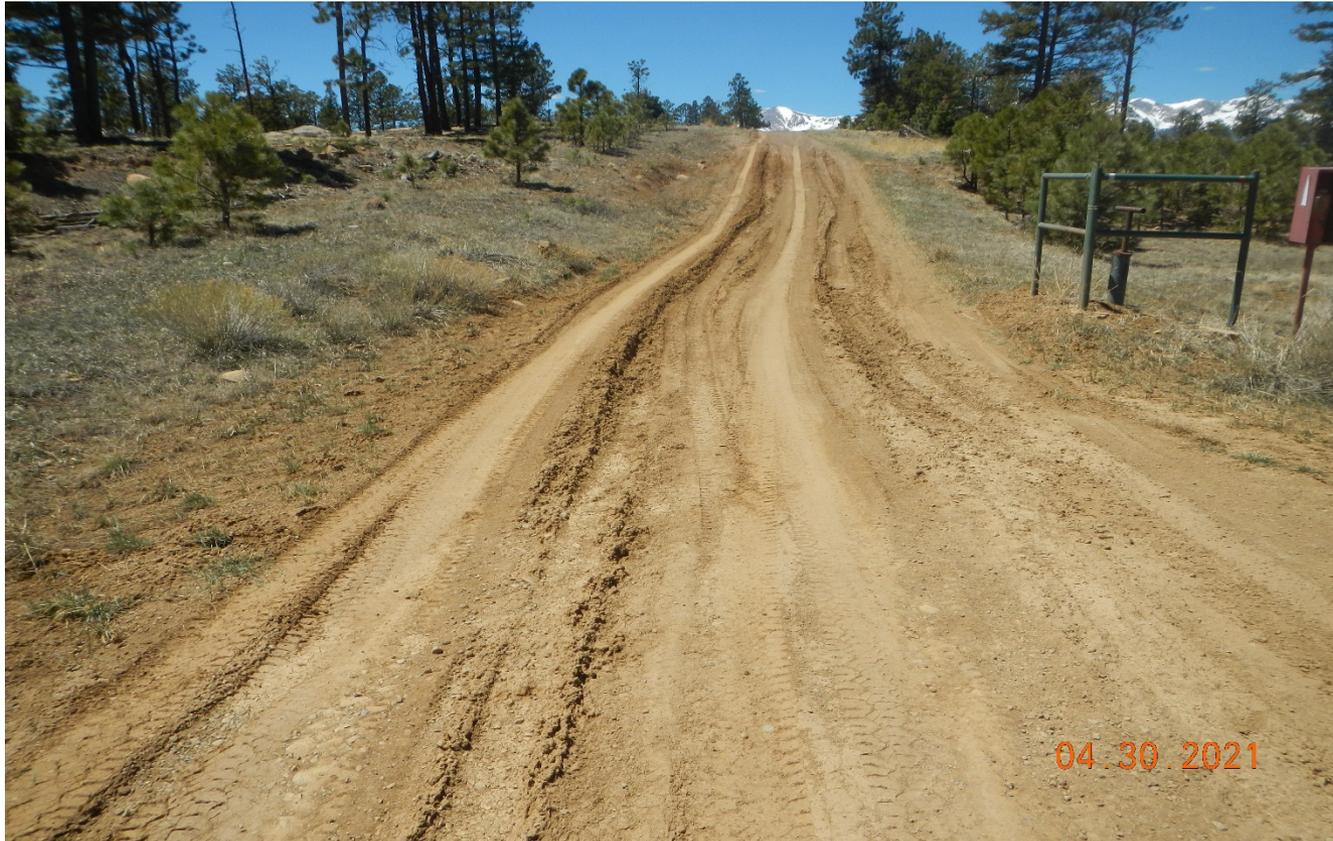
Photo 1. There is vehicle rutting along the road traveling to the location. The road needs to be maintained. Previous corrective action has not been completed.

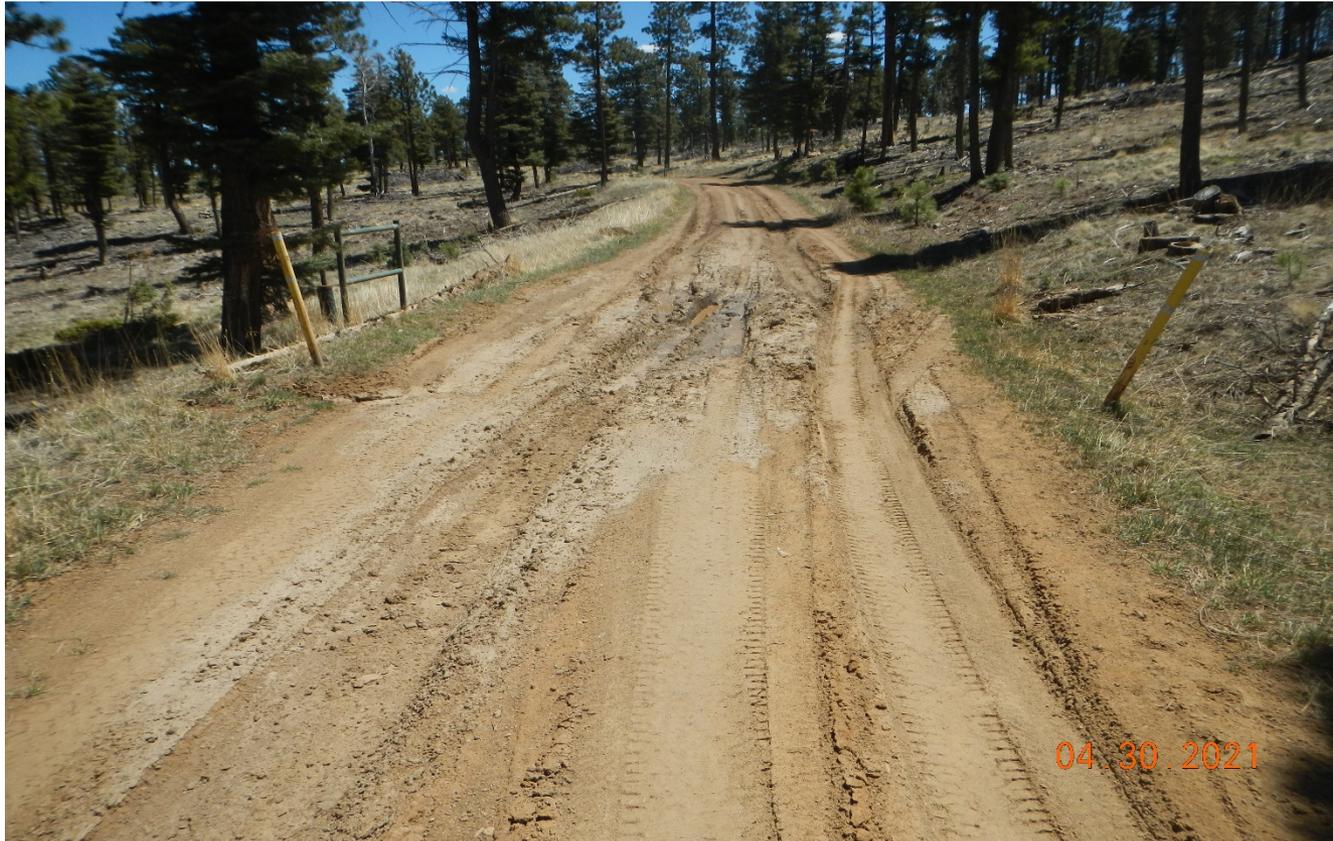
Photo 2. Facing southeast along the access road. There is a low spot in the road where stormwater accumulates. This area needs to be repaired to allow proper drainage. E.g. load of roadbase to repair and stabilize this area.

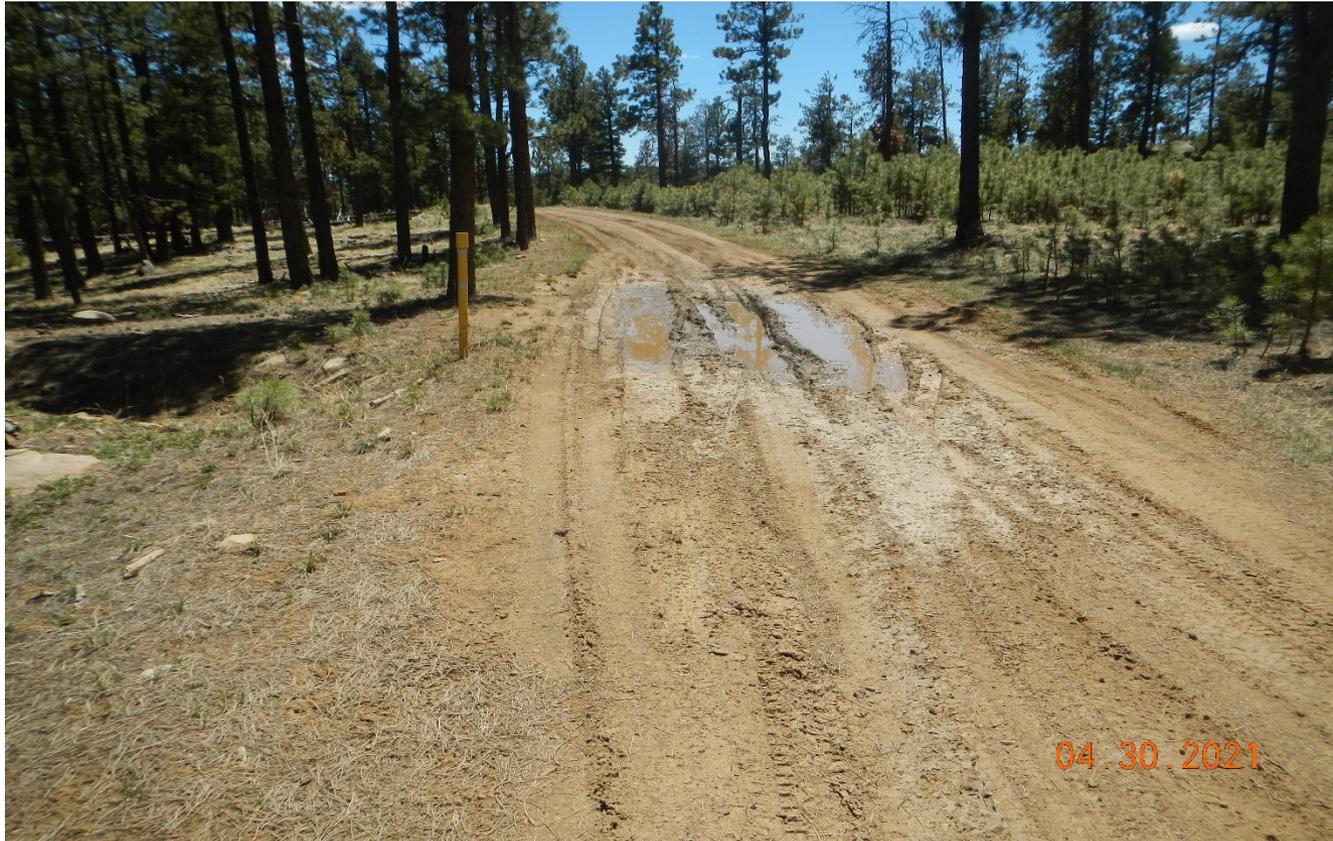
Photo 3. Likewise to previous photo. There is a low spot in the road where stormwater accumulates and vehicles are widening the road to avoid this area. This area needs to be repaired to allow proper drainage.

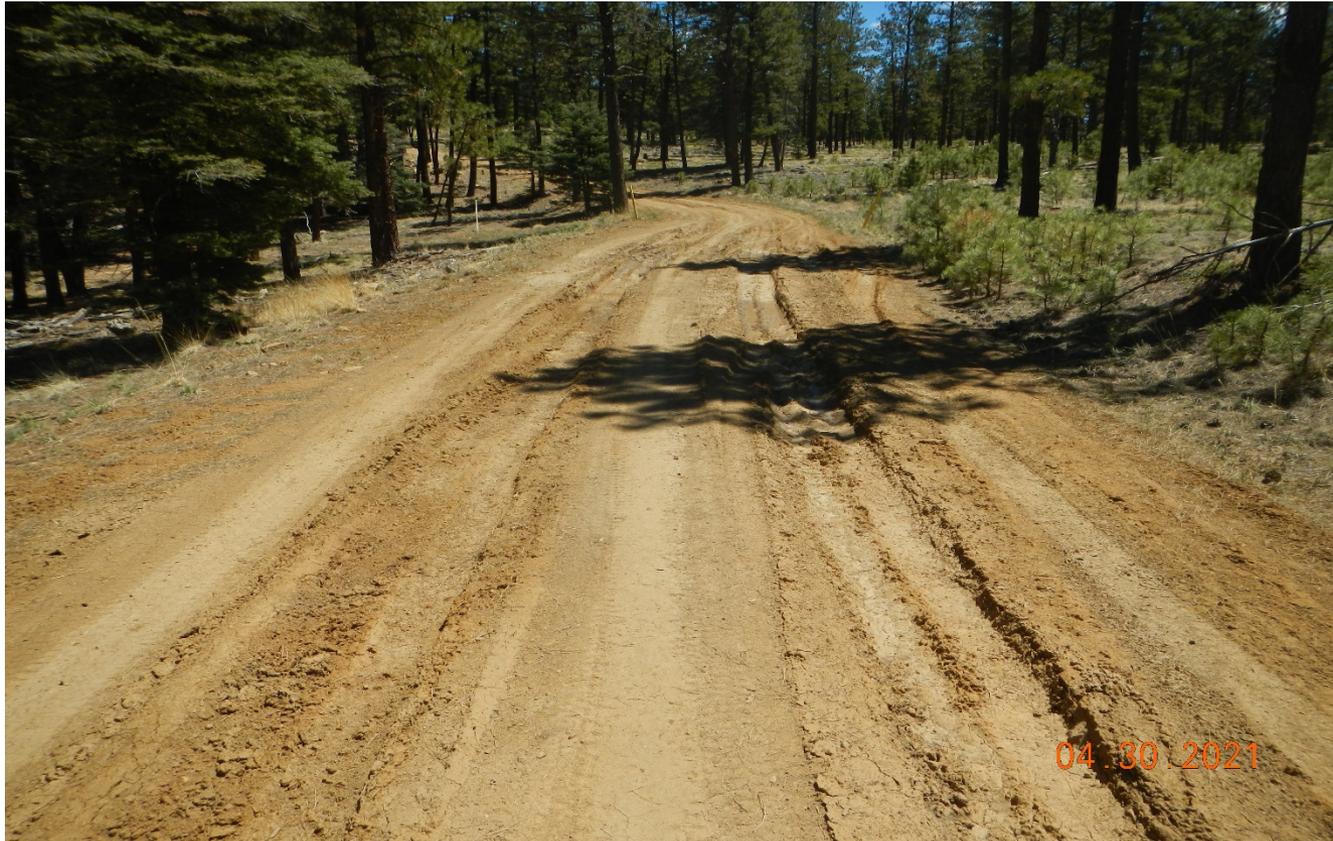
Photo 4. There is vehicle rutting along the road traveling to the location. The road needs to be maintained.

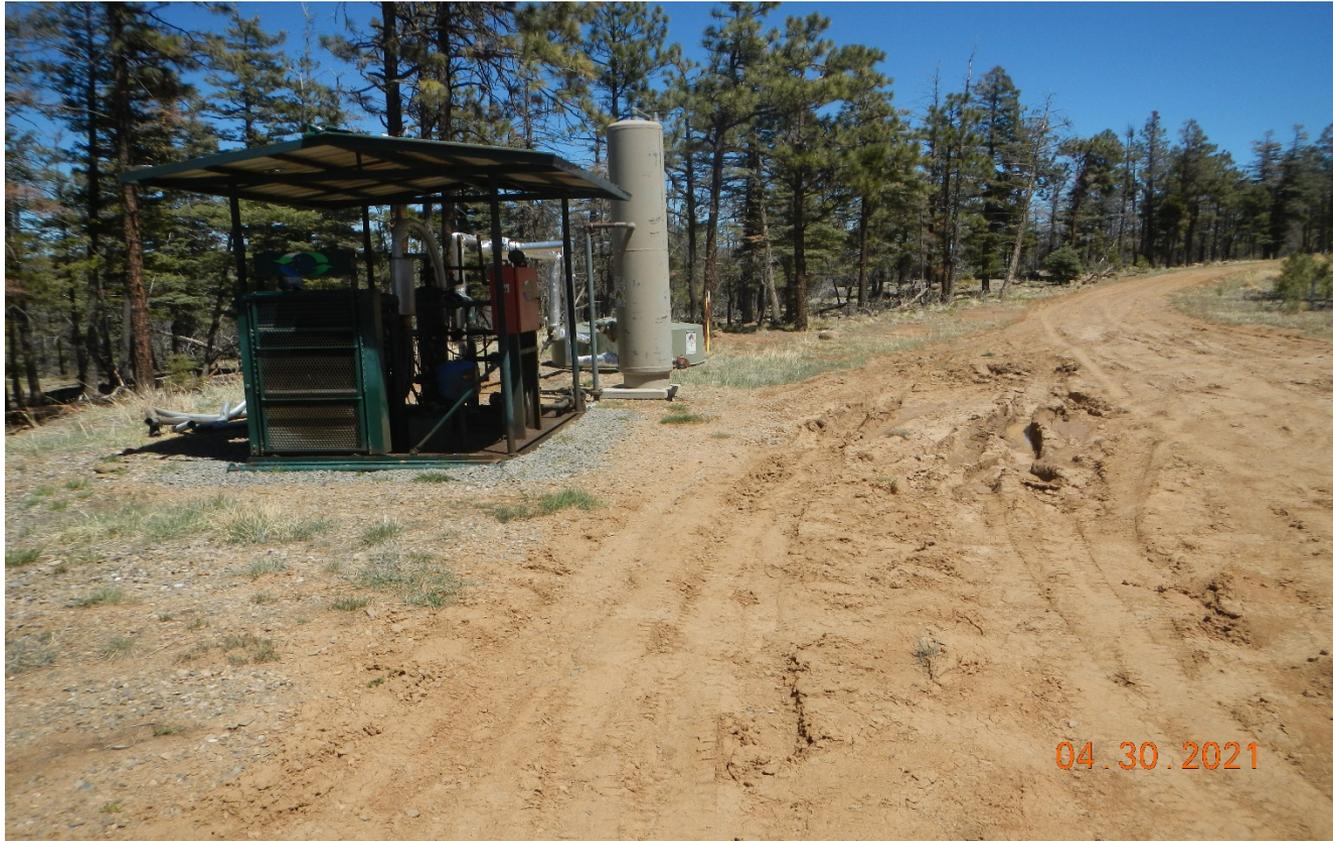
Photo 6. Facing toward the location. Areas of rutting at the location need to be repaired and stabilized.

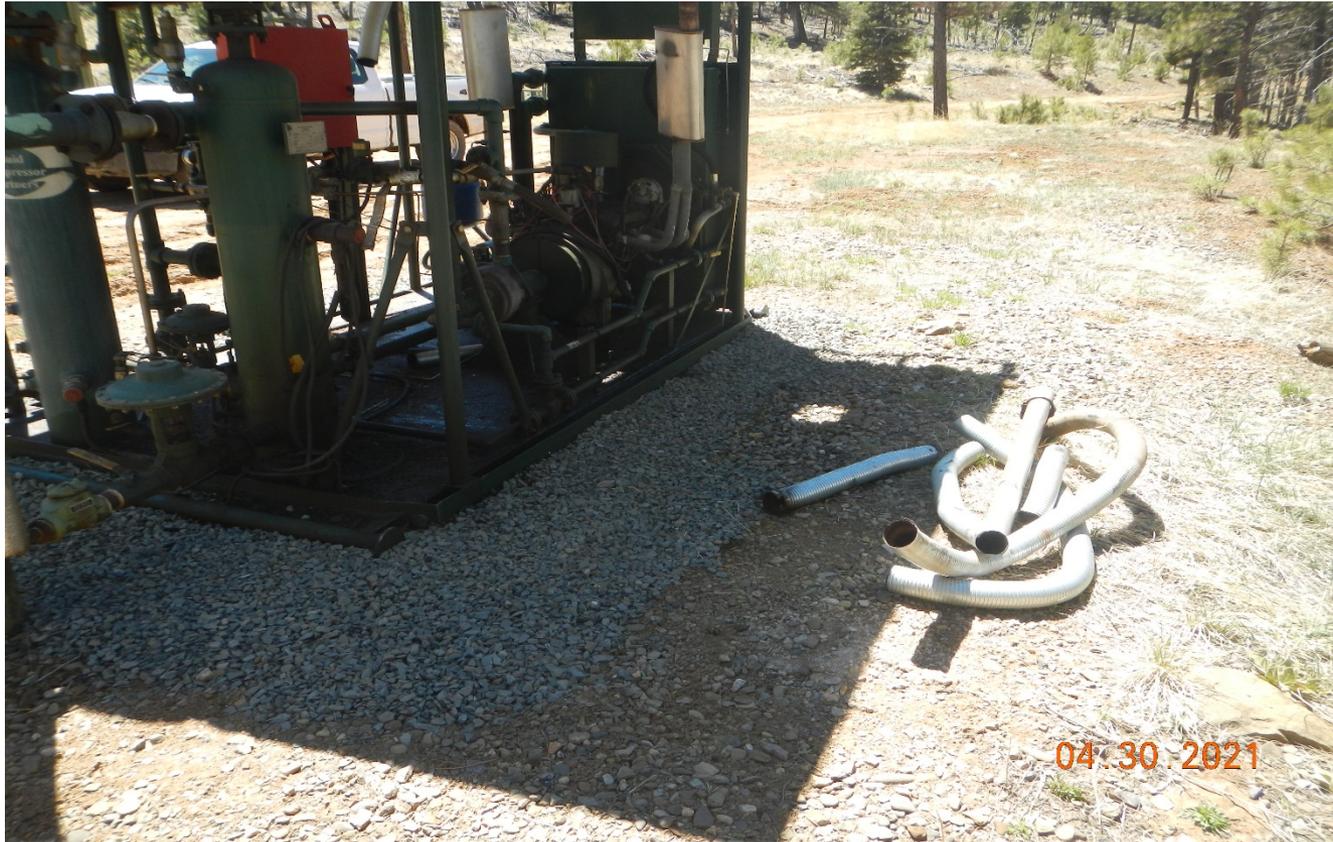
Photo 7. Stained soils near engine have been cleaned up.
