Colorado Oil and Gas Conservation Commission

KPK Grant#4 Issue Report

Created on May 3, 2021

Captured: April 26, 2021

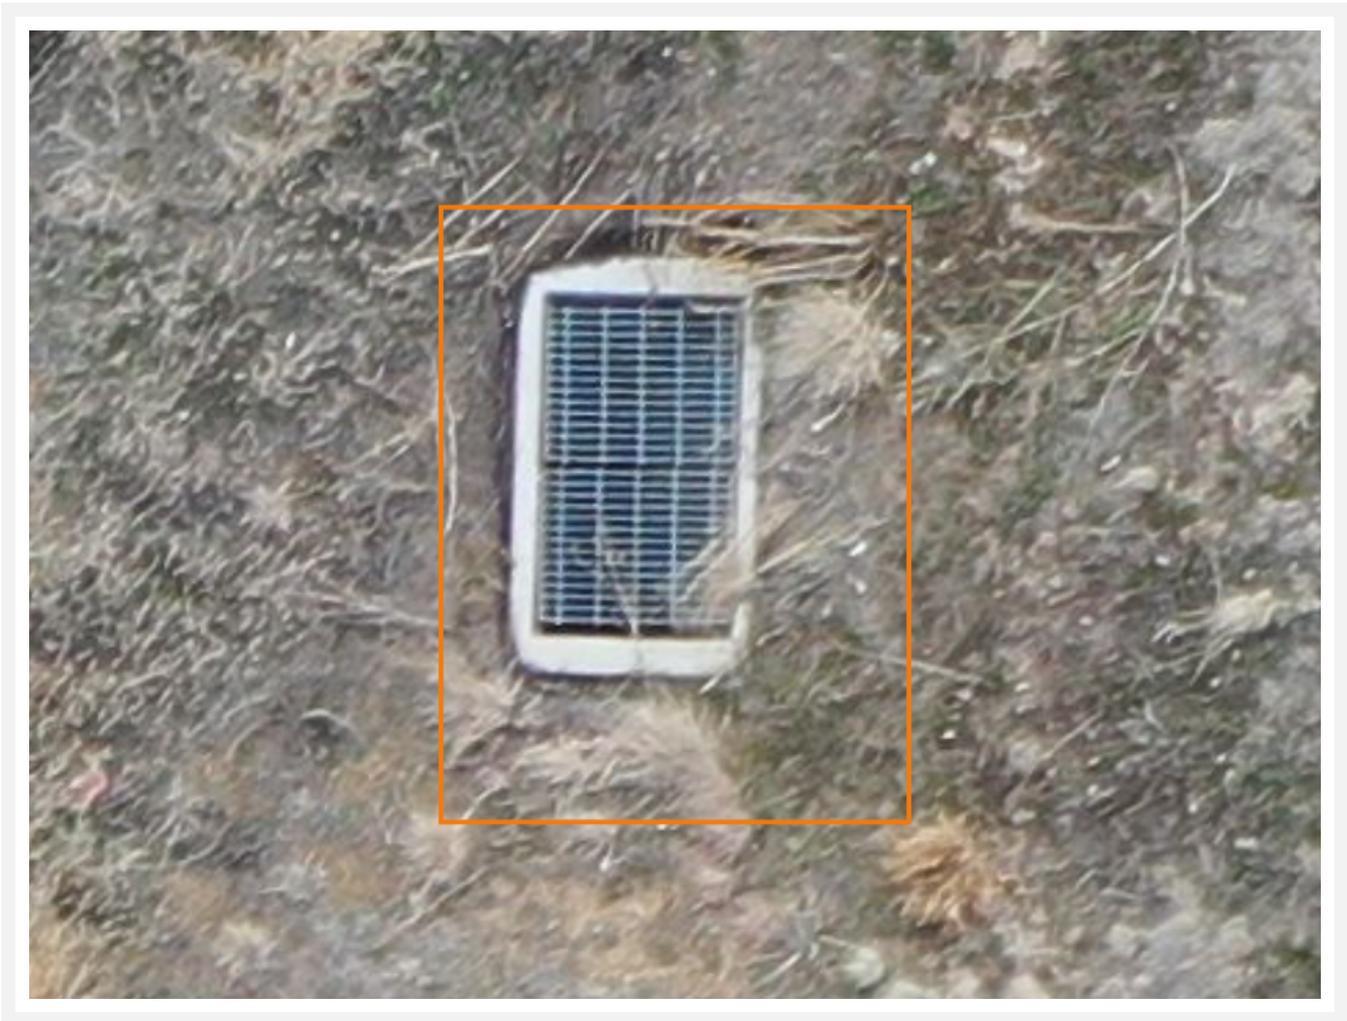
1 - Drainage Problem **OPEN**

No Inlet protection

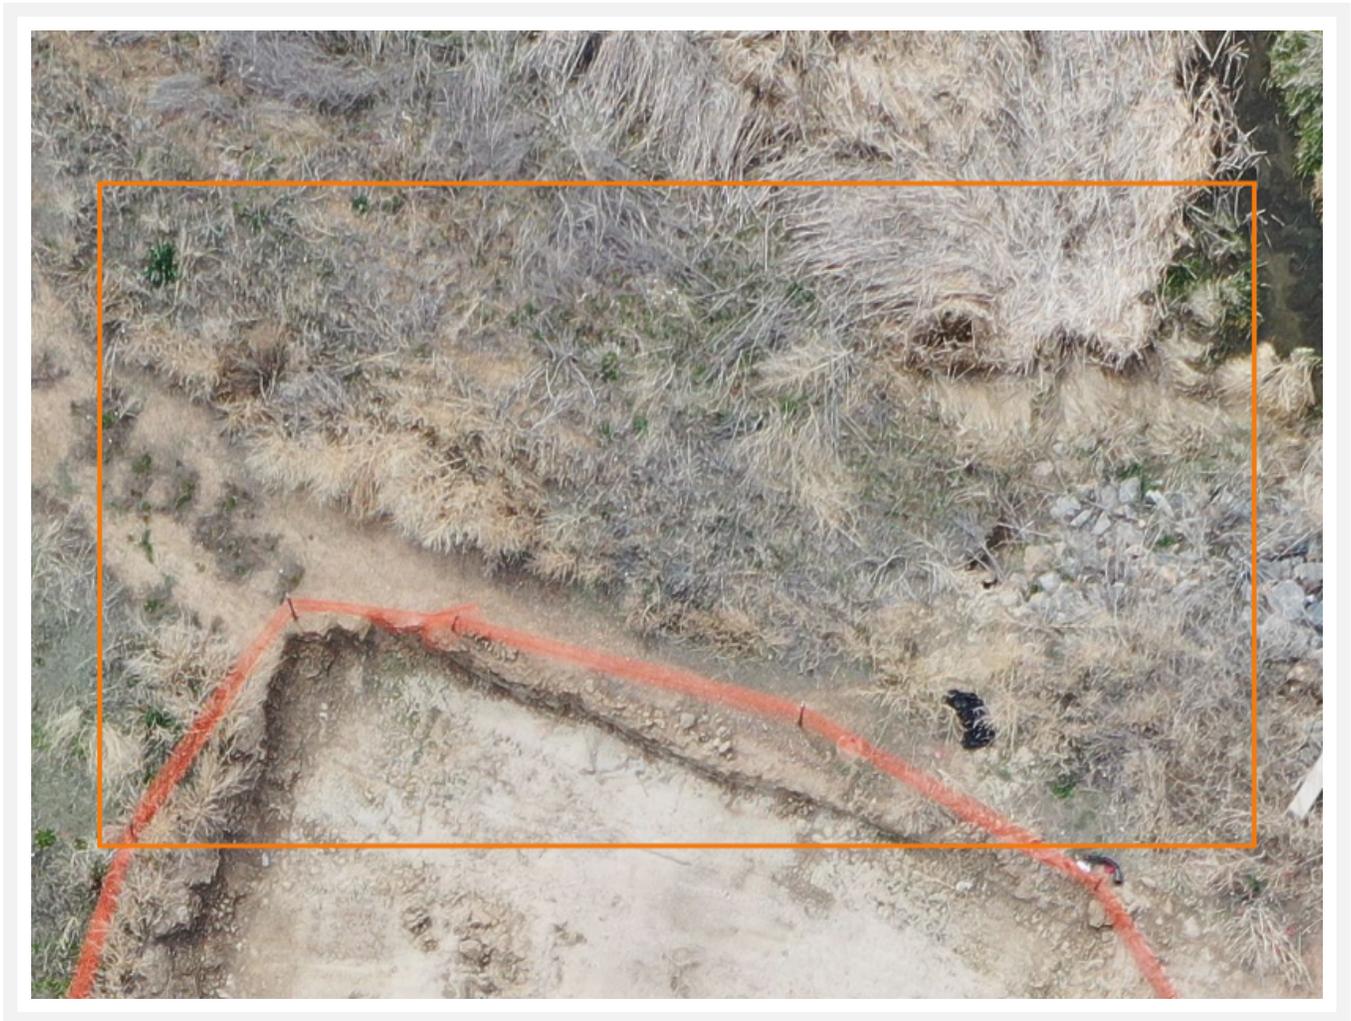
2 - Drainage Problem **OPEN**

No BMP for run off to wetland

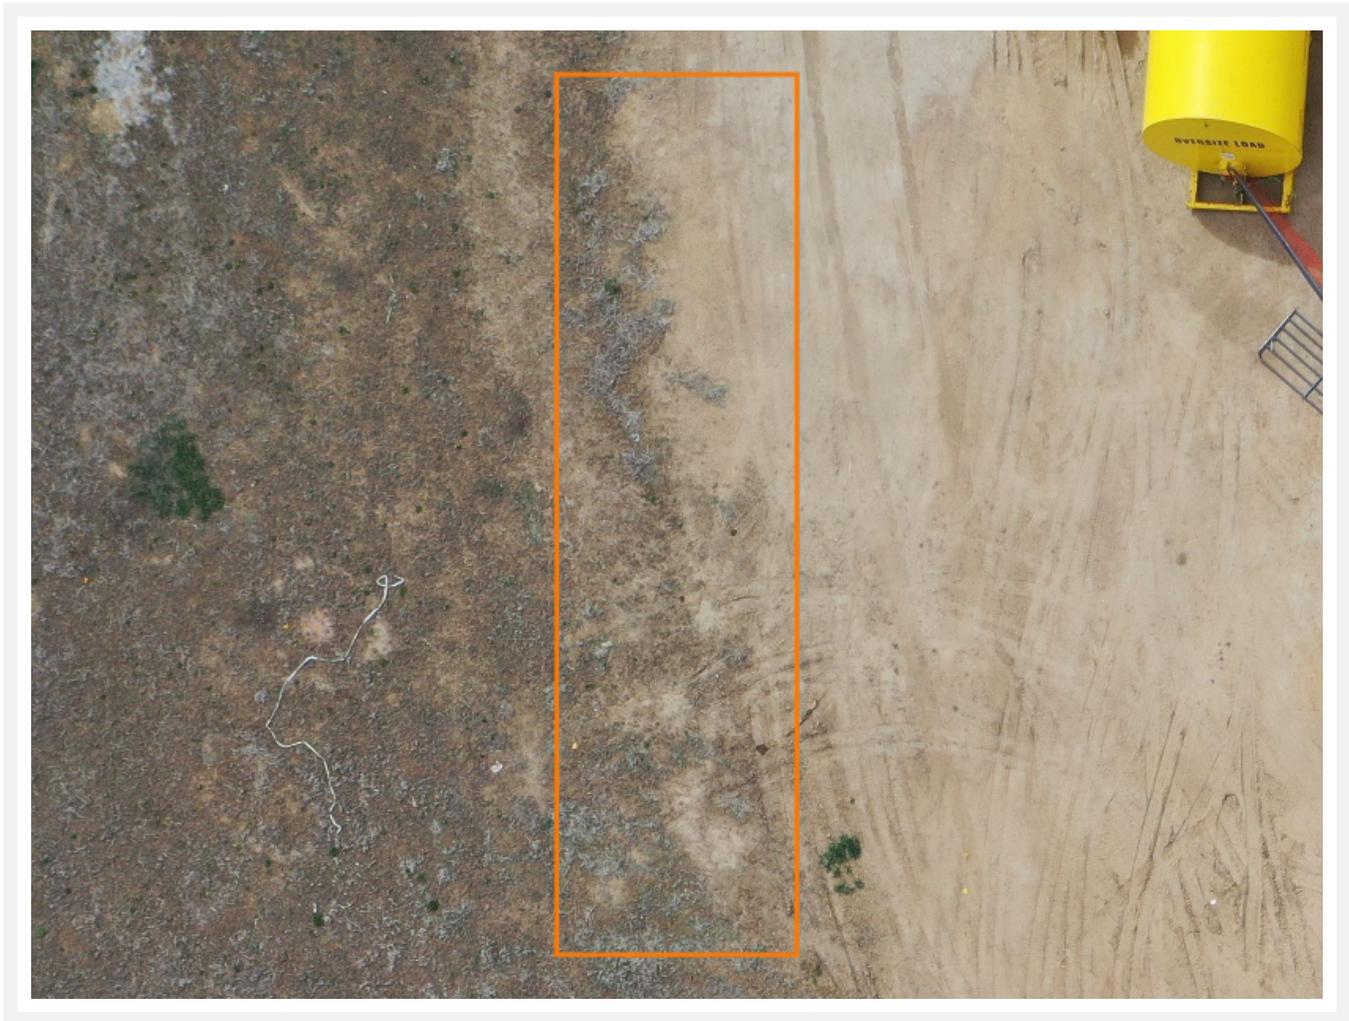
10 - Drainage Problem **OPEN**

No BMP in place during construction

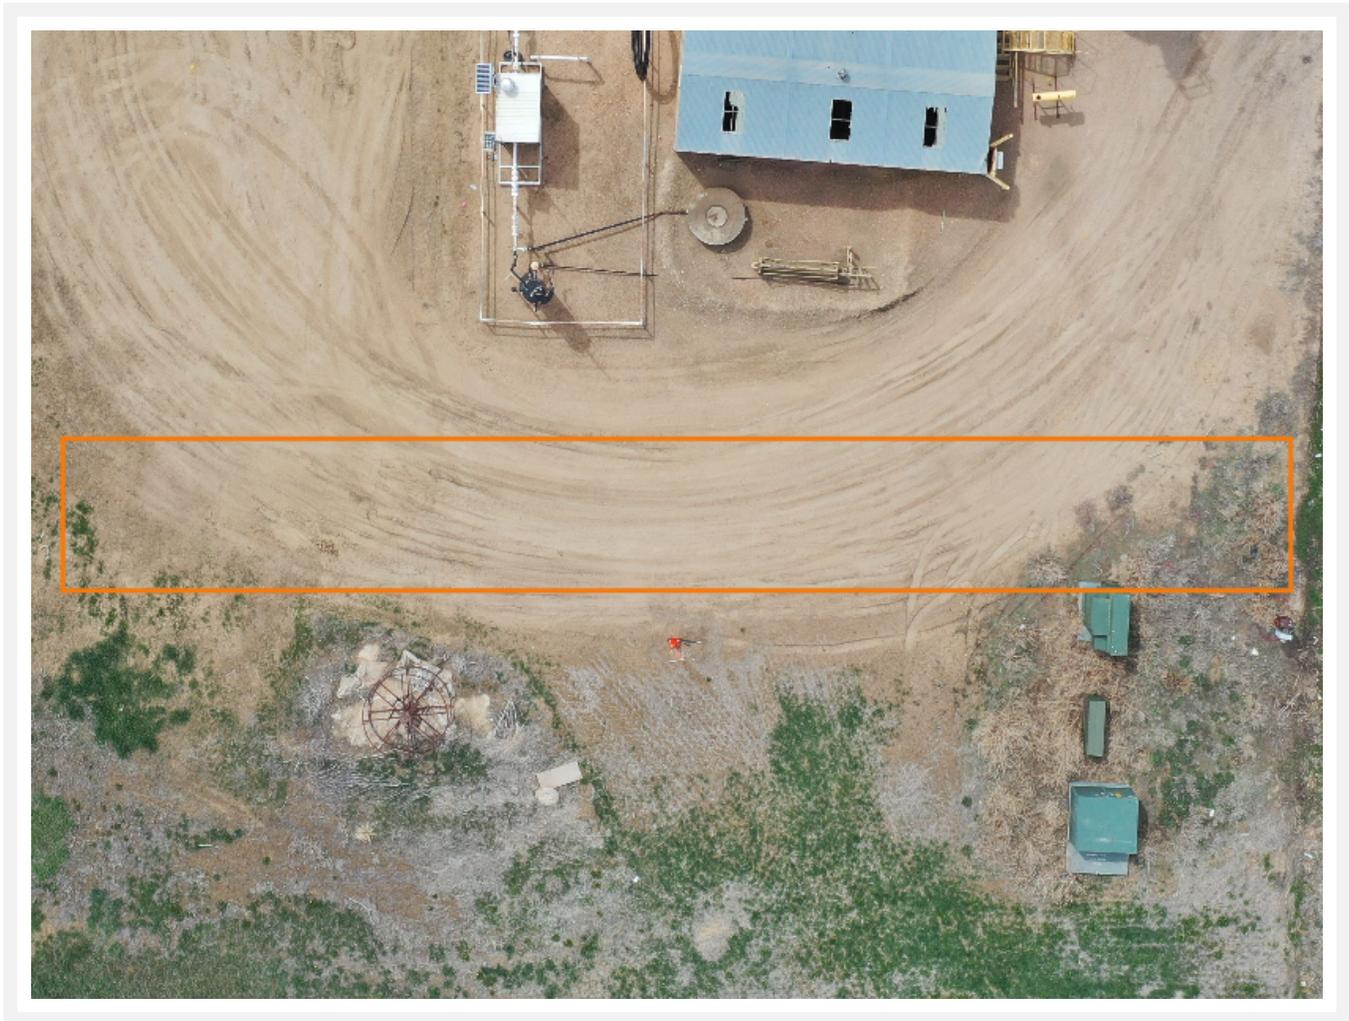
11 - Drainage Problem **OPEN**

No BMP in place during construction

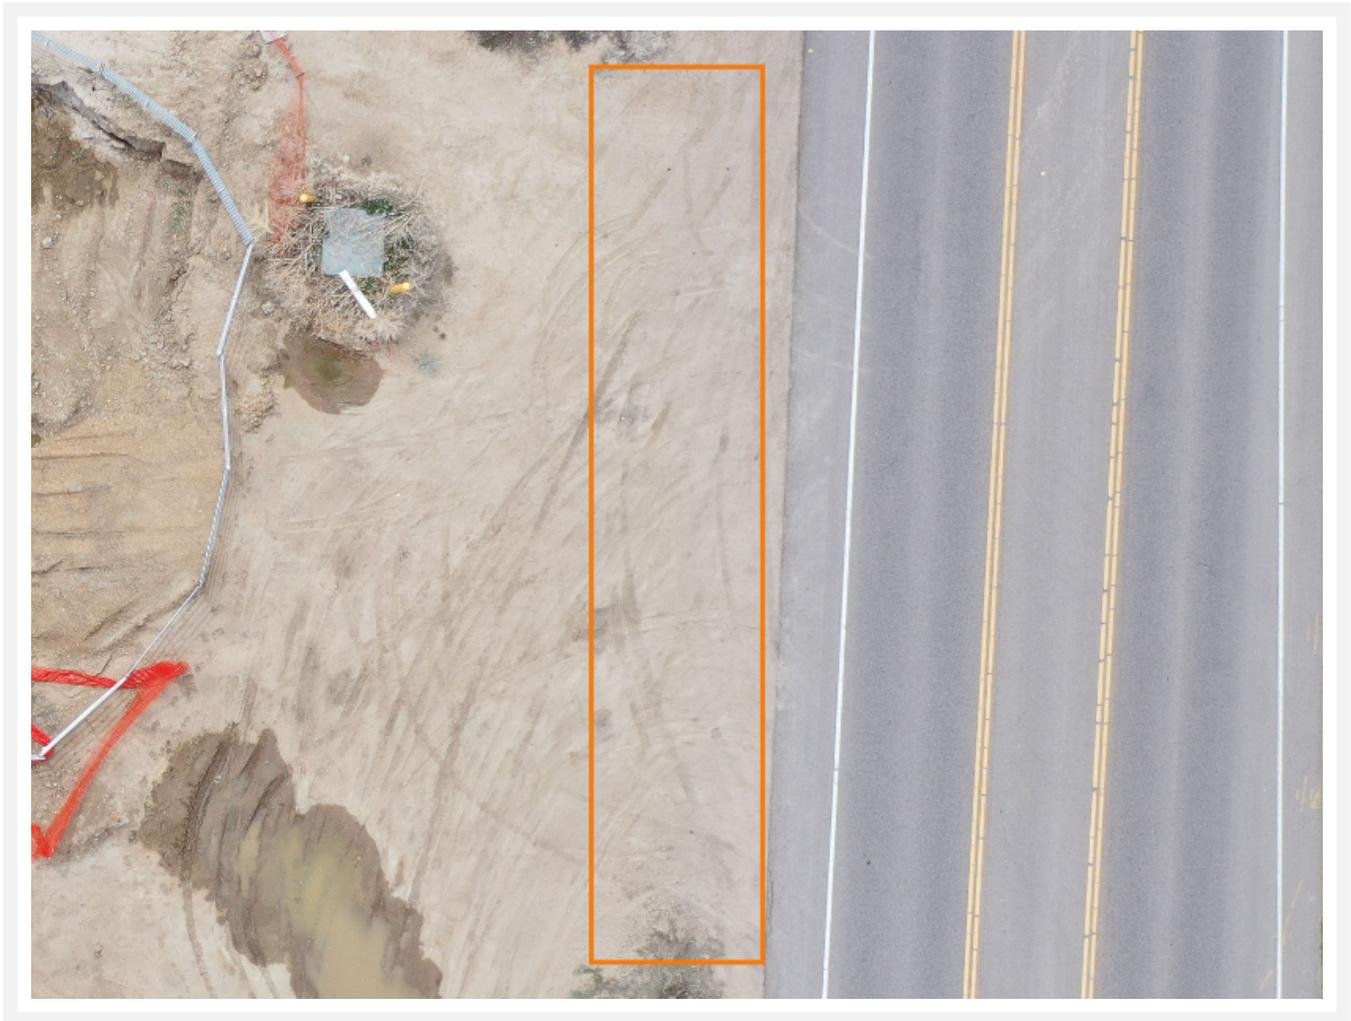
3 - Other **OPEN**

Summary
No vehicle tracking pad

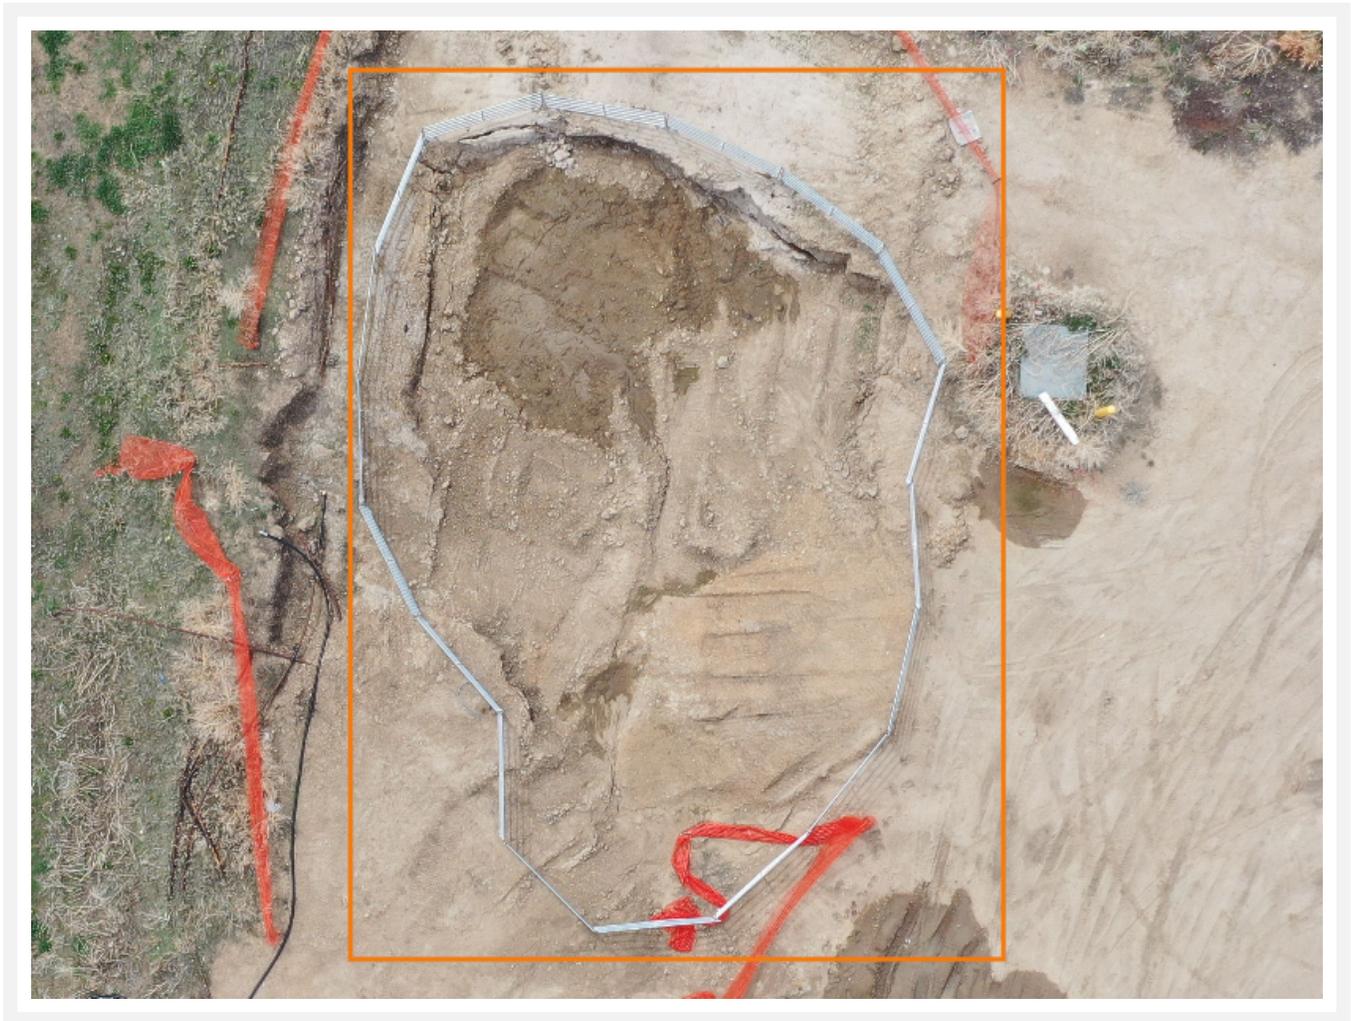
4 - Other **OPEN**

Summary
Improper fencing for safety

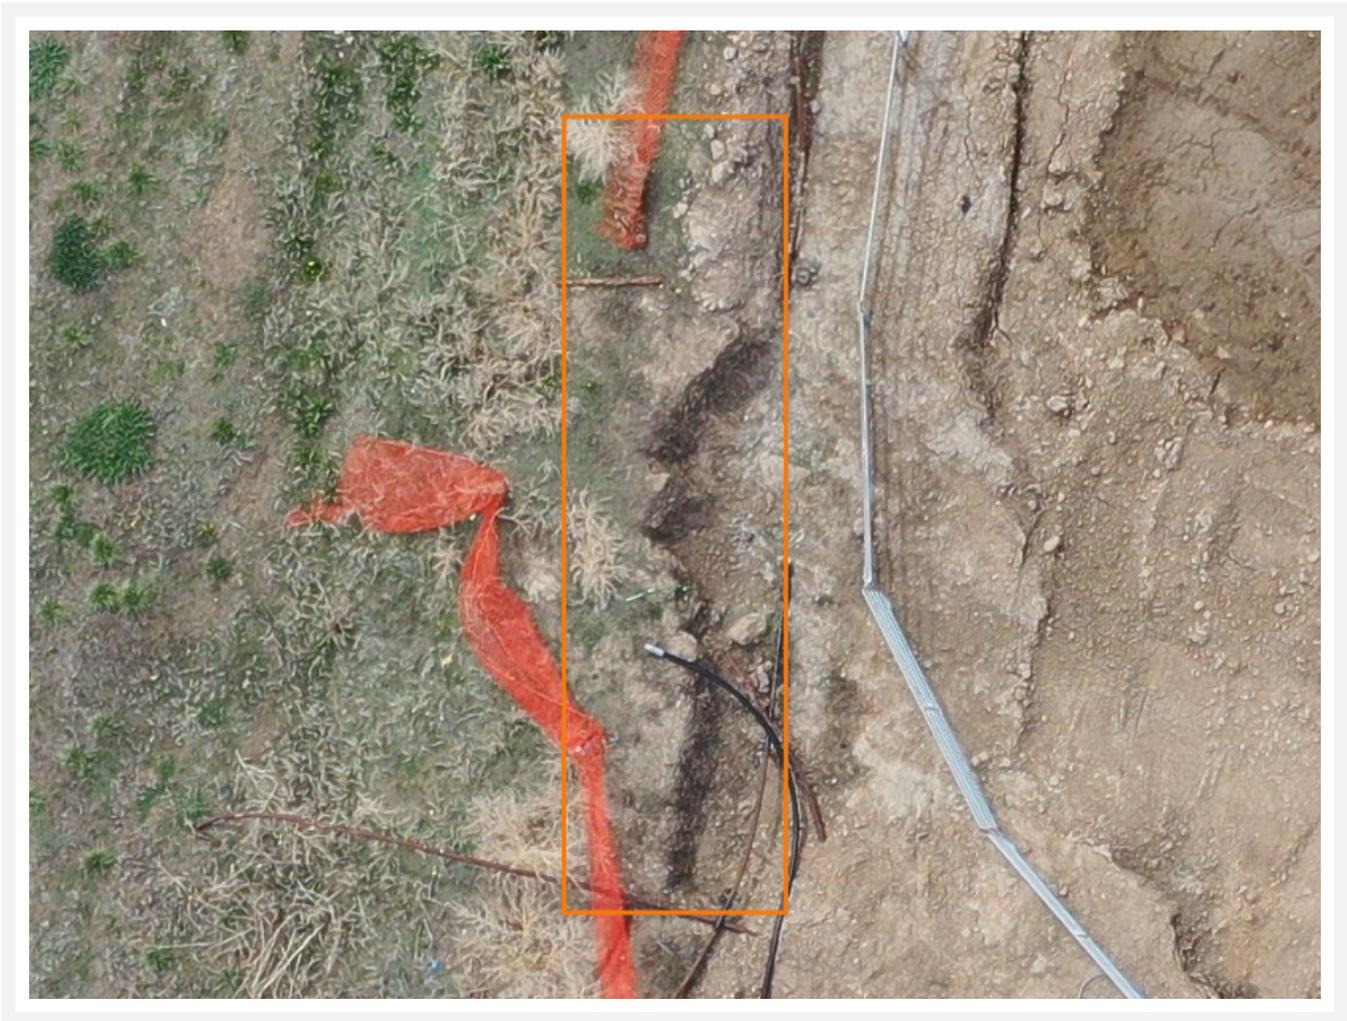
5 - Other **OPEN**

Summary
Improperly capped or secured flow lines

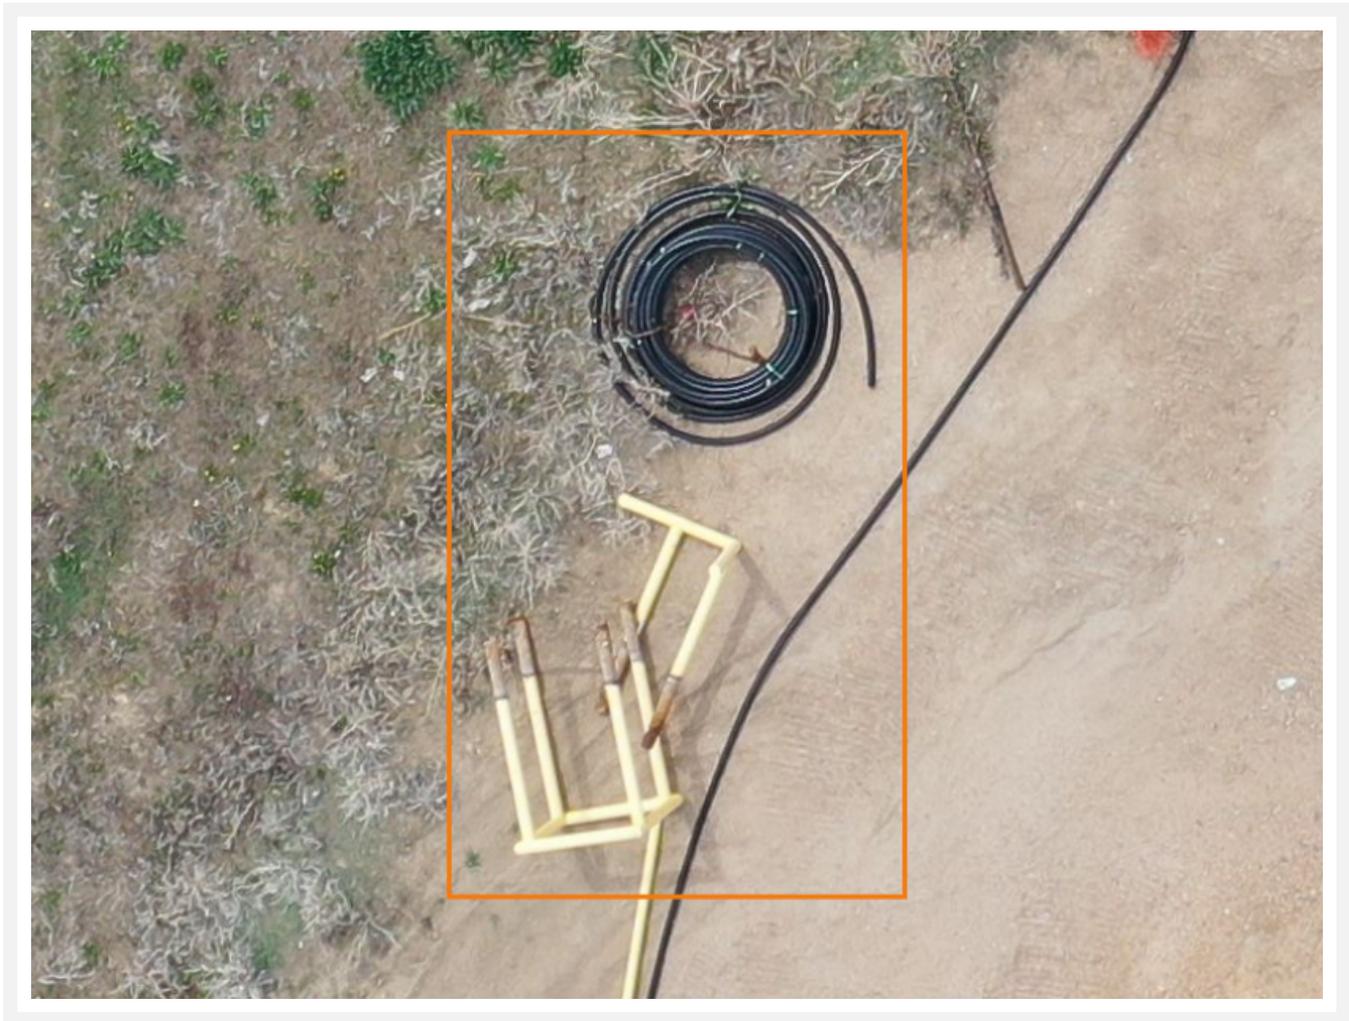
6 - Other **OPEN**

Summary
Unused Equipment

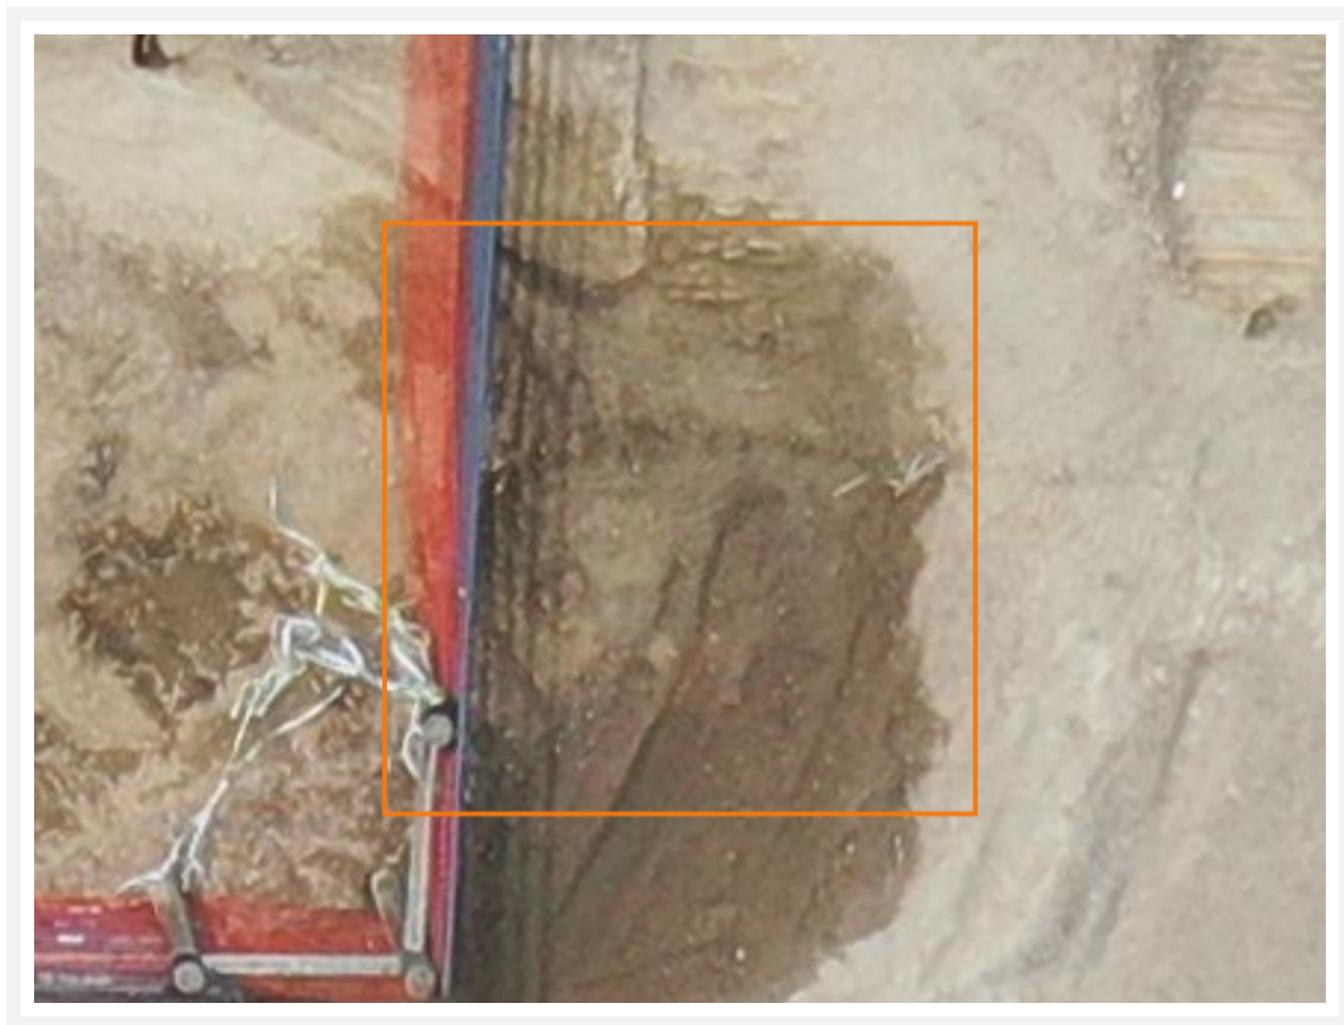
7 - Other **OPEN**

Improper fencing safety , Improper slopping or benching of open excavation. equipment and fencing is with in 2' of excavation. possible ground water contamination by improperly capped flow line

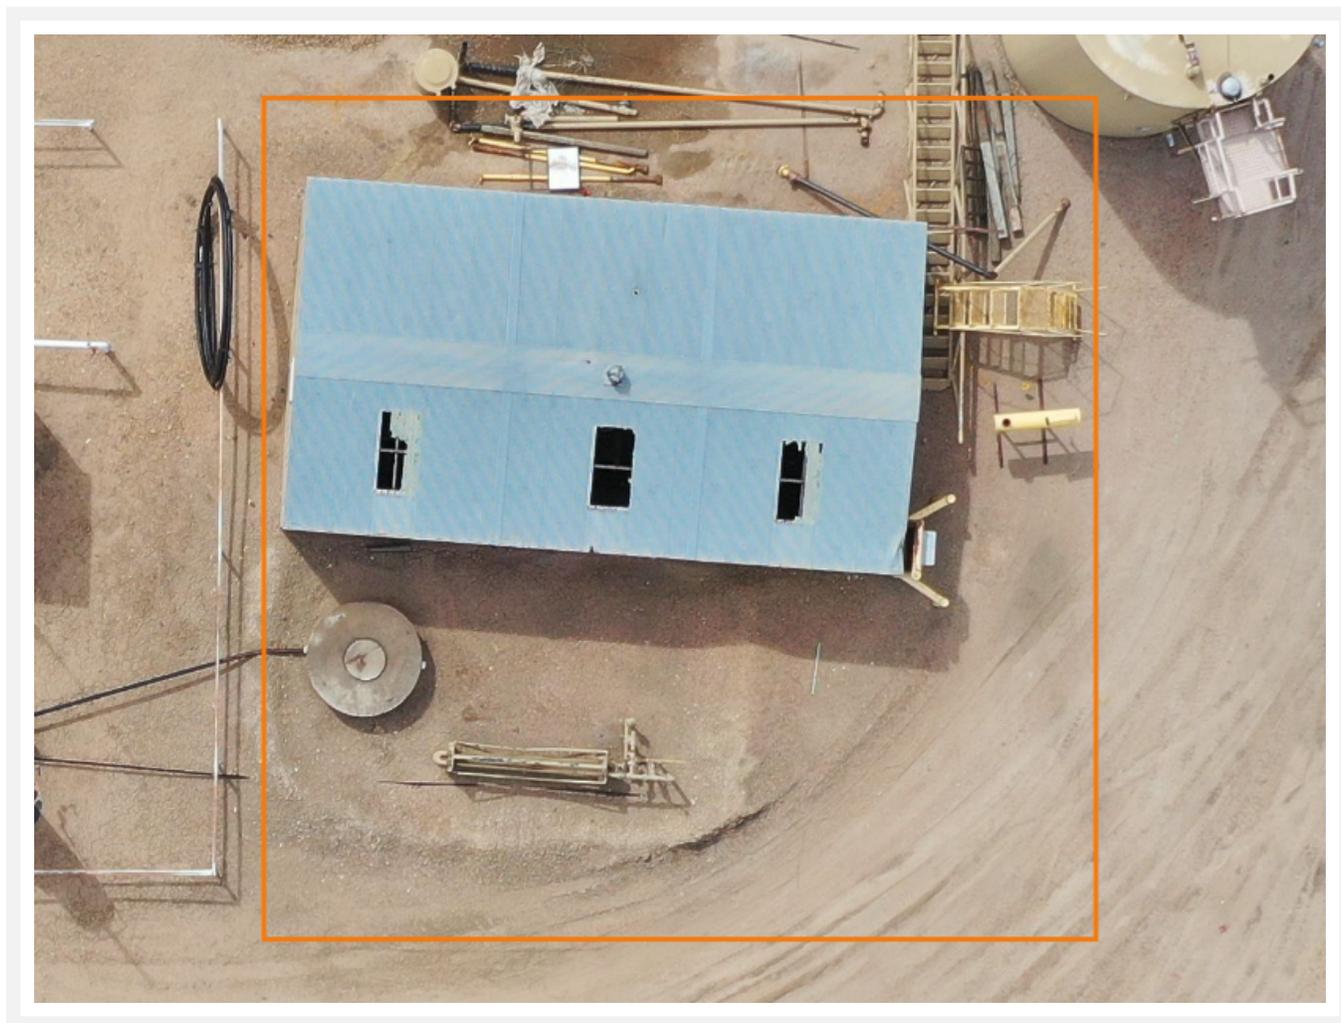
8 - Other OPEN

Improper loc out tag out on electrical panel. area not fenced for public protection. Stained soil in building unused equipment

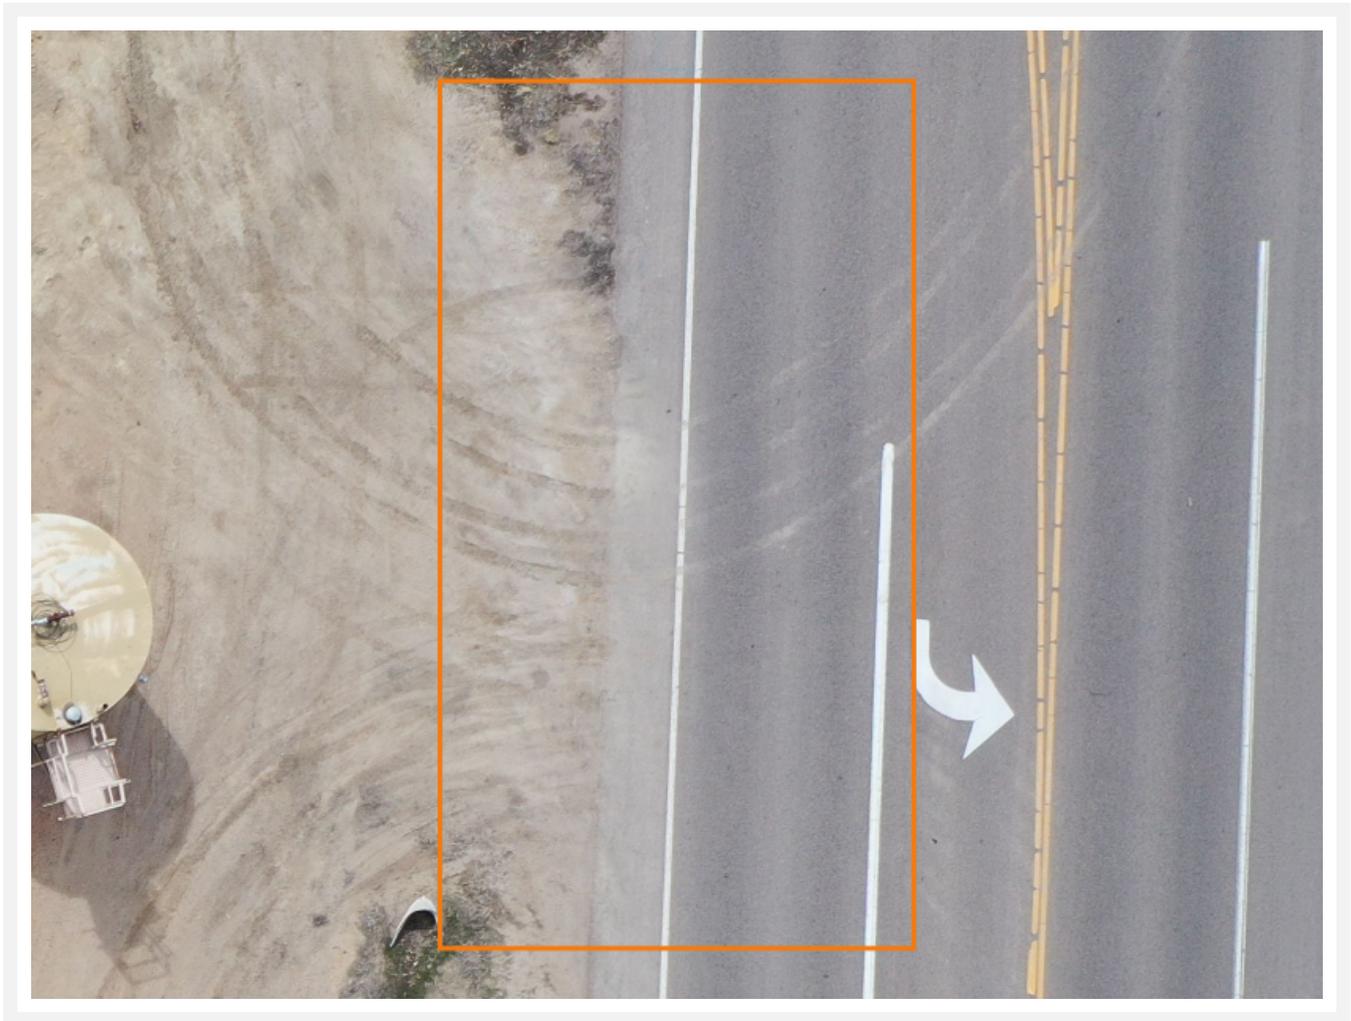
9 - Other **OPEN**

Summary
no vehicle tracking pad vehicle tracking on road way

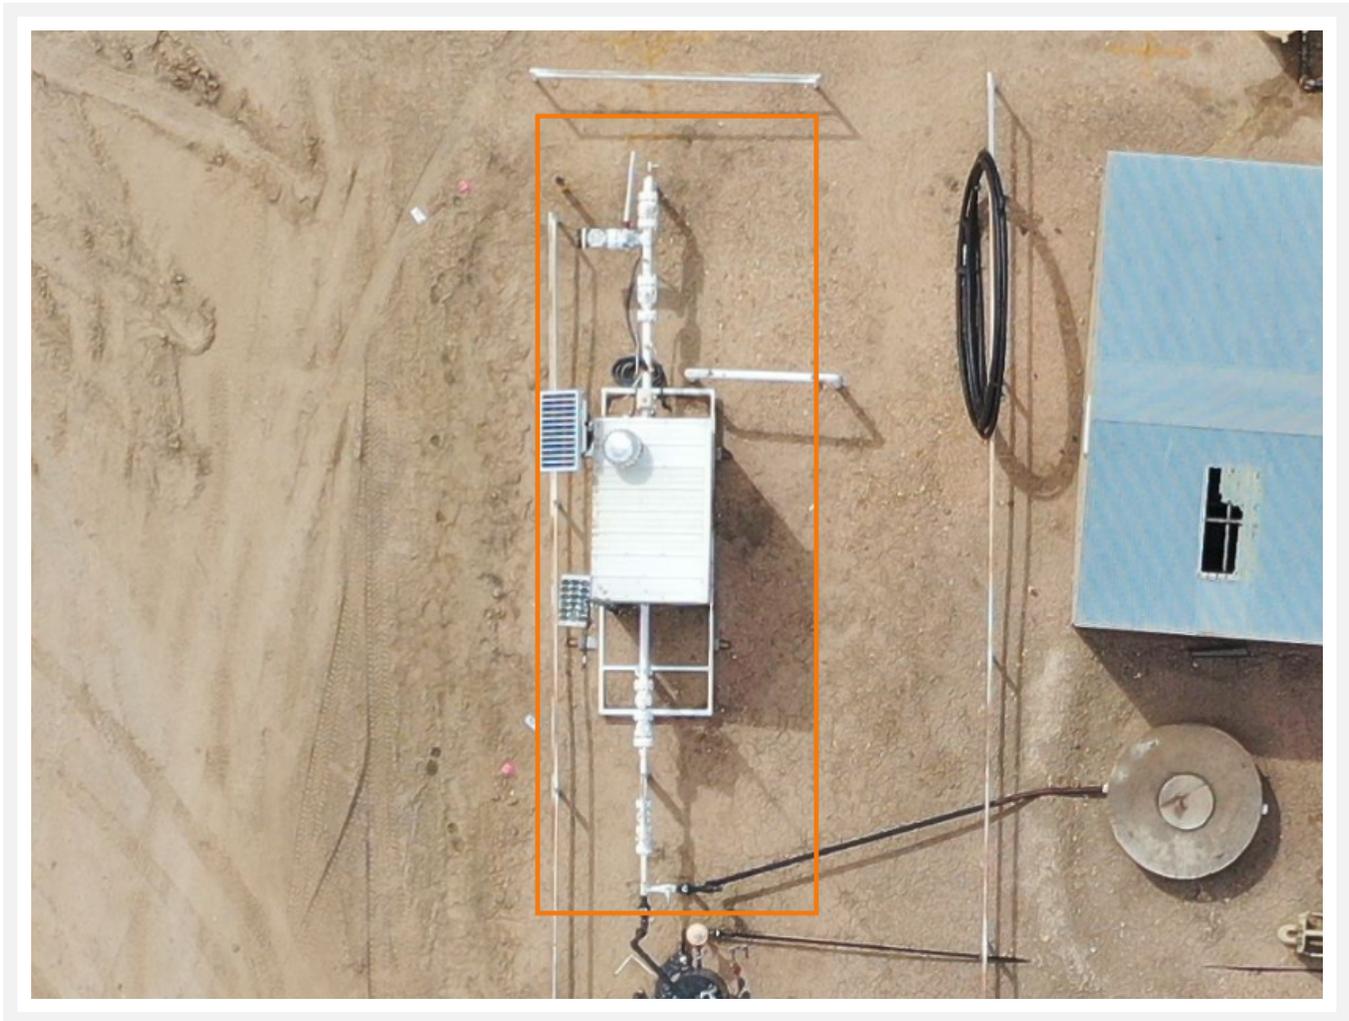
12 - Other **OPEN**

Summary
Meter not calibrated no lock out tag out
