Inspection Photos

Location Name: CAERUS PICEANCE LLC ORCHARD-68S96W /10NWSE

Location ID: 312690

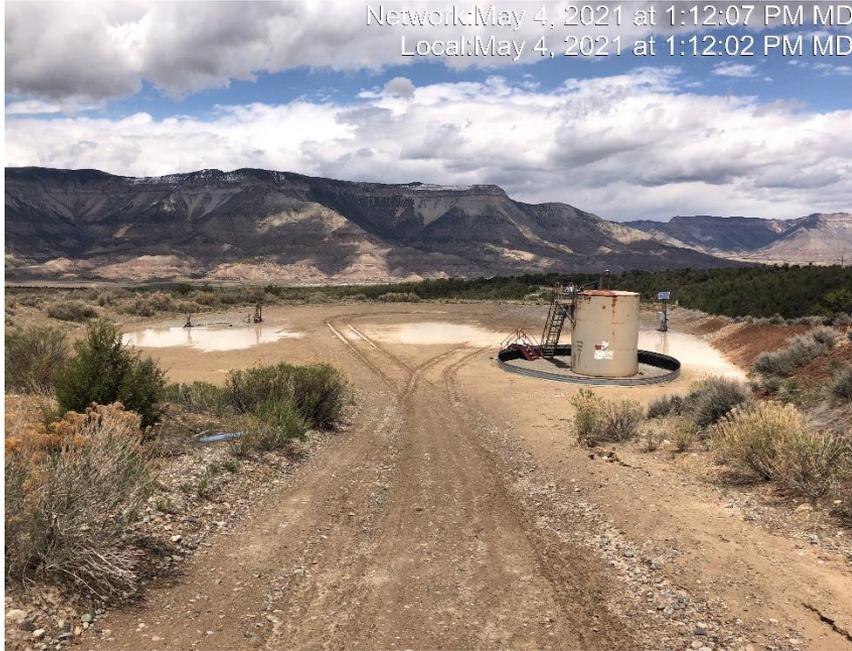
Photo #3690 from entrance to location.

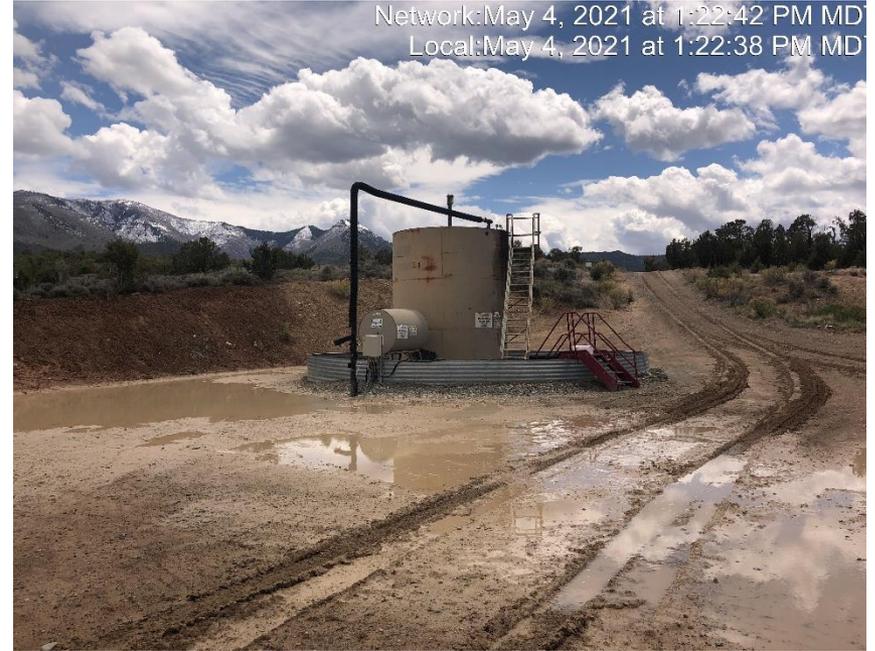
Photo #3696 No tank battery sign located at tank battery.

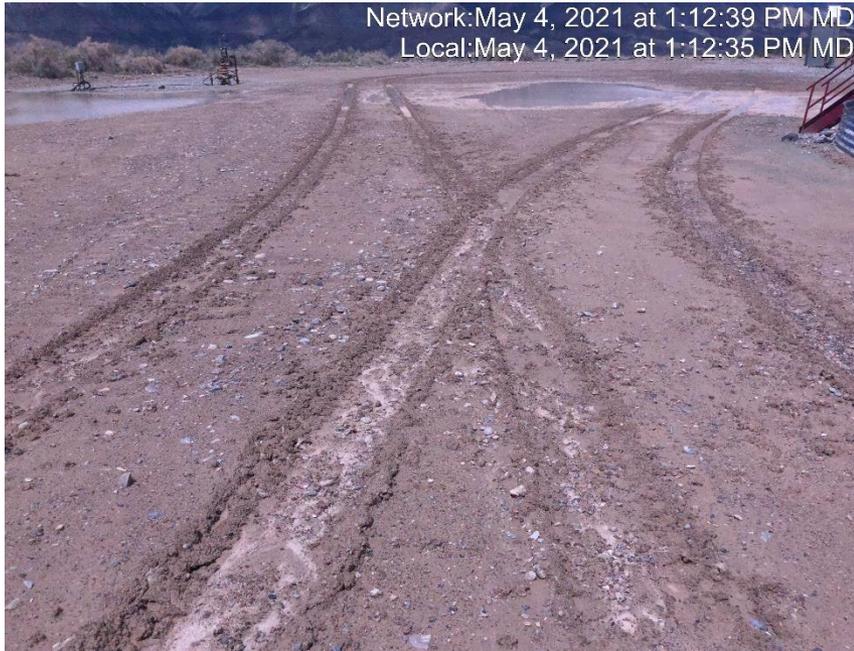
Photo #3691 Location lacks stabilization.

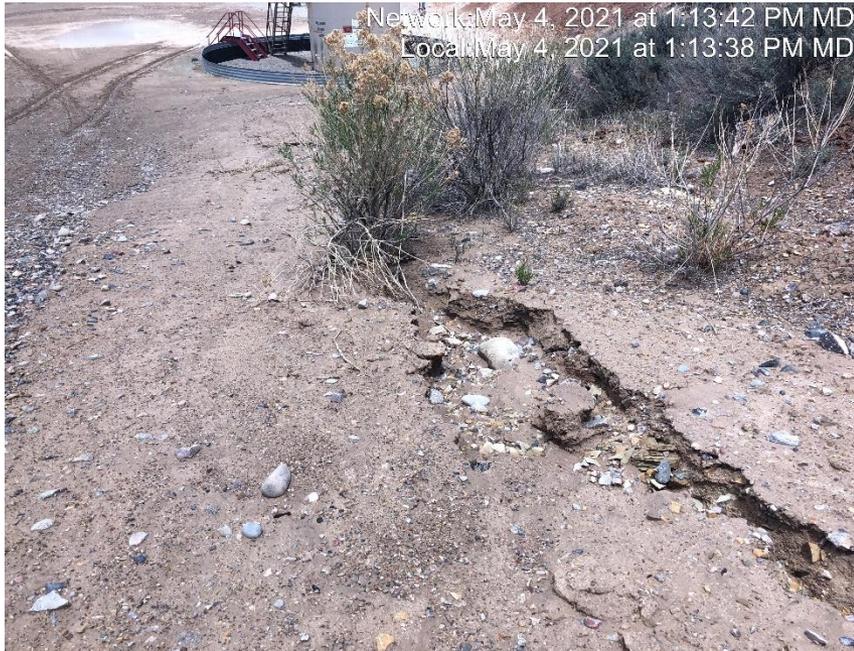
Photo #3694 Gully erosion occurring on Eastside of access road.

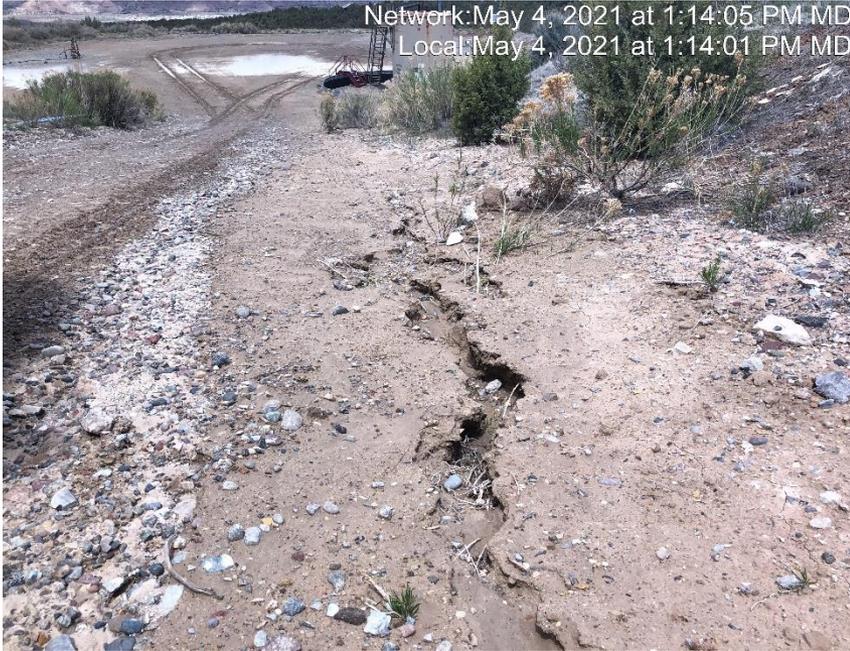
Photo #3695 Run on to location is not being controlled.

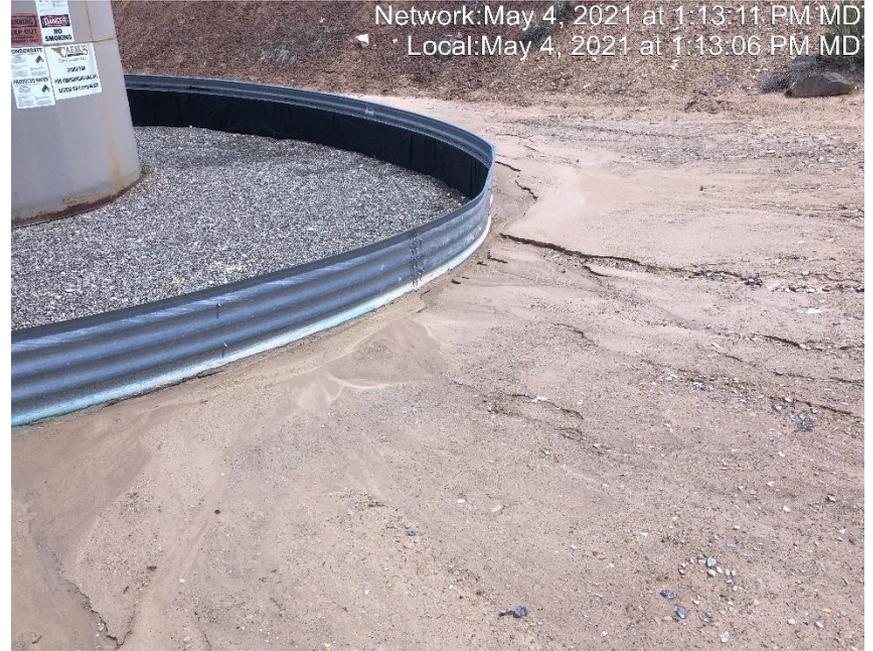
Photo #3693 Sediment is encroaching on tank containment.

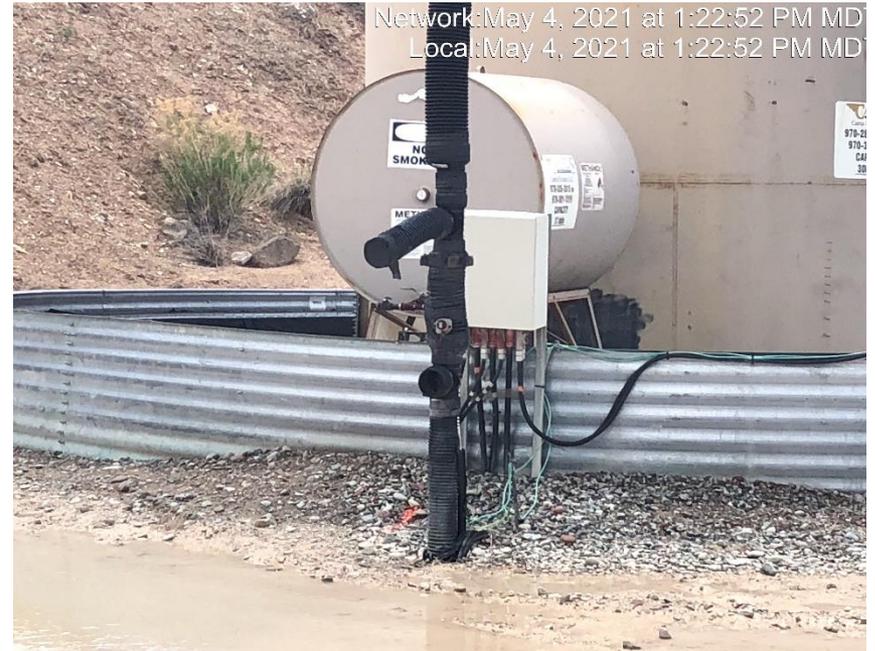
Photo #3697 Heating insulation open ended and not capped.

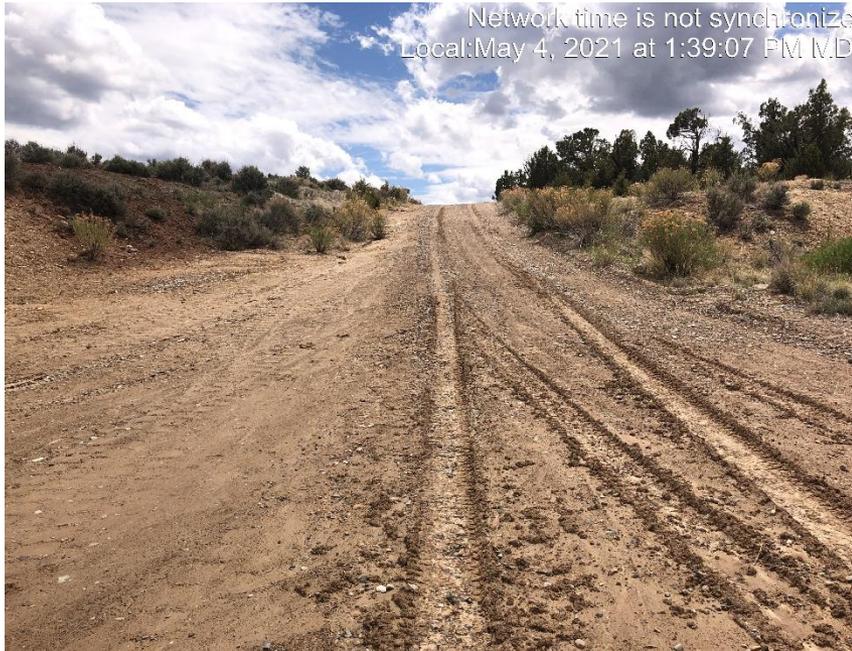
Photo #3698 no form of tracking control at entrance to location.
