**Inspection Photos**  
**UPRR 43 PAN AM G Consolidation #2**  
**Remediation Project #16131/Spill ID 478086 (CL)**

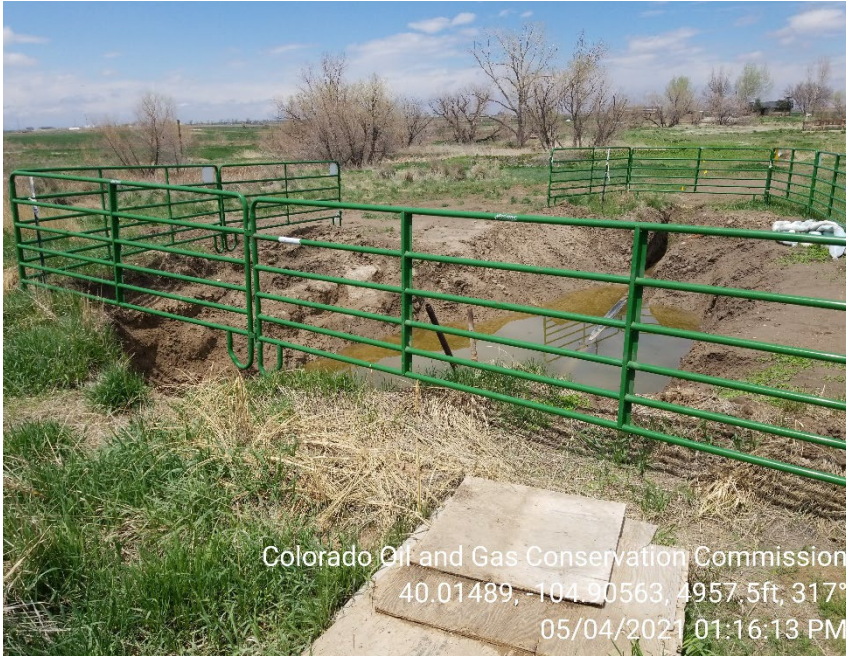
**Photo 1 – Spill area with open excavation.**

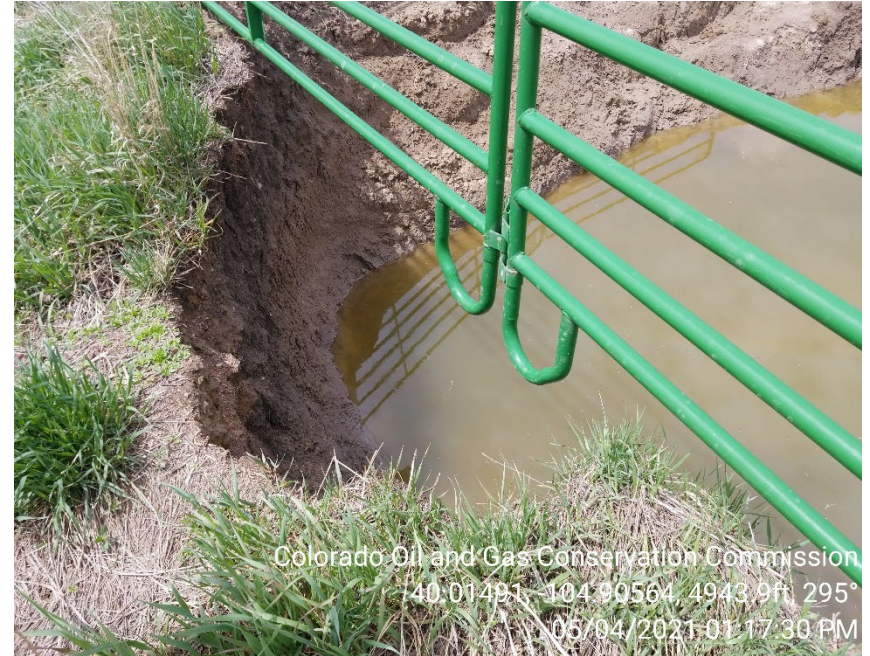
**Photo 2 – Fencing around open excavation does not adequately protect access to the site.**

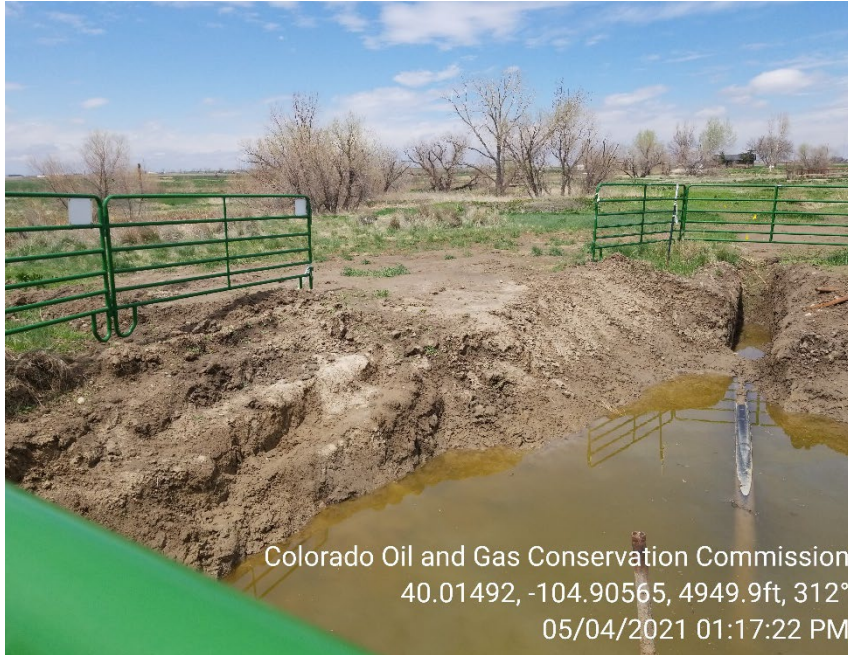
**Photo 3 – Fencing around open excavation does not adequately protect access to the site.**

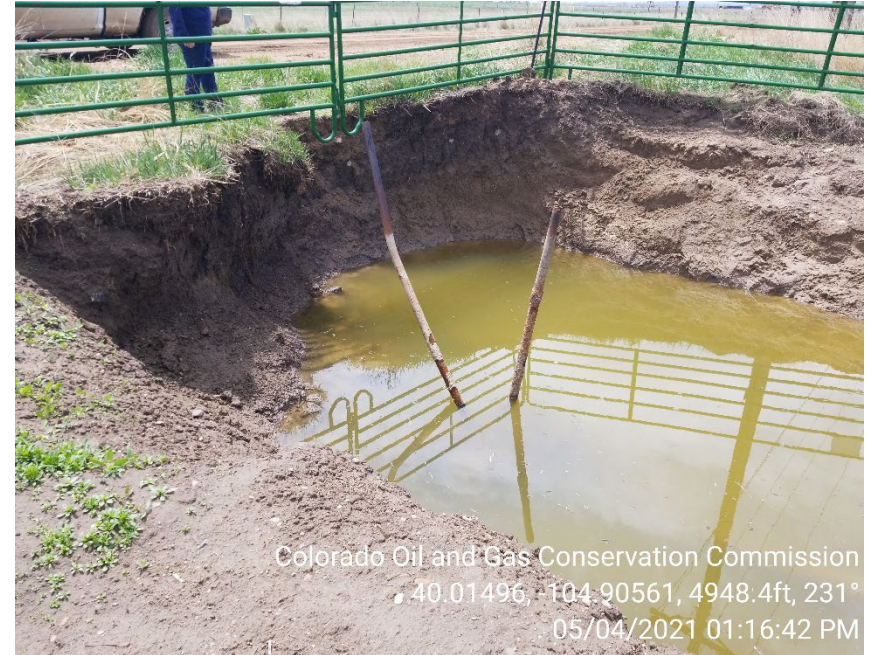
**Photo 4 – Open excavation. Impacts appear to remain in situ. Hydrocarbon sheen observed on groundwater.**

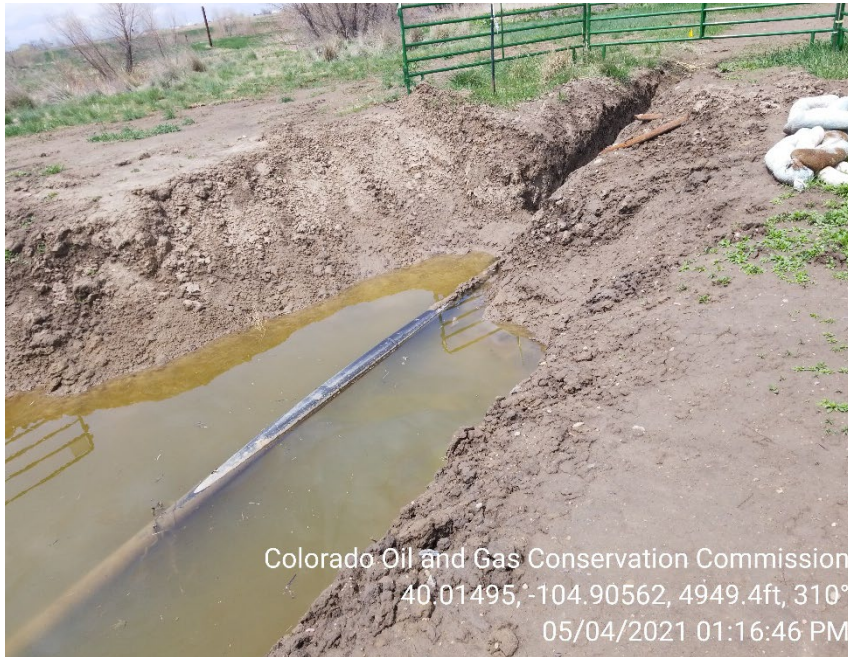
**Photo 5 –Open excavation. Hydrocarbon sheen observed on groundwater.**

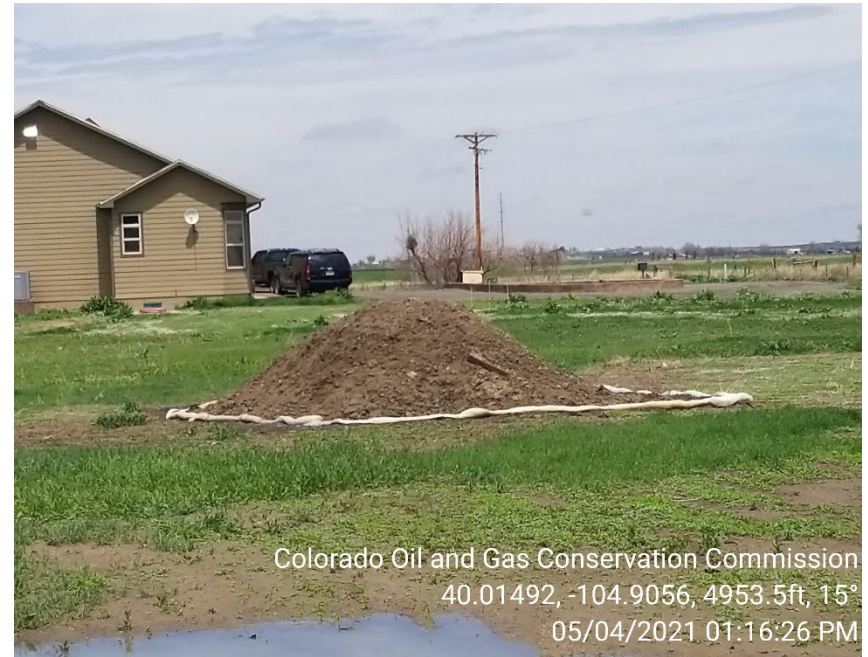
**Photo 6 – Soil stored on location. Lining present under soil stockpile but BMPs are inadequate to prevent stormwater runoff.**

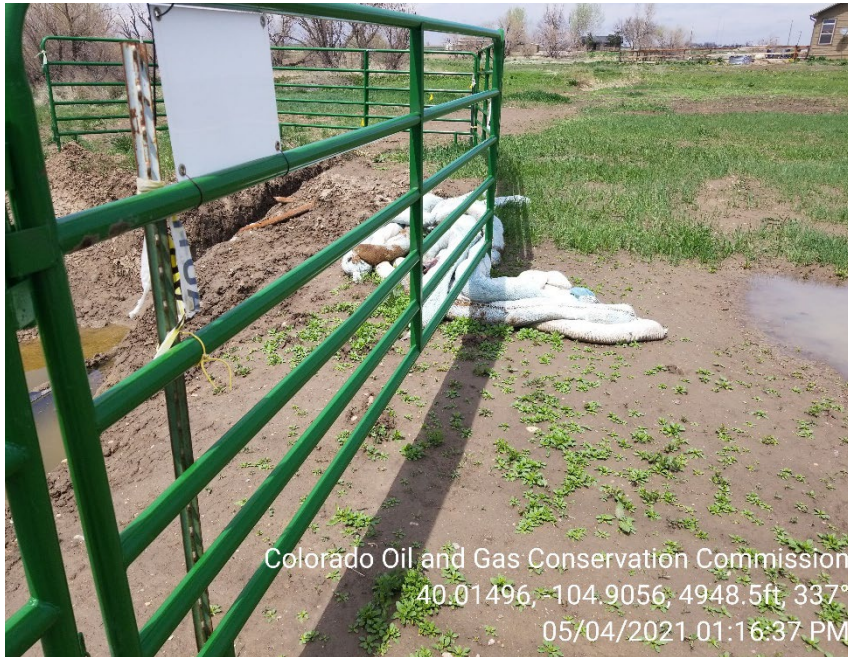
**Photo 7 – Trash on location.**

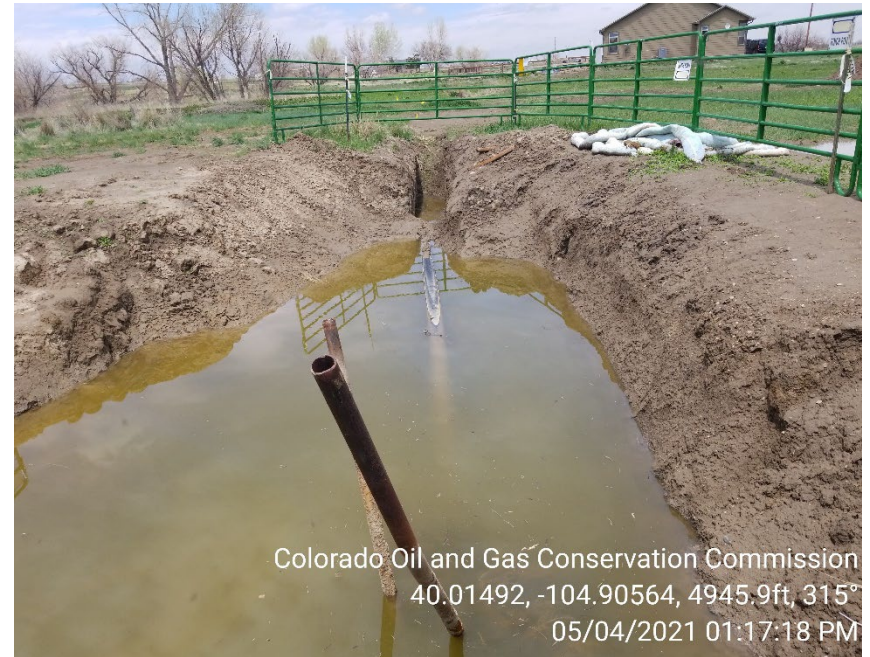
**Photo 8 – Trash on location.**
