Inspection Photos
KIEFER GEORGE W UT B #1A
Spill ID 479618 (AC)

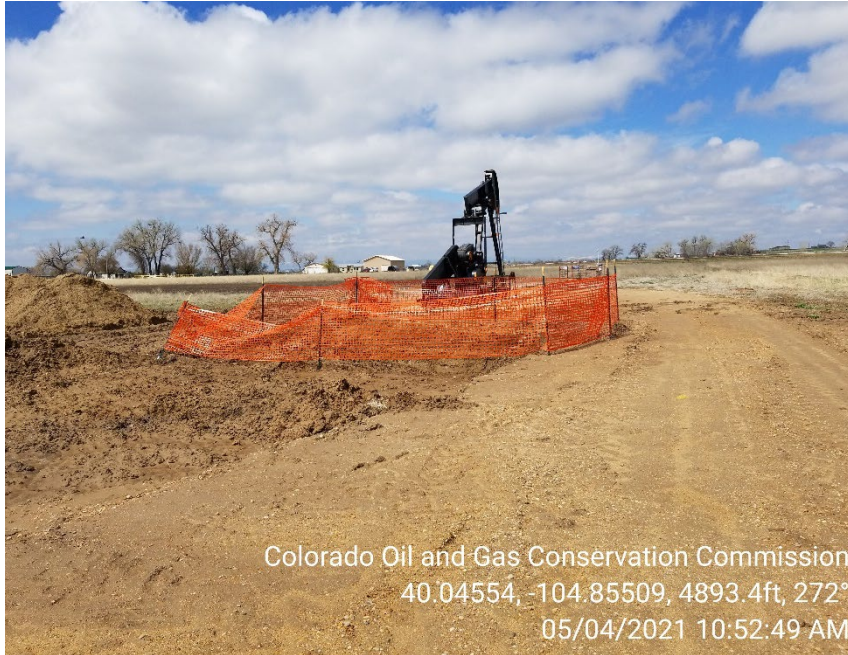
Photo 1 – Spill area. Fencing repaired around open excavation.

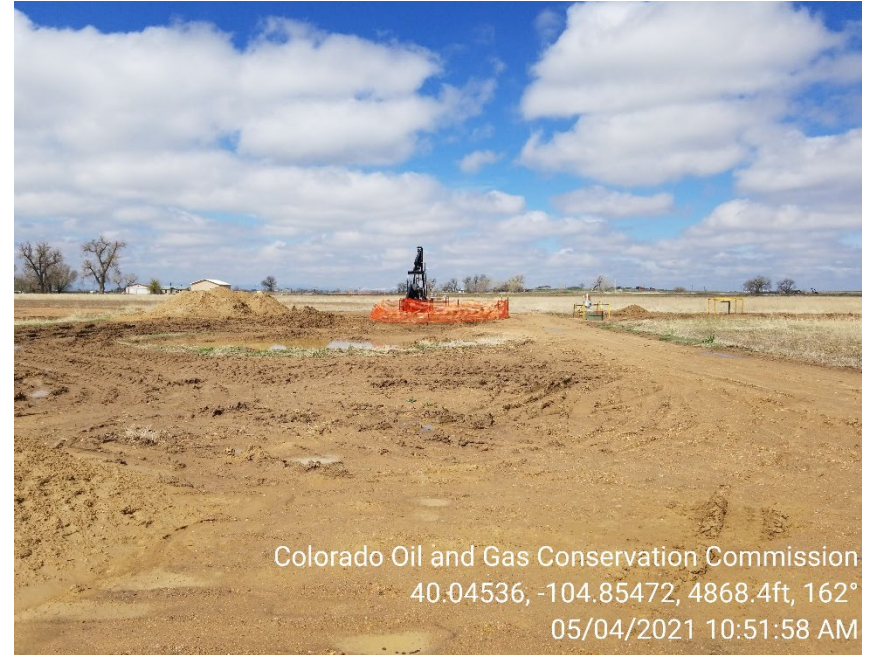
Photo 2 – Spill area. Area of surface scraping/disturbance extends east of open excavation.

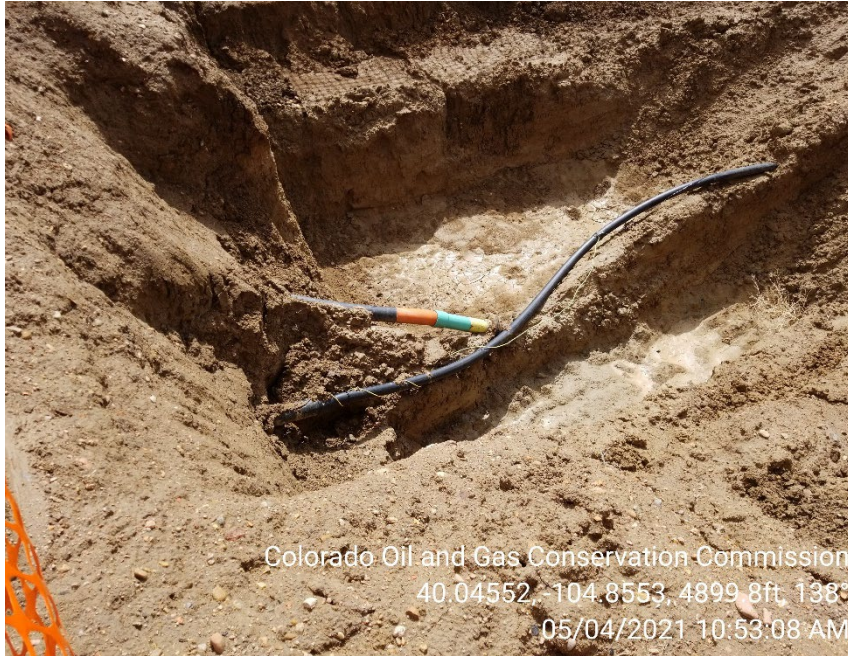
Photo 3 – Open excavation.

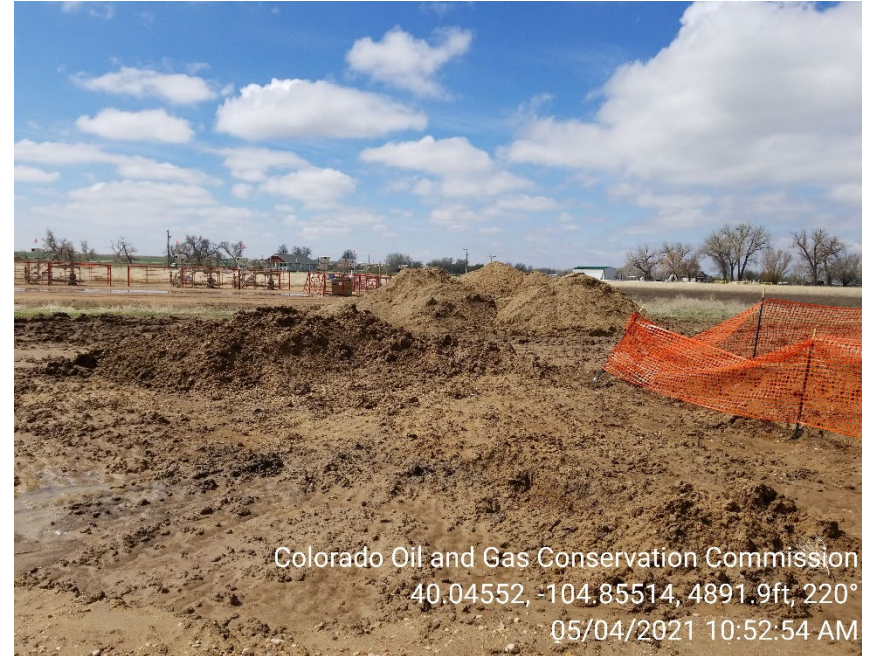
Photo 4 – Soil stored on location with inadequate BMPs.
