Inspection Photos

API: 009-06082

Operator: DOVER ATWOOD CORPORATION

Inspection Date: 5/5/2021

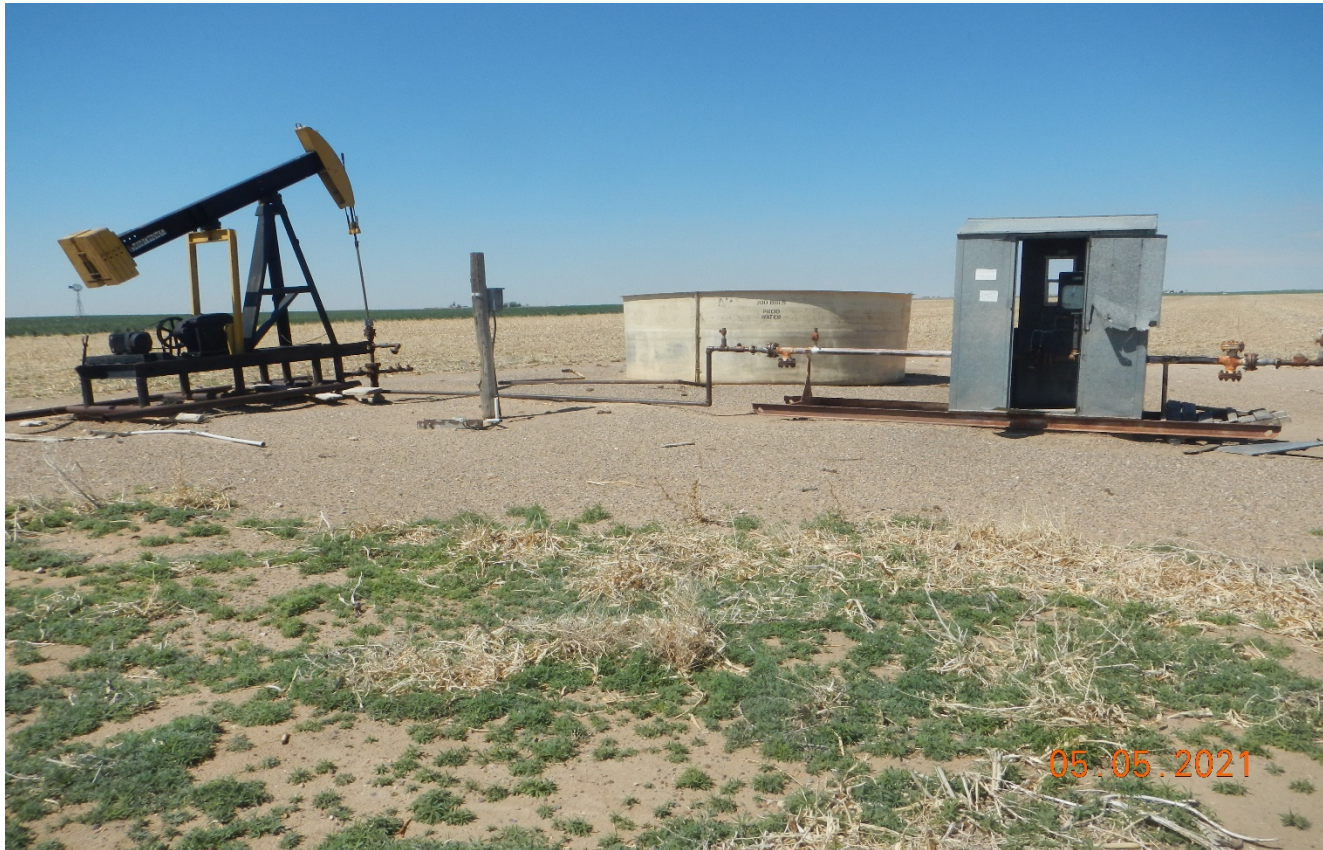
Photo 1. Facing east toward the location..

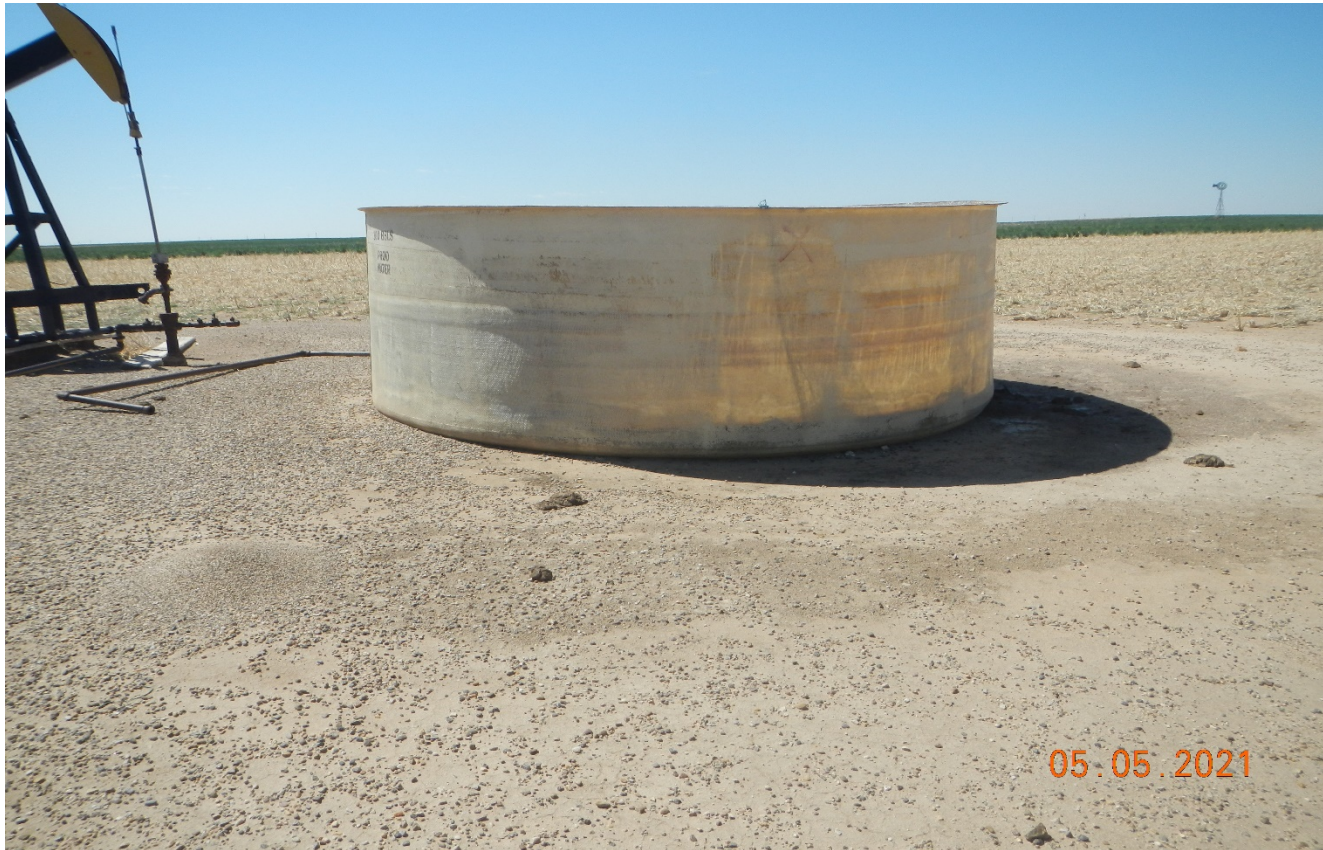
Photo 2. Missing tank NFPA labeling and missing INFO per 605.h..

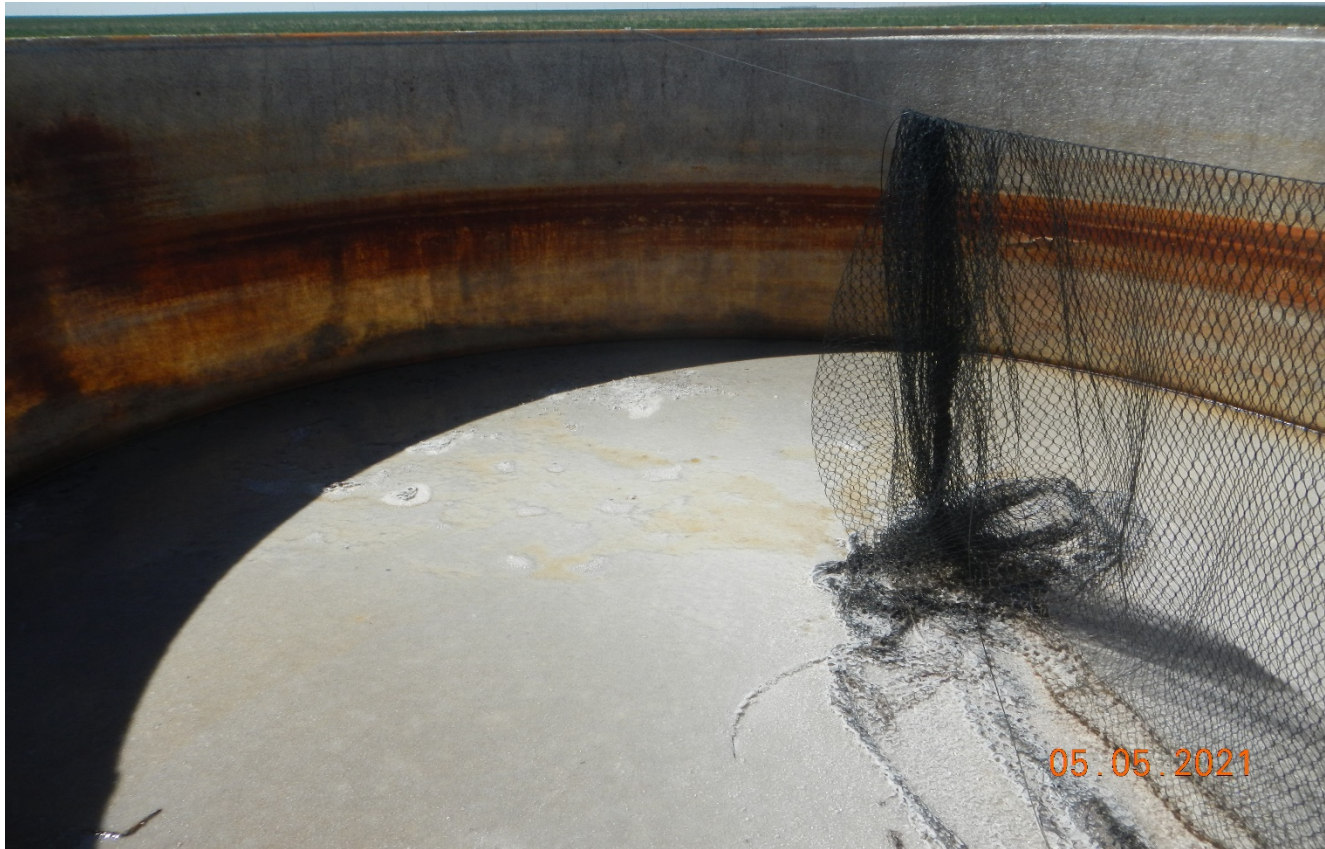
Photo 5. View of fluids inside the tank. Tank is labeled Produced Water. It appears to be solidified salty produced water. The netting on the tank is in disrepair.

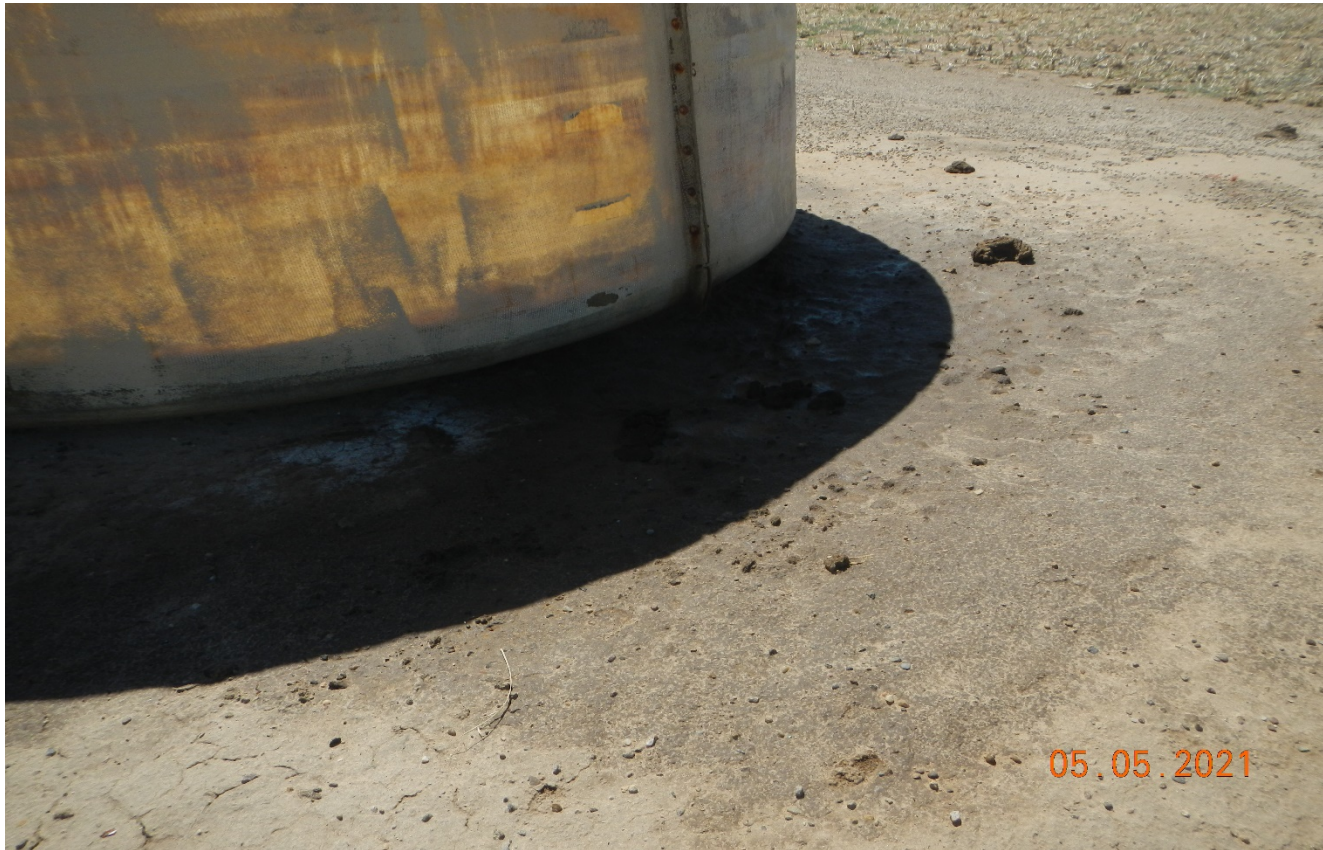
Photo 3. There appears to have been a leak at the tank due to stained soil in this area. If tank contains produced salty water, this can impact the soil and crop growth.

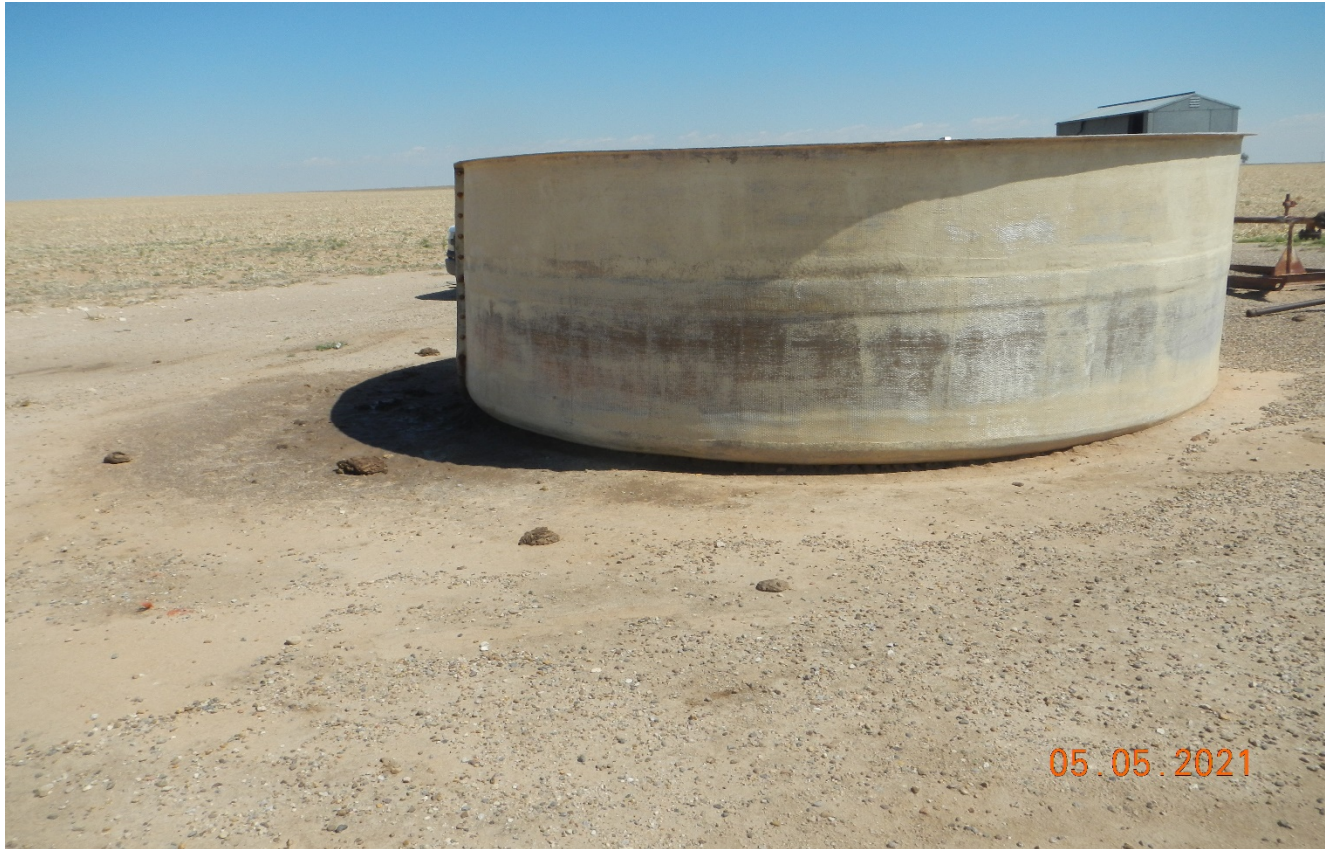
Photo 5. Secondary containment is inadequate to contain 150% of the volume of the tank.

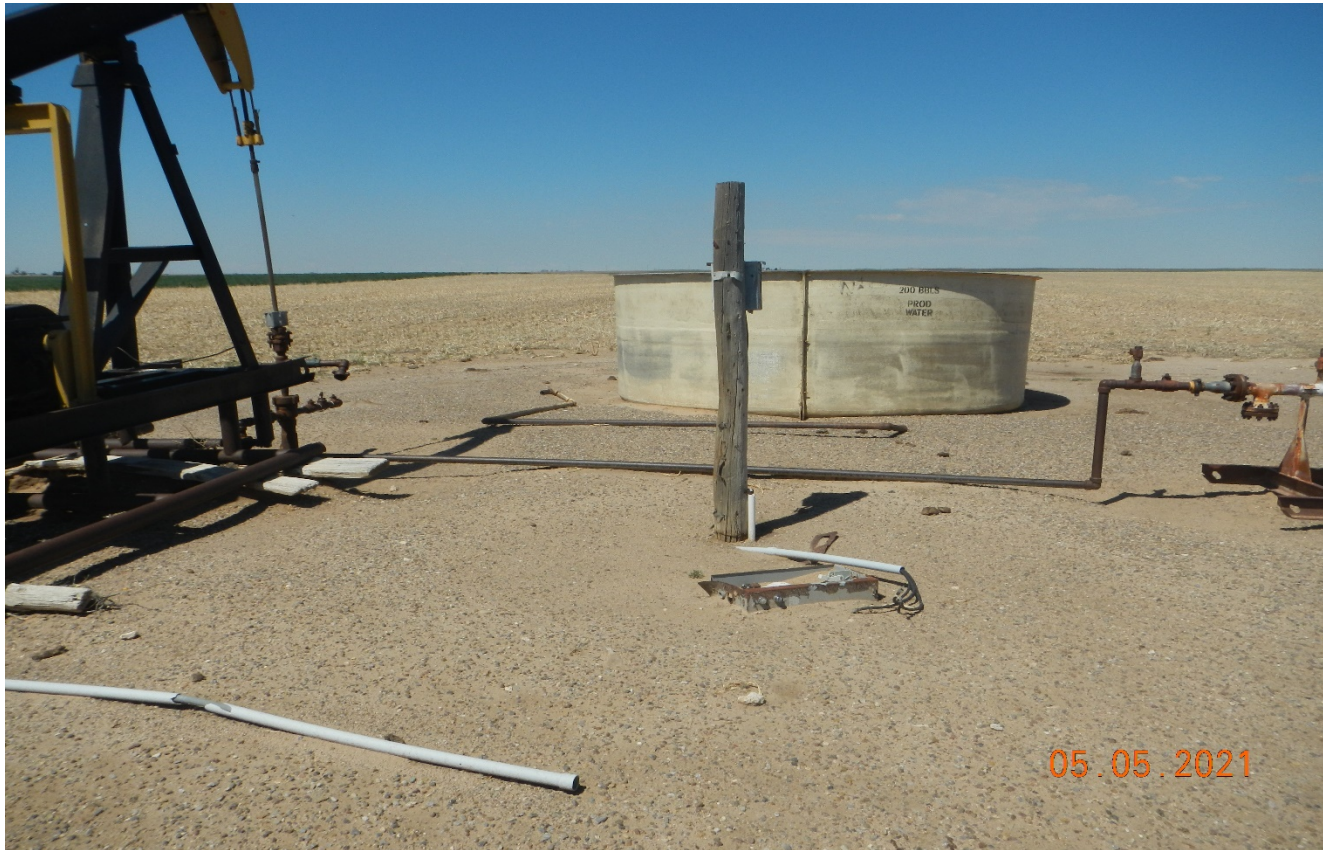
Photo 6. There is exposed electrical wire on the ground and panel box. All unused supplies and equipment need to be removed.

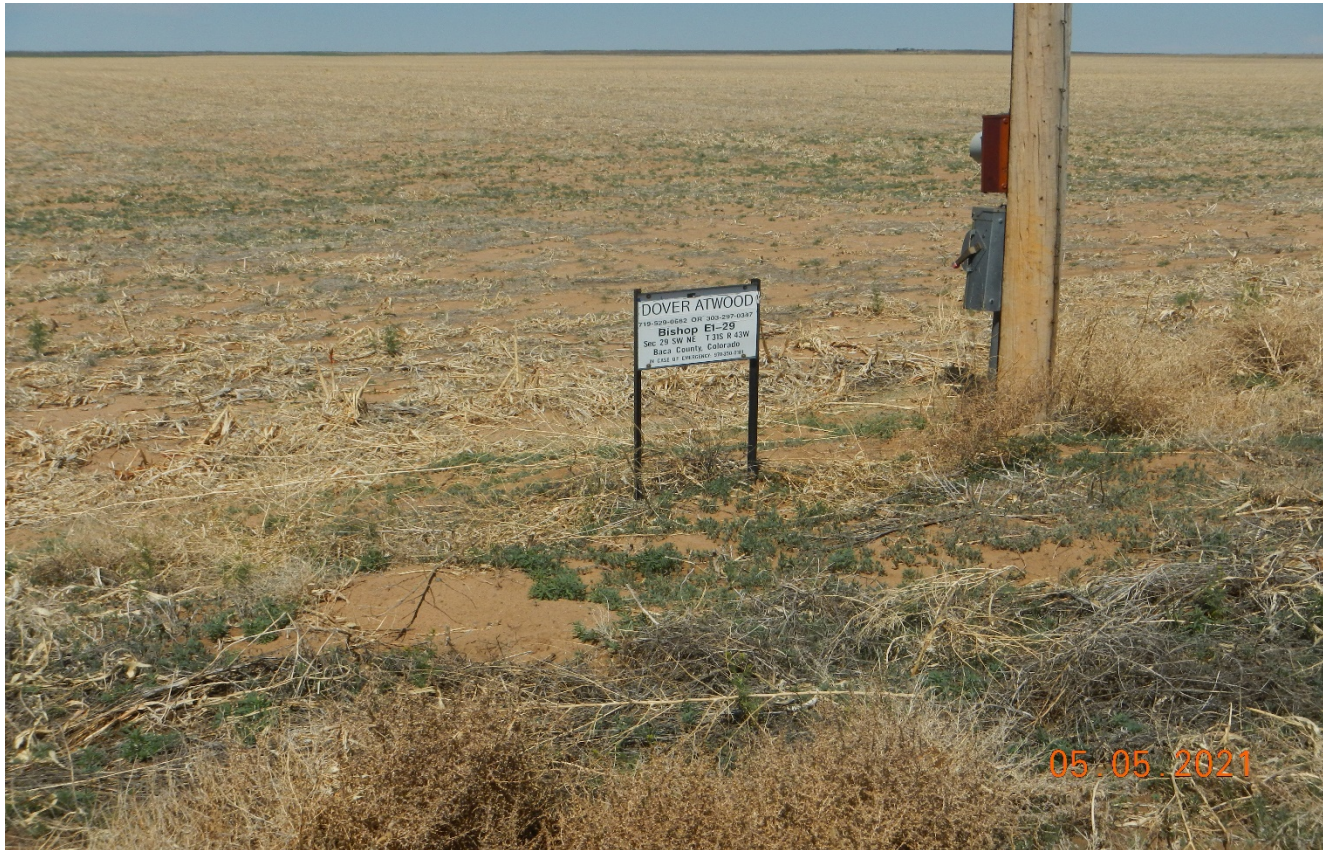
Photo 7. Well sign is located at beginning of the access road. The sign needs to be posted at the wellhead.
