Inspection Photos

API: 009-06081

Operator: DOVER ATWOOD CORPORATION

Inspection Date: 5/5/2021

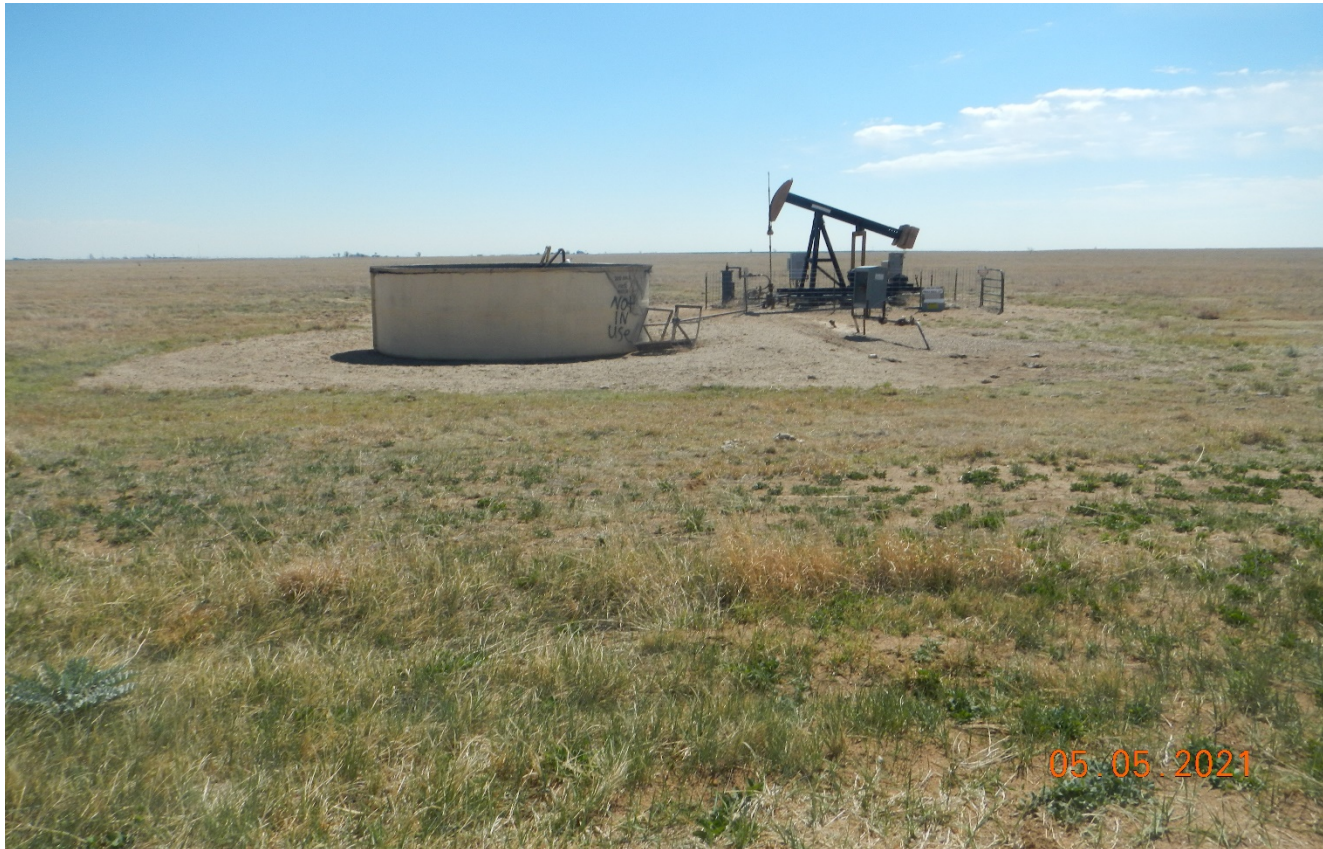
Photo 1. Facing east toward the location..

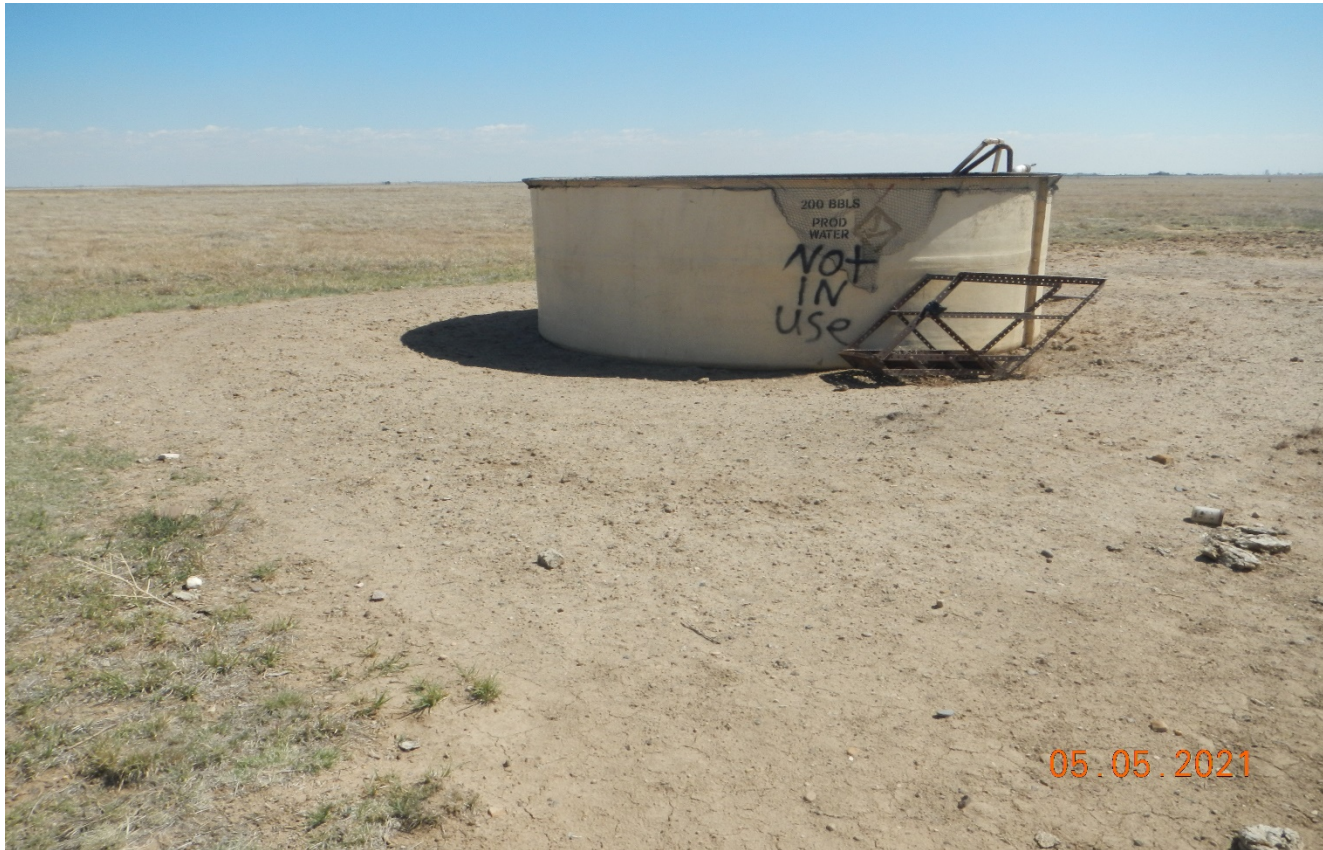
Photo 2. The tank is marked as not in use and labeled Produced Water. Next photo shows oily fluids inside the tank which apparently the tank is in use. Secondary containment is inadequate to contain 150% of the volume of the tank.

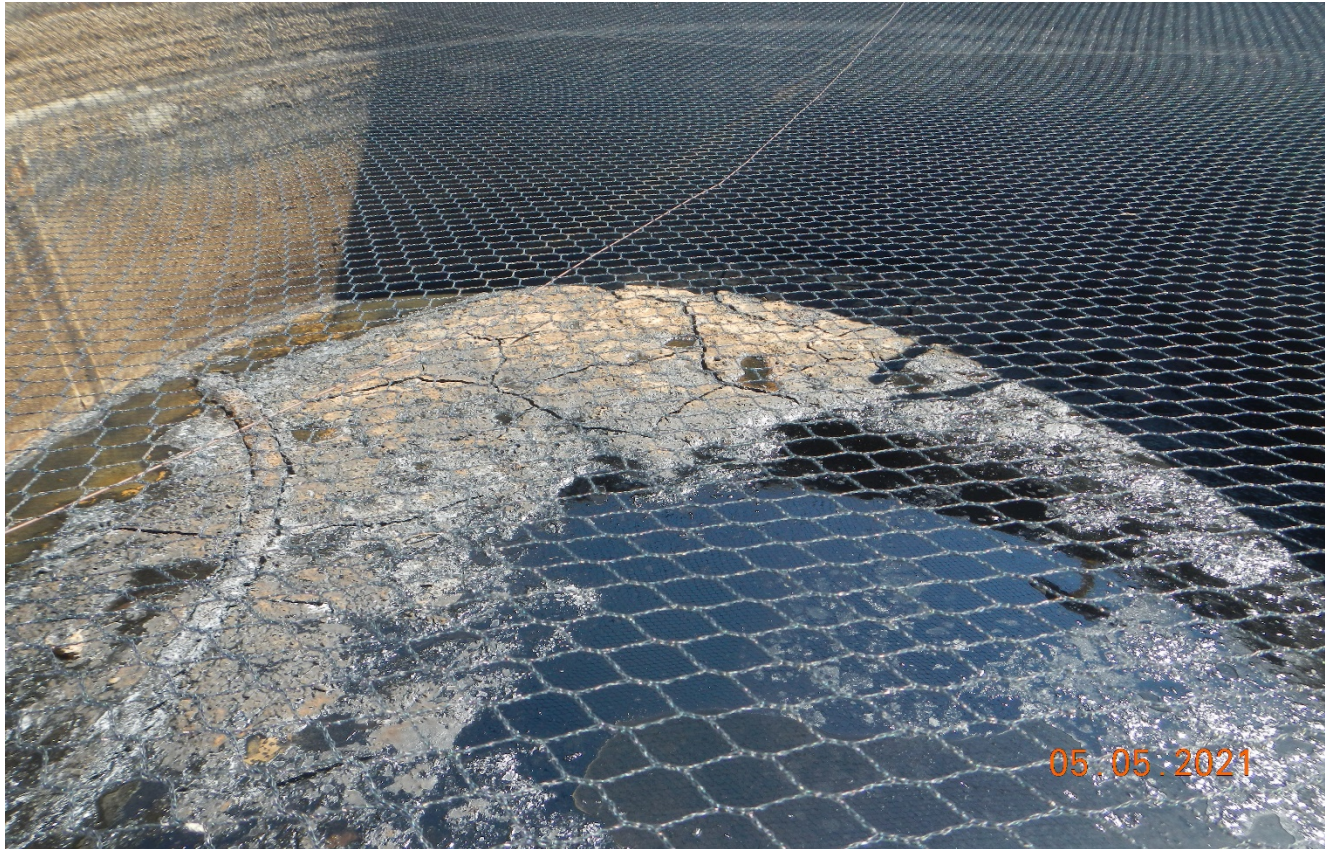
Photo 3. View of oil fluids inside the tank. Tank is labeled Produced Water which is not accurately labeled.

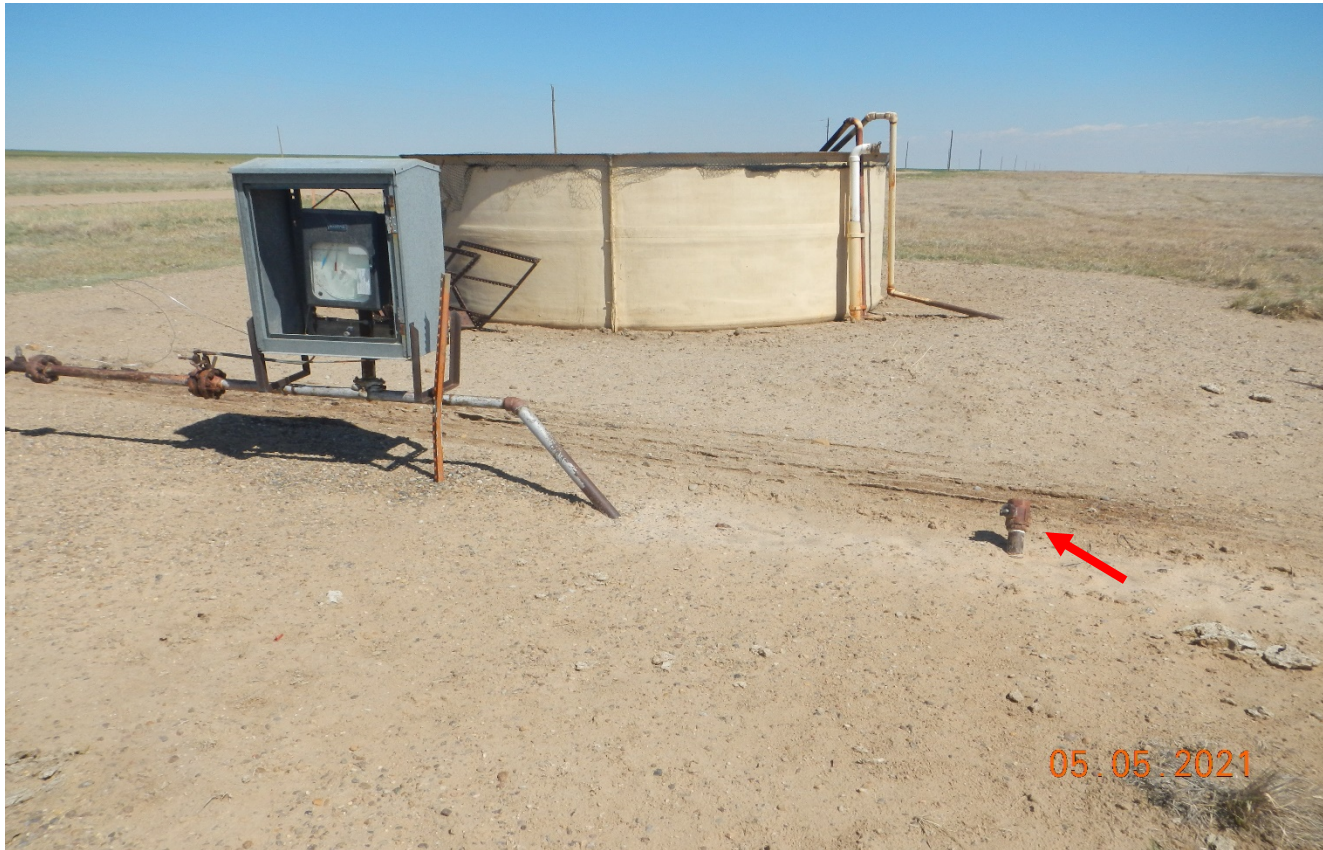
Photo 4. The unused pipe has been removed. There is a pipe riser shown at red arrow with no LOTO.

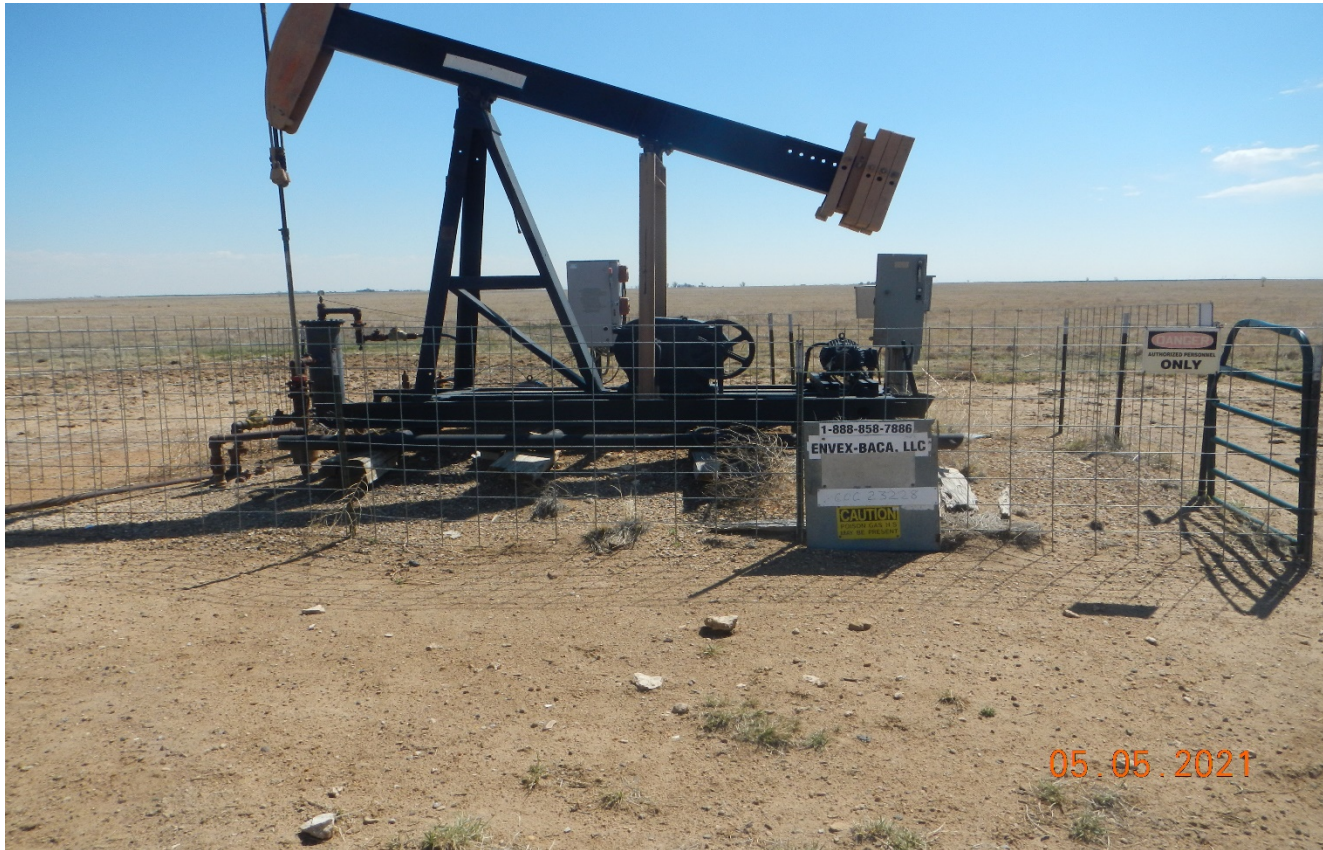
Photo 5. The well sign does not comply with 605. The gate and fence around the pumpjack has been repaired.

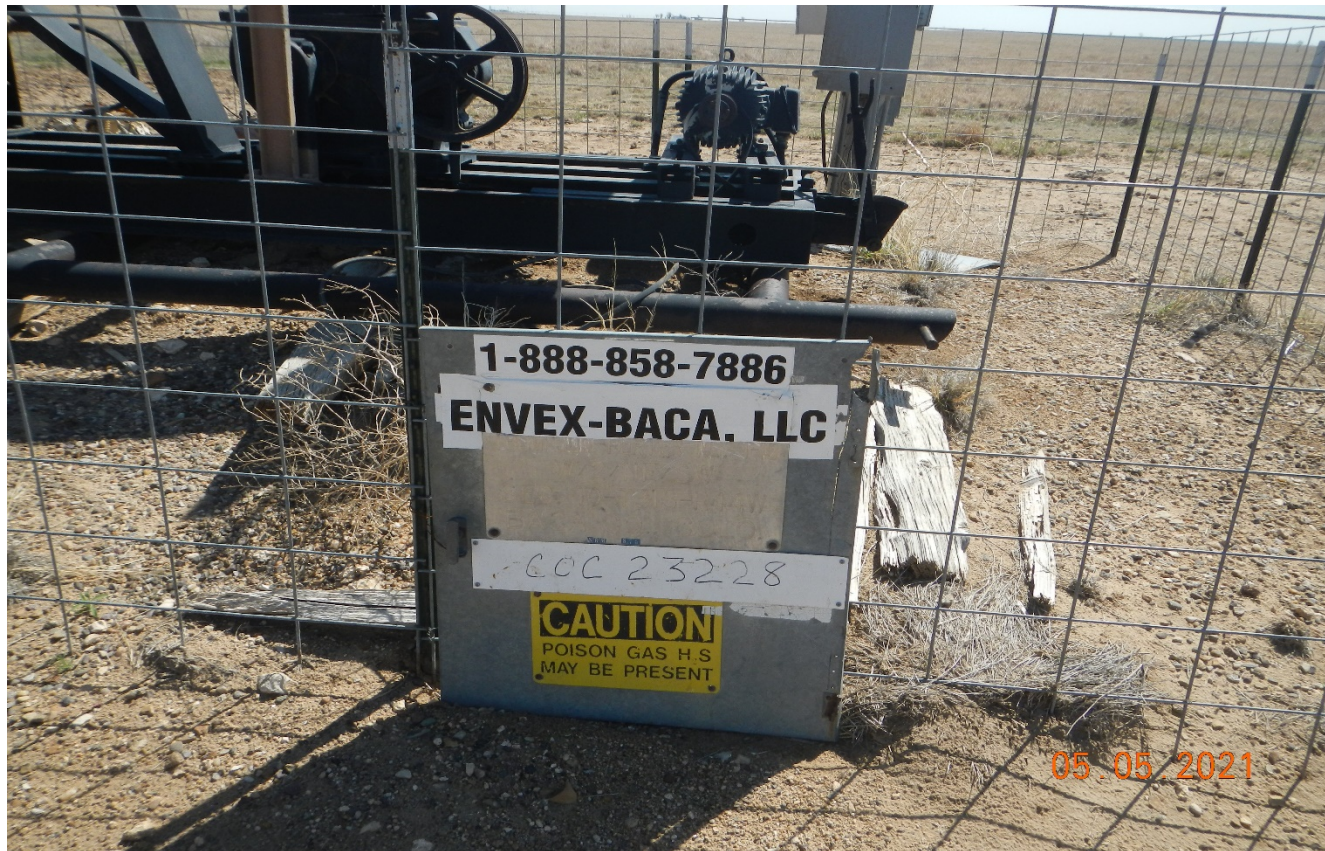
Photo 6. The well sign does not comply with 605. Incorrect Operator name and missing information.
