# Inspection Photos

API: 009-06047

Operator: DOVER ATWOOD CORPORATION

Inspection Date: 5/5/2021

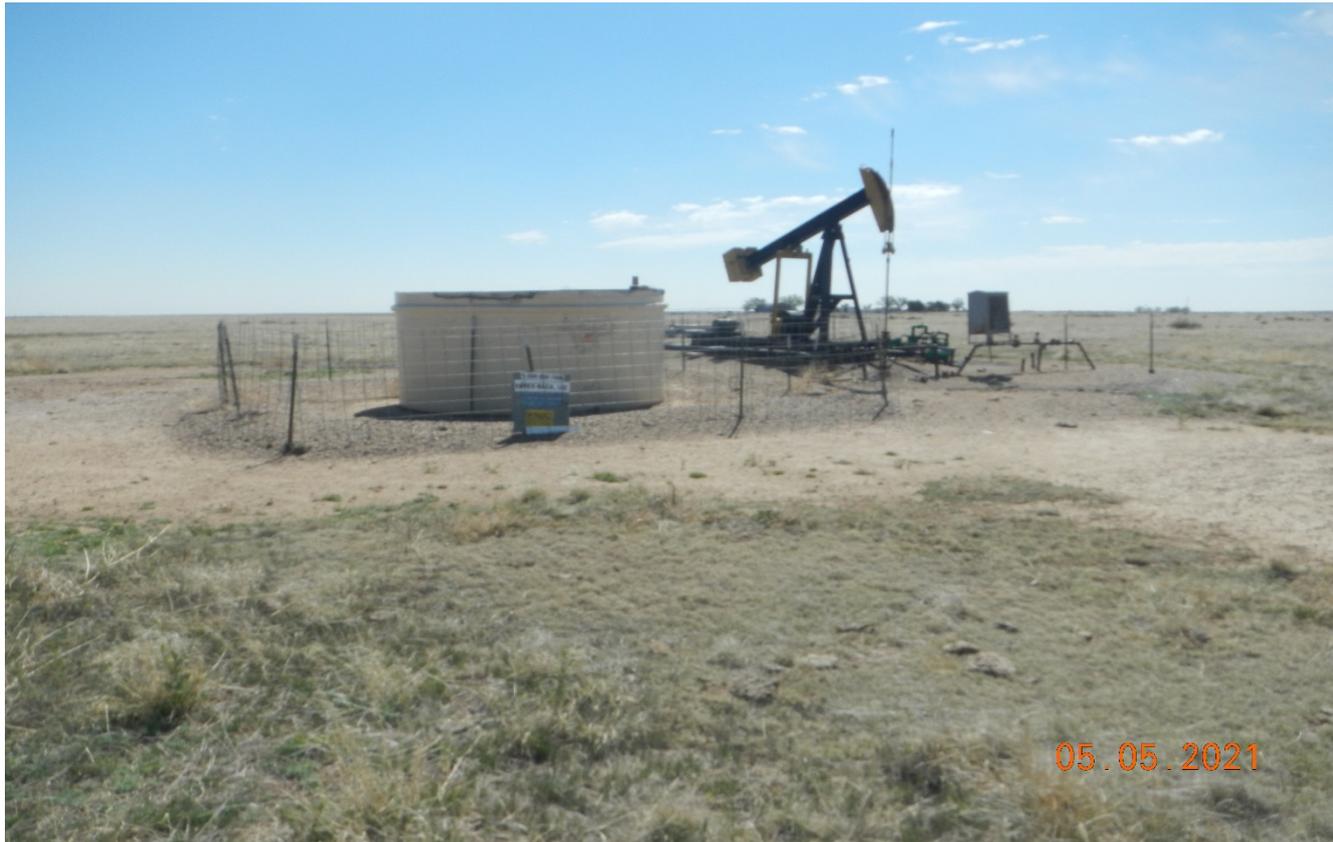
**Photo 1.** Facing east toward the location..

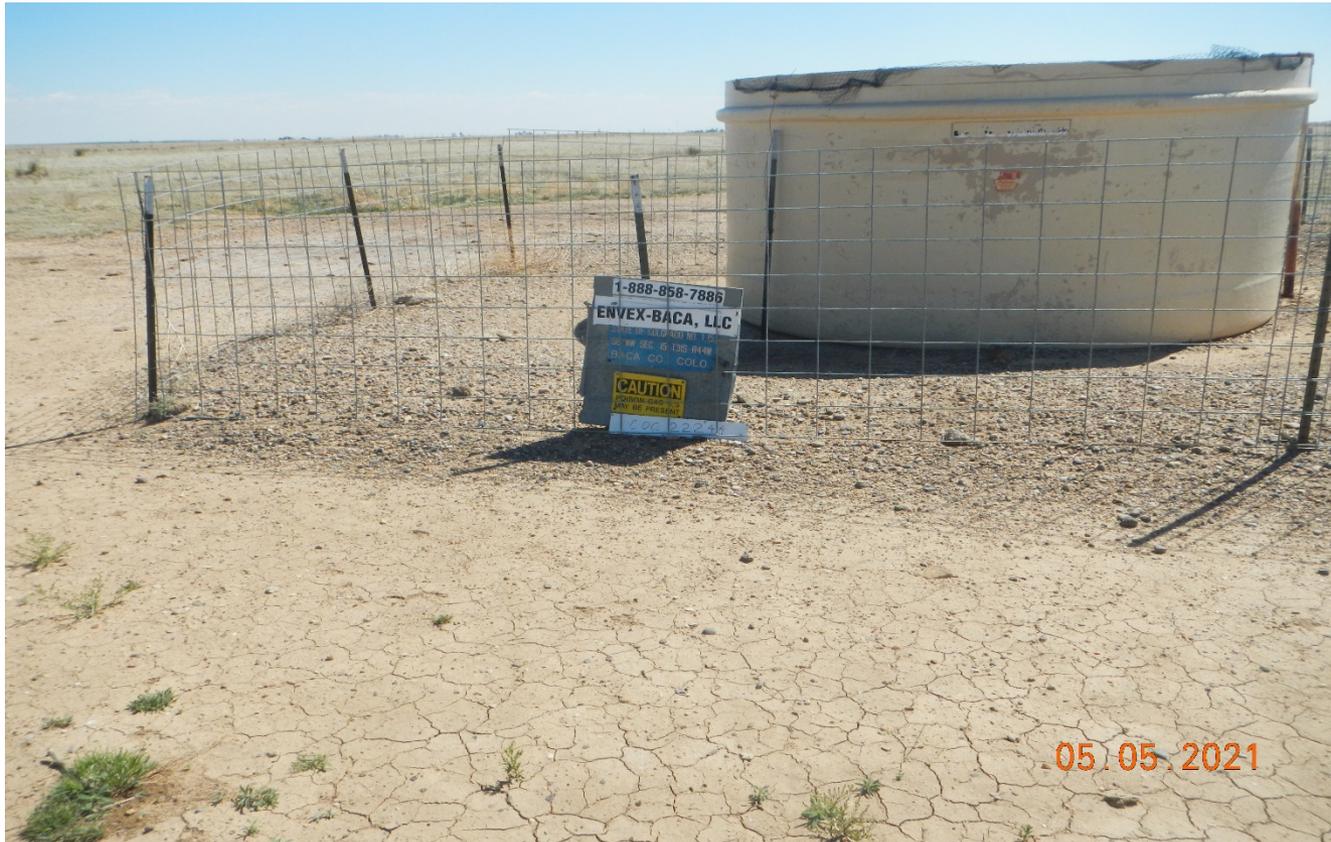
**Photo 2.** The well sign does not comply with 605. Incorrect Operator name and missing information. Missing tank NFPA labeling and missing INFO.

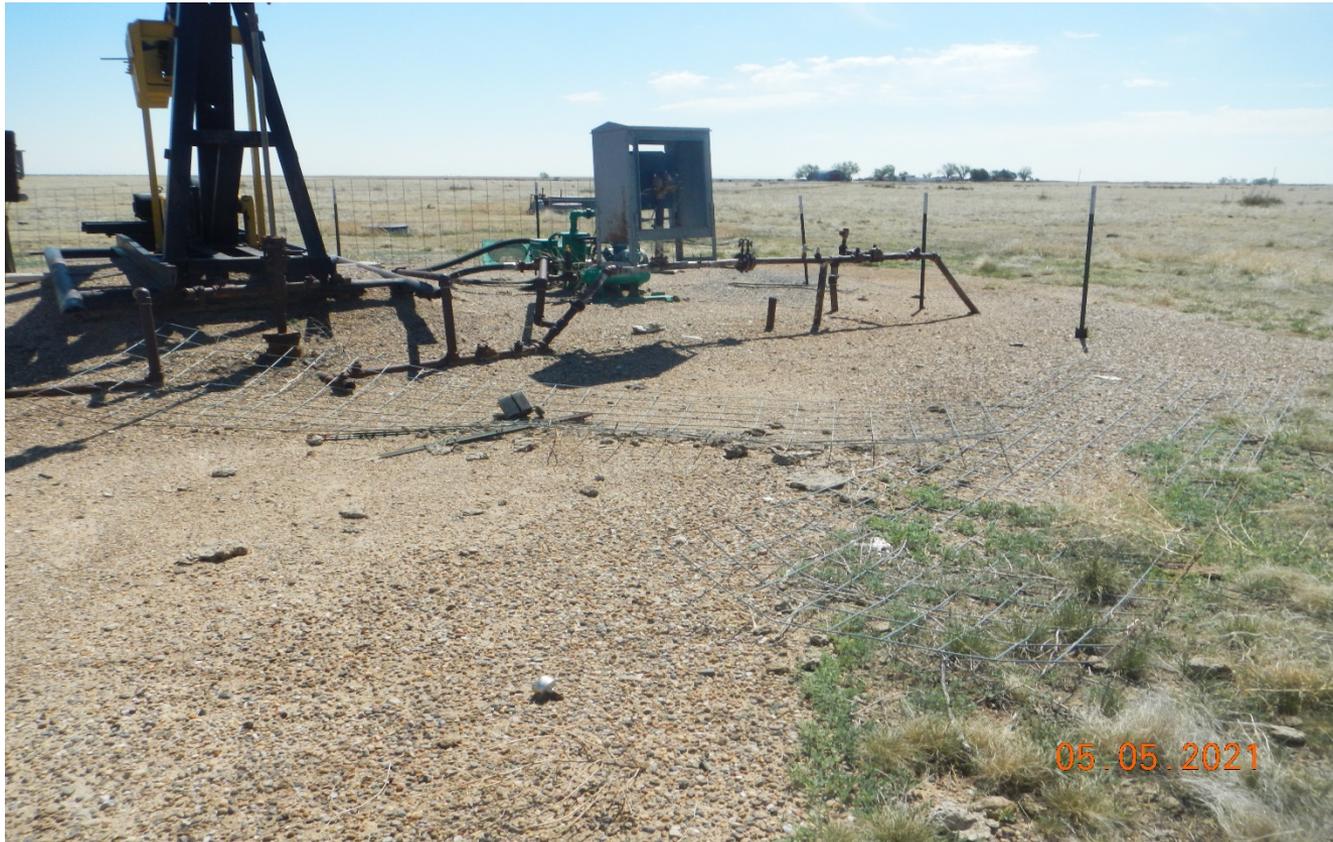
**Photo 3.** The fencing around the pump jack is not maintained and is laying on the ground.

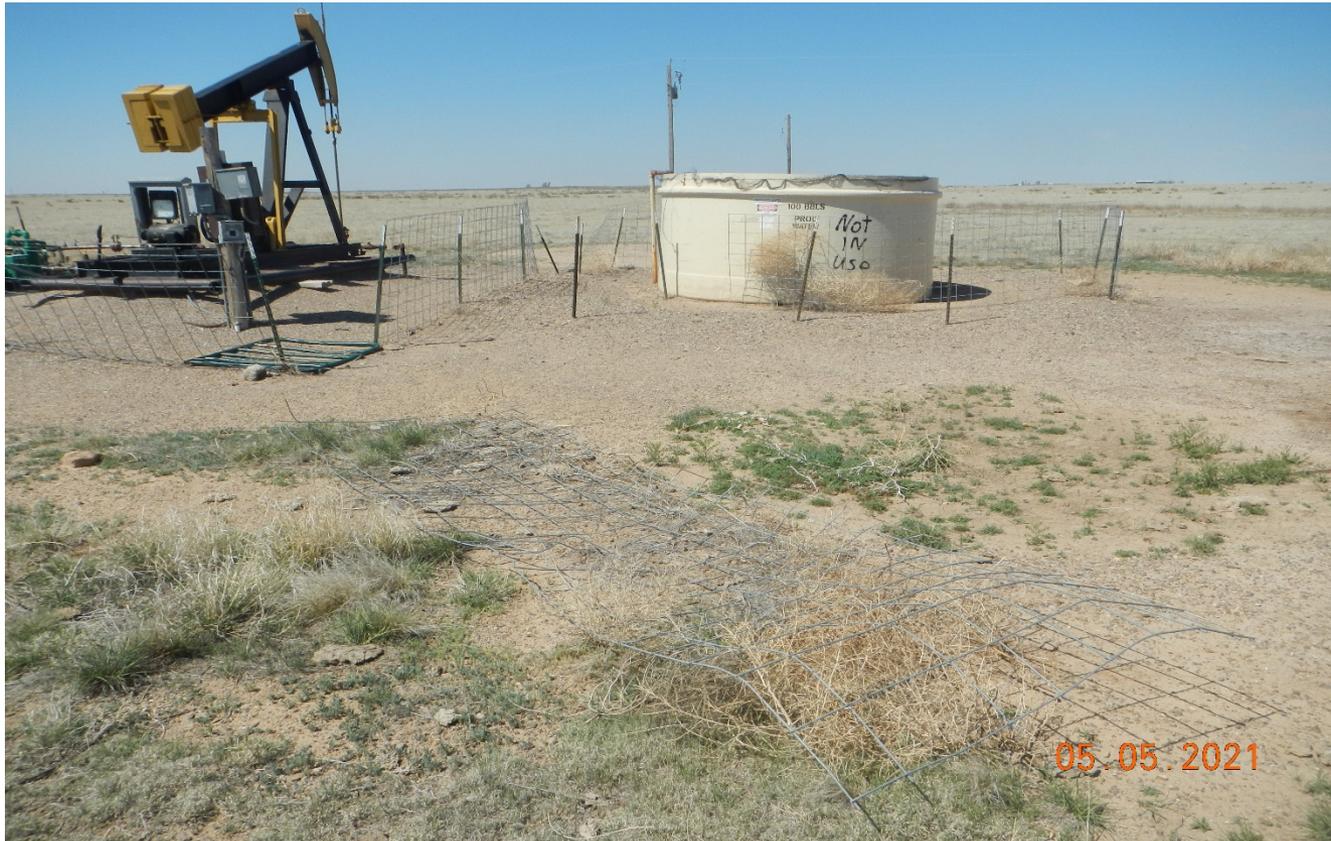
**Photo 4.** The tank is marked as not in use and labeled Produced Water. Next photo shows fluids inside the tank which apparently the tank is in use. Secondary containment is inadequate to contain 150% of the volume of the tank.

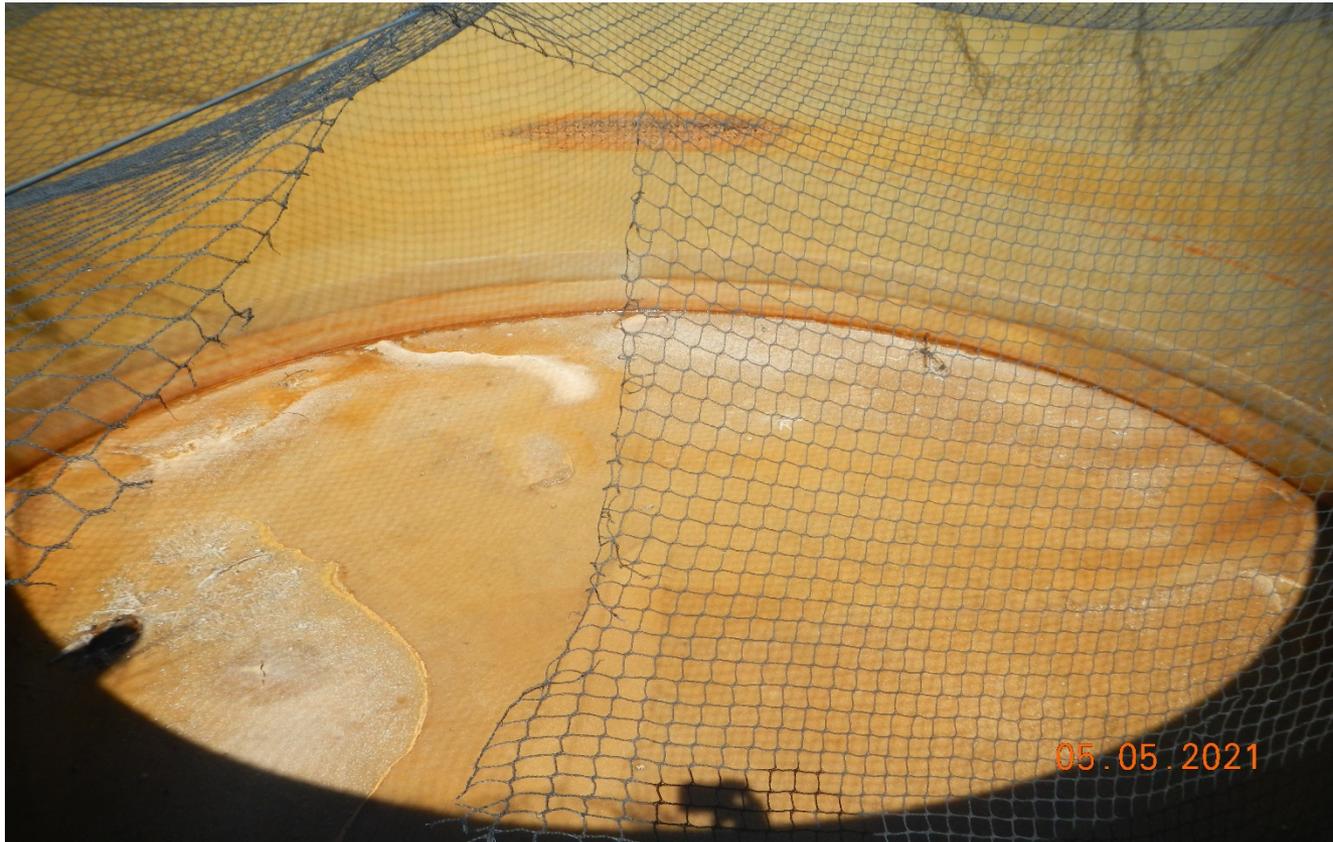
**Photo 5.** View of fluids inside the tank. Tank is labeled Produced Water
