Inspection Photos
Operator: Williford Res.
API: 067-05446
Date: 5/5/2021

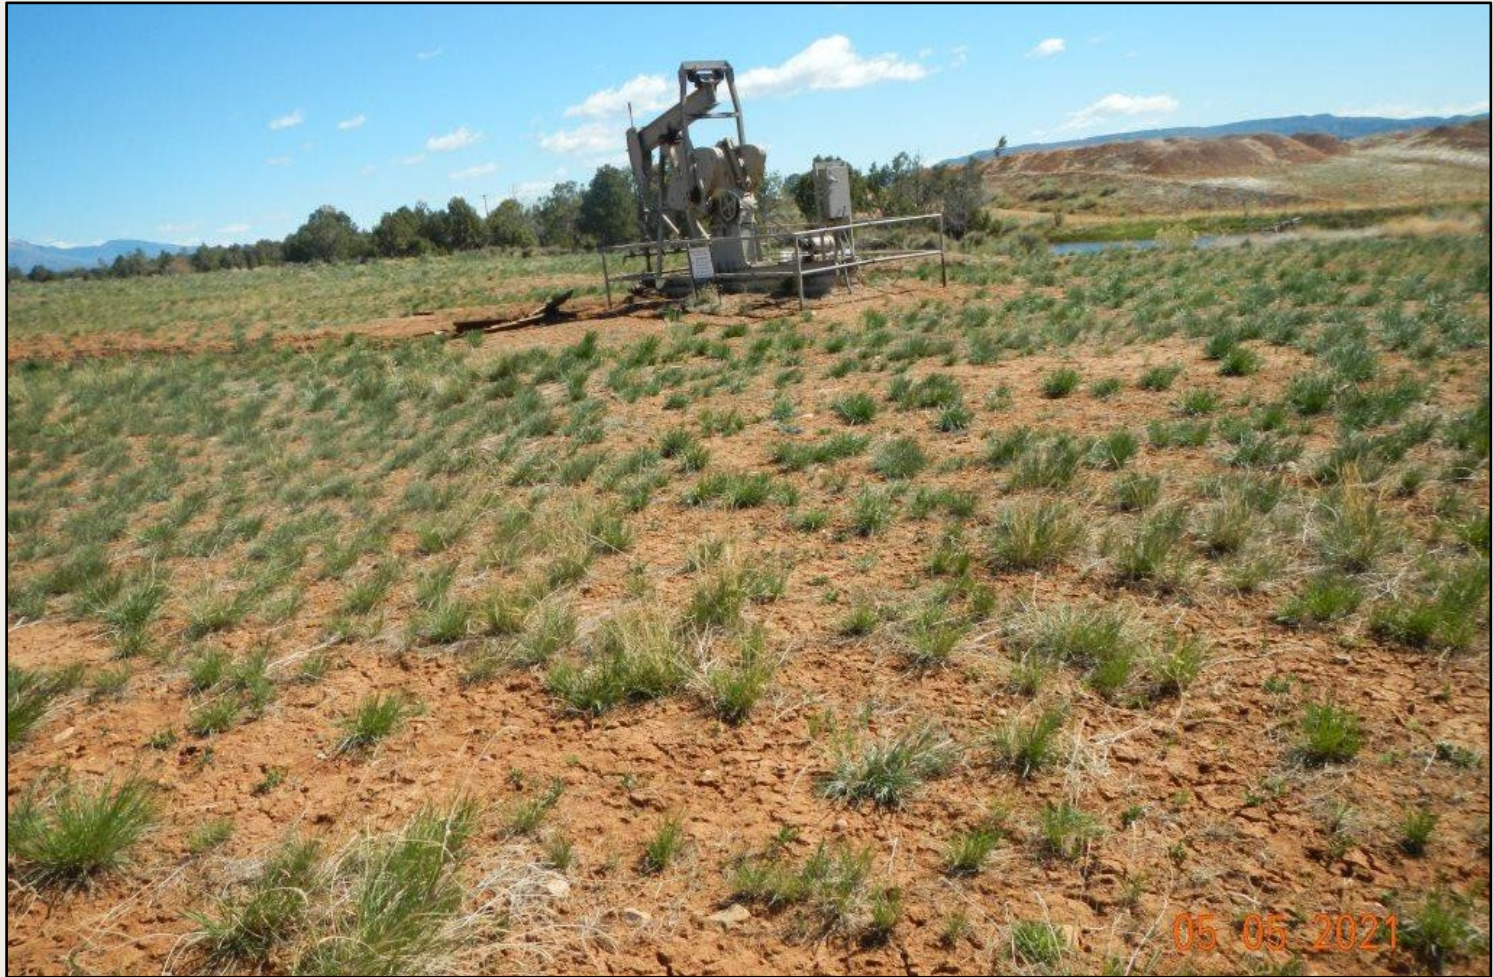
Photo 1. View of the project area from the southwestern corner facing center.

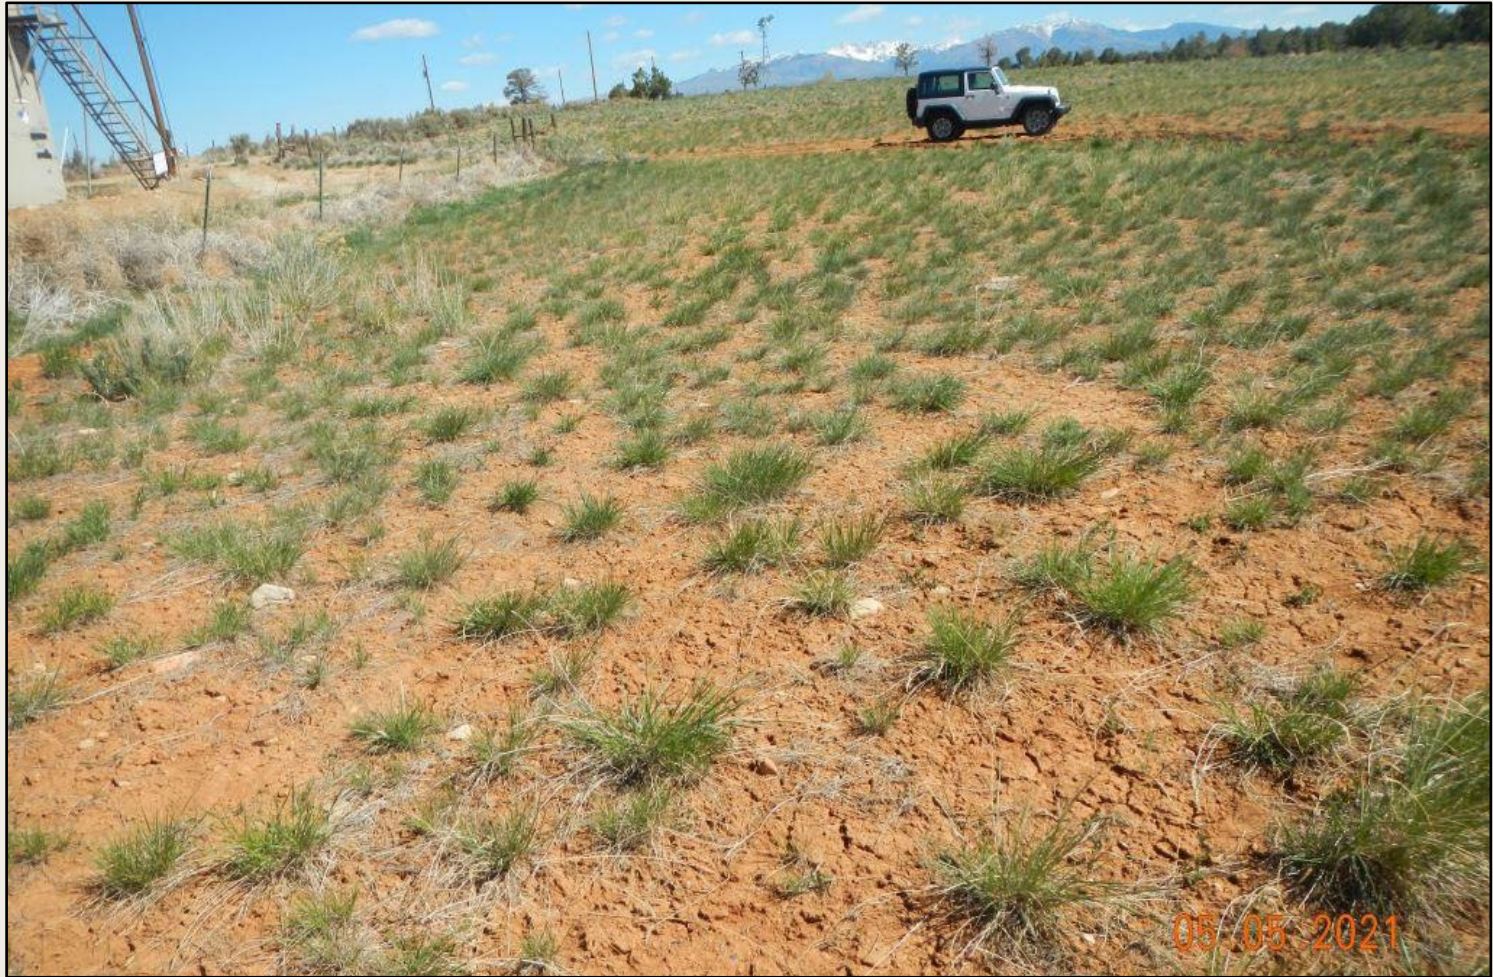
Photo 2. View of the western project area facing northward from the southwestern corner. Revegetation is progressing, largely with crested wheatgrass.

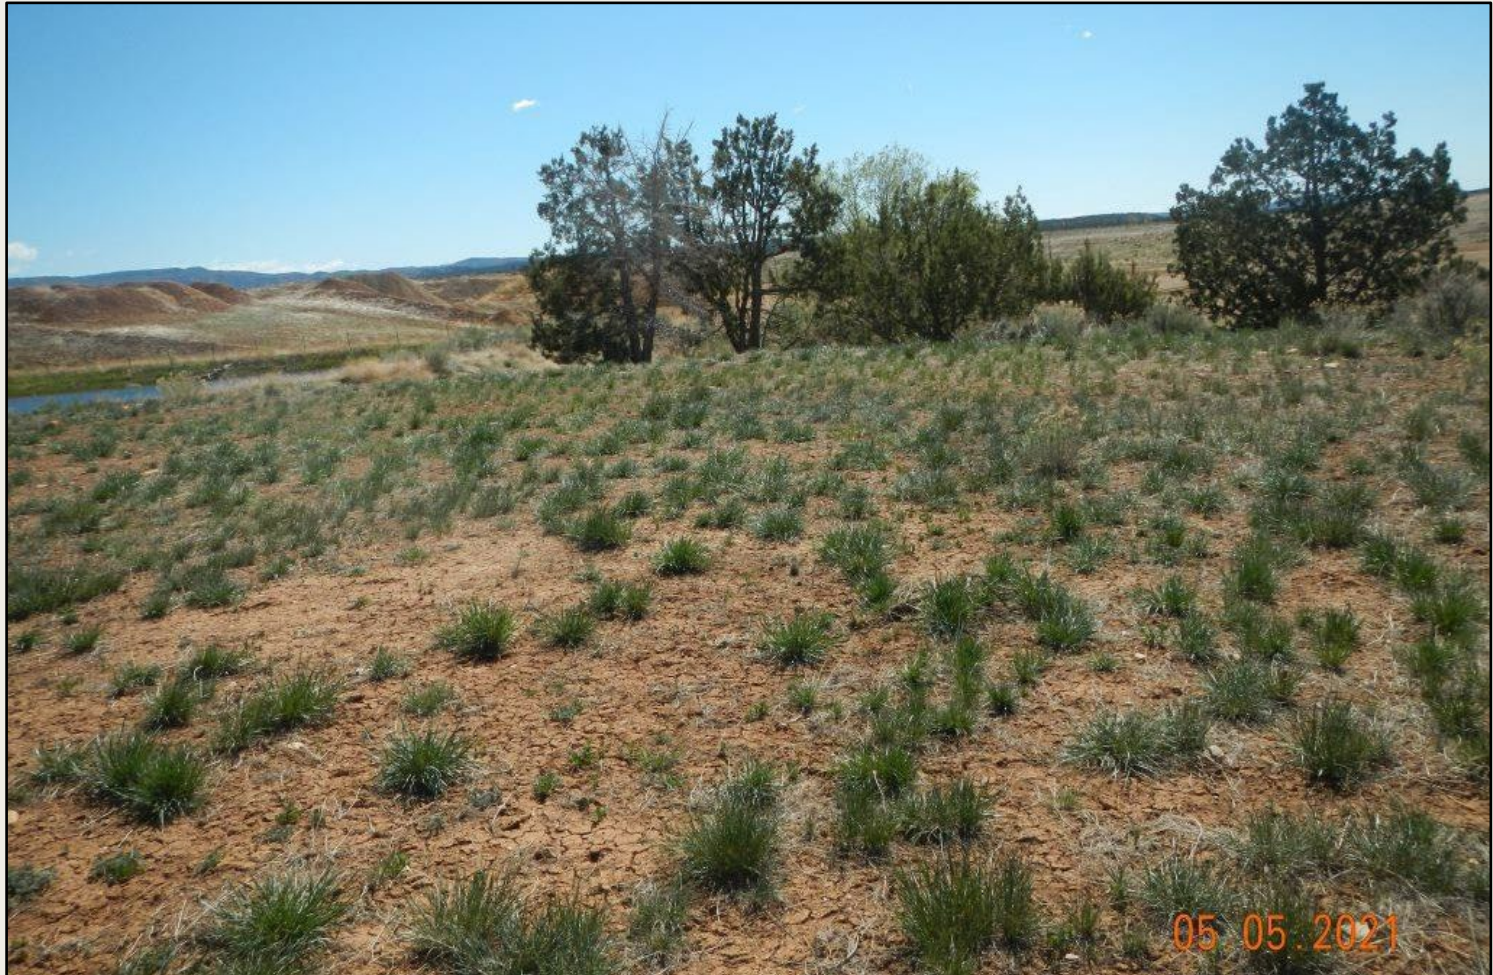
Photo 3. View of the southern project area from the southwestern corner facing eastward.

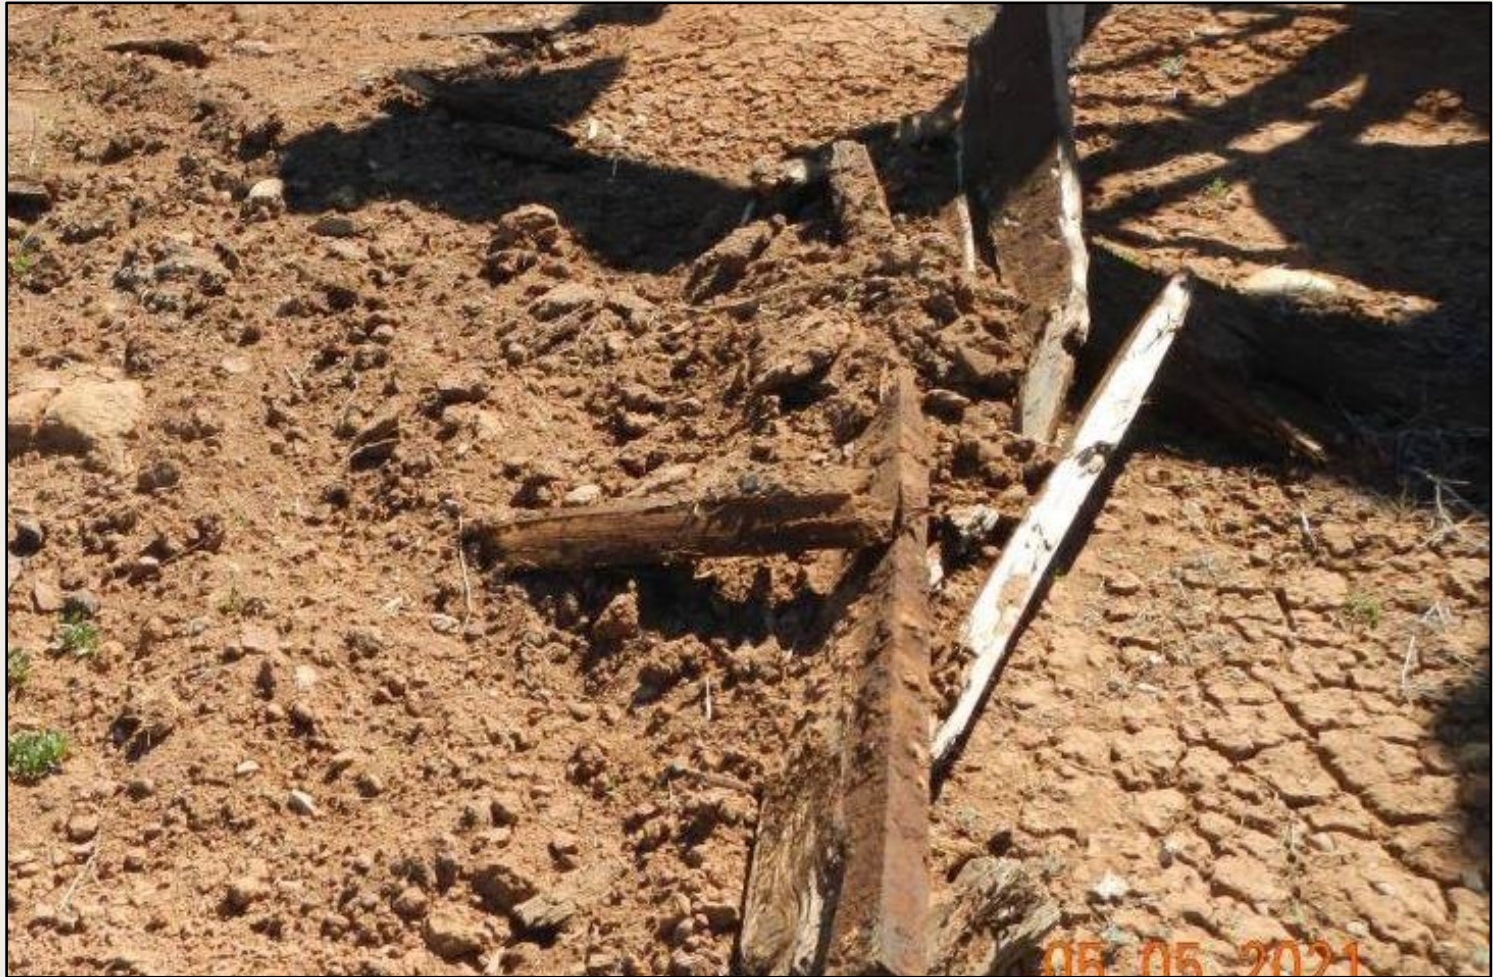
Photo 4. View of wood debris near the wellhead,needs to be removed and properly disposed of.

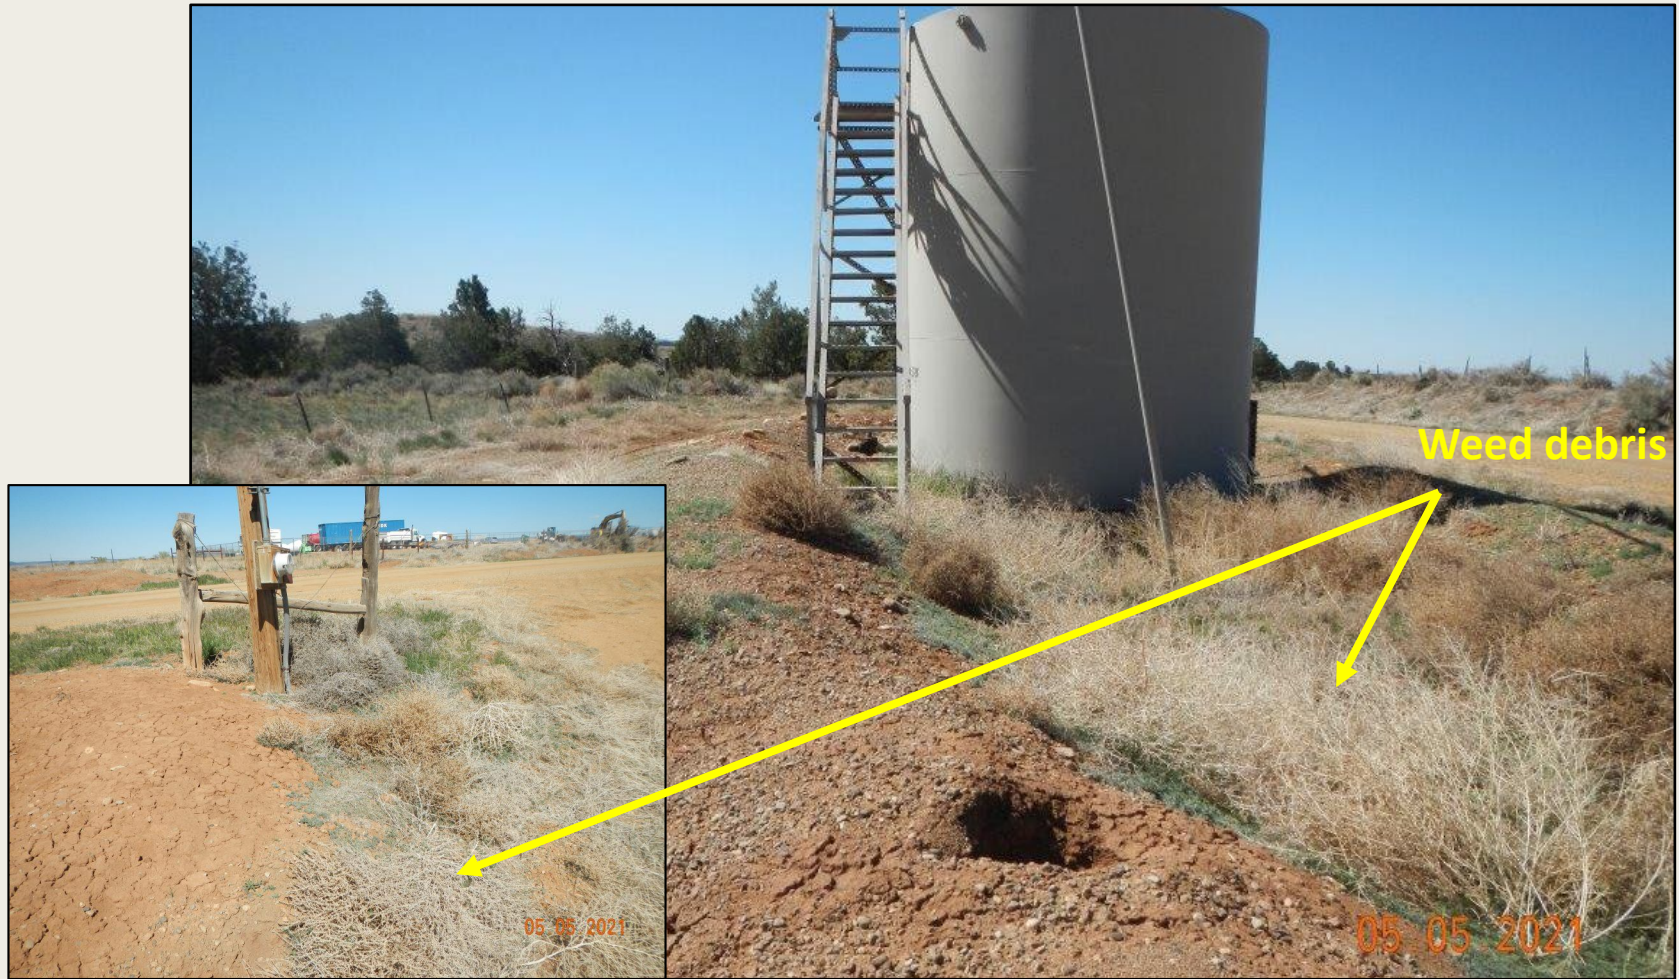
Photo 5. View of weed debris within the tank battery area west of the well.

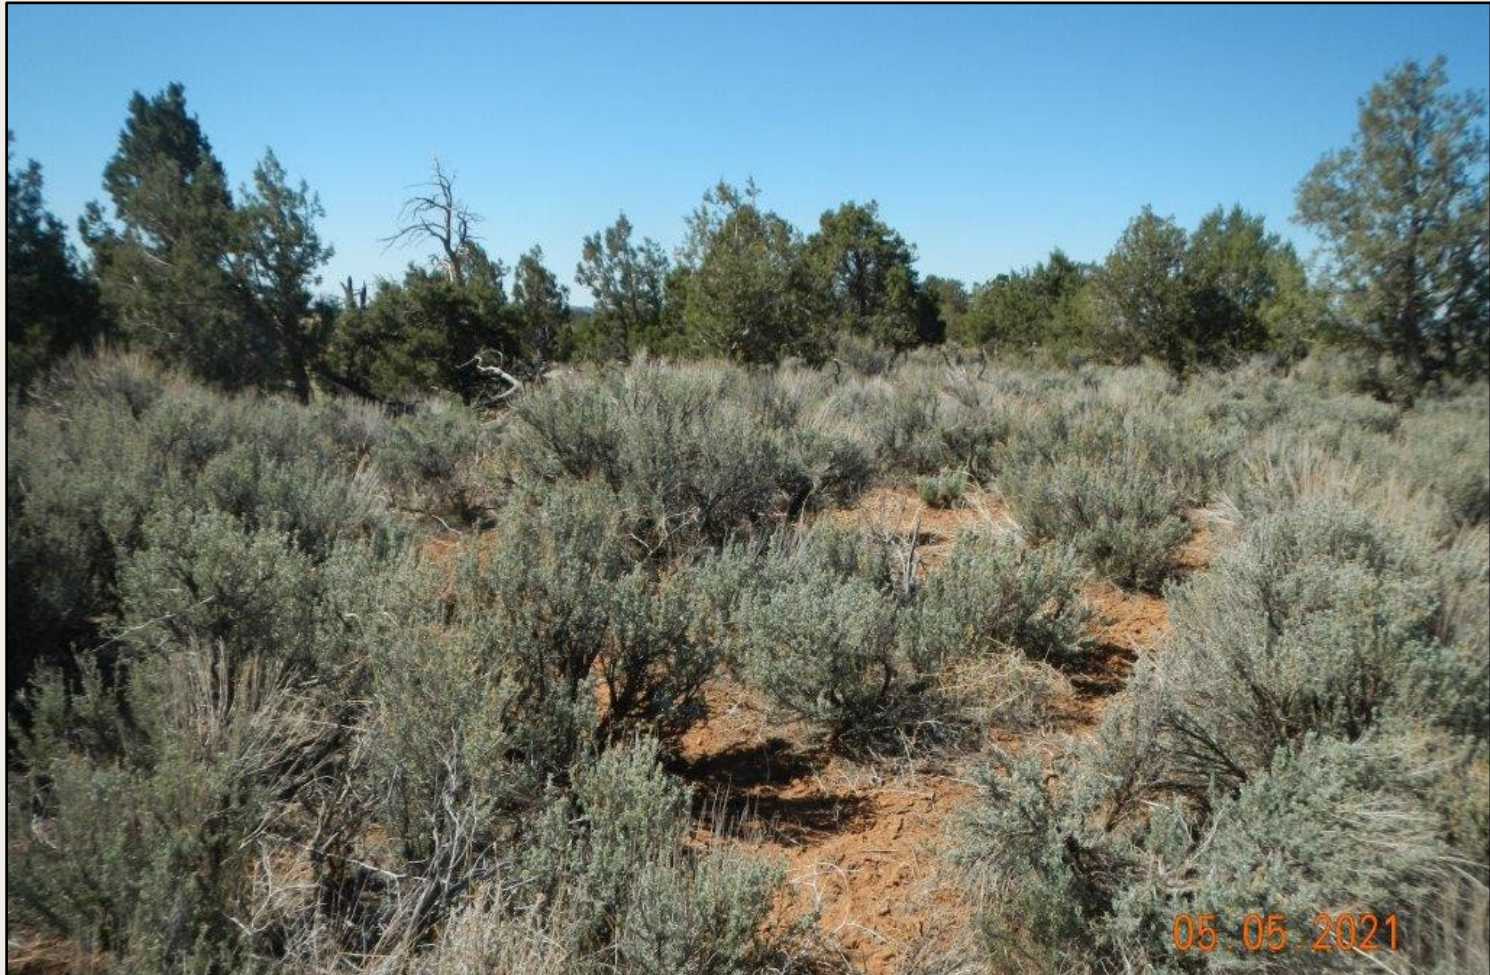
Photo 6. View of reference area comprised of sagebrush shrubland with grasses such as squirreltail and James galleta. Scattered pinyon and juniper trees are present.
