Inspection Photos  
Operator: Williford Res.  
API: 067-05758  
Date: 5/5/2021

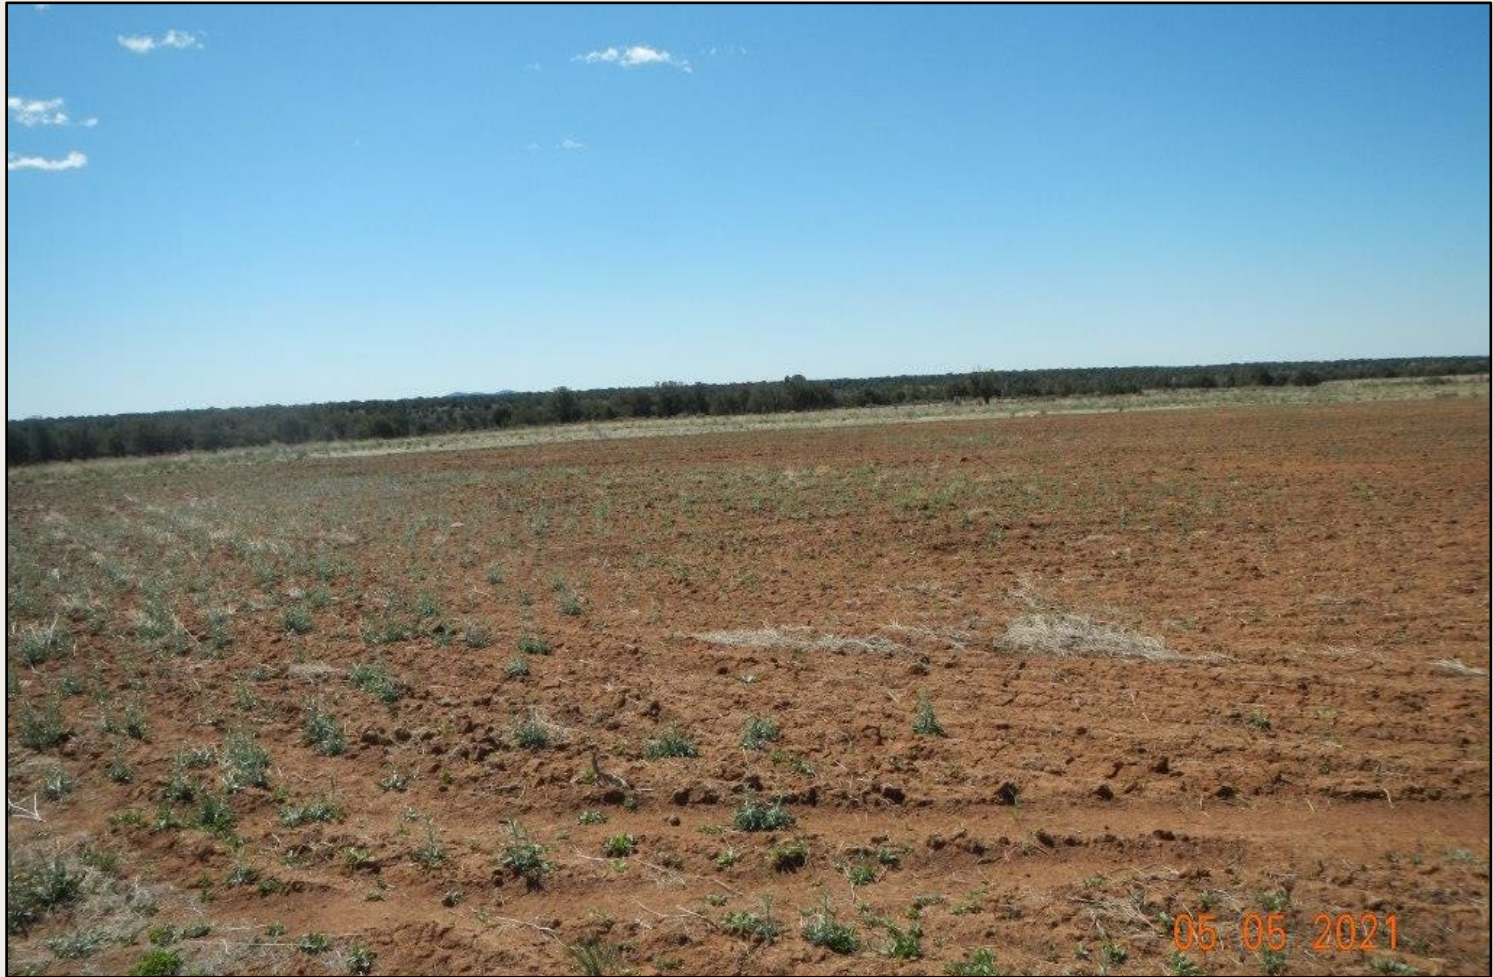
Photo 1. View of the project area from the northwestern corner facing center. Area is graded, young grasses crested wheatgrass observed.

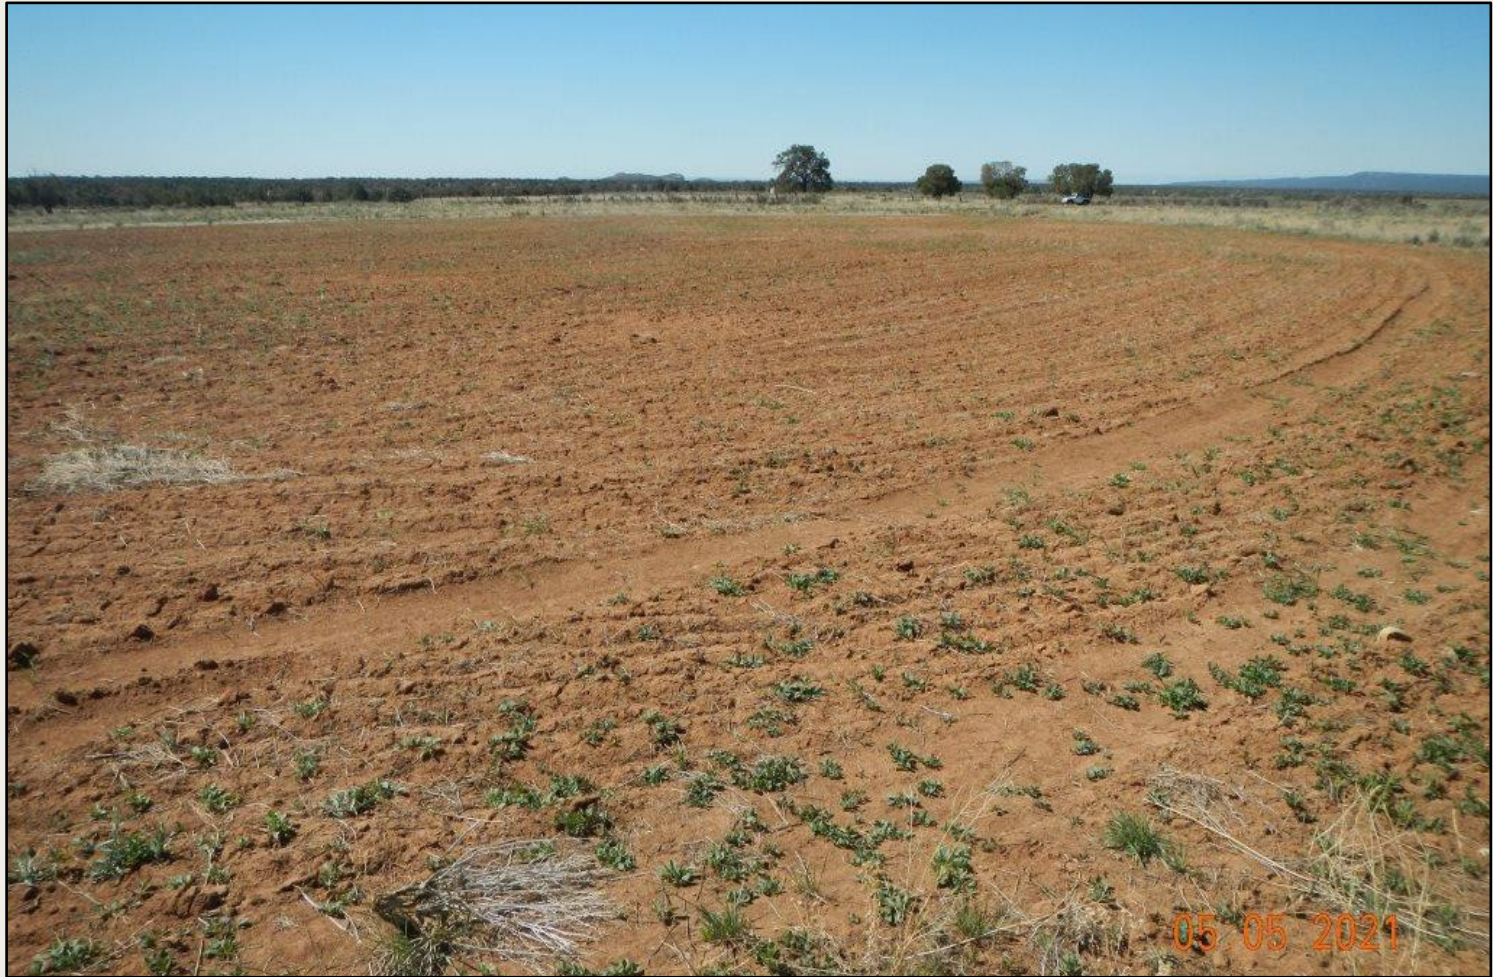
Photo 2. View of the western project area facing southward from the northwestern corner.

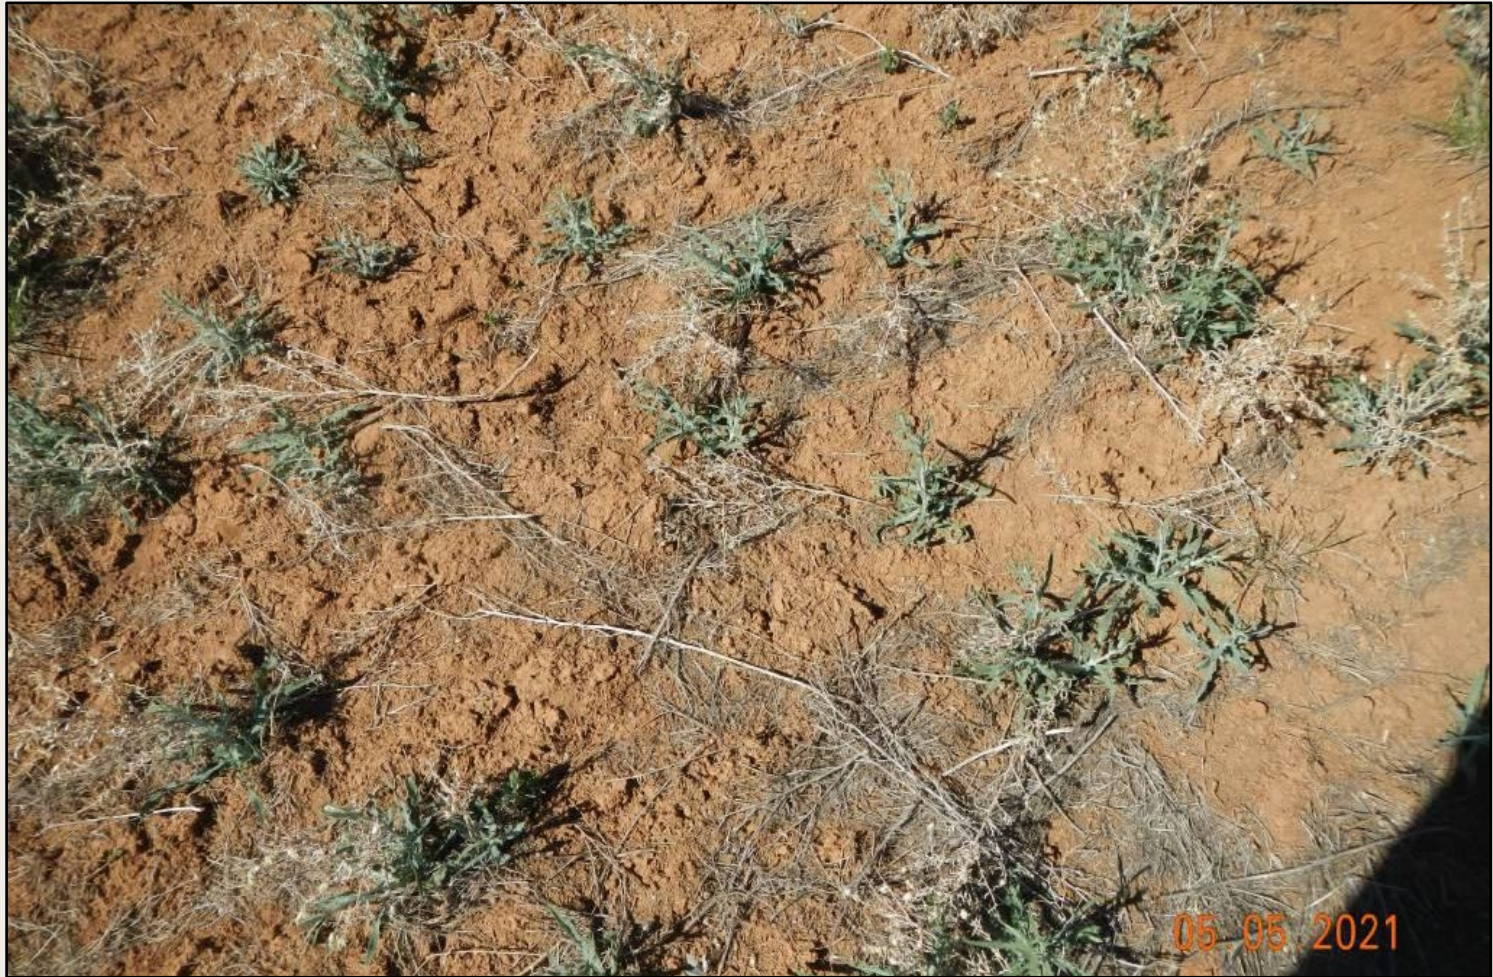
Photo 3. View of Russian knapweeds within the northern project area.

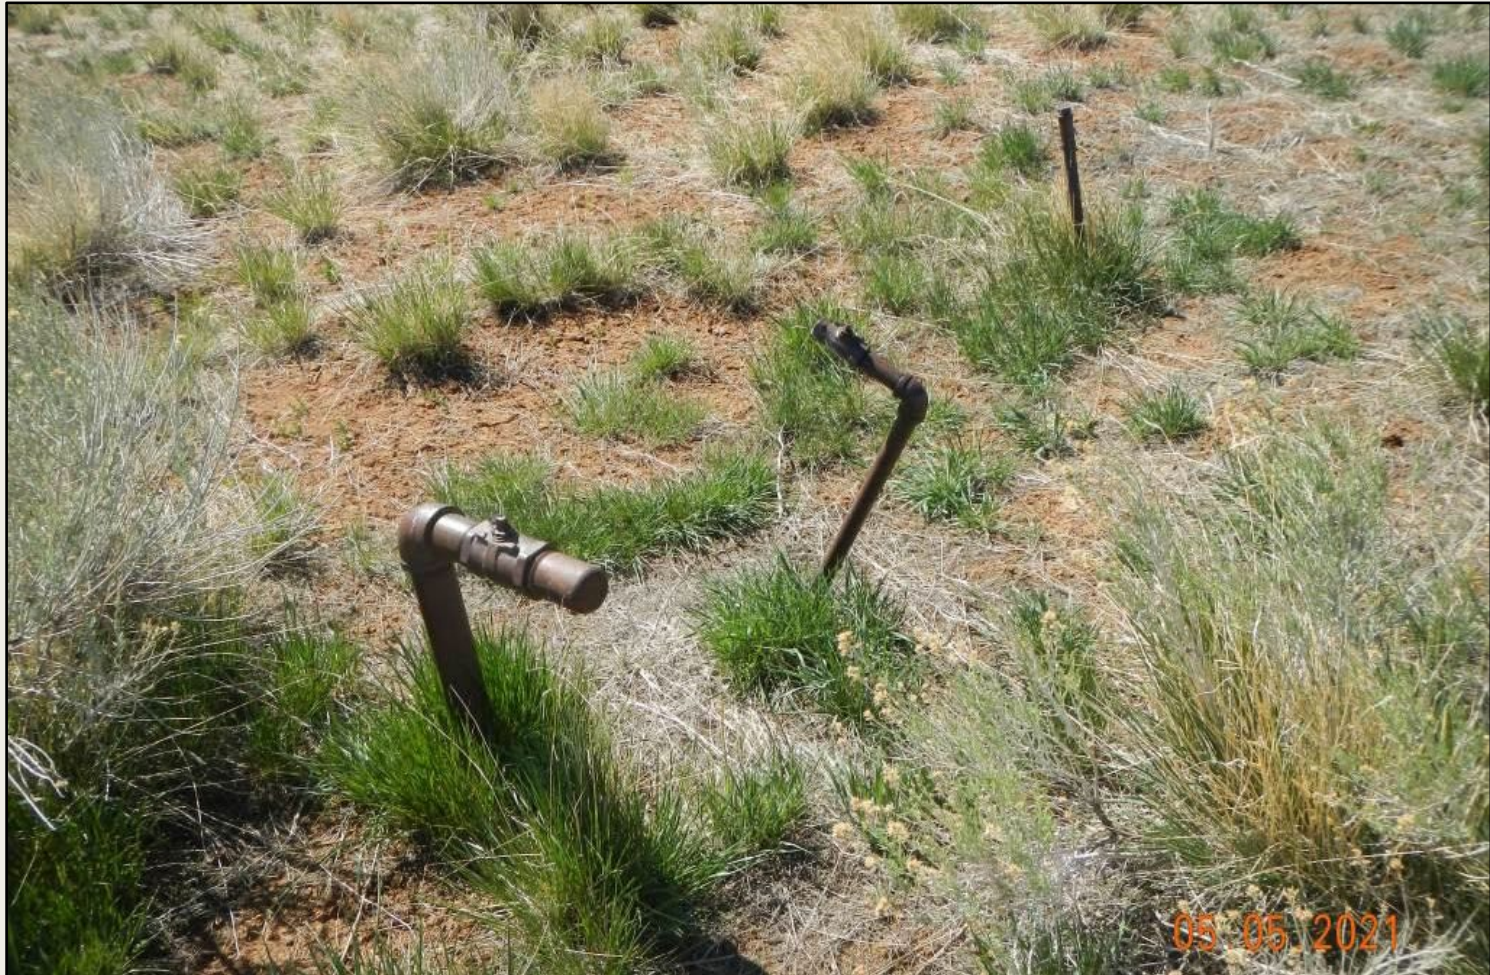
Photo 3. View of risers that remain within the northeastern project area, need to be properly abandoned and removed.

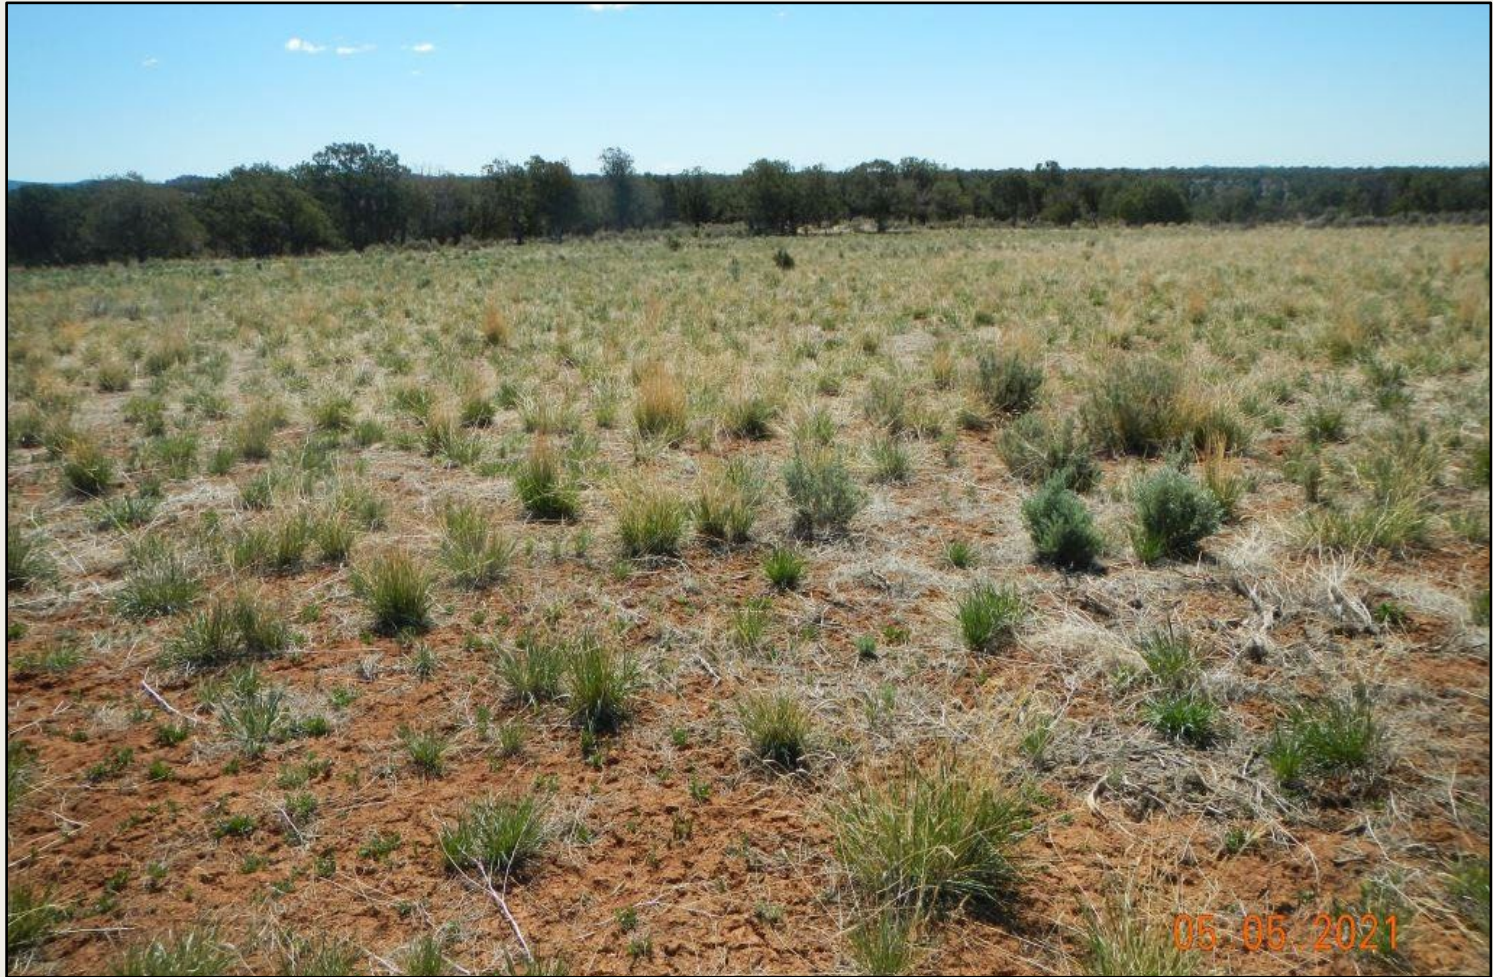
Photo 4. View of reference area comprised of mixed sagebrush and grass field with crested wheatgrass.
