Inspection Photos

Location Name: LARAMIE ENERGY LLC Currier BCU /1K Pad

Location ID: 312707

COLORADO
Oil & Gas Conservation
Commission
Department of Natural Resources

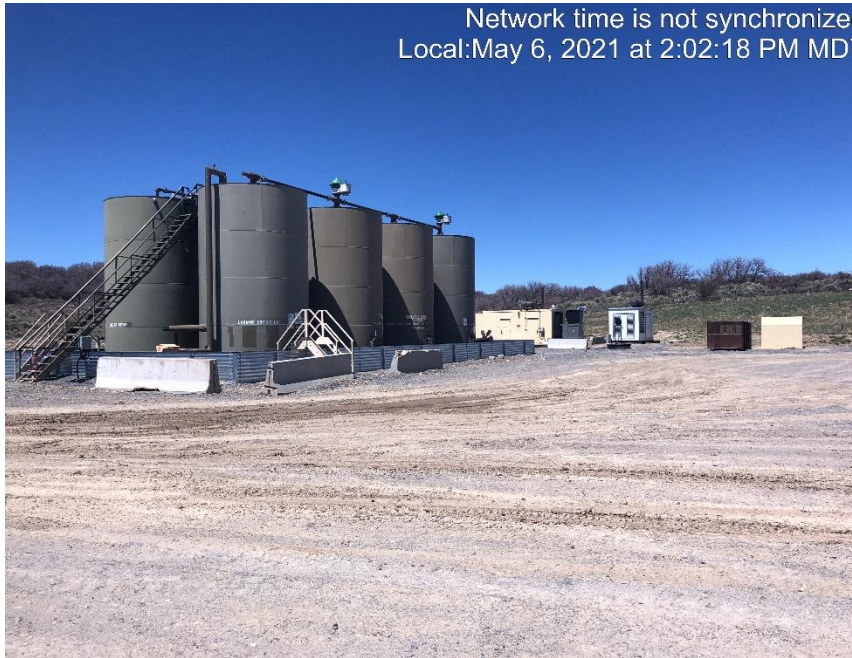
Photo #3741 from entrance to location.

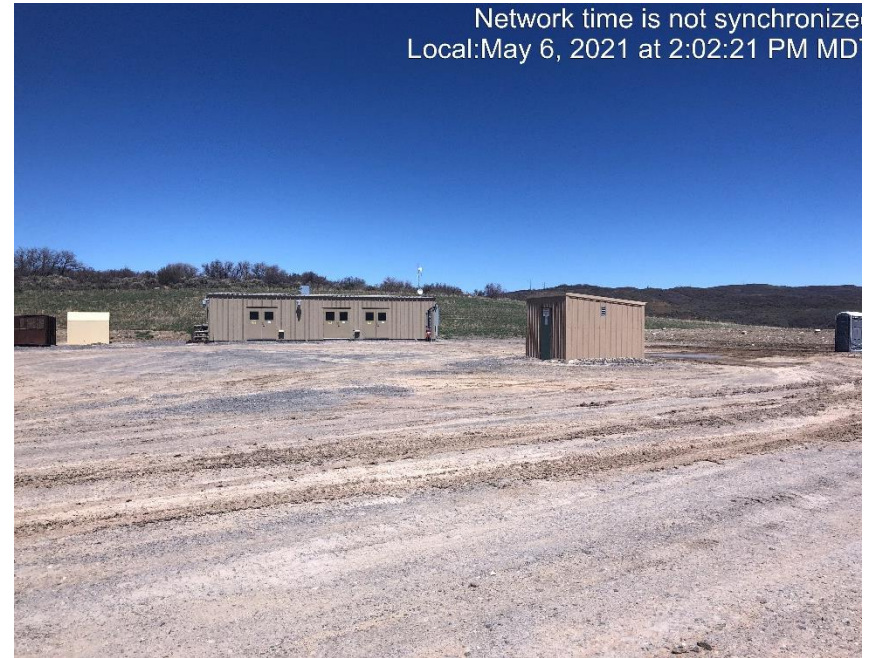
Photo #3742 from entrance to location.

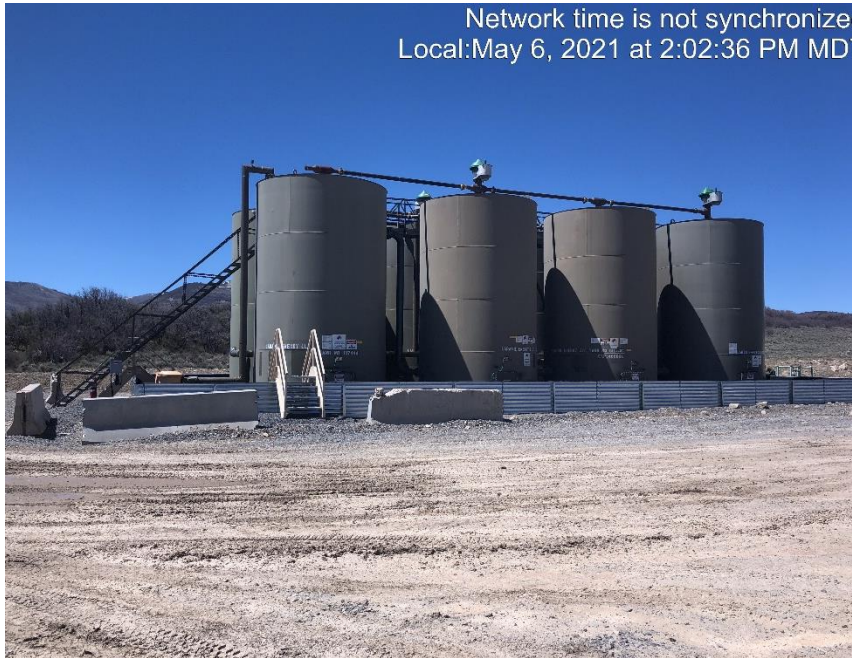
Photo #3743 No battery sign located at the tank battery.

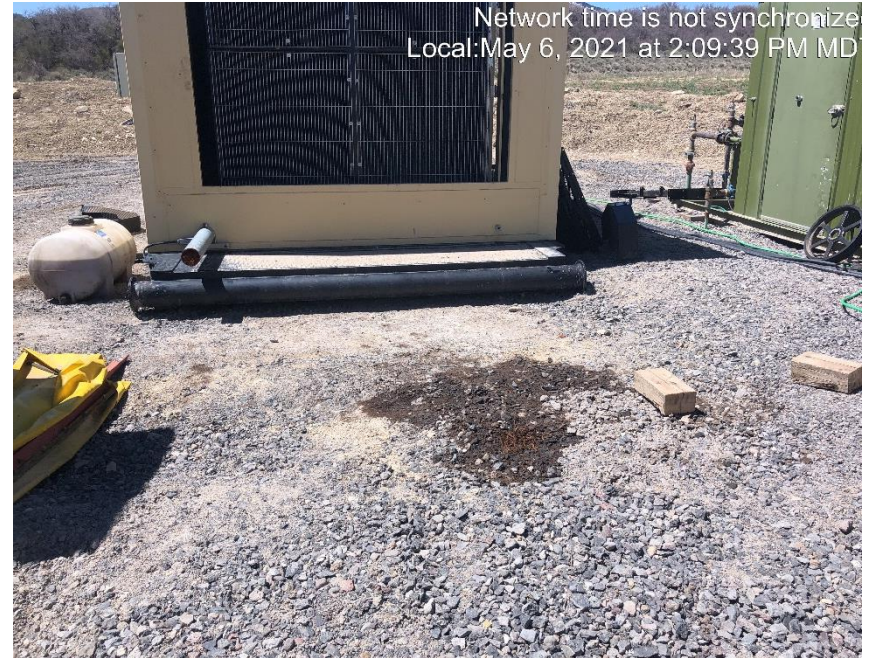
Photo #3749 Multiple places with stained soil outside of containment.

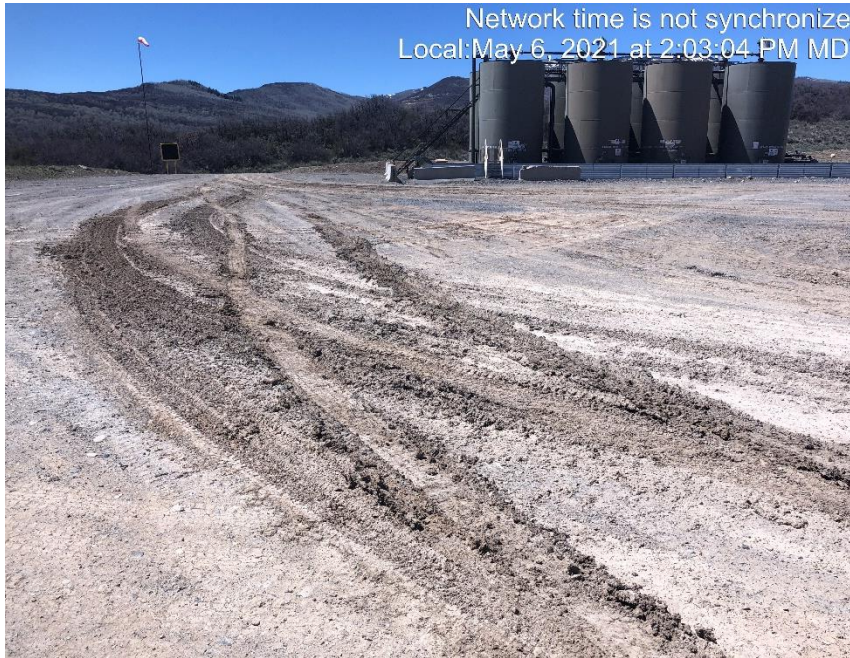
Photo #3744 Location lacks stabilization.

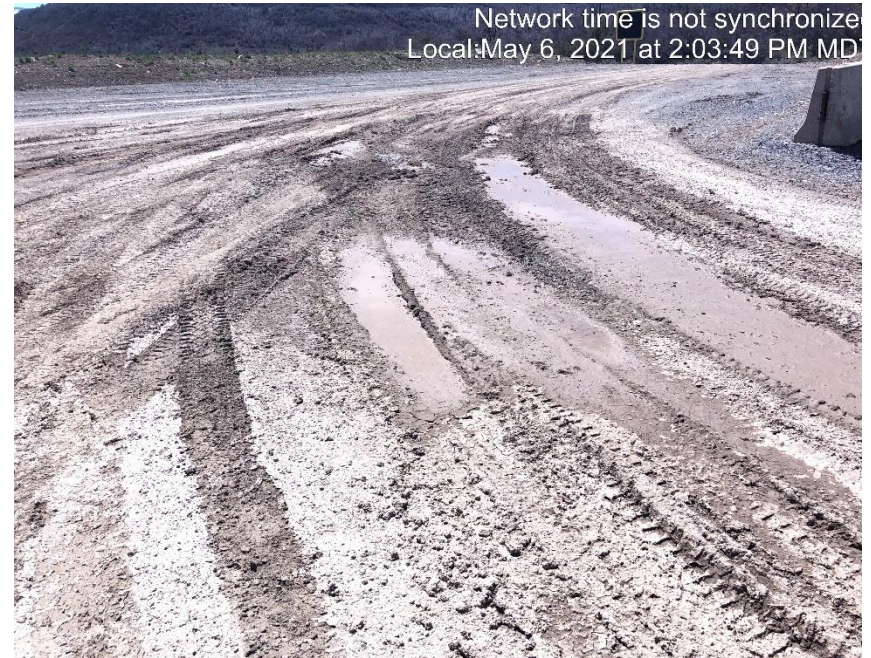
Photo #3745 Location lacks stabilization.

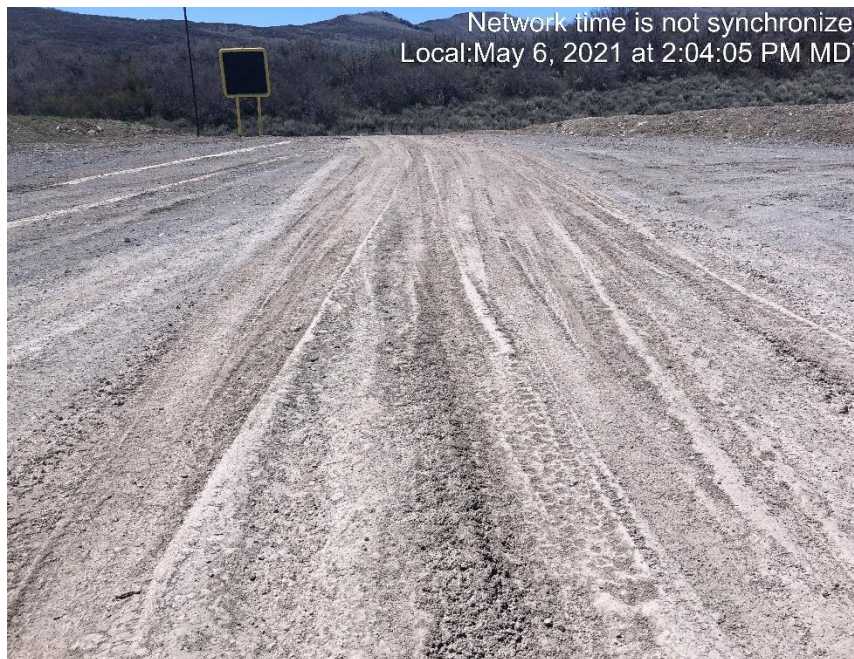
Photo #3746 No form of tracking BMP located at entrance to location.

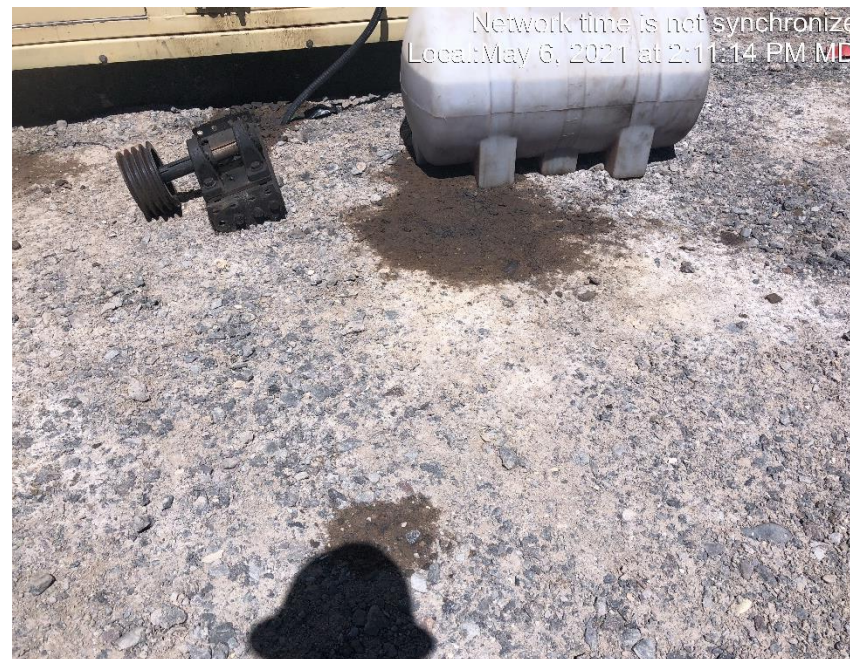
Photo #3750 No chemical BMP located at chemical tank. Stained soils under chemical tank.
