# Inspection Photos

5/6/2021

Operator: SG INTERESTS I LTD - 77330

Location ID: 418697

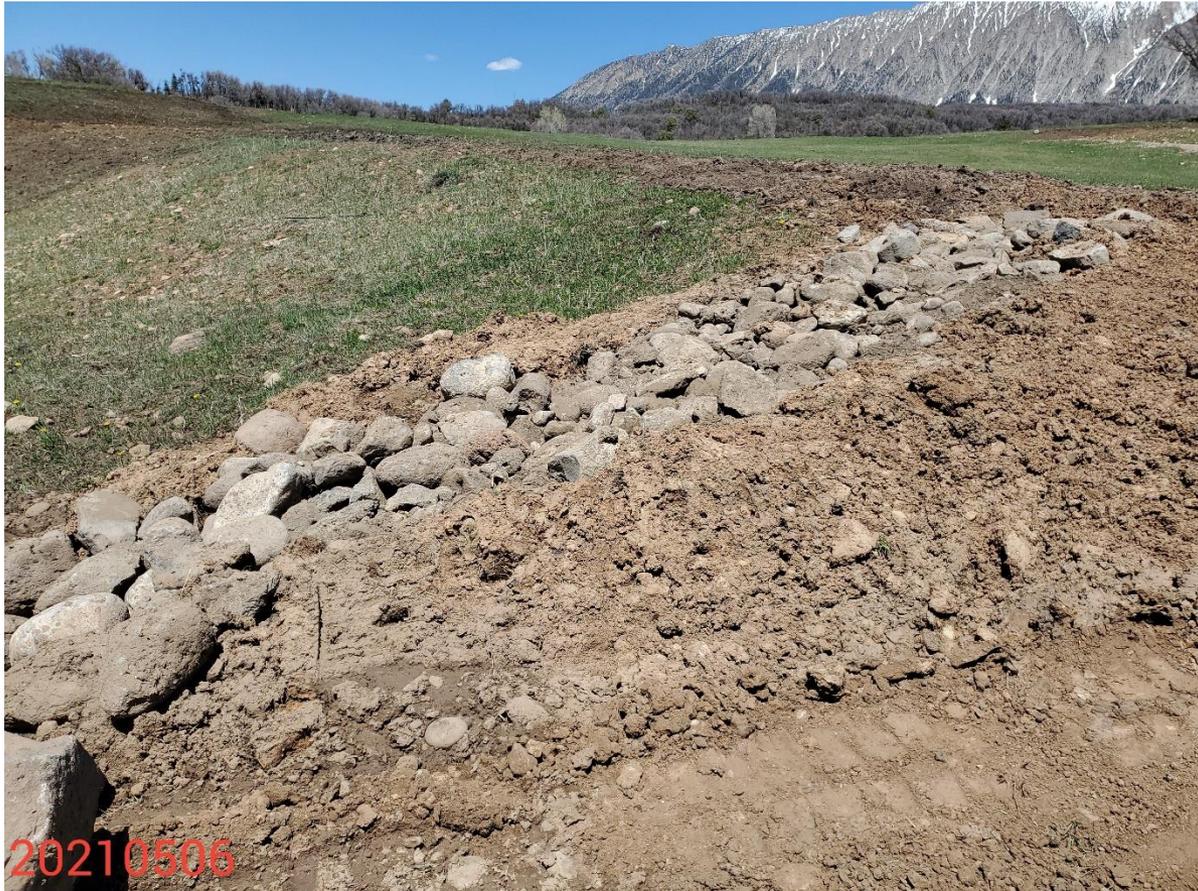
**Photo 1:** Photo taken from the east end of the Location, facing north. Construction activities to address stormwater issues observed to be in process at time of inspection. Photo shows ditch and armoring in process of being constructed to manage runoff. Armoring has been constructed with different sized aggregate and lined with geotextile.

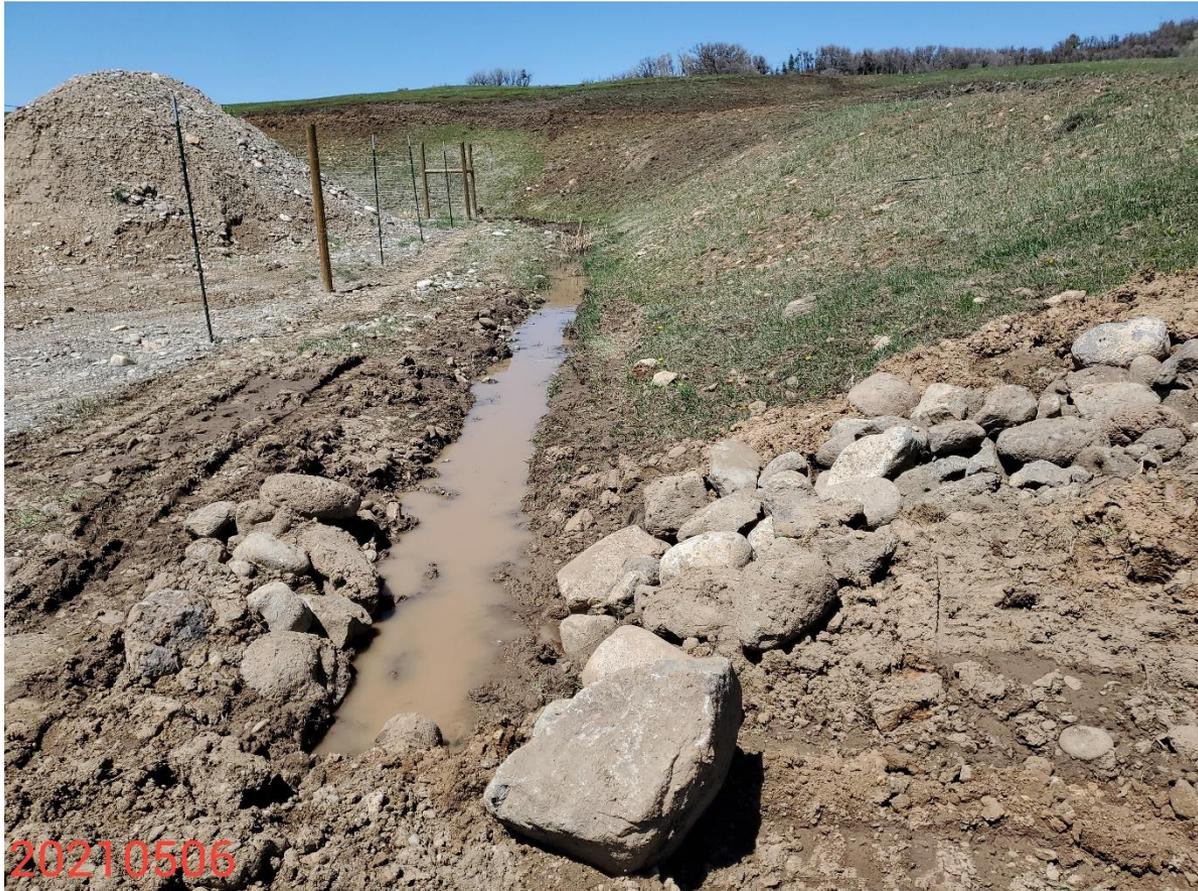
**Photo 2:** See comments under photo 1.

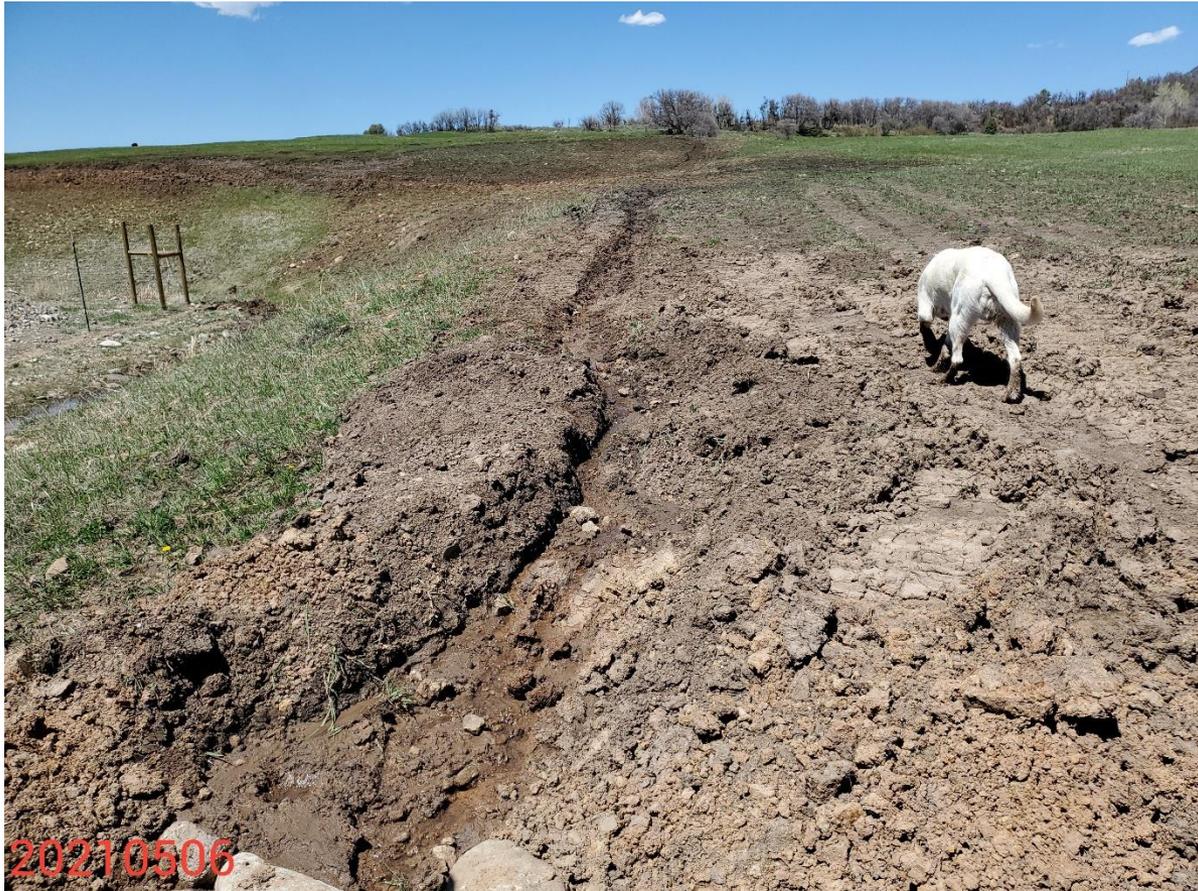
**Photo 3:** See comments under photo 1.

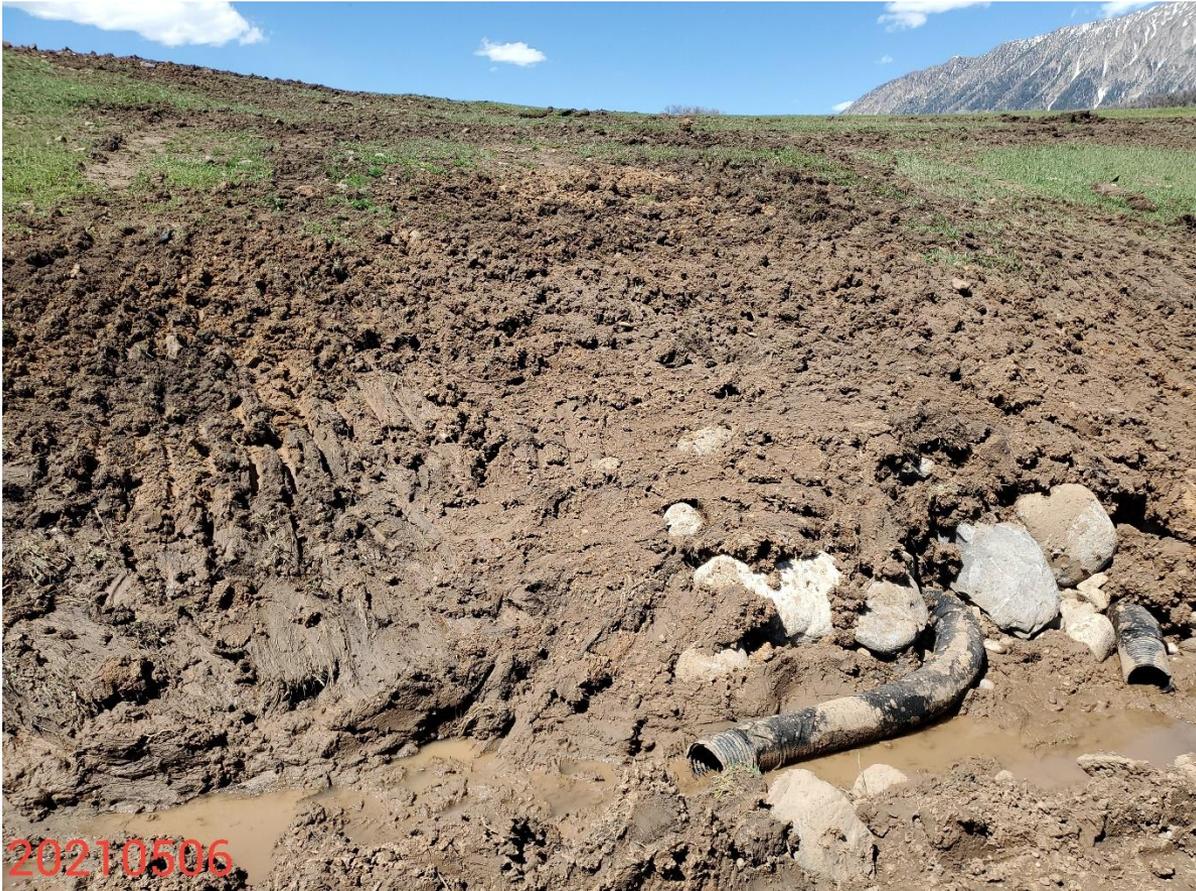
**Photo 4:** Photo taken from the cut slopes on the north end of the Location. Photo shows the sloughing slope observed in previous inspections has been repaired and a French drain system has been install. Slopes still requiring stabilization control measures and revegetation.

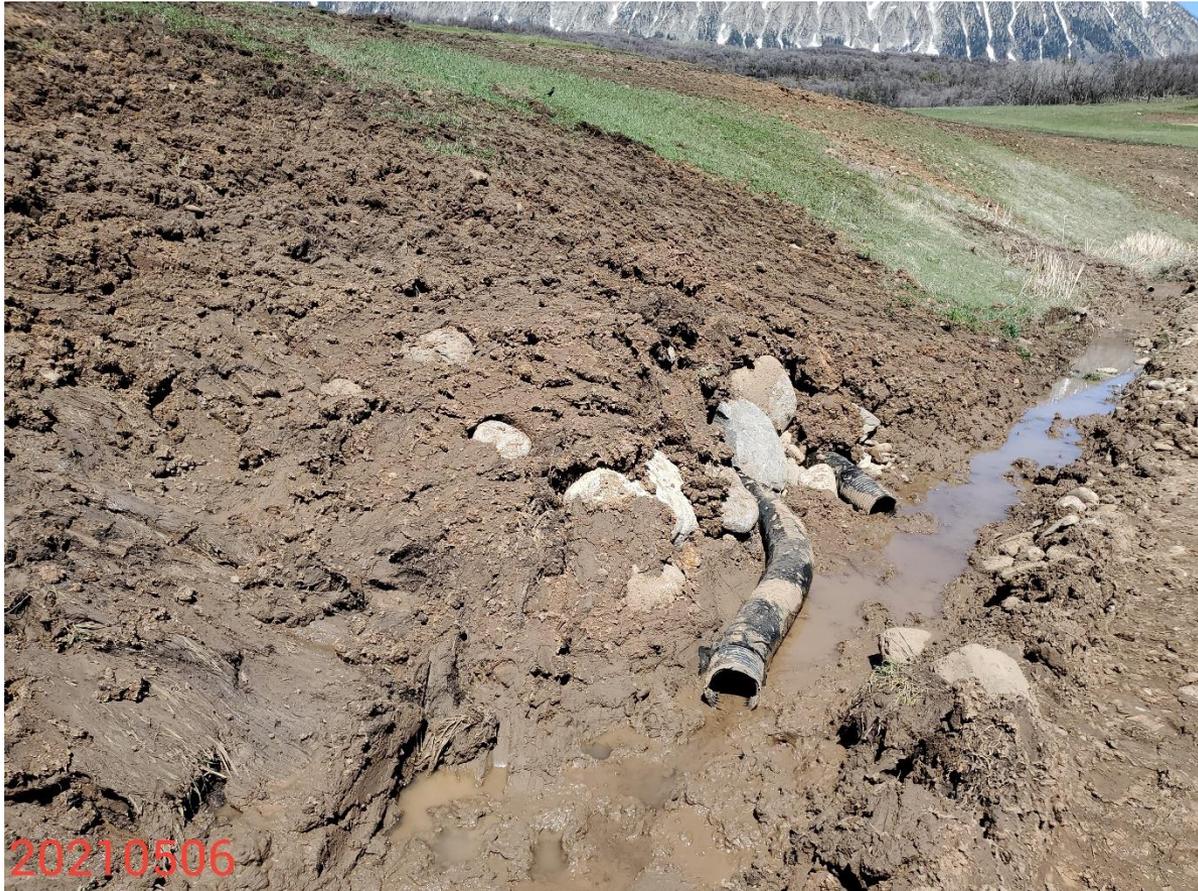
**Photo 5:** See comments under photo 4.

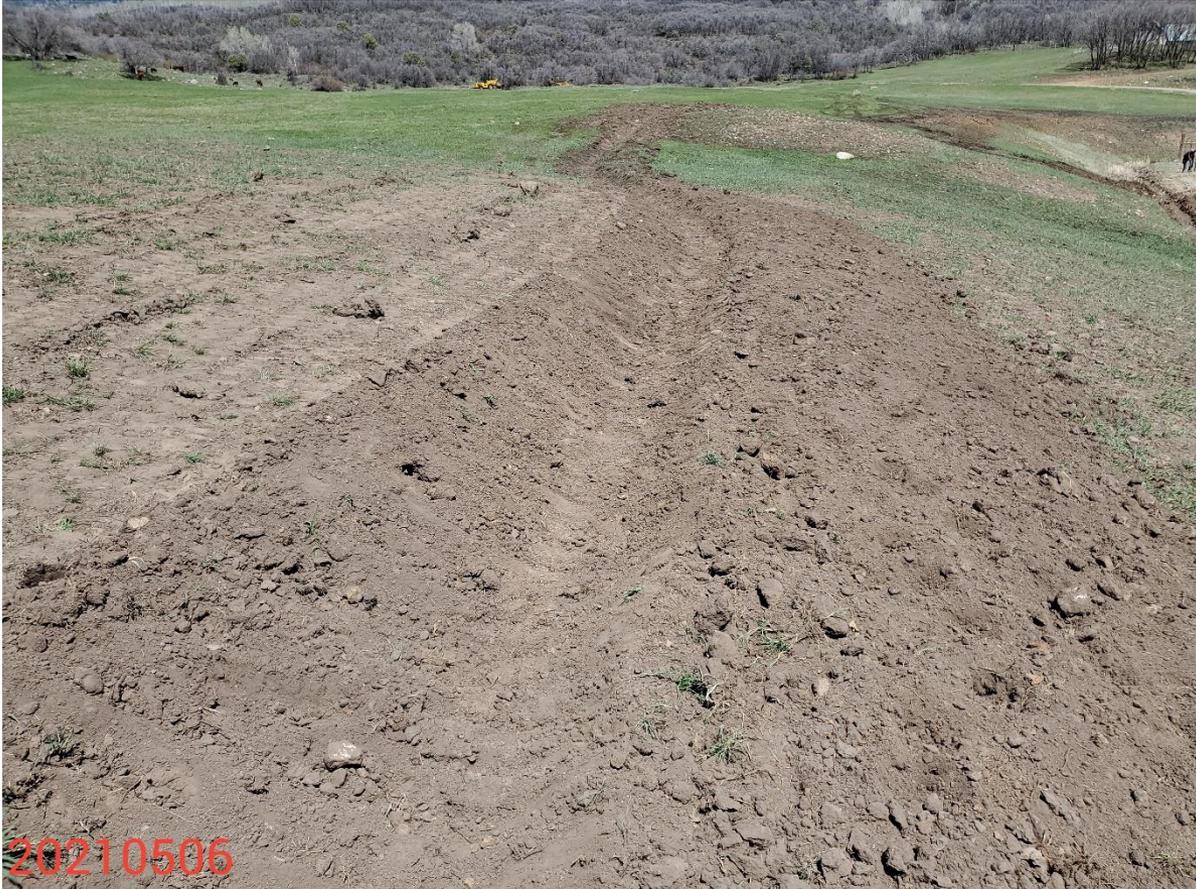
**Photo 6:** Photo taken from the north of the Location, facing east. Construction activities to address stormwater issues observed to be in process at time of inspection. Photo shows ditch being constructed to manage runoff.

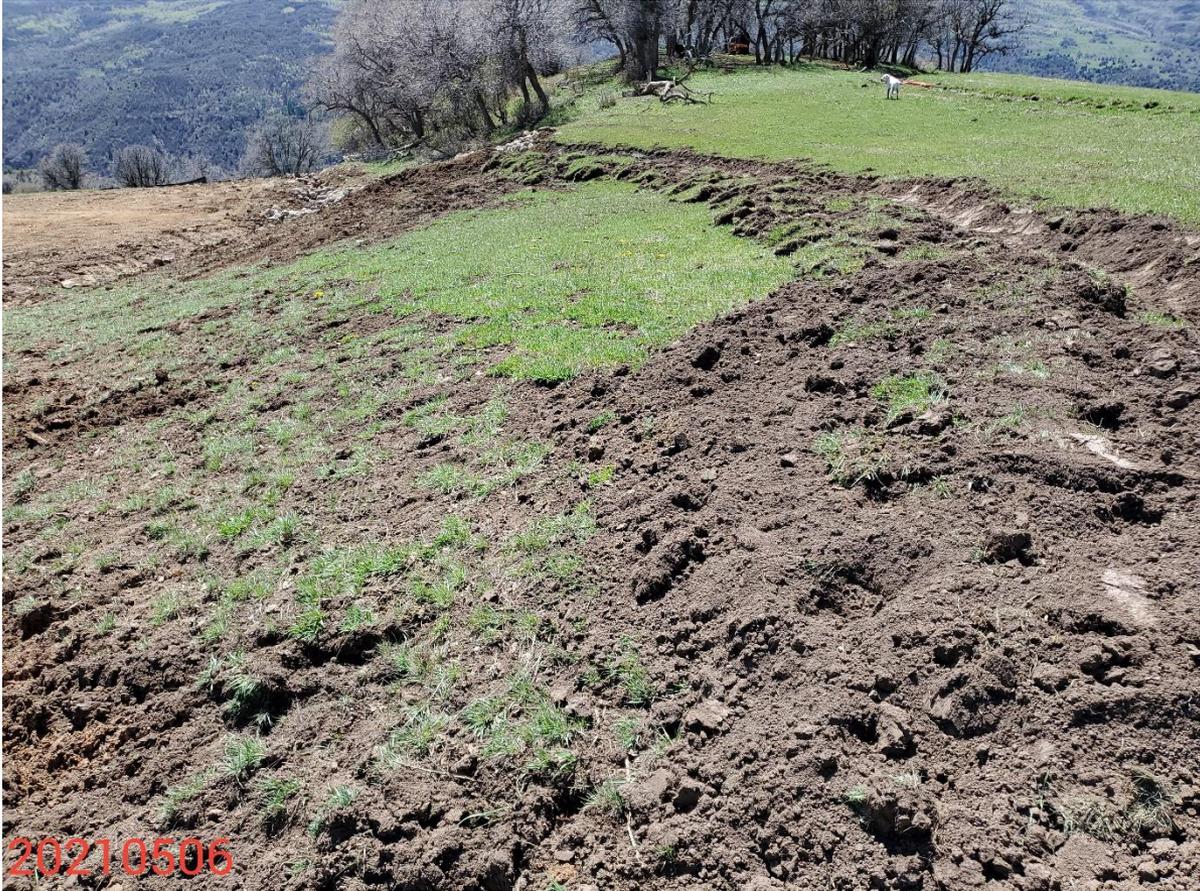
**Photo 7:** Photo taken from the north of the Location, facing west. Construction activities to address stormwater issues observed to be in process at time of inspection. Photo shows ditch being constructed to manage runoff.

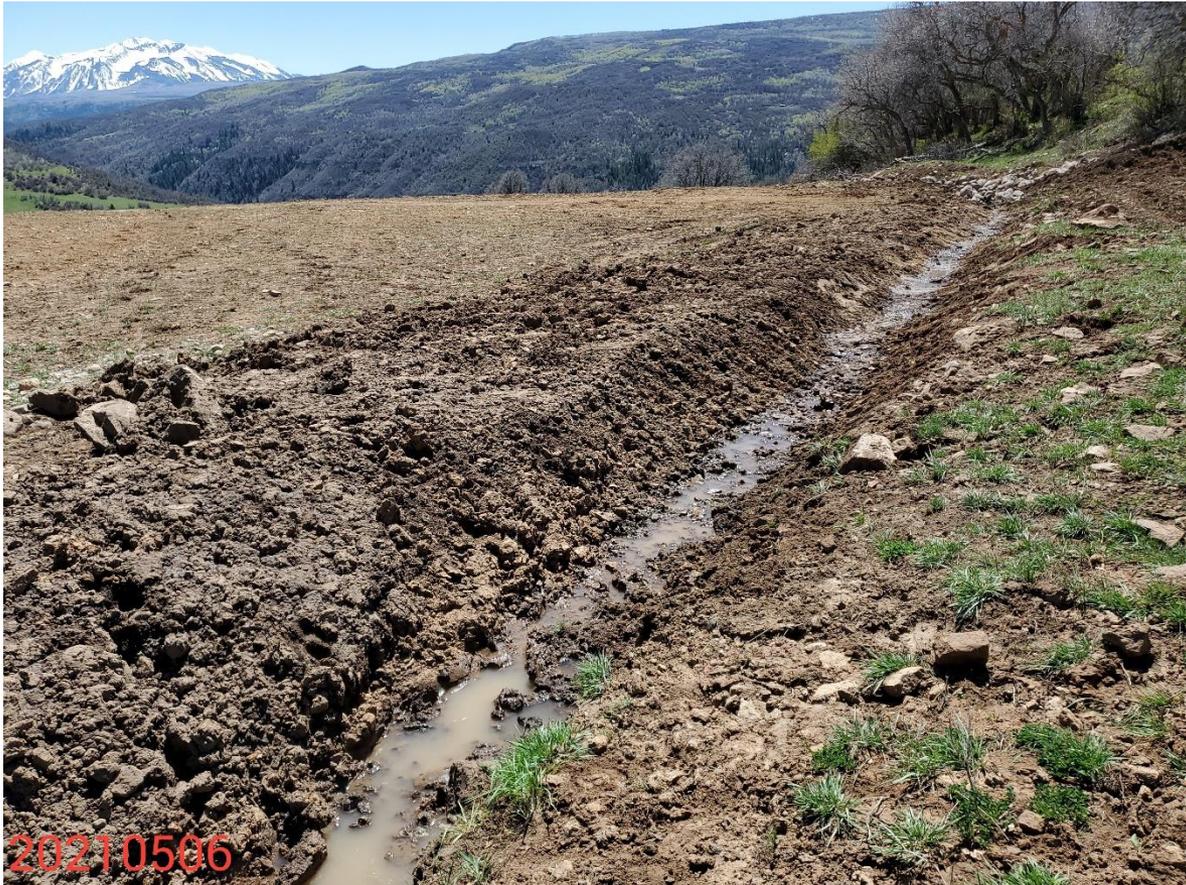
**Photo 8:** See comments under photo 7.

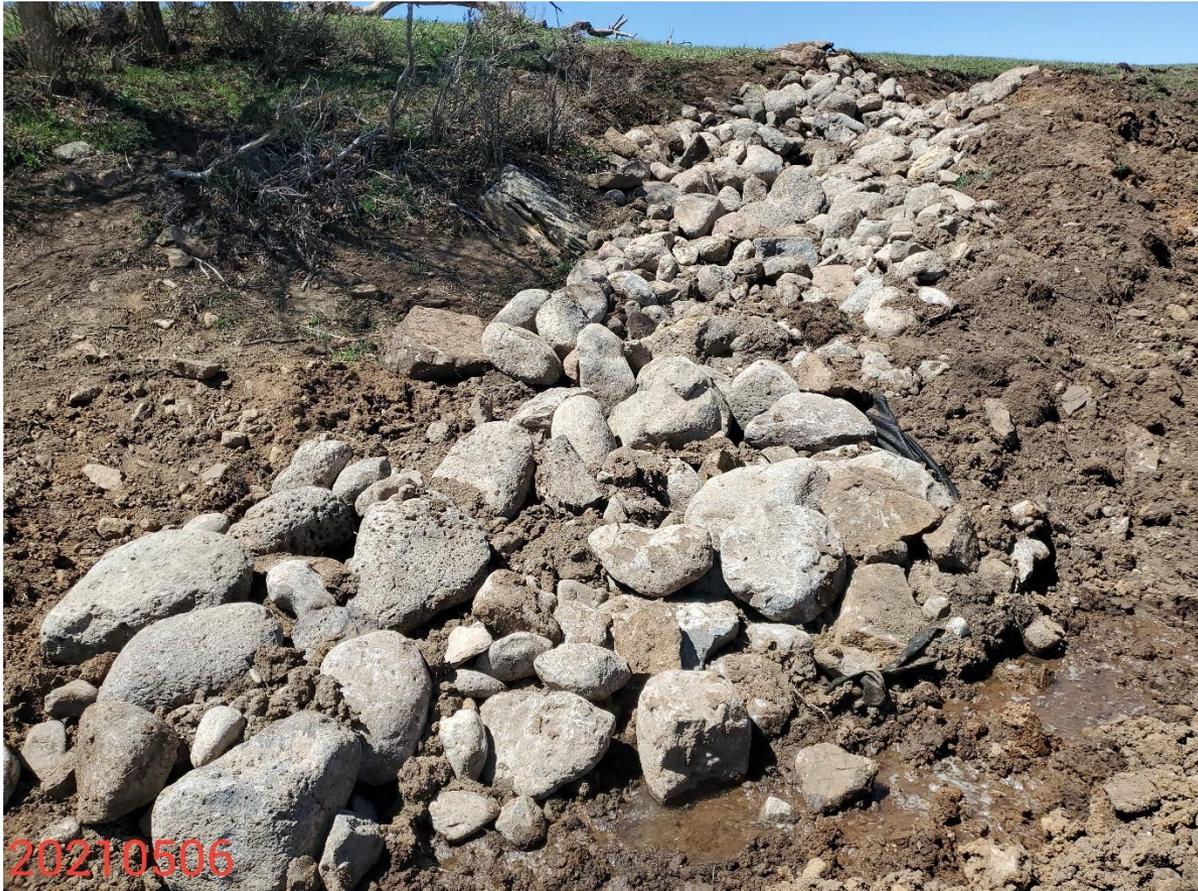
**Photo 9:** Photo taken from the northwest corner of the Location, facing north. Photo shows Operator has installed armoring along section of the ditch that travels downslope. Rock used is very large and not properly sized per good engineering practices. Geotextile lining has been placed beneath the riprap.

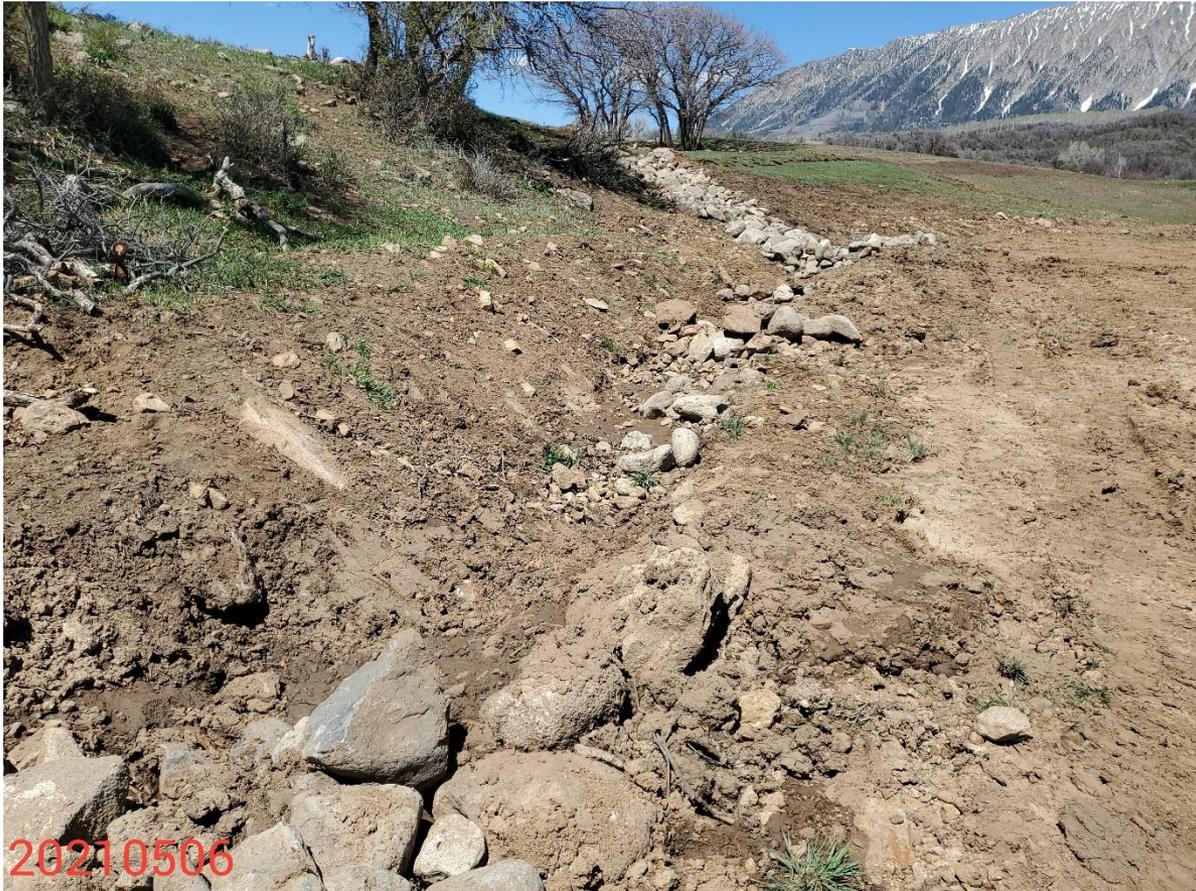
**Photo 10:** Photo taken from the west end of the Location, facing northeast. Construction activities to address stormwater issues observed to be in process at time of inspection. Operator on site indicated control measures such as a sediment trap or pond is being considered at the end of the ditches to allow for appropriate stormwater discharge from the disturbance area.

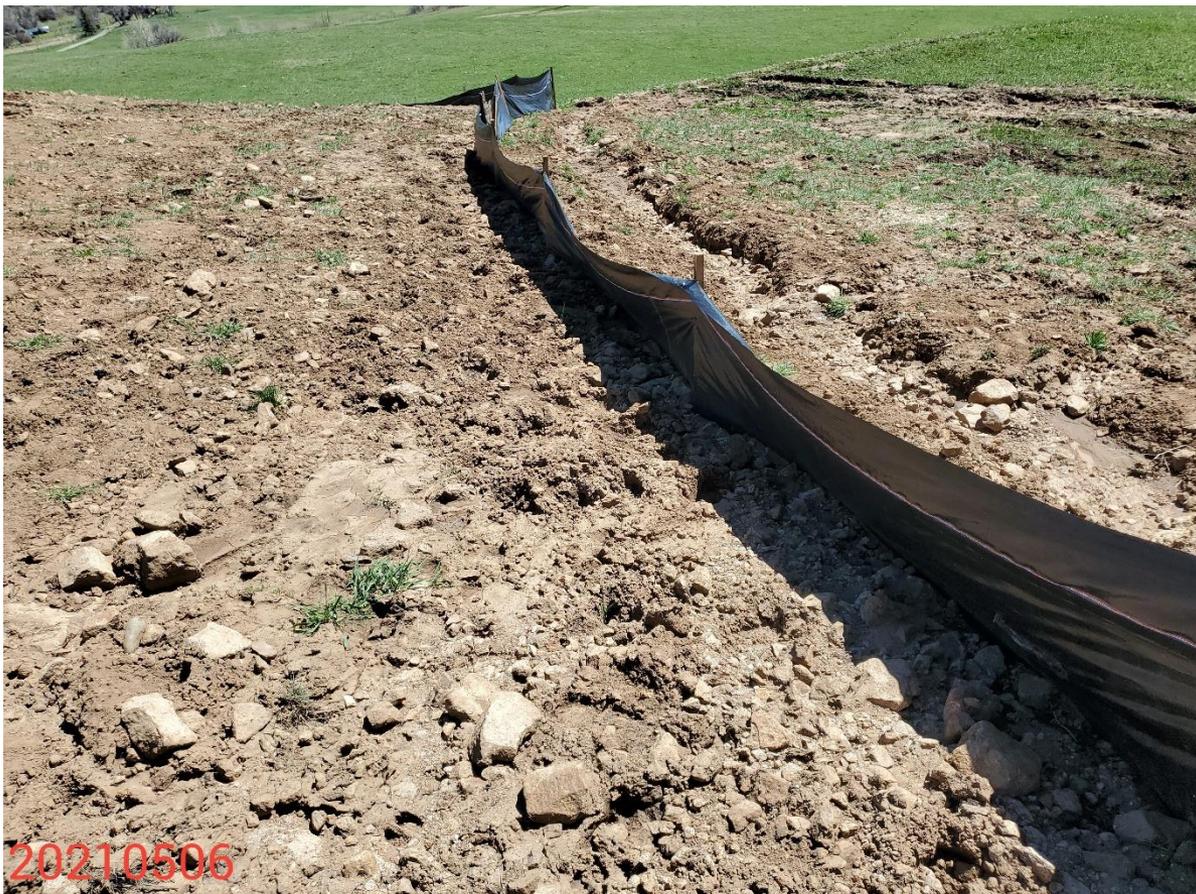
**Photo 11:** Photo taken from the southwest end of the Location, facing east. Photo shows Operator has installed silt fence as a temporary measure to manage runoff.

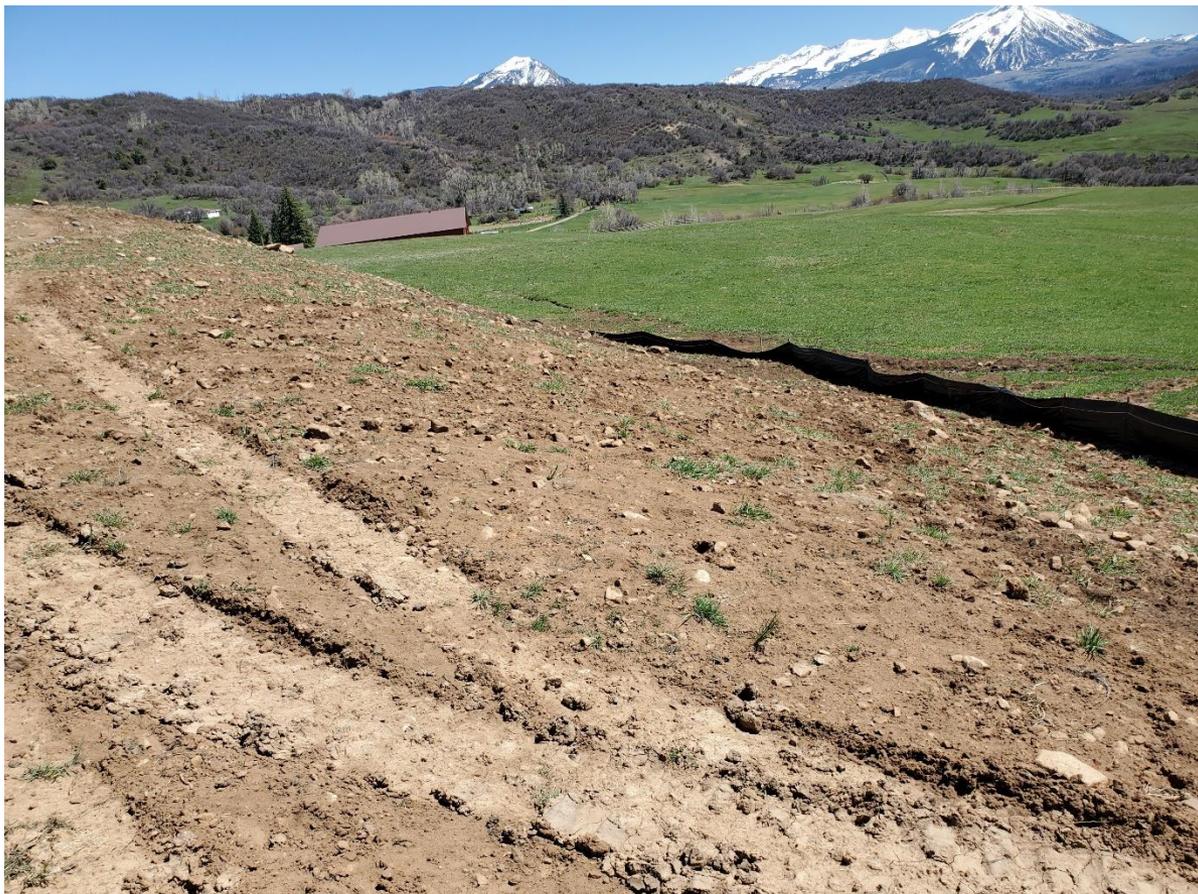
**Photo 12:** See comments under photo 11. Operator on site stated that control measures to stabilize soils and additional revegetation activities are planned.

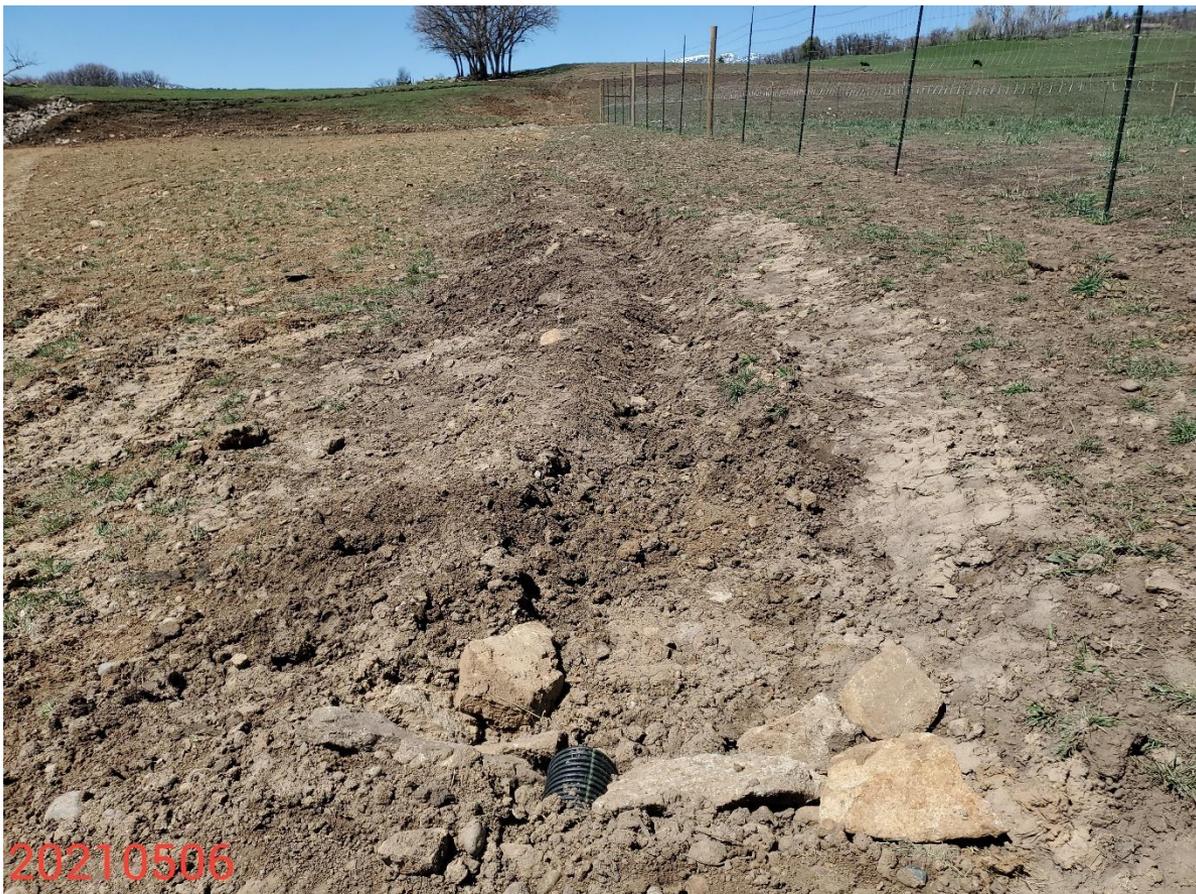
**Photo 13:** Photo taken from the ditch on the west end of the former pad, facing north. Photo shows inlet to a slope drain that has been installed at end of the Ditch.

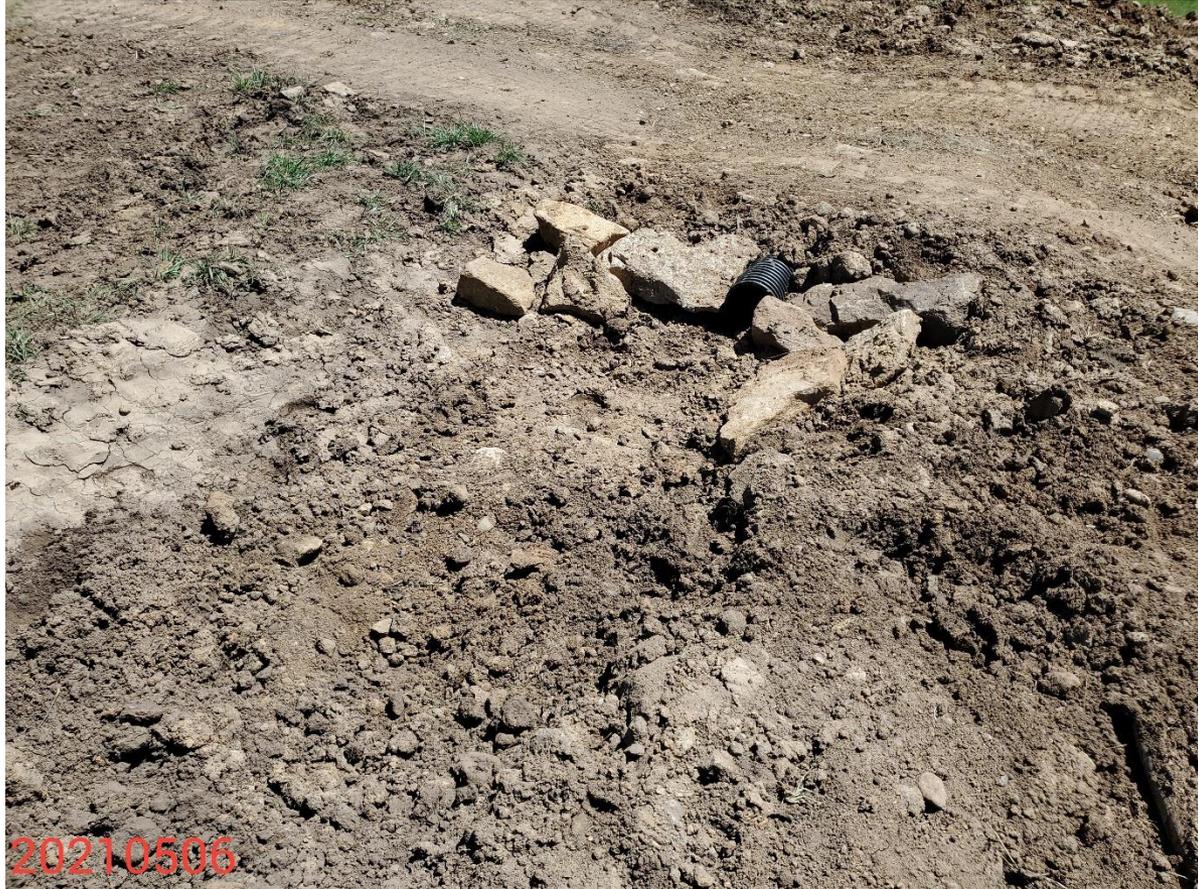
**Photo 14:** See comments under photo 13.

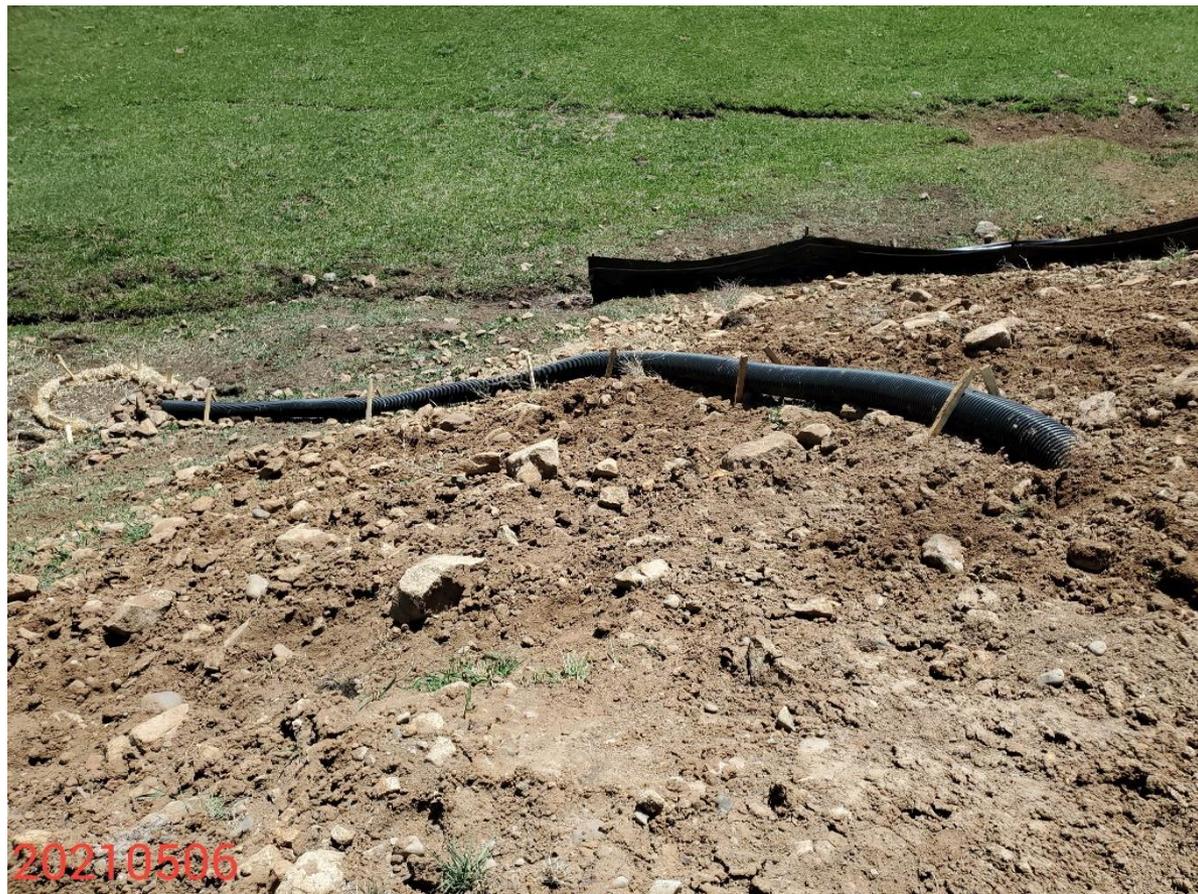
**Photo 15:** Continued from photo 13. Photo shows slope drain and the outlet. Unclear if the slope drain is sufficiently secured.

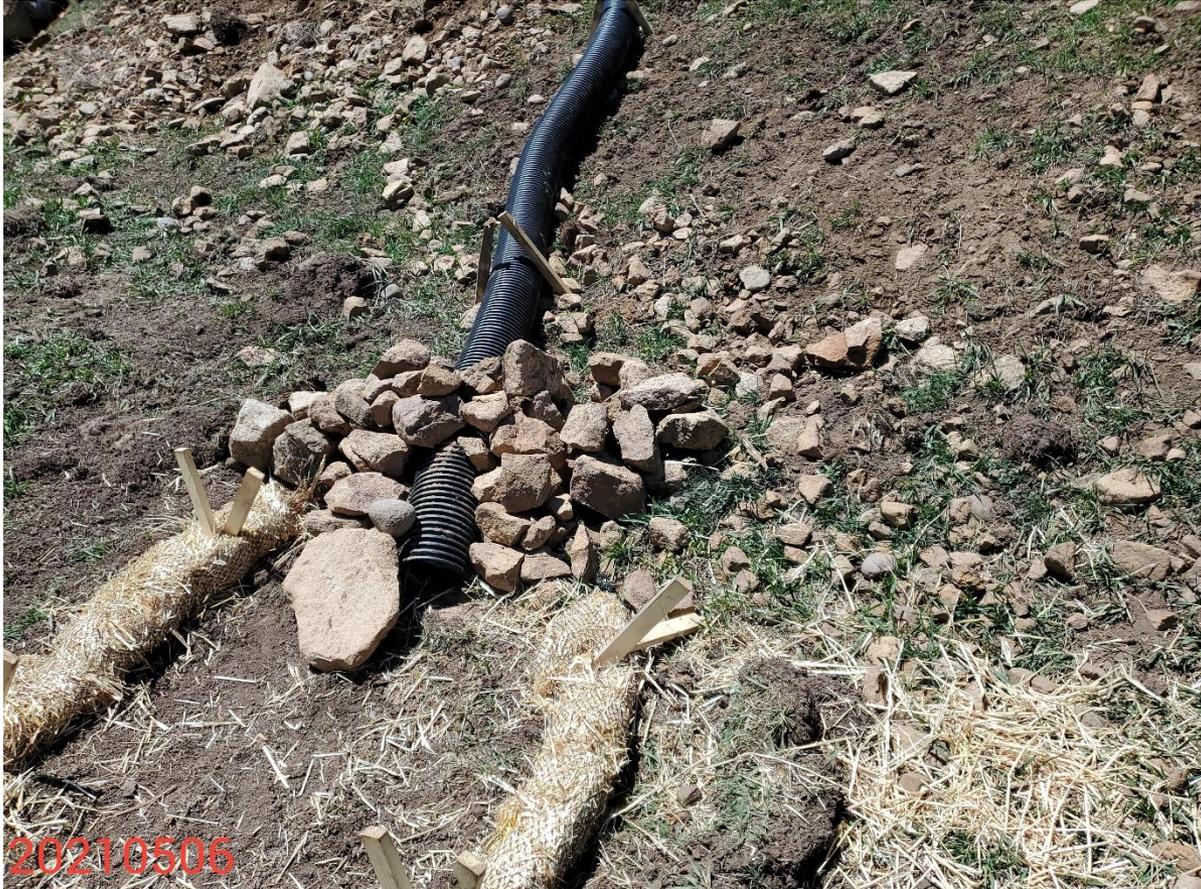
**Photo 16:** Continued from photo 13. Photo shows slope drain has not been constructed with an appropriate outlet in accordance with good engineering practices.

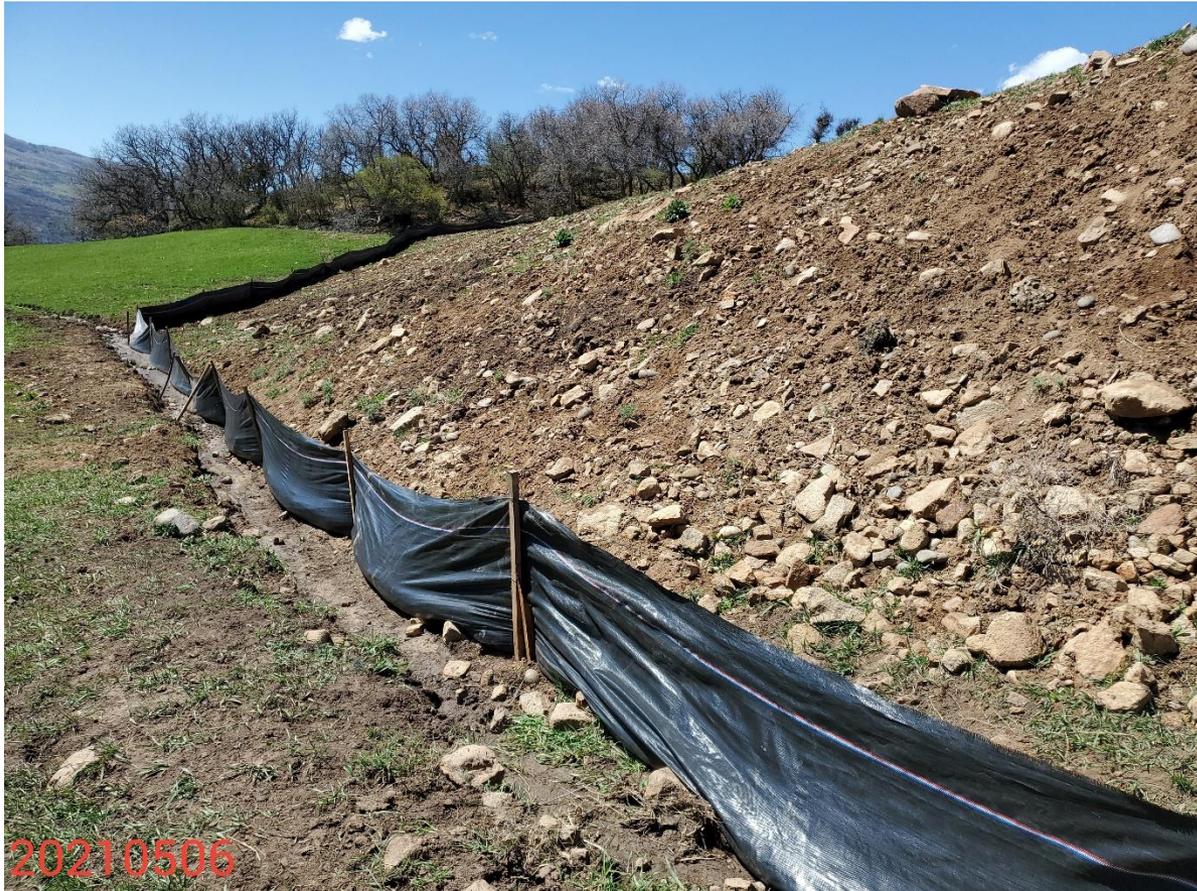
**Photo 17:** Photo shows silt fence along the western areas of the Location's disturbance.

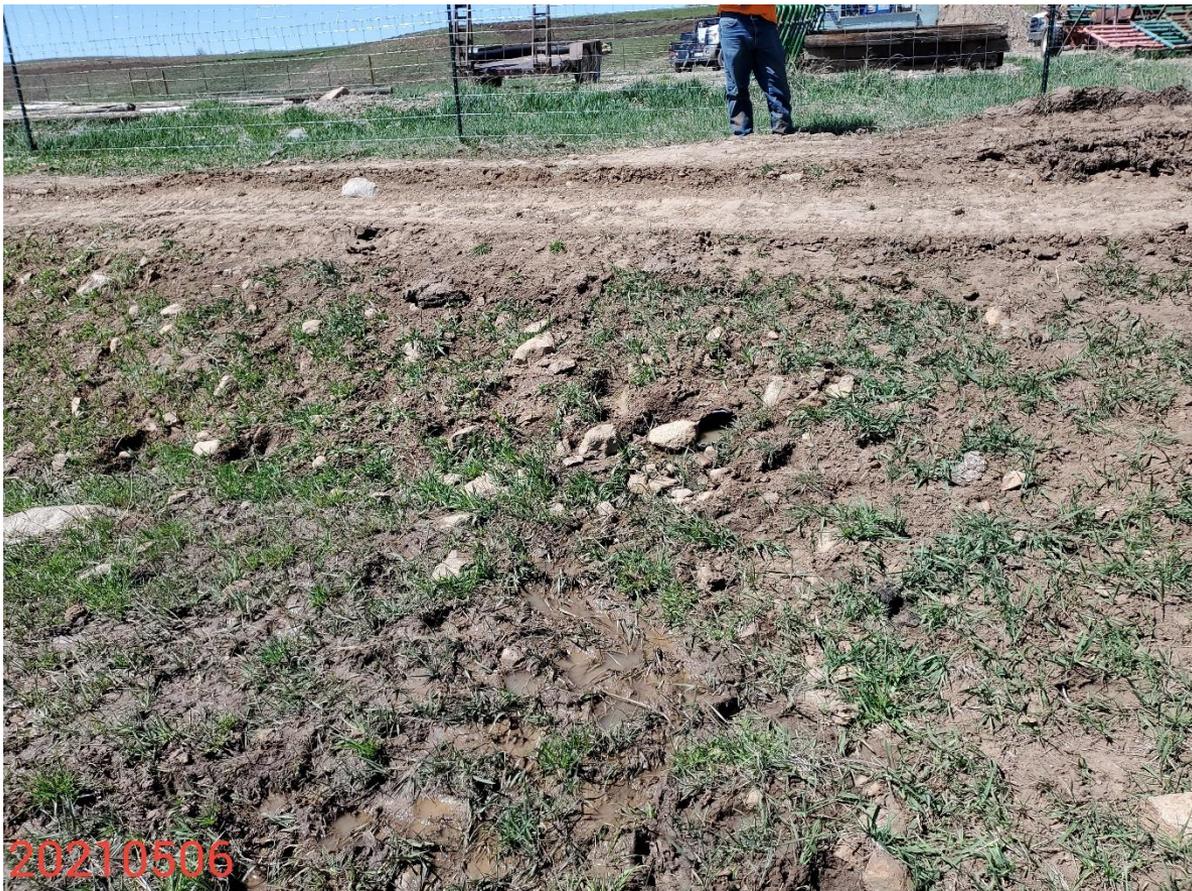
**Photo 18:** Photo taken from the south end of the Location. Operator has installed a drain/culvert that travels beneath the soils from the pad to the slopes. Drain has not been constructed with an appropriate outlet.
