Inspection Photos

API: 009-06215

Operator: SOVEREIGN OPERATING COMPANY

Inspection Date: 5/5/2021

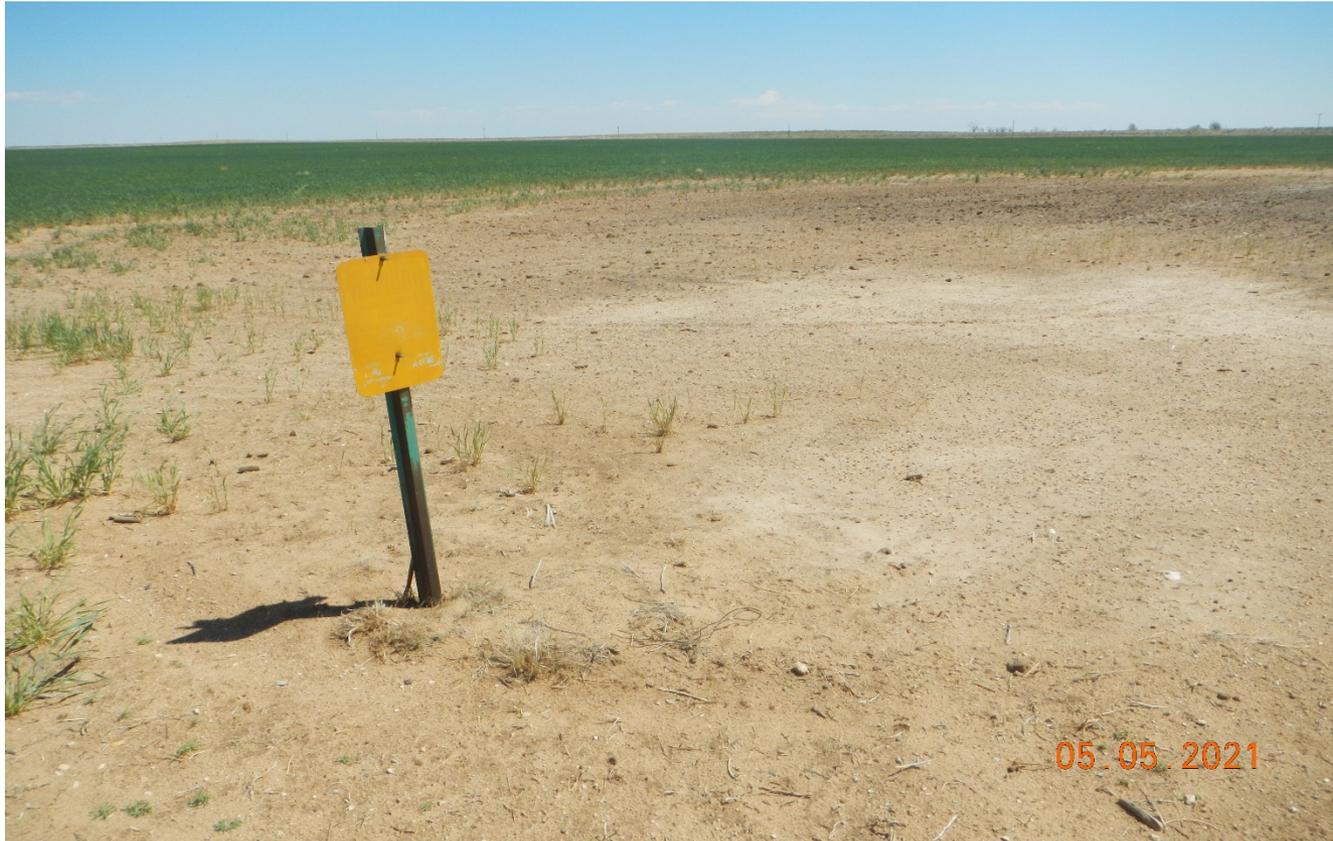
Photo 1. Facing northeast toward the area where the tank battery was location. This area does not have crop establishment and soils will need to be reclaimed.

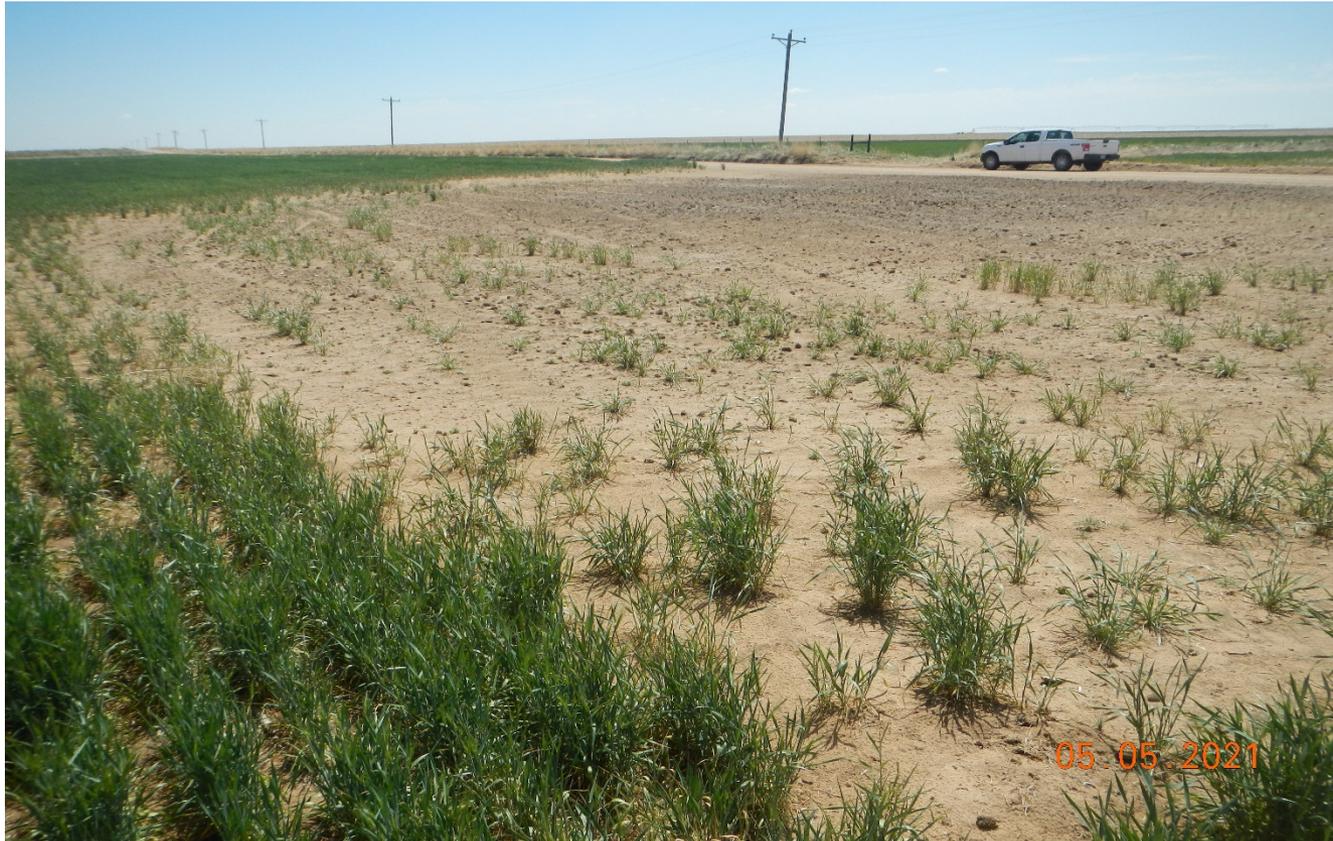
Photo 2. Facing southeast toward the area where the tank battery was location. This area does not have crop establishment and soils will need to be reclaimed.

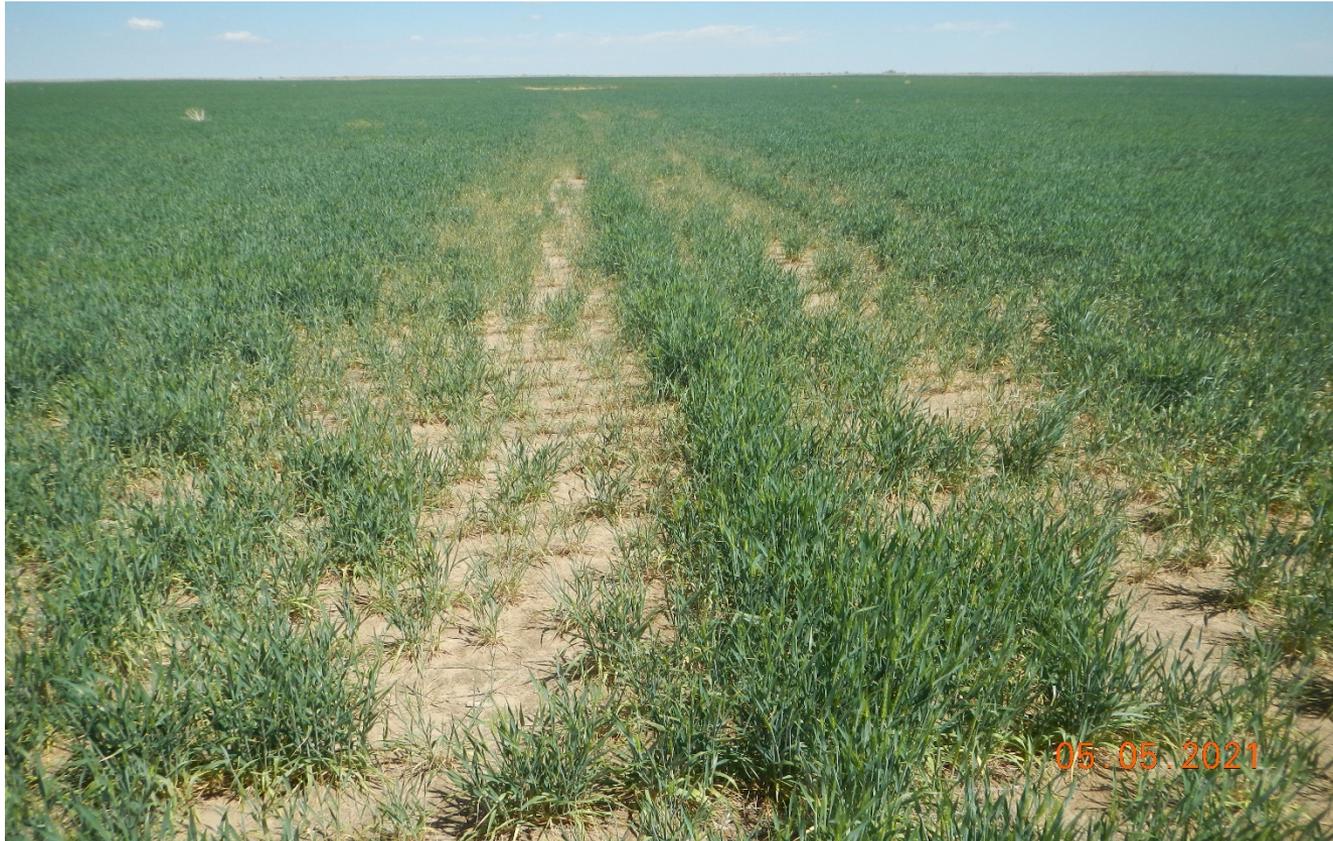
Photo 3. Facing north along the former access road. There are areas along the access road where the crop is not establishing very well.

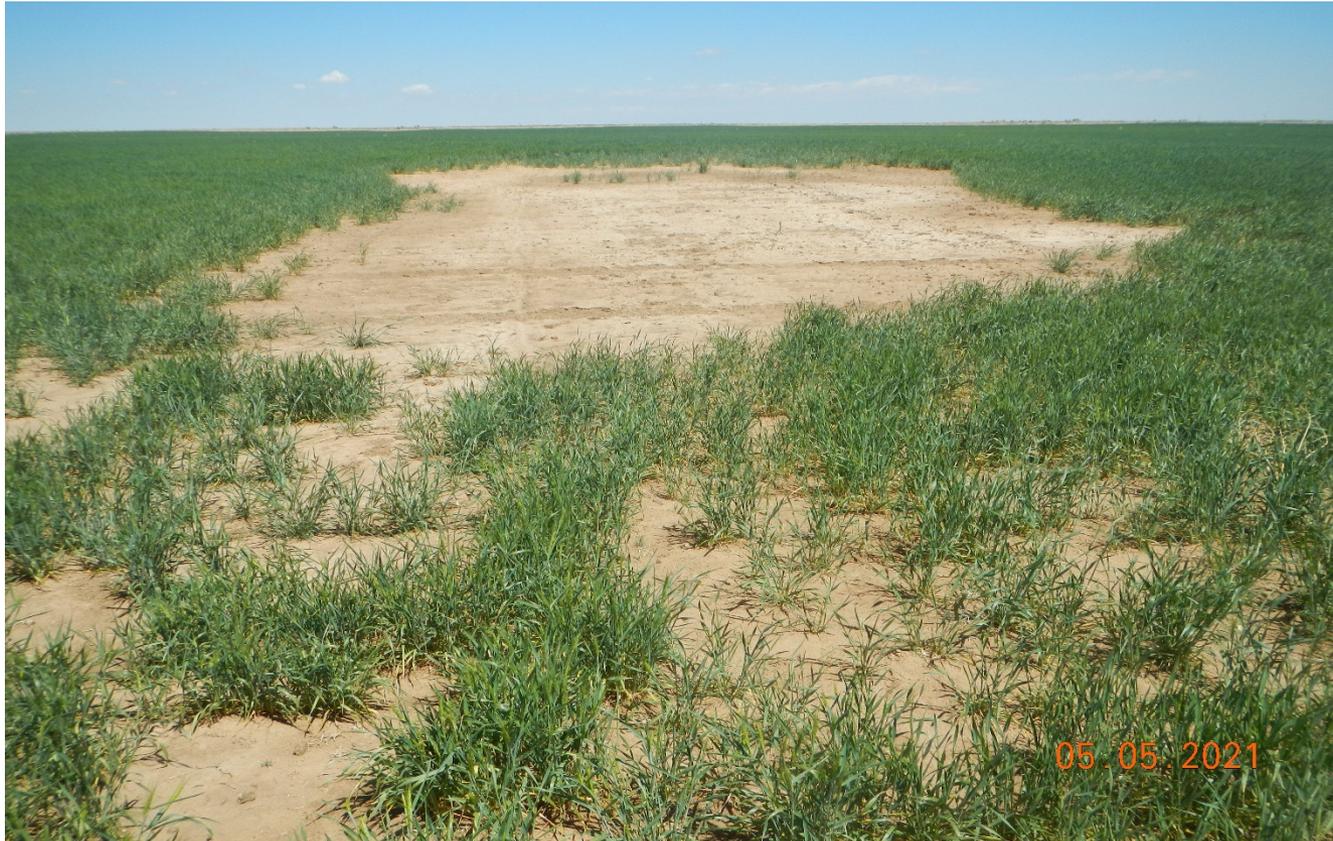
Photo 4. Facing north at the location. There is no crop growth at this area of the location approximately 120'x80'.

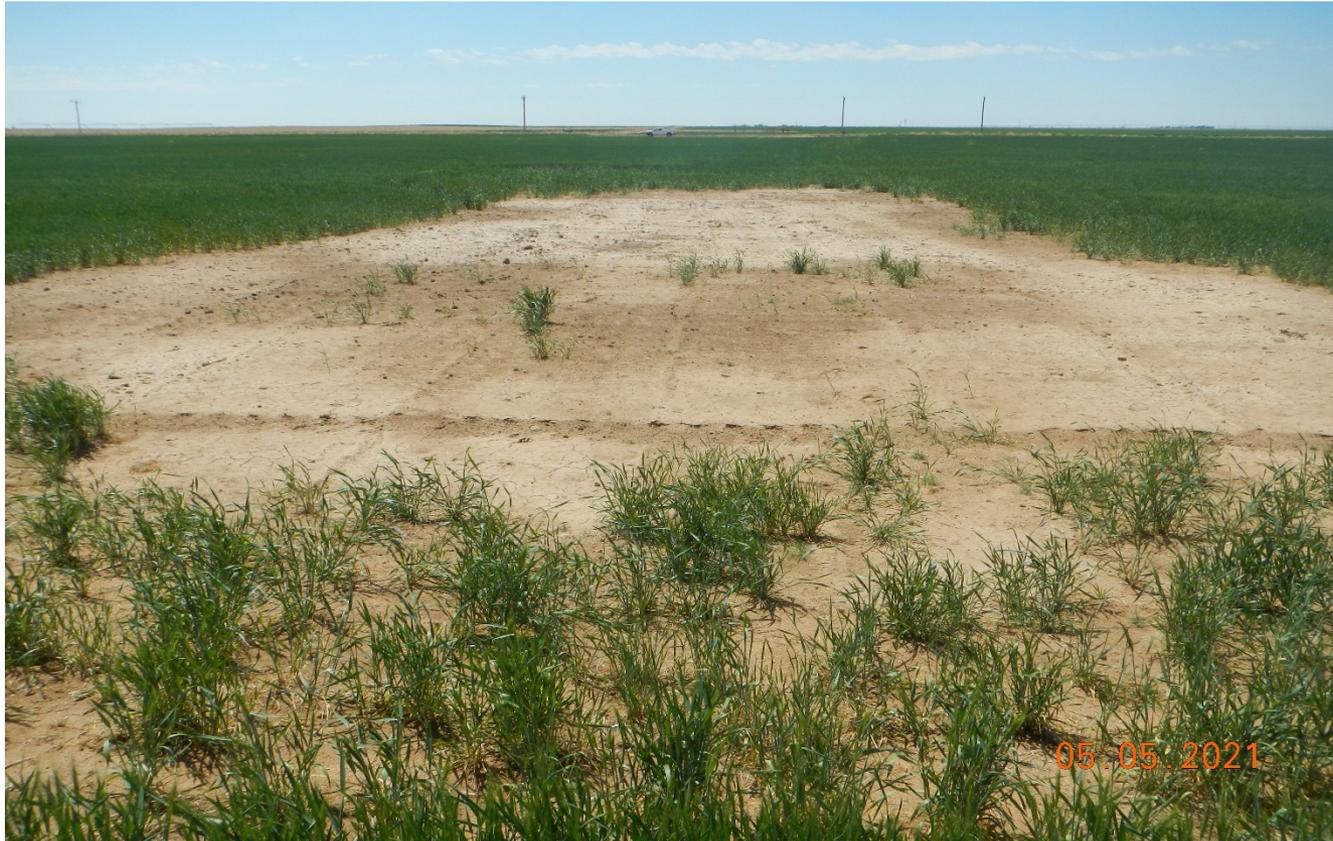
Photo 5. Facing south at the location. There is no crop growth at this area of the location approximately 120'x80'.
