Inspection Photos

API: 009-06322

Operator: DOVER ATWOOD CORPORATION

Inspection Date: 5/5/2021

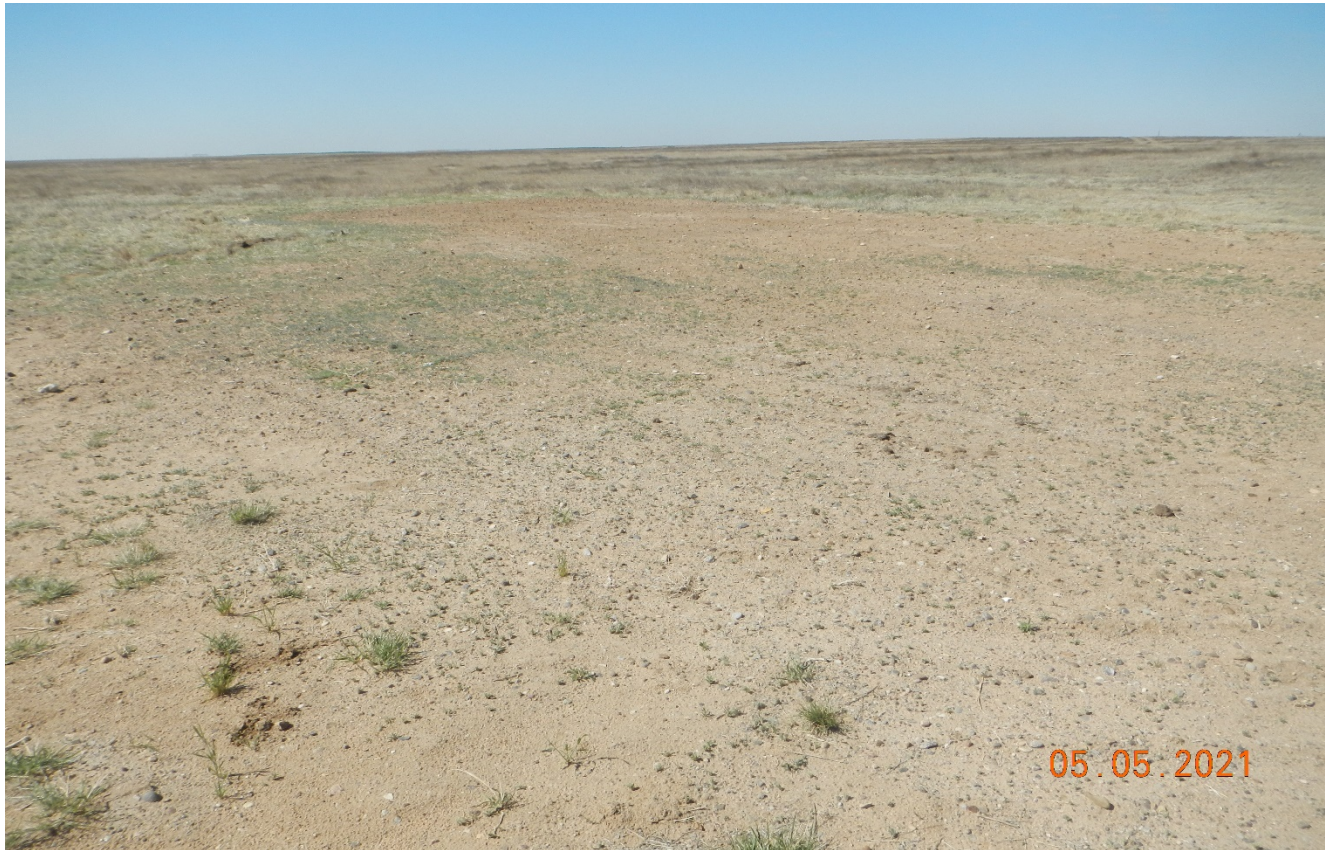
Photo 1. Facing southeast toward the location. The location has been recontoured and decompacted. All equipment has been removed.

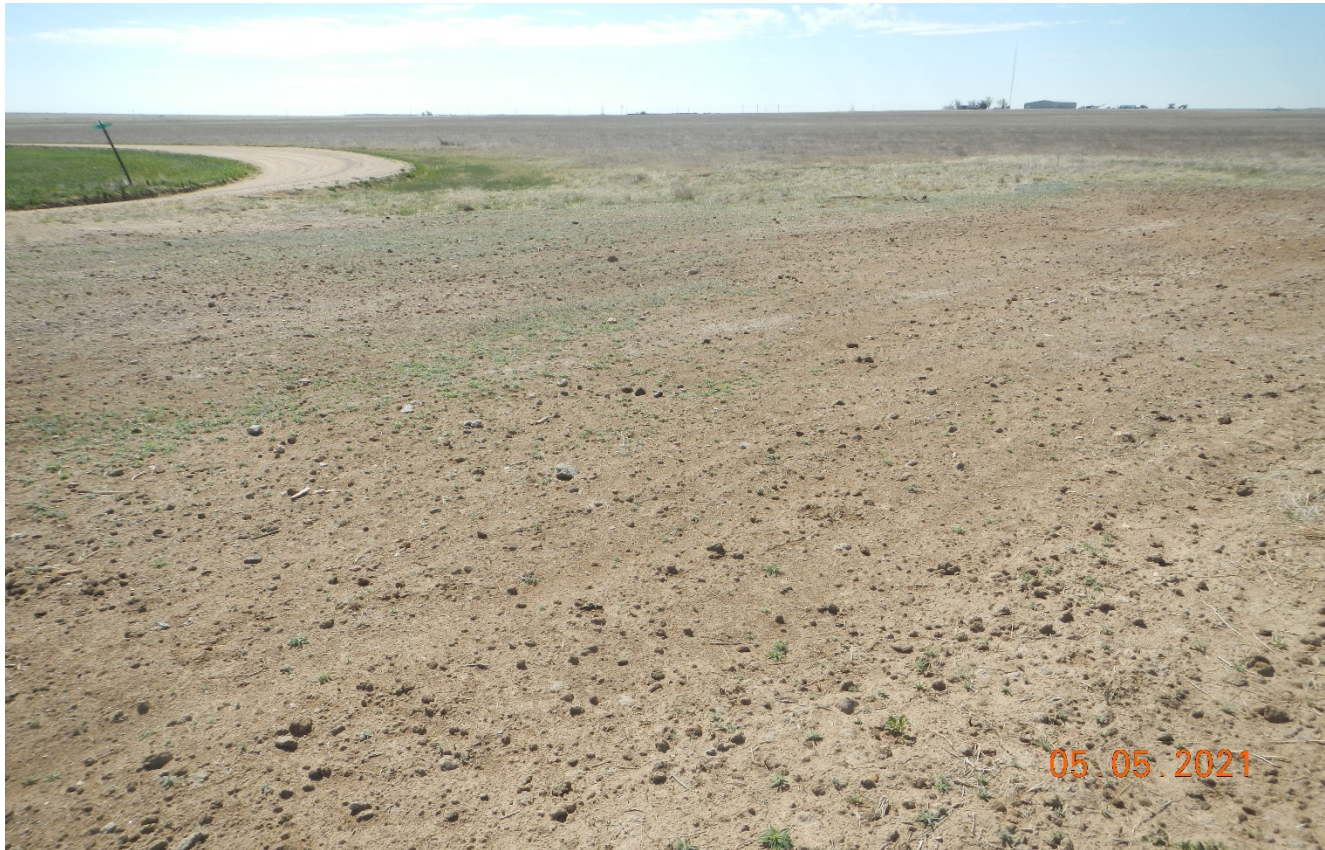
Photo 2. Facing southeast toward the location. The location has been recontoured and decompacted. It is unknown if seeding occurred. No desirable vegetation germination was observed.

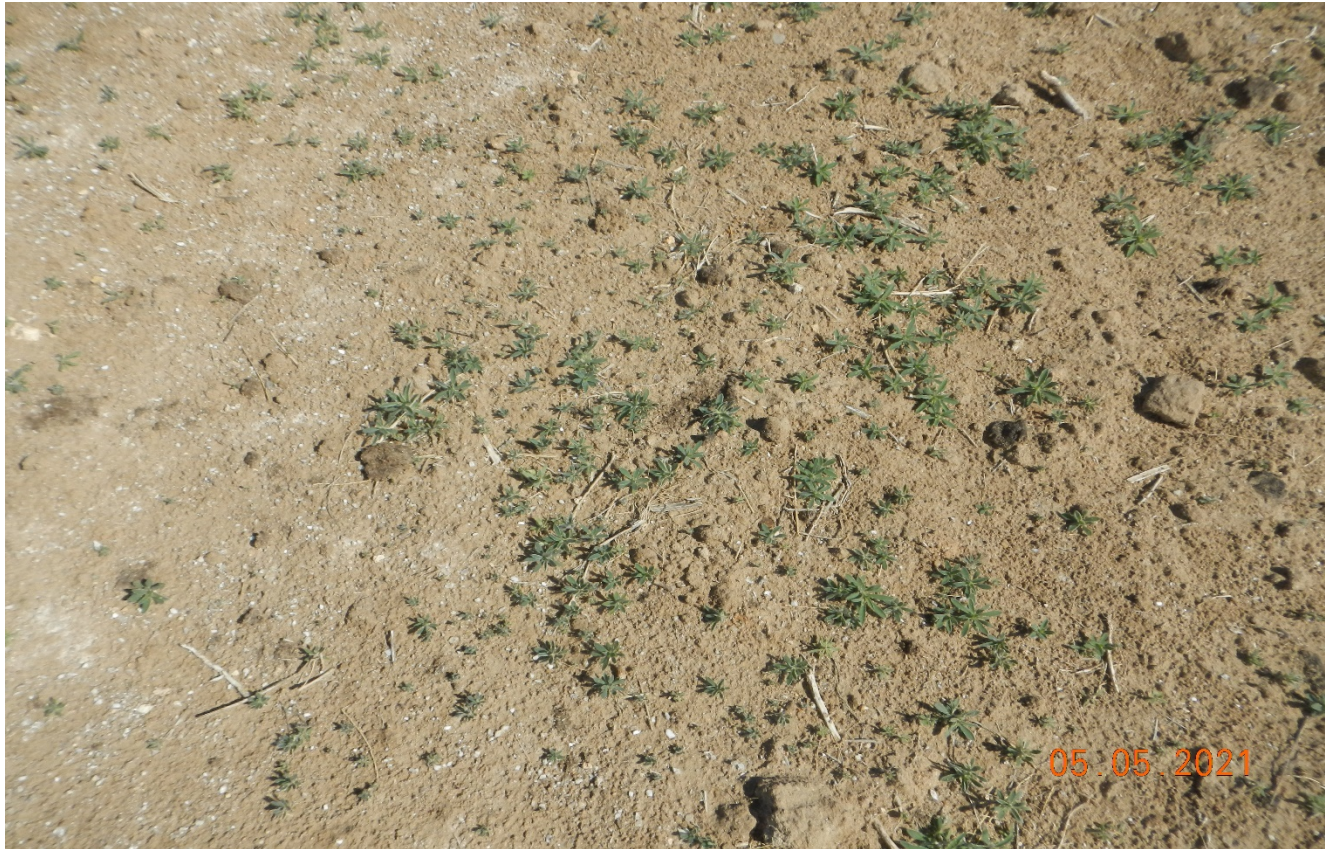
Photo 3. View of groundcover. The green vegetation is undesirable weeds which will need to be controlled.

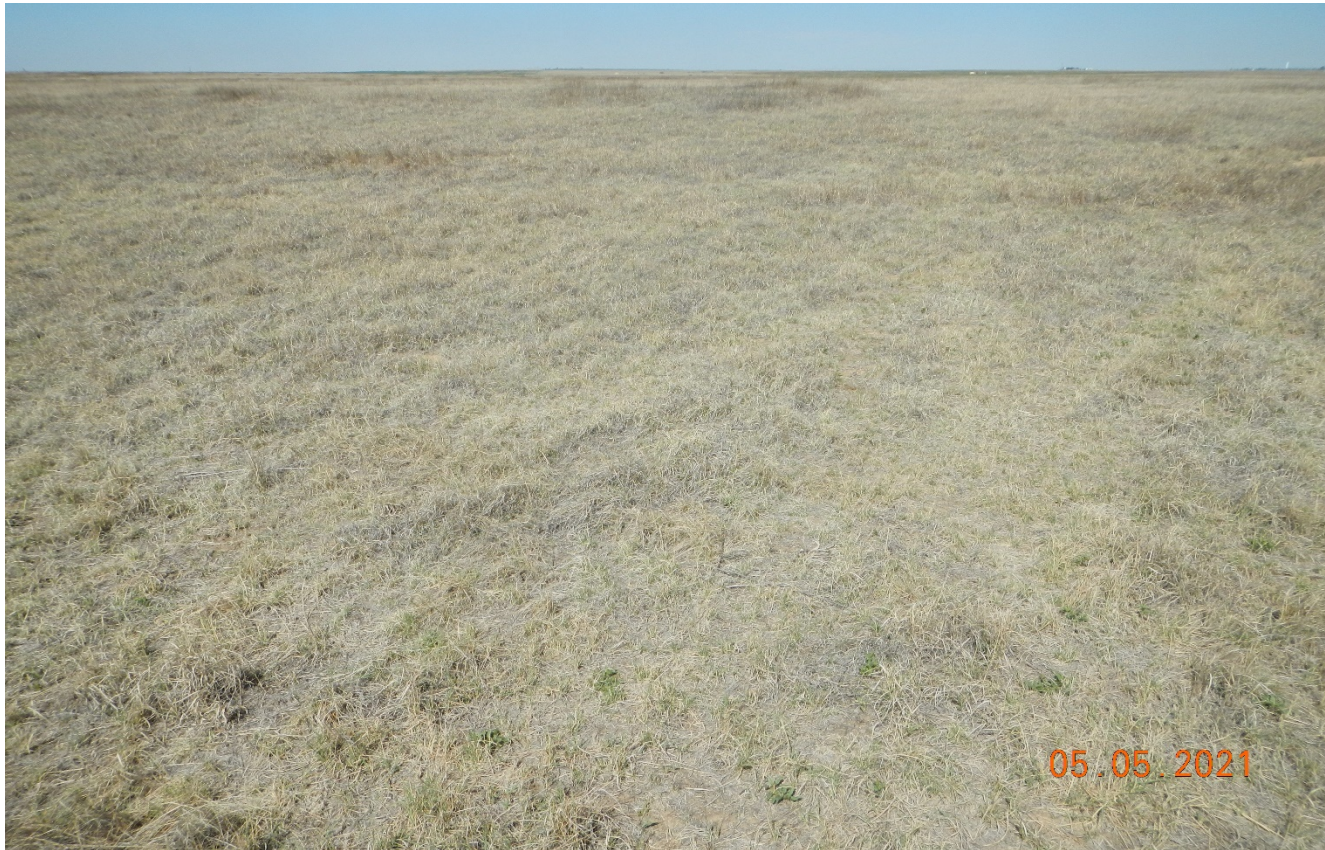
Photo 4. Facing west toward the surrounding undisturbed pasture which consists of native desirable vegetation cover.
