## Inspection Photos

Location Name: Silver Spur Minerals 35-2H

API: 05-057-06490

Date: May 6, 2021

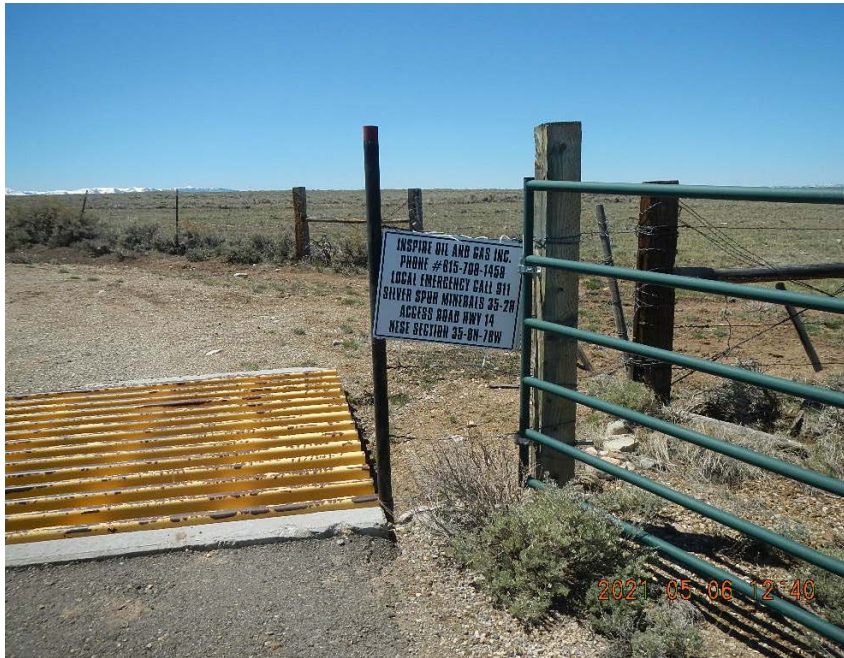
Location sign off of Hwy 14.

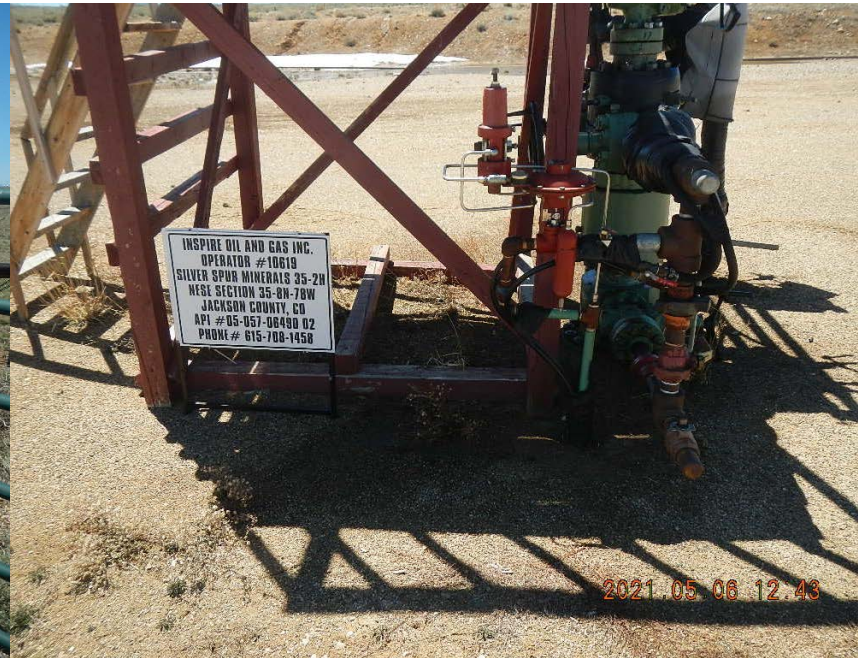
Well sign.

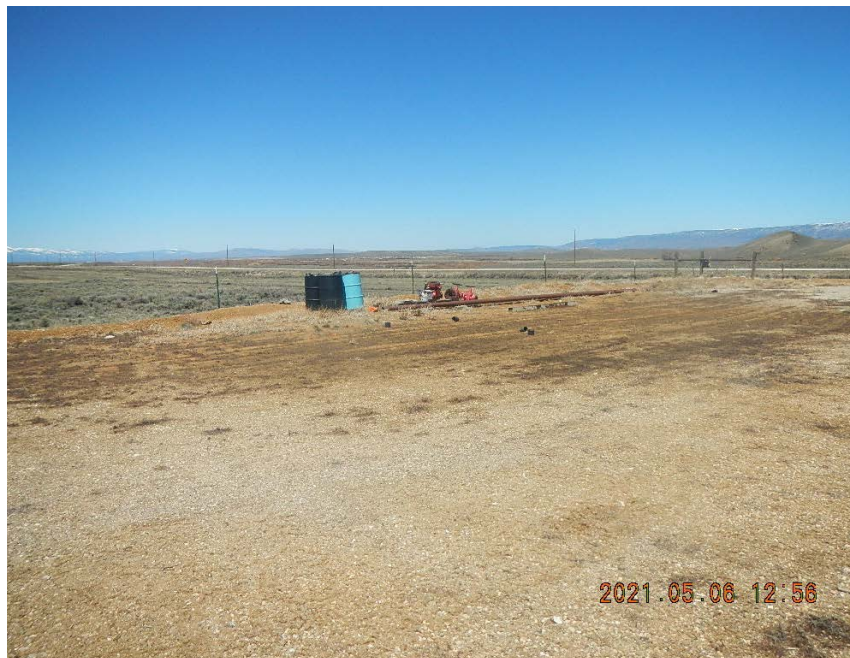
Equipment stored on Location.

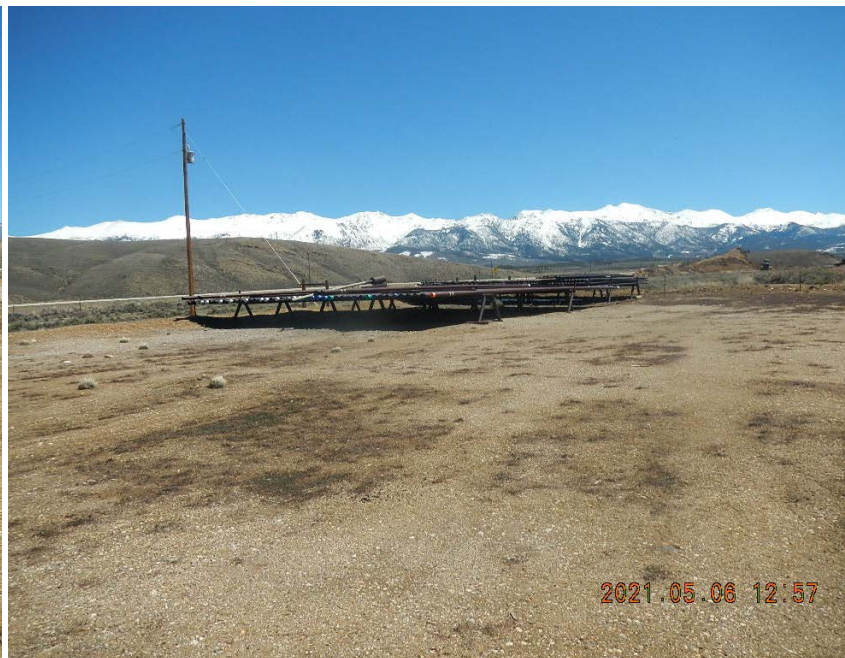
Equipment stored on Location.

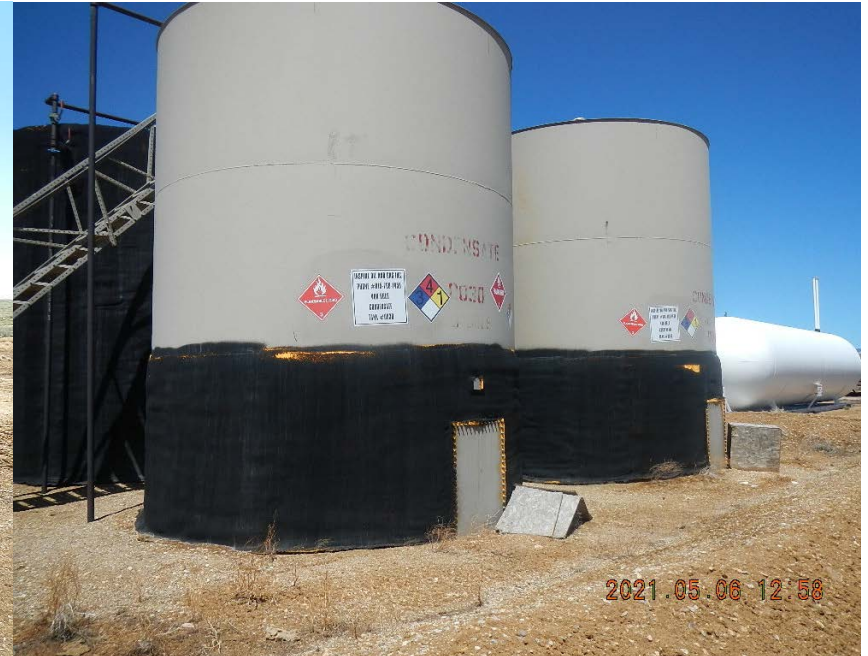
Tank signage, labels, and placards are illegible.

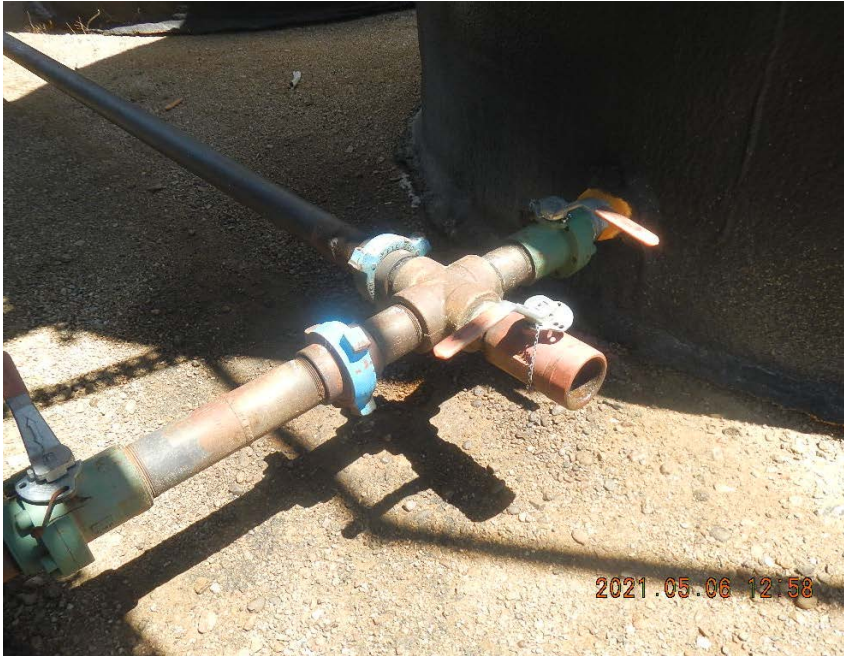
Tank 0030, staining beneath hammer unions.

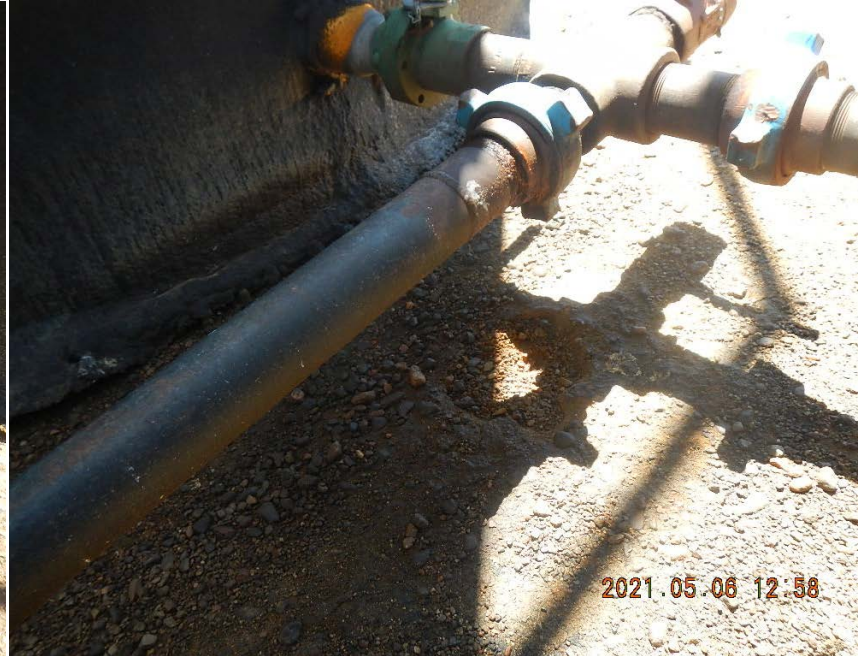
Tank 0030, staining beneath hammer unions.

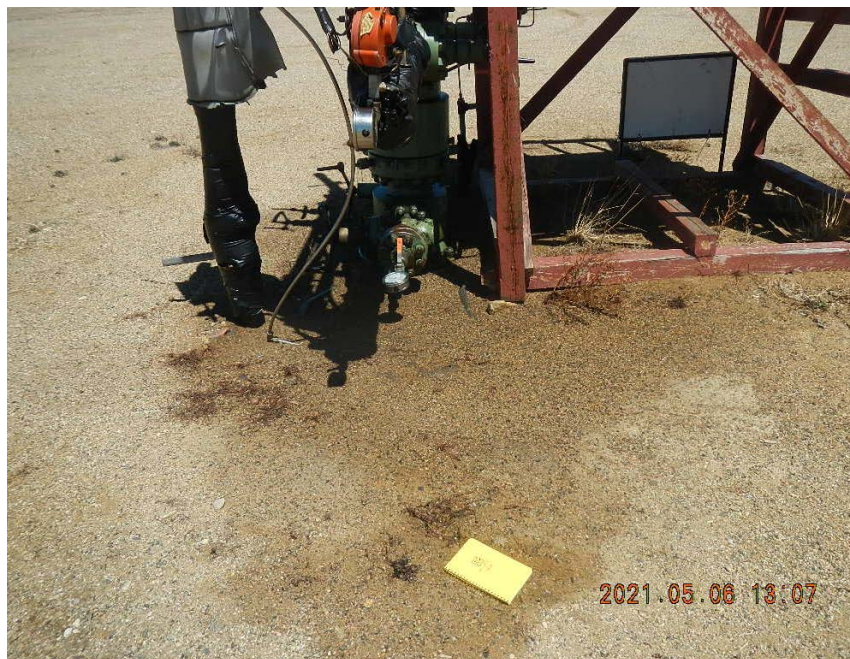
Staining from on-going gas leak/vent and condensate around wellhead.

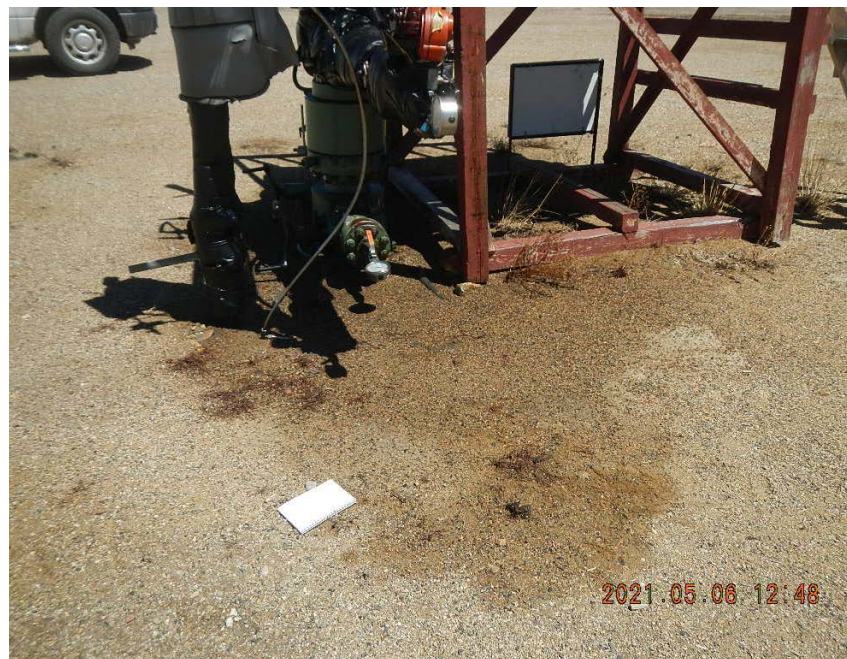
Staining from on-going gas leak/vent and condensate around wellhead.

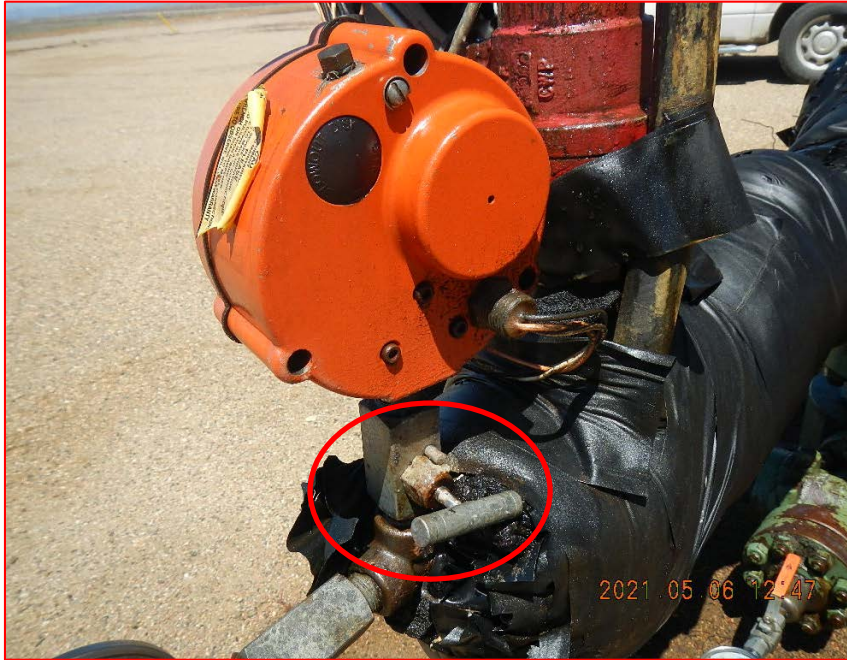
Valve in red circle is where gas was venting.

Valve is where gas was venting.
