Inspection Photos

5/11/2021

Operator: LARAMIE ENERGY LLC - 10433

Location ID: 335091

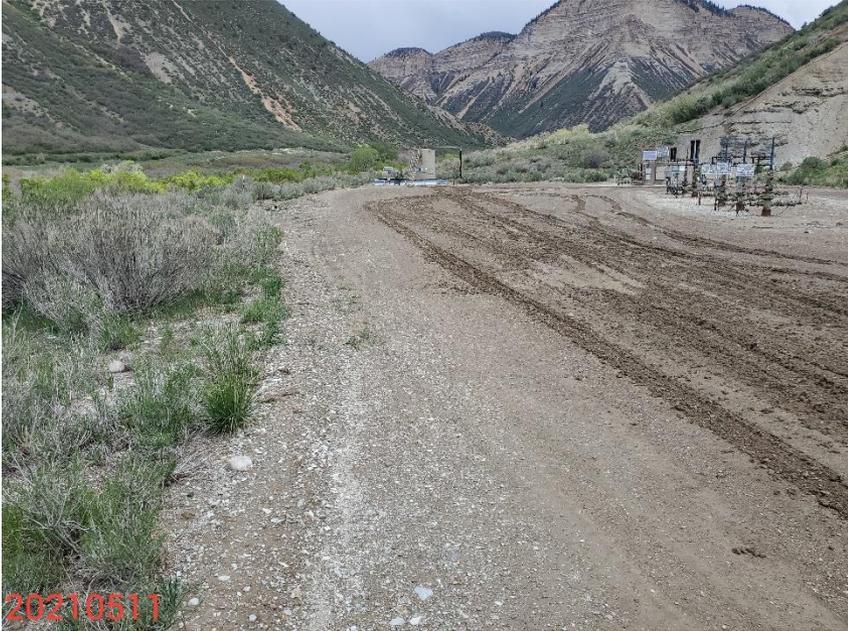
Photo 1: Photo taken from the west end of the production area, facing north. Photos 1-4 provide an overview of the Location from north, northeast, southeast to south.

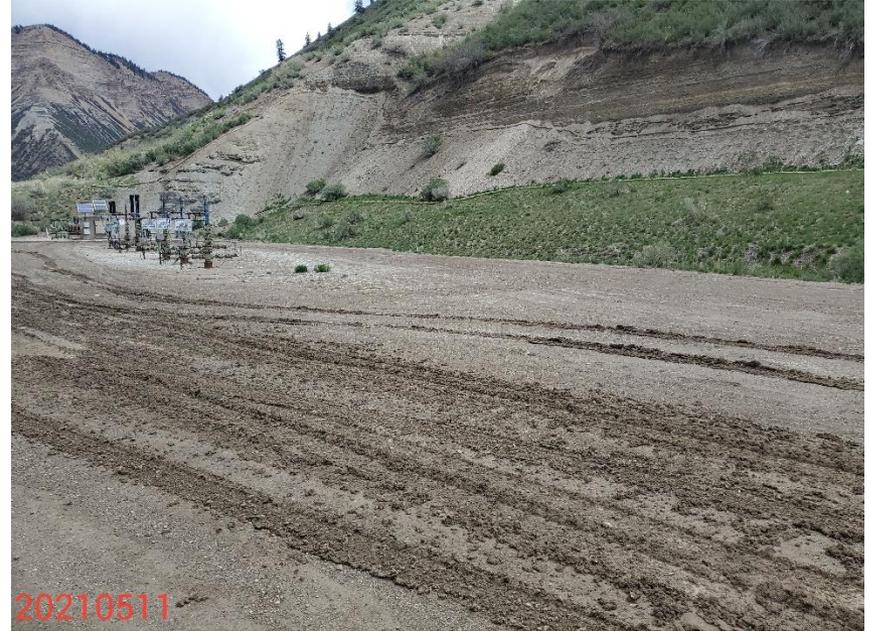
Photo 2: See comments under photo 1.

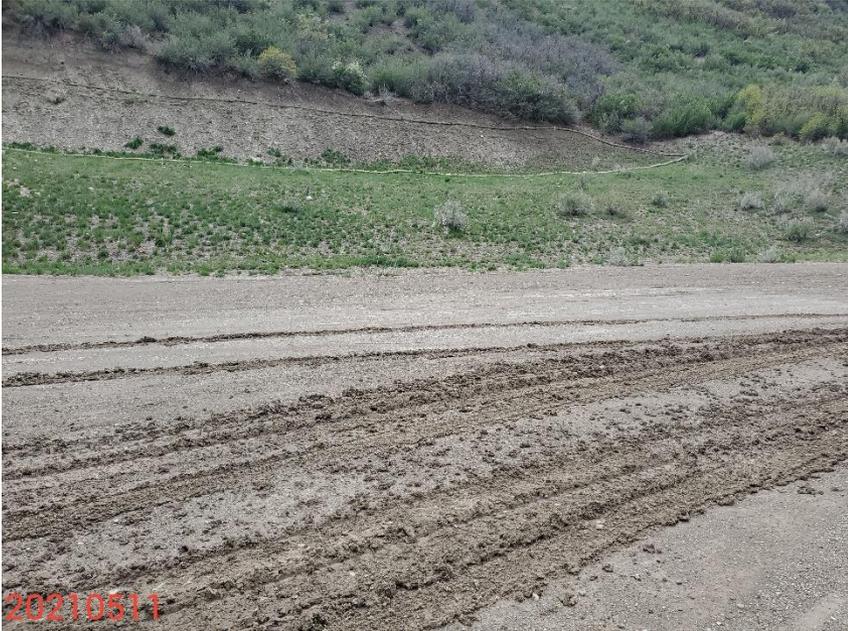
Photo 3: See comments under photo 1.

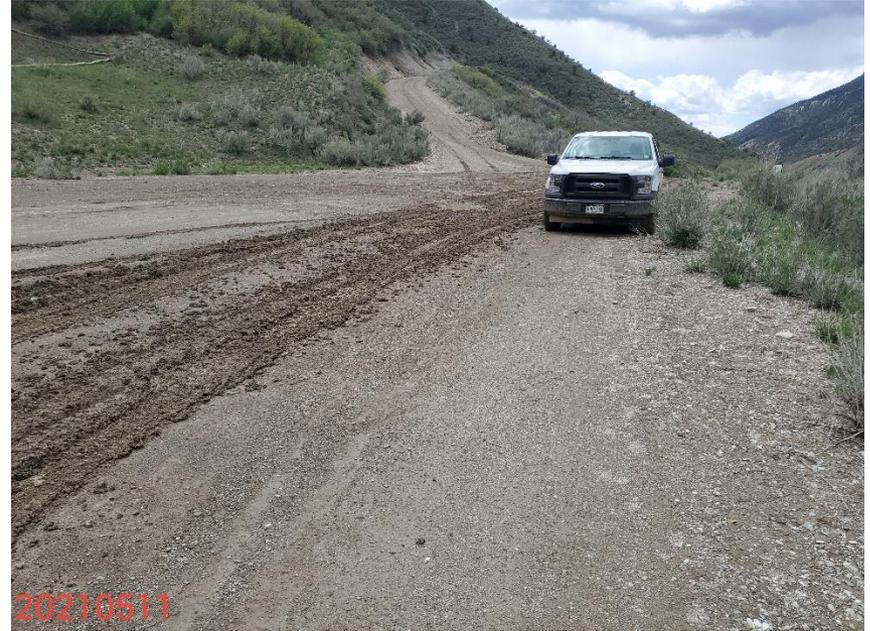
Photo 4: See comments under photo 1.

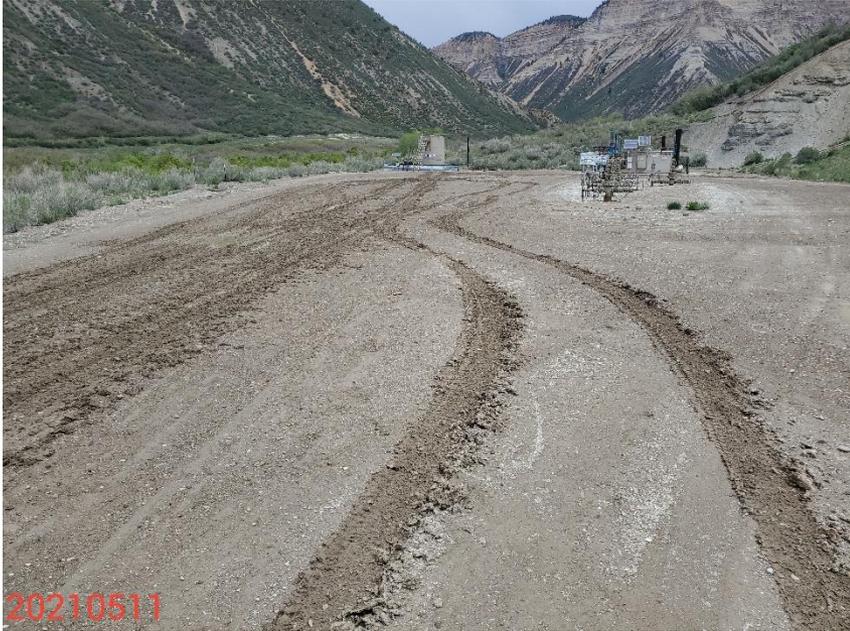
Photo 5: Photo taken from the production area, facing north.. Photo shows control measures to stabilize the production area are missing or insufficient.

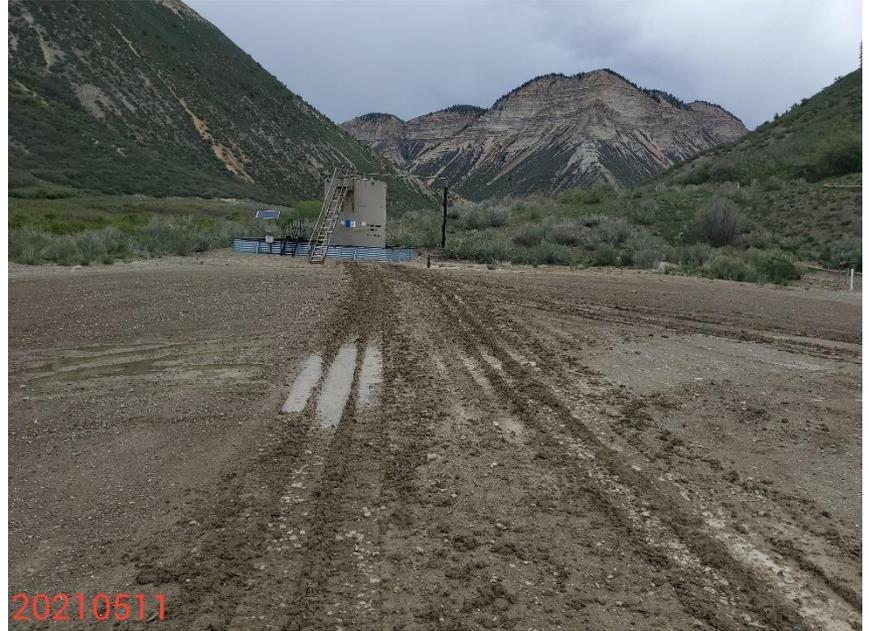
Photo 6: Photo taken from the production area, facing north.. Photo shows control measures to stabilize the production area are missing or insufficient.

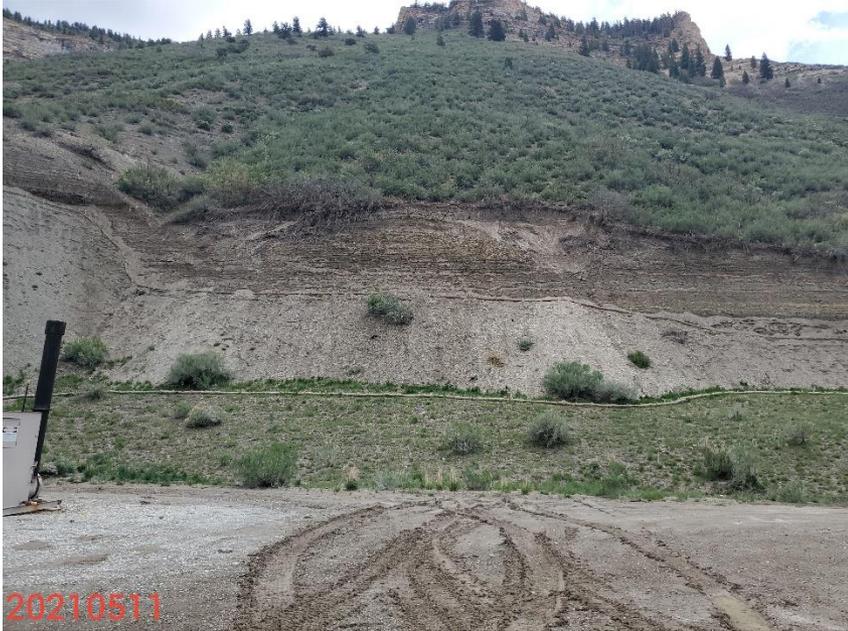
Photo 7: Photo taken from the production area, facing east. Operator has installed wattles along the base and upper portions of the cut slope; no other control measures were observed to be used in conjunction with the wattles on the slopes. Photo shows areas where erosion on the cut slopes have covered multiple sections of wattles. BMPs to stabilize/protect remain missing or insufficient.

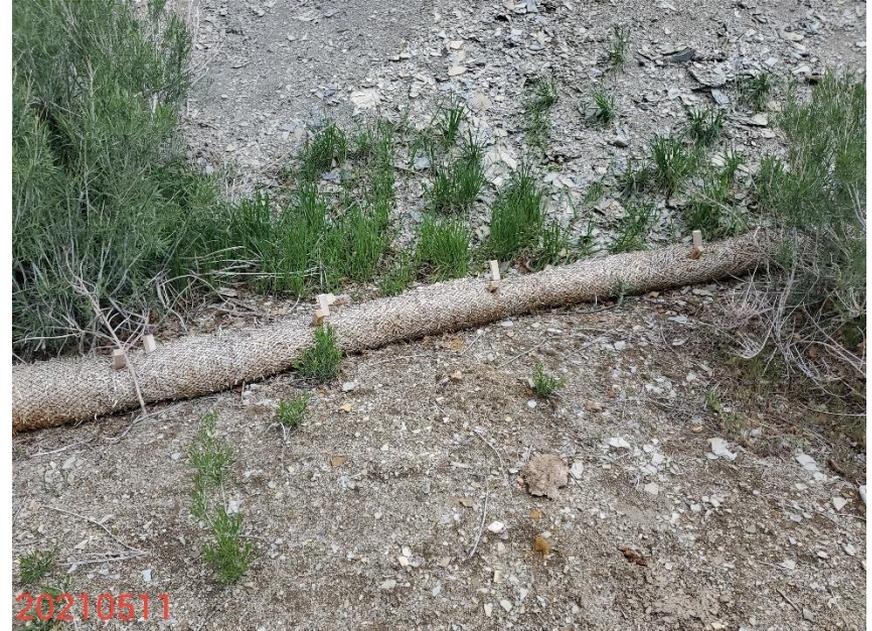
Photo 8: Photo shows wattles along base of cut slope; wattles do not appear to have been properly trenched and backfilled in accordance with good engineering practices.

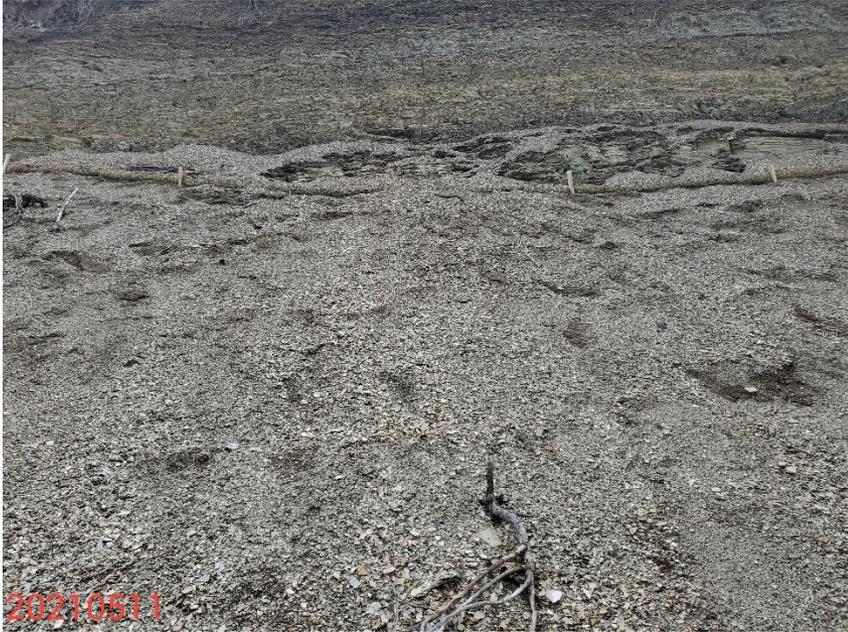
Photo 9: Photo shows areas where erosion on the cut slopes have covered multiple sections of wattles.

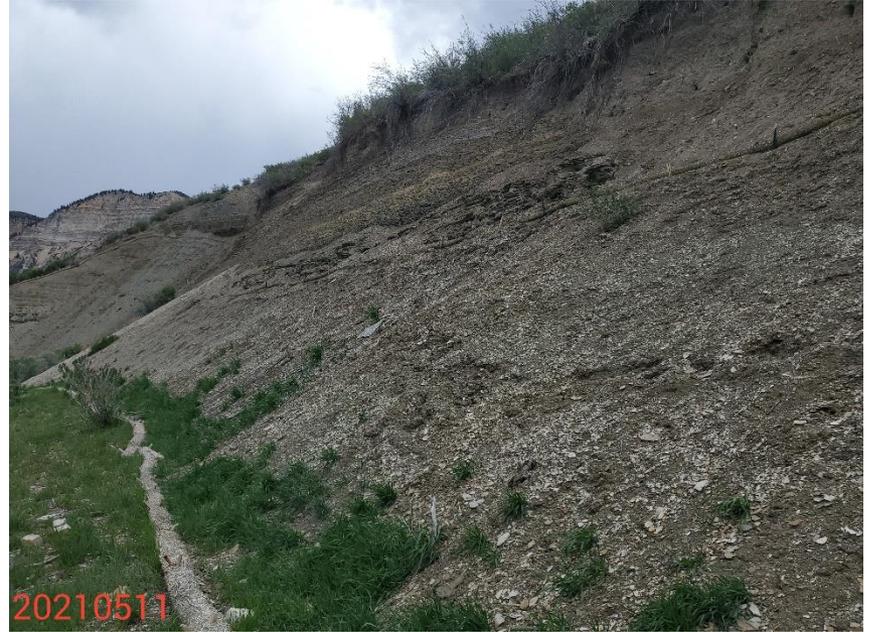
Photo 10: Photo taken from the cut slope on the east end of the Location, facing north. Operator has installed wattles along the base and upper portions of the cut slope; no other control measures were observed to be used in conjunction with the wattles on the slopes. BMPs to stabilize/protect remain missing or insufficient.

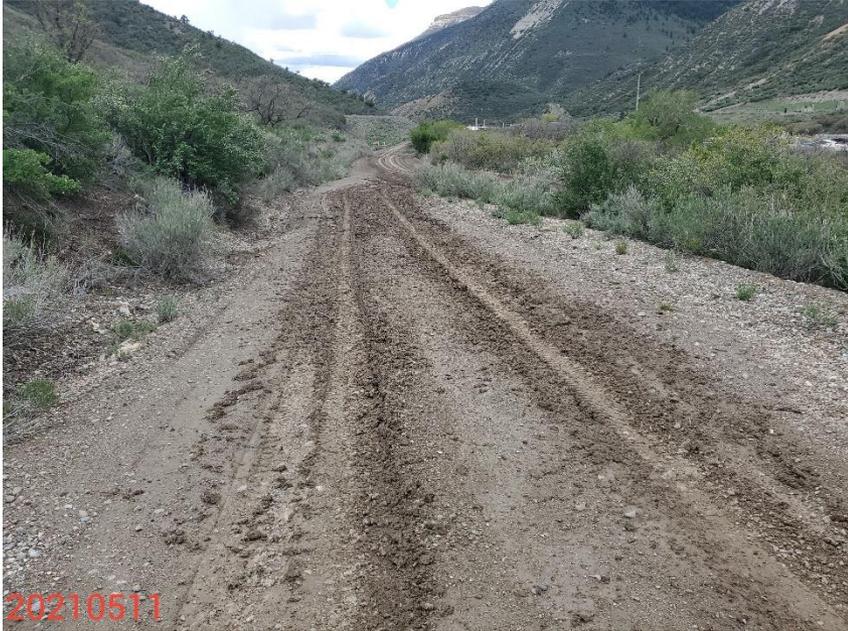
Photo 11: Photo taken from the access road, facing southwest. Photo shows BMPs to stabilize production areas/access road and to prevent off-location sediment transport during wet conditions are missing or insufficient

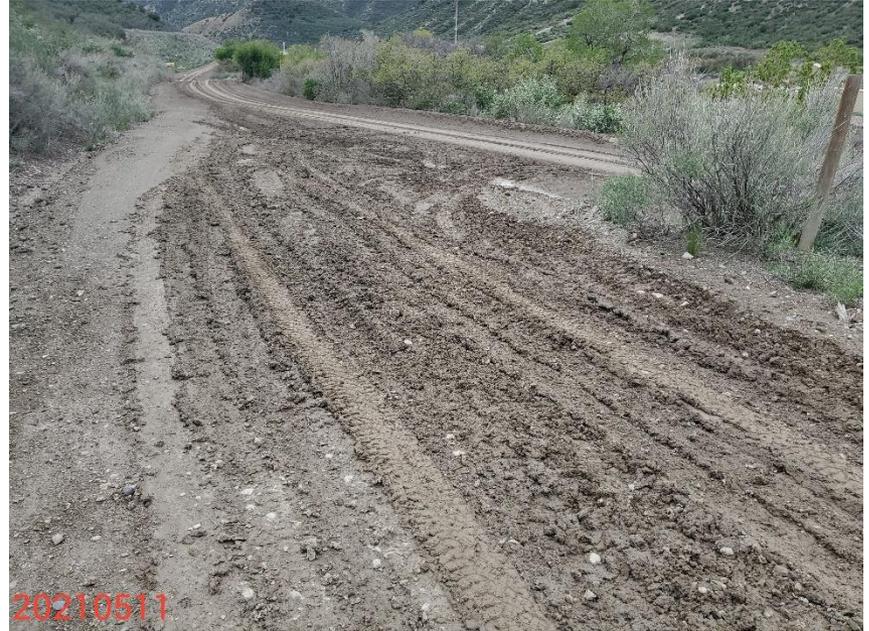
Photo 12: Photo taken from the access road entrance, facing southwest. Photo shows BMPs to stabilize production areas/access road and to prevent off-location sediment transport during wet conditions are missing or insufficient

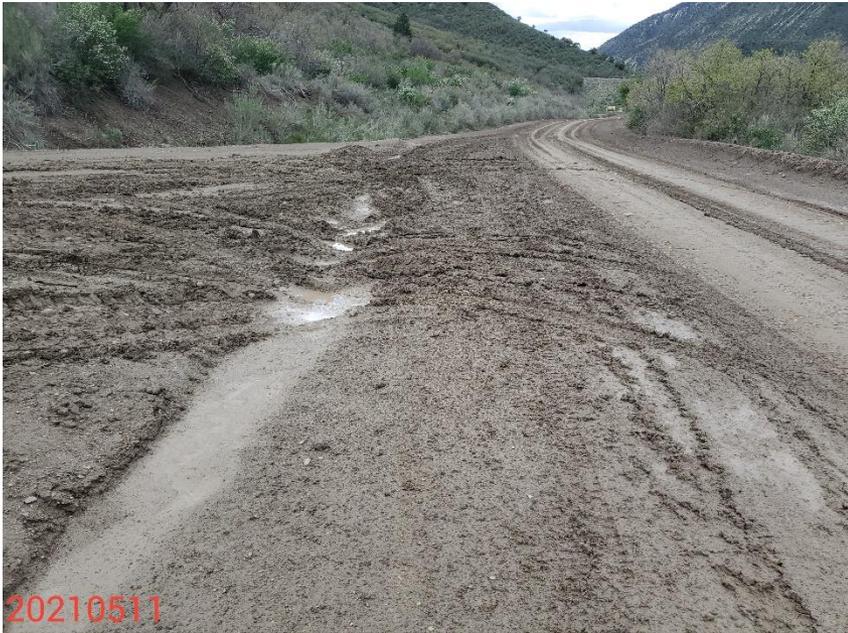
Photo 13: Photo taken from the access road entrance, facing south. Photo shows BMPs to stabilize production areas/access road and to prevent off-location sediment transport during wet conditions are missing or insufficient
