Inspection Photos

Location Name: CAERUS PICEANCE LLC WALLING-68S96W /1NWSE

Location ID: 334062

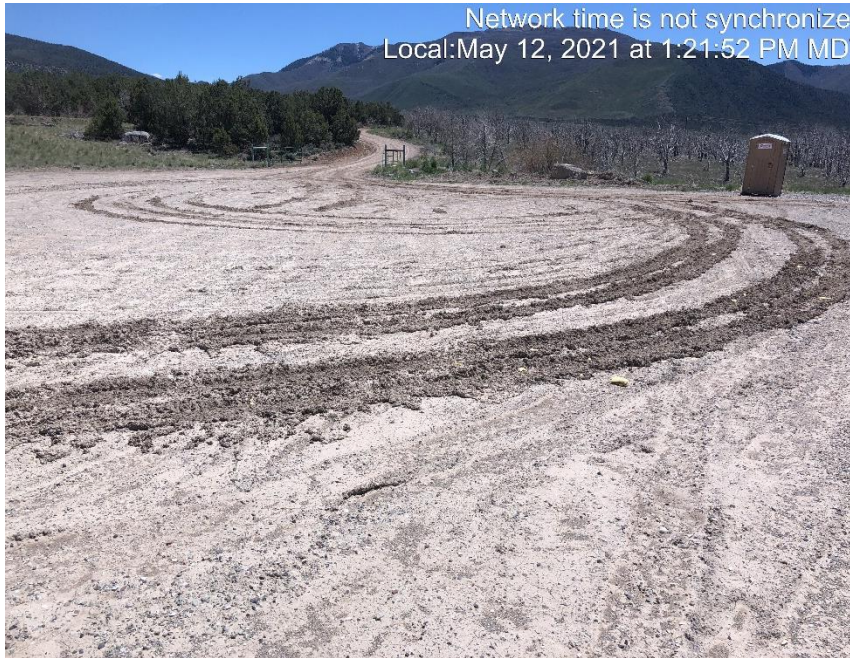
Photo #3787 Location lacks stabilization.

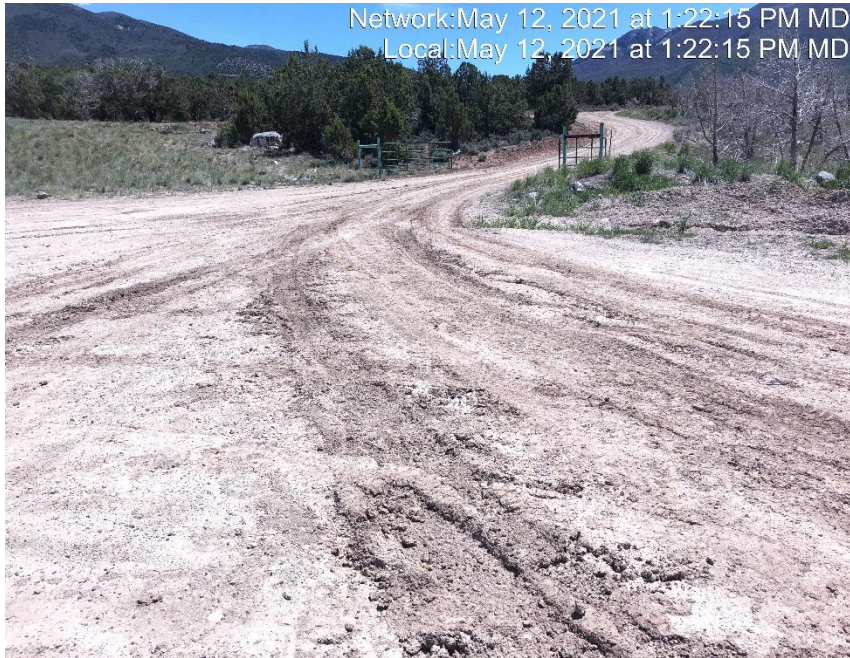
Photo #3788 No form of tracking BMP at entrance to location.

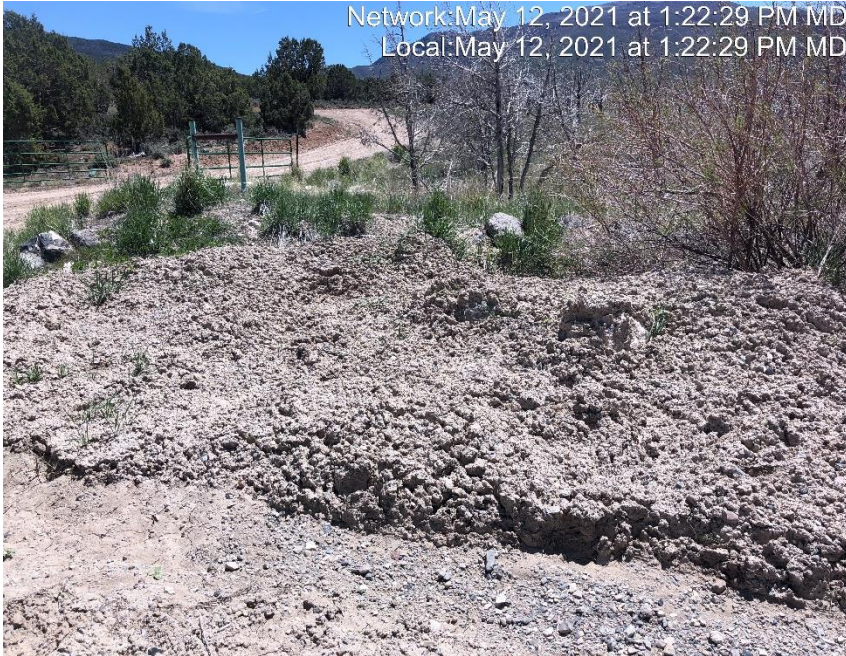
Photo #3789 Sediment has been transported off of location.

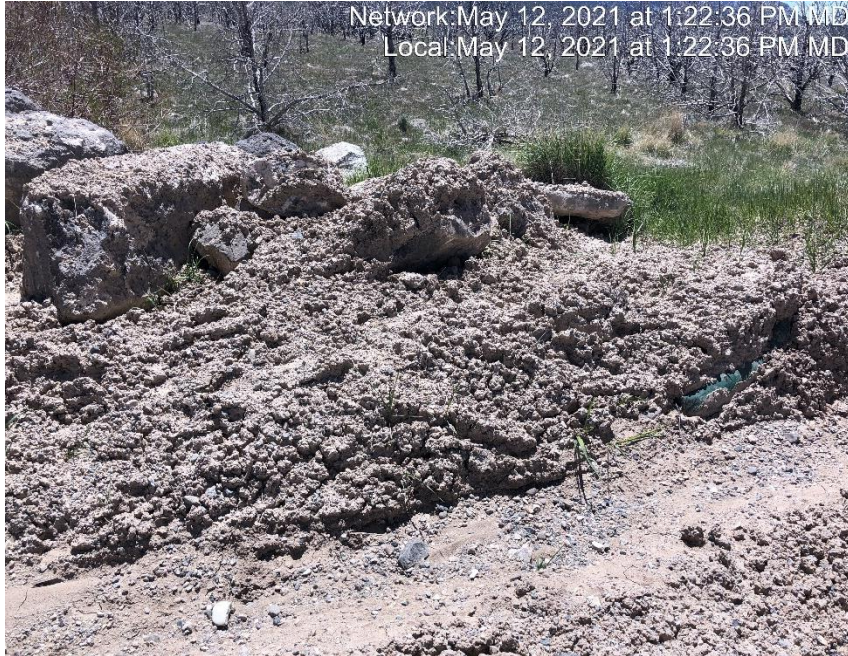
Photo #3790 Sediment is choking off vegetation.

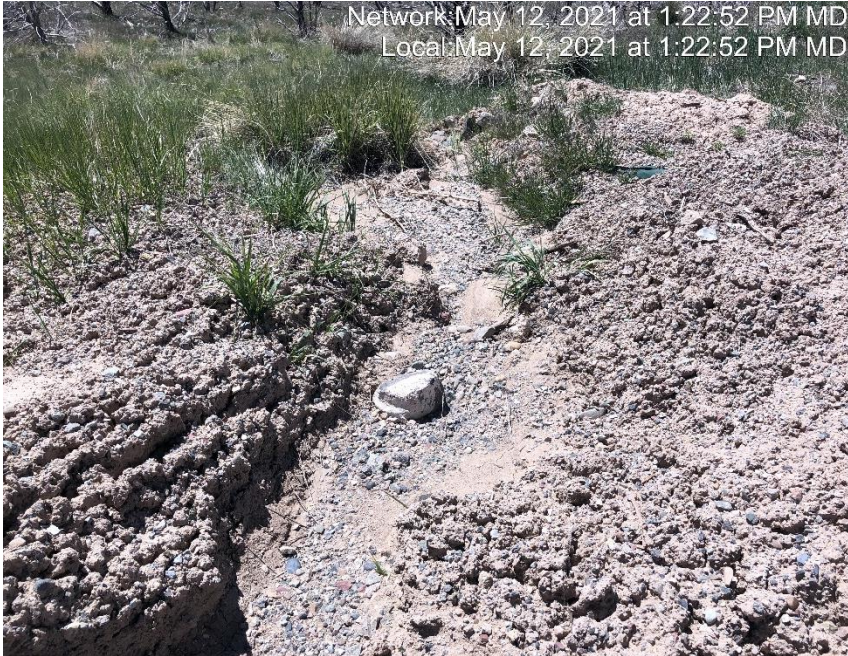
Photo #3791 Sediment has been transported off location.
