Inspection Photos
Operator: Catamount
API: 067-05434
Date: 5/10/2021

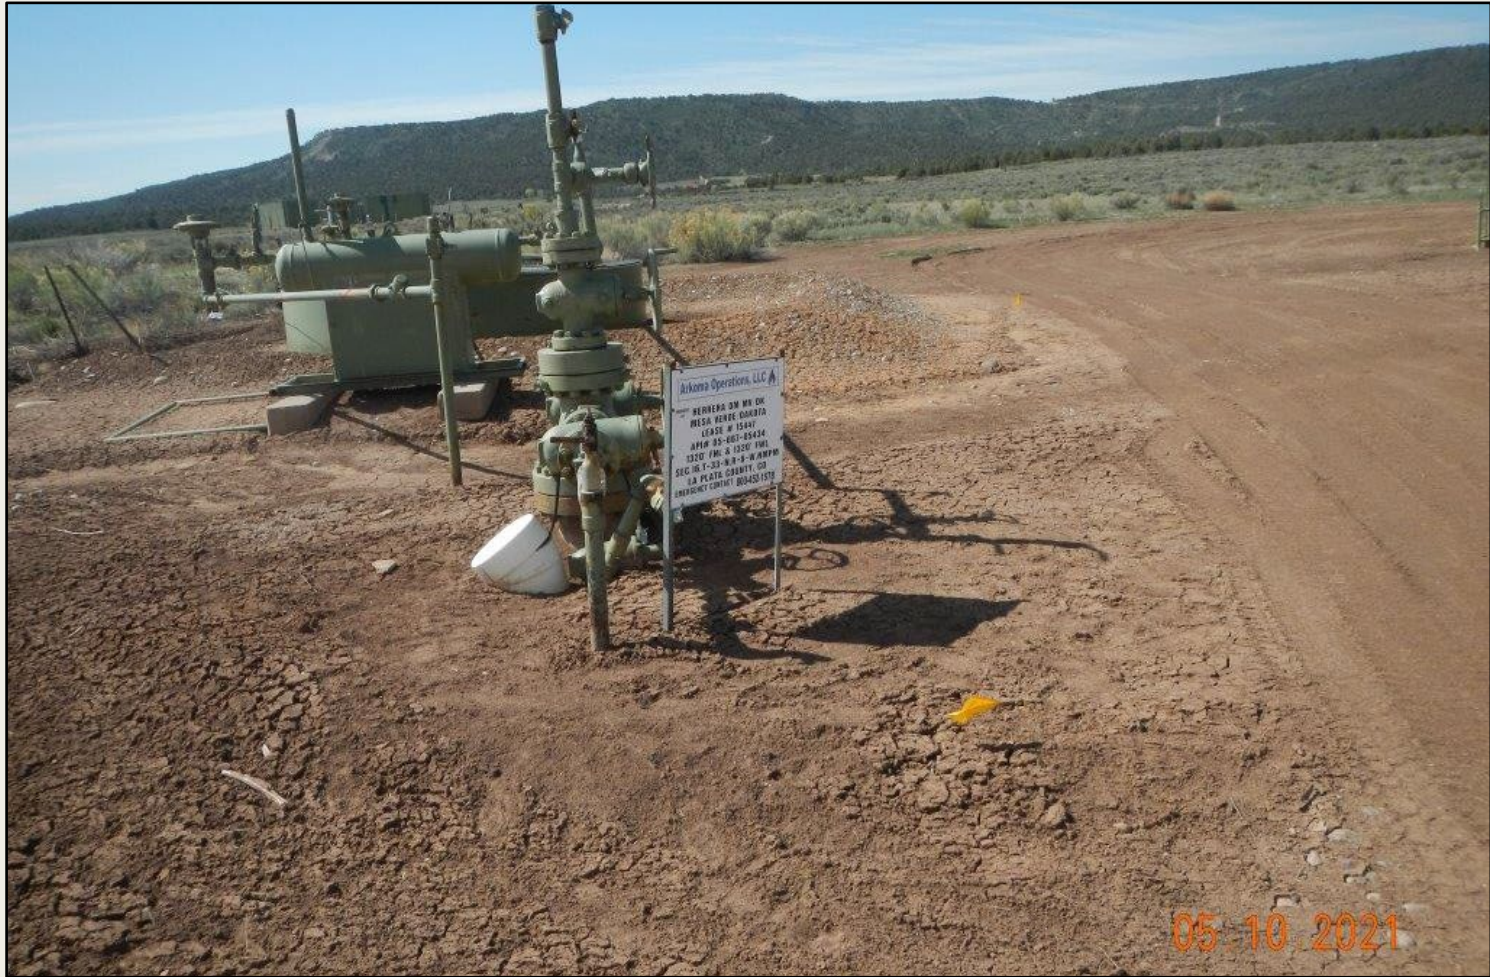
Photo 1. View of the project area from the well pad entrance facing southward.

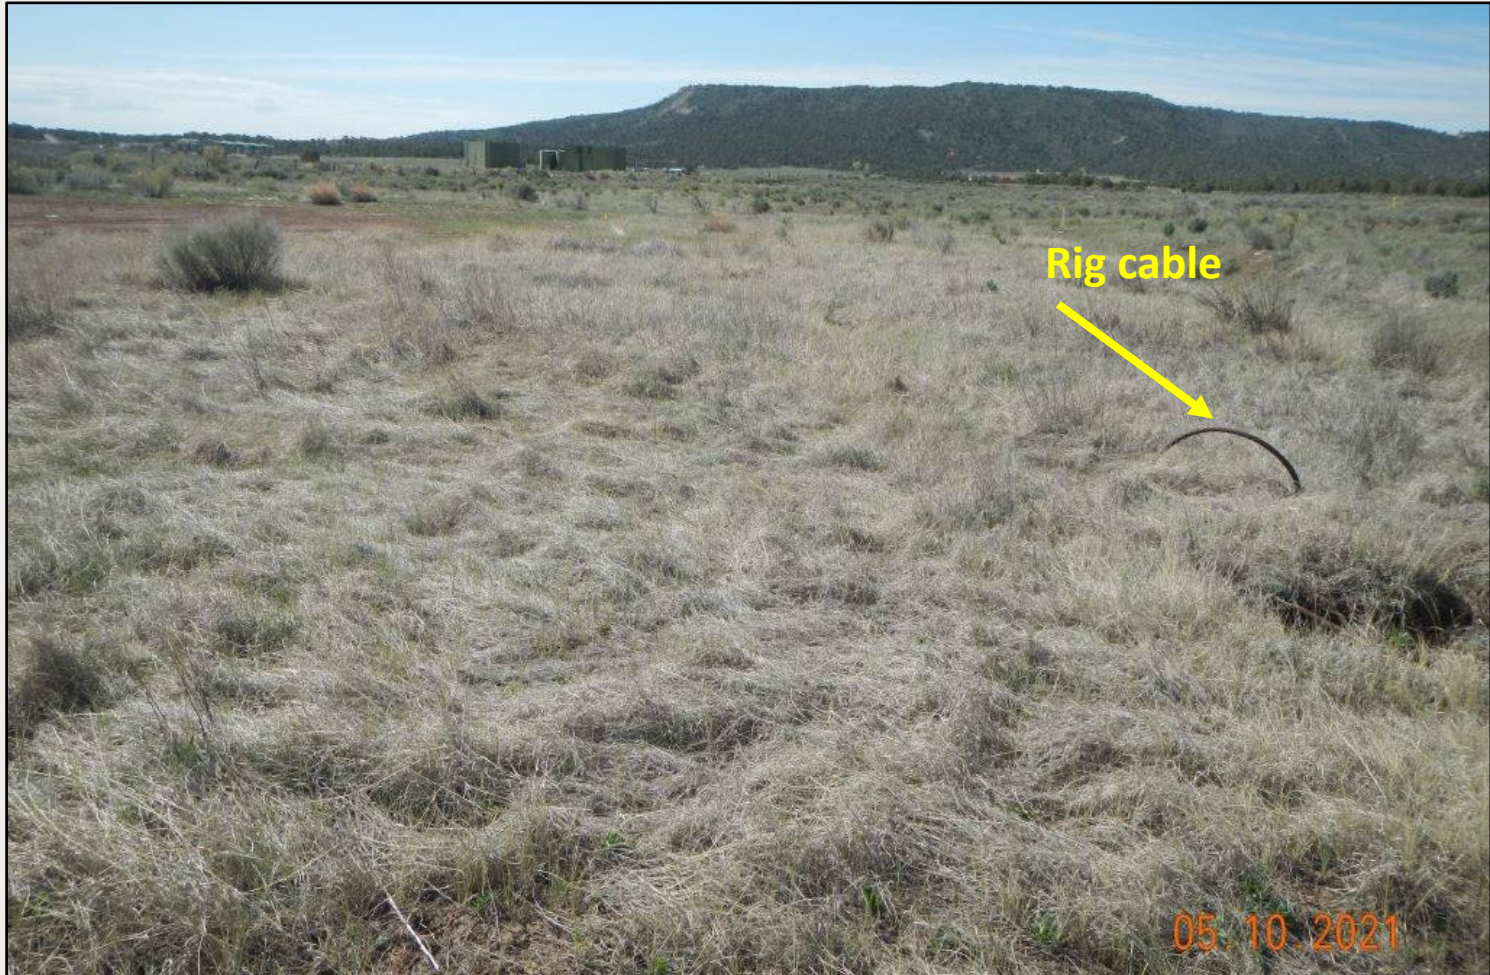
Photo 2. View of the western project area from the northwestern corner facing southward. Revegetation is established within the interim reclamation areas. Rig cable needs to be removed.

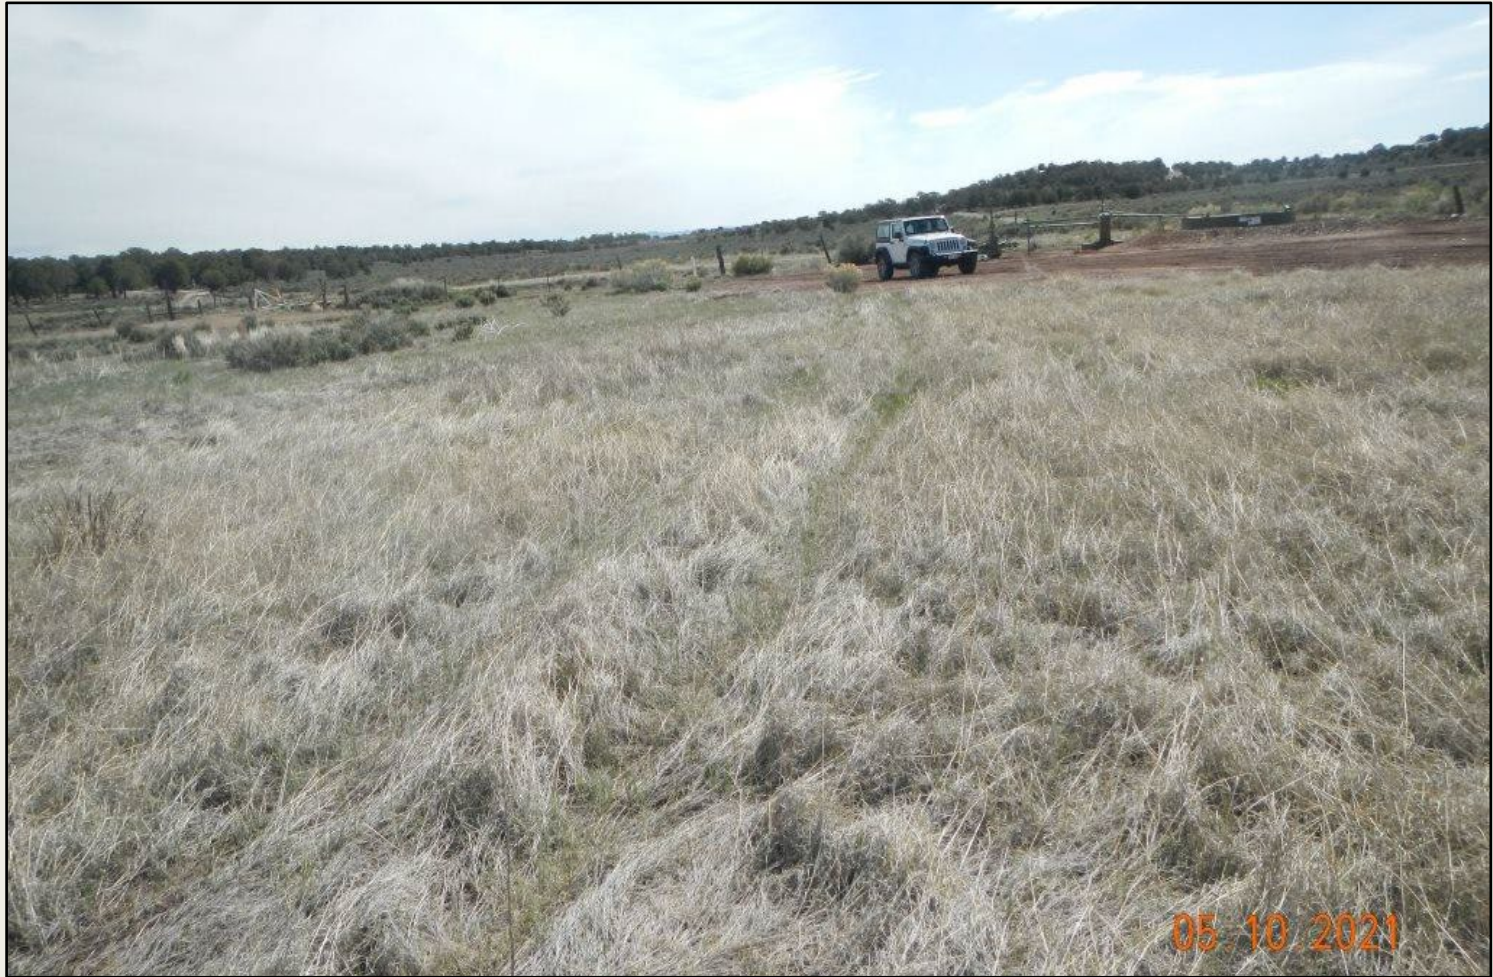
Photo 3. View of the northern project area from the northwestern corner facing eastward.

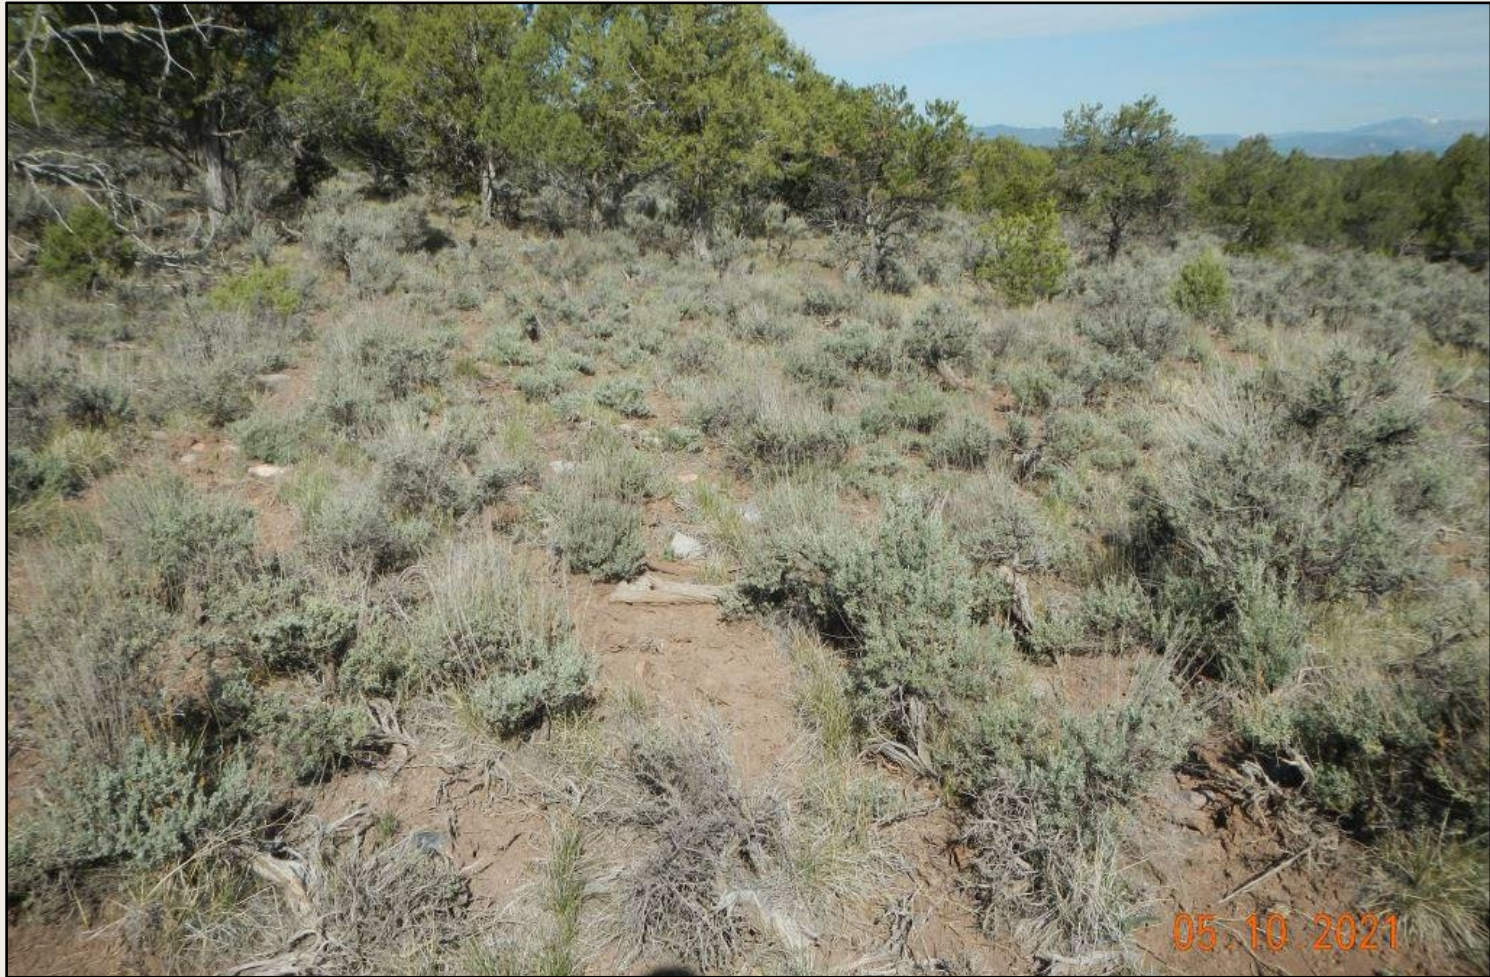
Photo 4. View of the reference area comprised of sagebrush shrubland with scattered pinyon and juniper trees, squirreltail, western wheatgrass, and forbs such as penstemon, and phlox.
